Germantown/Mount Airy Properties

Physical Conditions and Needs Assessment

Premises A

6526-34 Germantown Ave

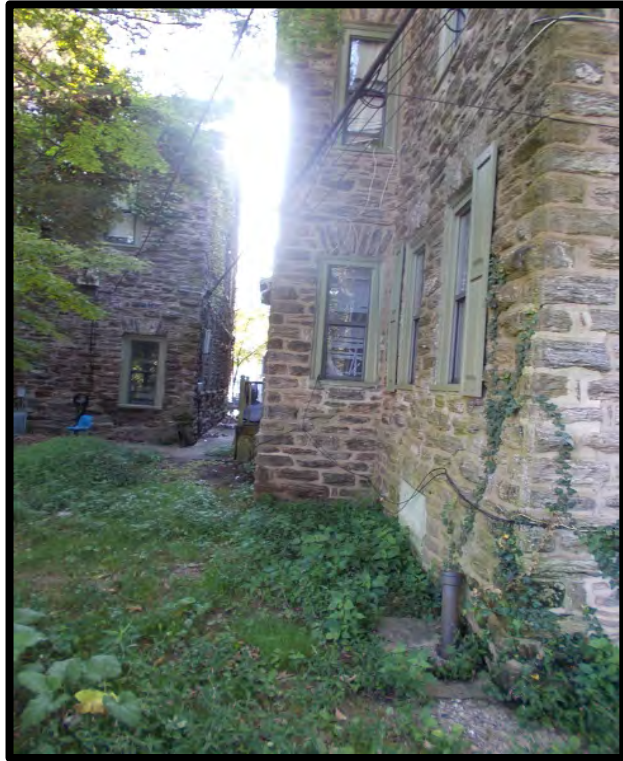
Photo No. 8

Detailed view of same corner. Note downspout is missing from boot. Also seen in background is the partial west and south elevations of 6534 Germantown Avenue.

Roofs should be inspected for failure at seams and flashings. Replace gutters and downspouts in their entirety to ensure continuous uninterrupted storm water flow away from the building.

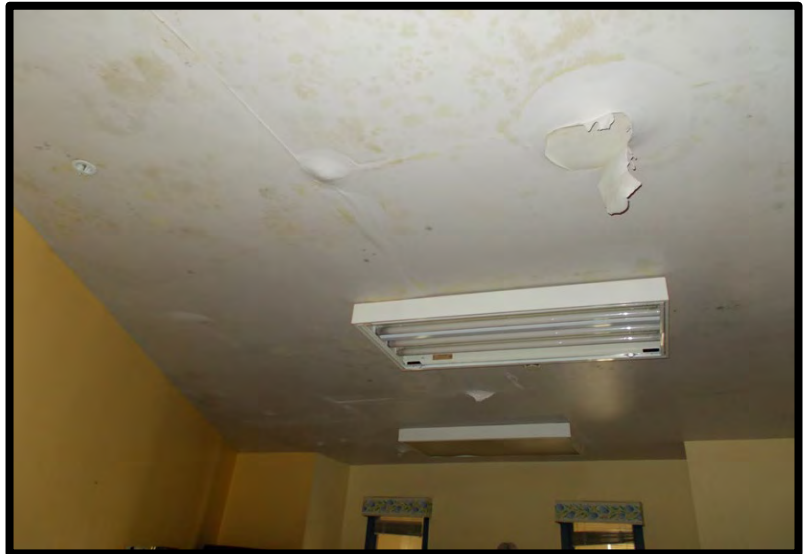
Photo No. 99

The rental office, located on the first floor of 6534 Germantown Ave, consists of an open office area and a unisex toilet room for employee use. Finishes in the office consist of gypsum wallboard in poor condition. Large areas of moisture damaged ceiling was noted. Mold remediation is required. Flooring in the office is carpet in poor condition. Vinyl tile is provided in the toilet room, also in poor condition.

View of water infiltration along ceiling first floor office
space.

New floor treatment is required. Repaint interior walls. Replace finishes within the office area, including toilet room.

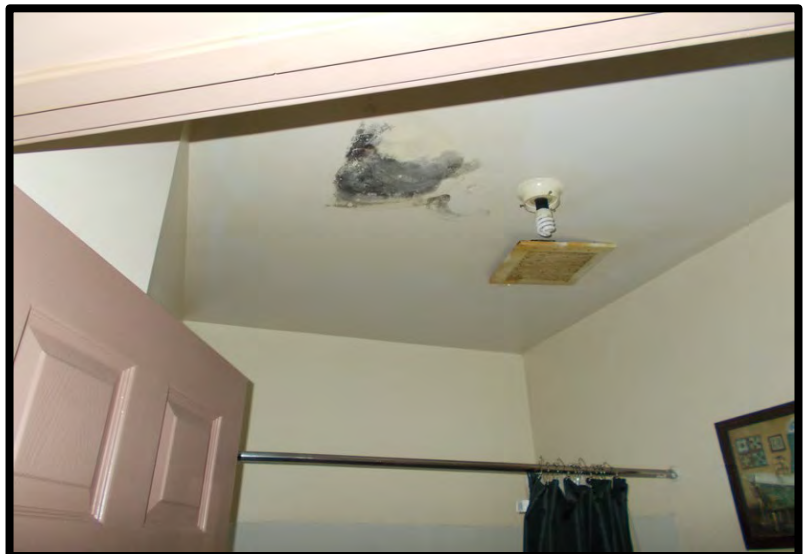
Photo No. 175

Panning up from previous photo. View of water infiltration and mold at ceiling.

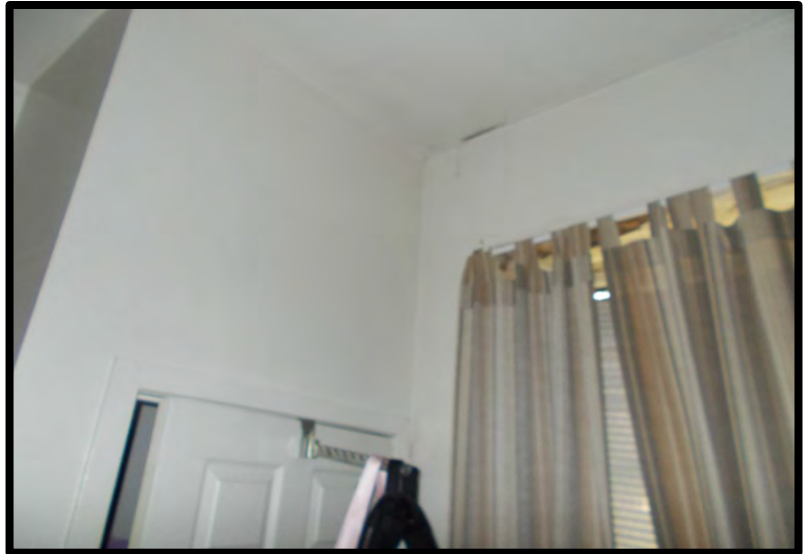
Photo No. 196

View of moisture damage in wall and ceiling of
bedroom 2.

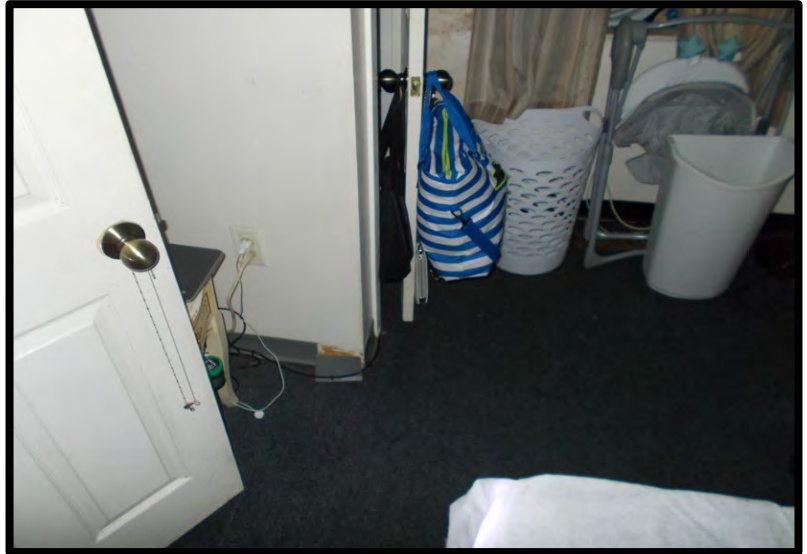
Photo No. 198

View floor at bedroom 2 closet. This area was found to be soft and may exhibit damage from water infiltration with compromised sub floor.

Replacement of subfloor and possibly floor framing in this area is required.

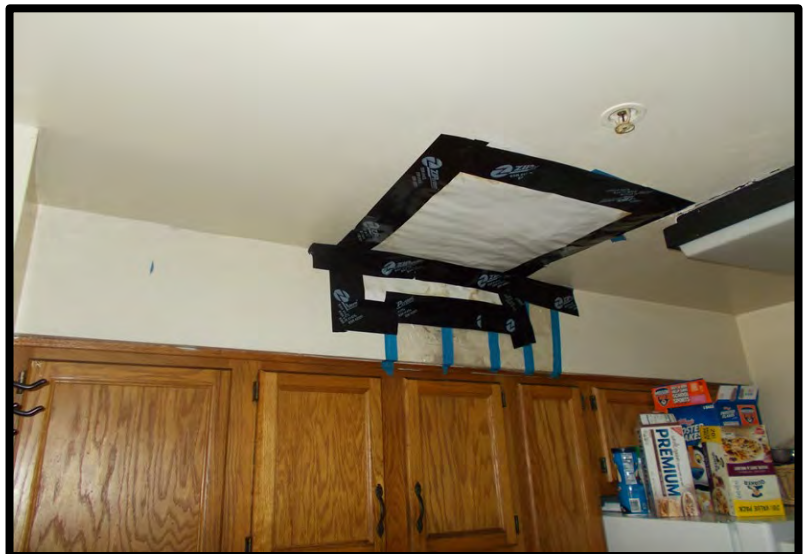
Photo No. 207

Unit 3 - Repairs are required to walls and ceilings, especially at the first floor half bath and kitchen. Water damage from bathroom above is causing damage at the kitchen soffit. Repairs are also required at the second floor bathroom around the tub and at hallway light/fan.

View of damaged ceiling and wall above kitchen
cabinets presumably below the bathroom above.

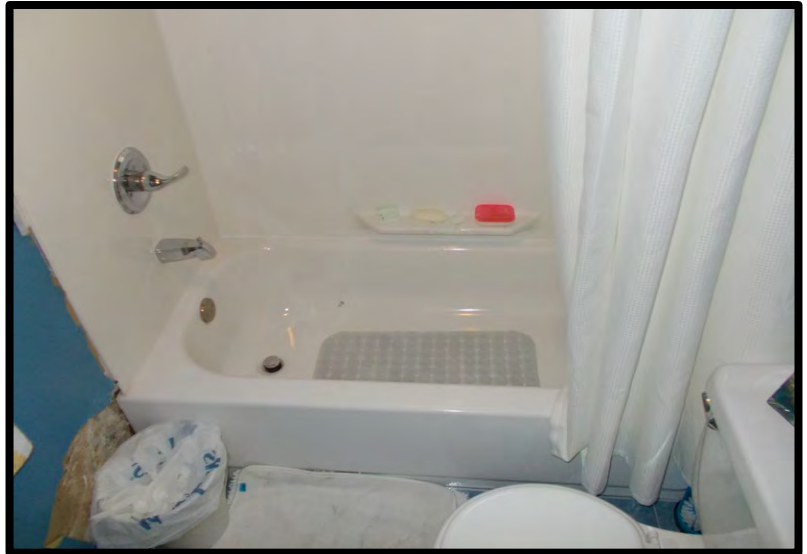
Photo No. 212

View of bathtub and fiberglass tub surround. Also visible in the photo bottom left corner is probable water infiltration around bathtub leading to leak below.

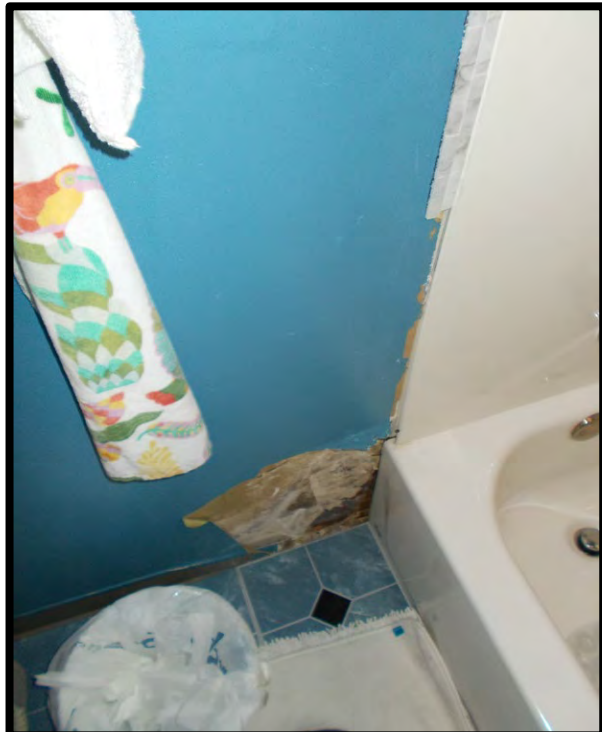
Photo No. 213

Close up view of damaged wall section probably allowing water infiltration to kitchen below.

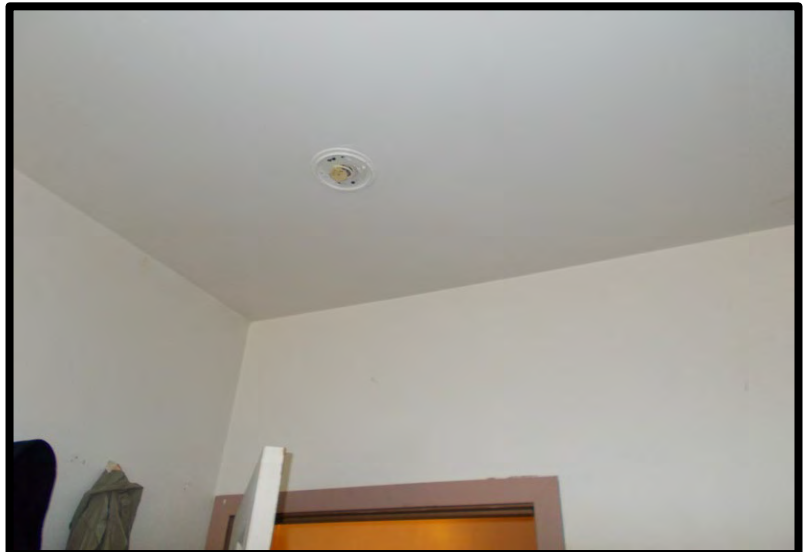
Photo No. 221

View of missing smoke detector head above door in
bedroom 2.

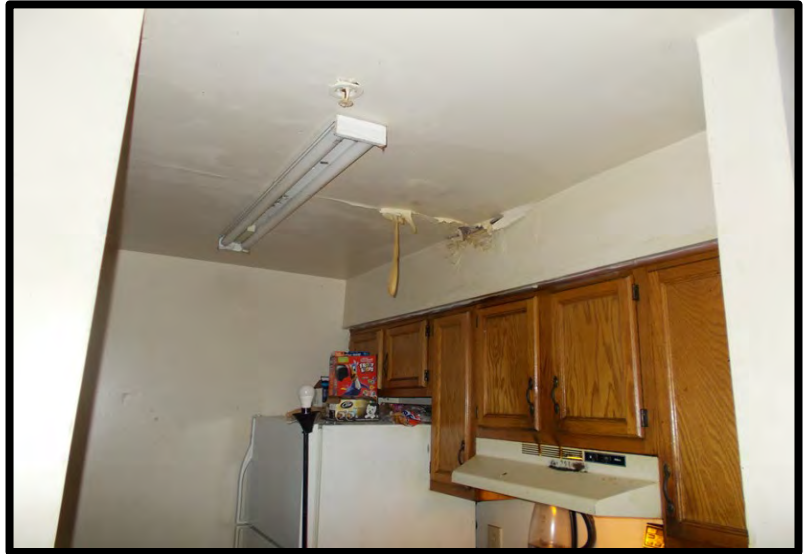
Photo No. 229

View of ceiling damage likely similar cause of water infiltration from bathroom above.

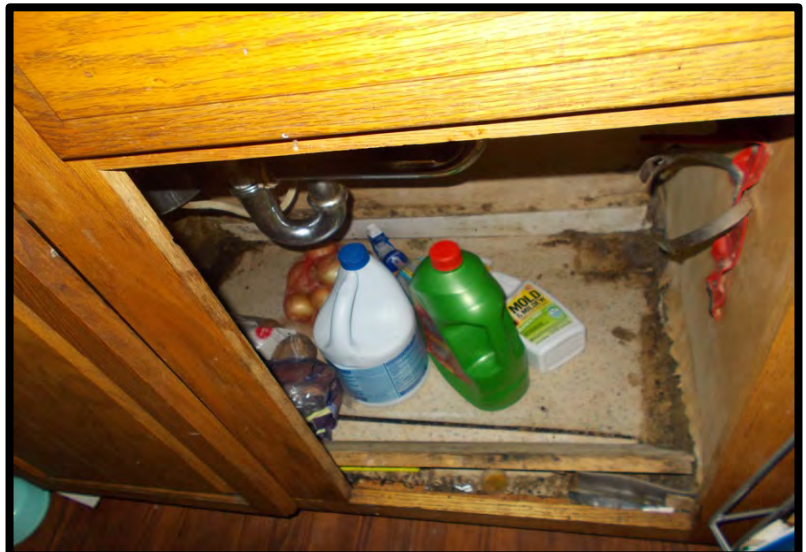
Photo No. 232

Depicts damaged sink base cabinet probably from plumbing issues at kitchen sink.

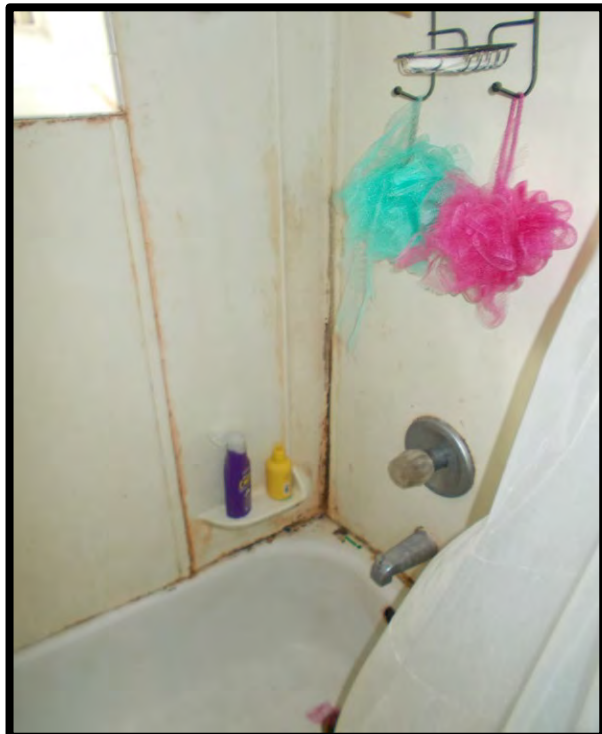
Photo No. 238

Depicts likely cause of water infiltration at fiberglass
tub surround.

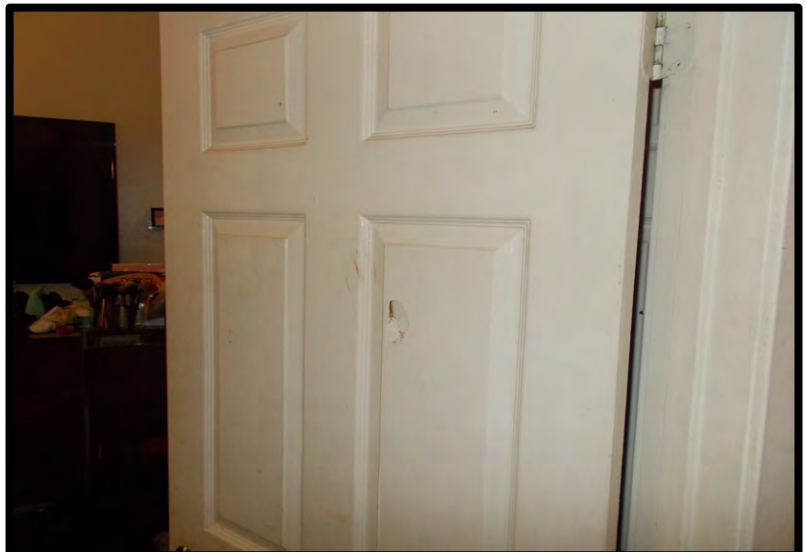
Photo No. 243

Depicts damaged door at bedroom 2.
