# Germantown/Mount Airy Properties

## Physical Conditions and Needs Assessment

### Premises B

**6657-59 Blakemore Street**

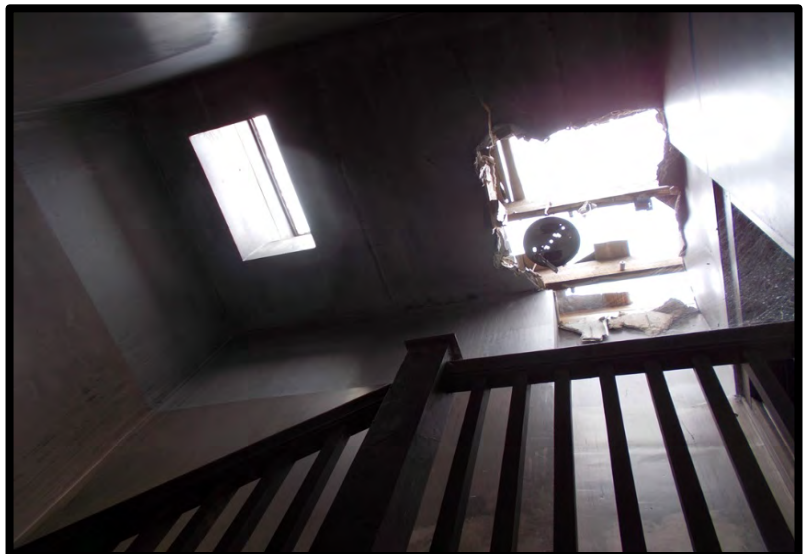
**Photo No. 2**

View of collapsed ceiling above and skylight at west entry to 2nd Fl unit.

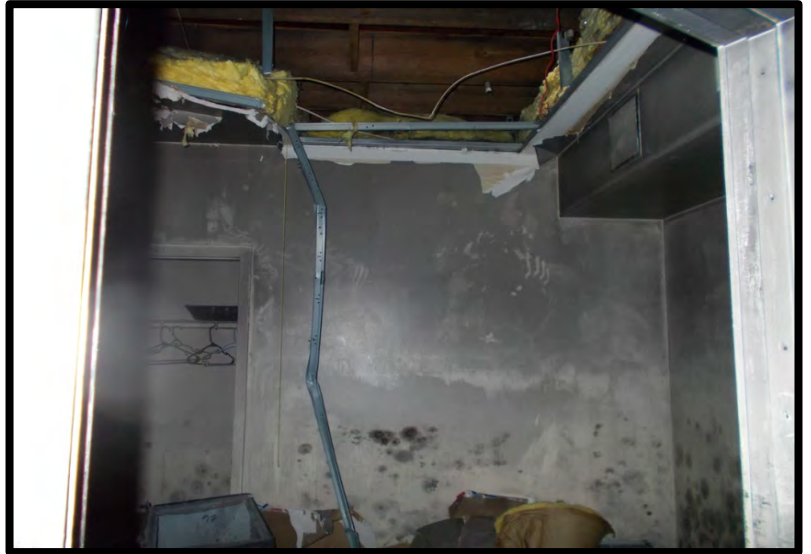
**Photo No. 9**

Exhaust system will have to be repaired due to fire damage.

Depicts typical collapsed ceiling and ductwork with smoke damage throughout.

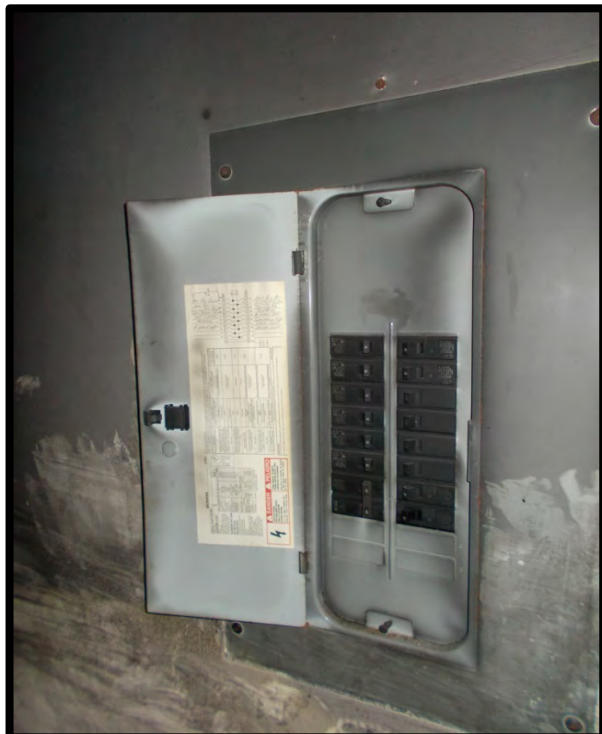
**Photo No. 10**

Electrical systems and fixtures will have to be repaired/replaced due to fire damage.

Depicts typical apartment electrical panel.

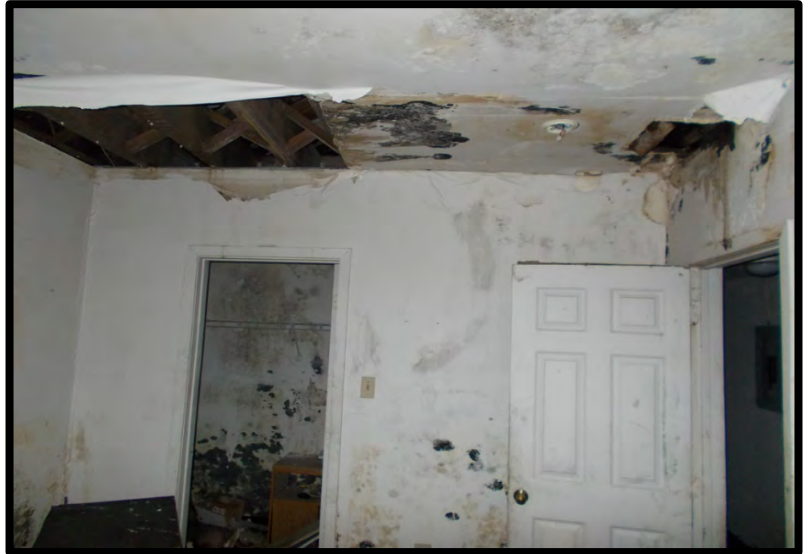
**Photo No. 13**

Depicts view of 1st Fl south apartment. Note typical collapsed ceilings and mold throughout.

*General conditions of the units are poor with noted areas of spalled drywall, damaged walls and ceilings. Finishes throughout should be replaced. Mold remediation is required. Replace all interior doors in all units.*

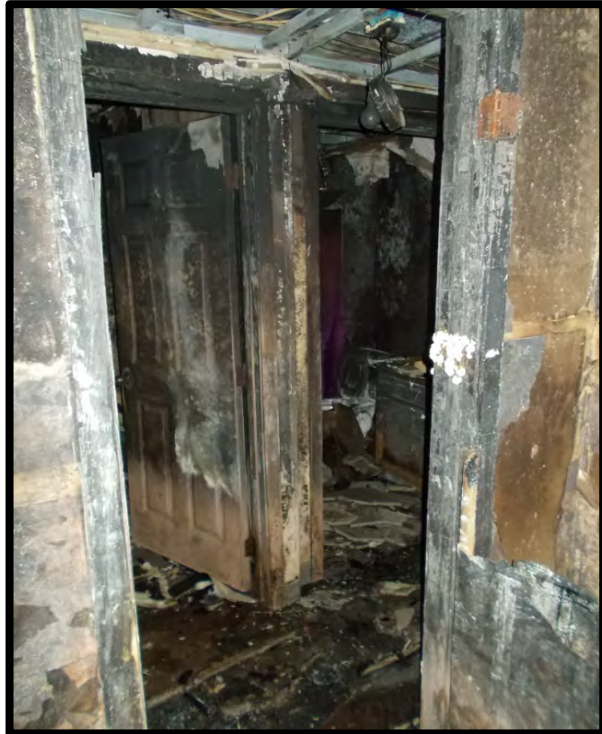
**Photo No. 17**

View of 1st FI north unit. Note damage from previous fire and subsequent water to douse it.

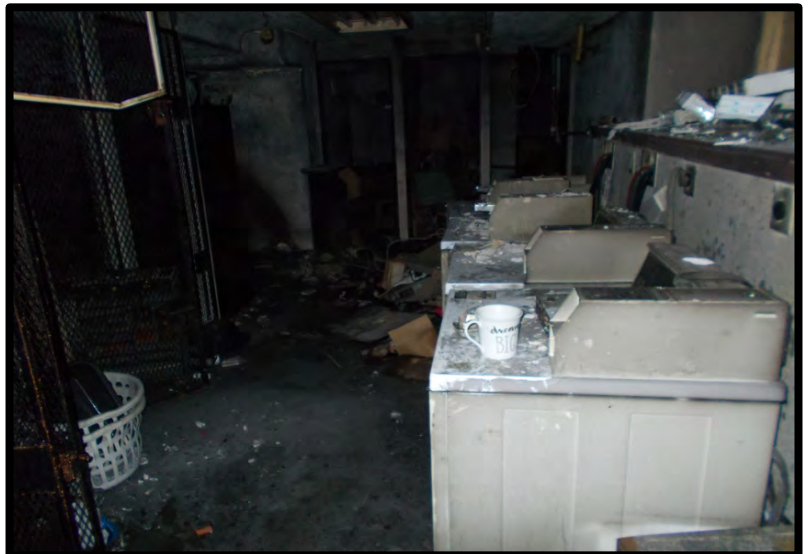
**Photo No. 29**

Common areas are entry hallways at the entries with what appears to be 12" x12" vinyl tile over sub-floor. The floor is missing most tiles and is generally in very poor condition. The basement also contains a community laundry and storage room. Each apartment was provided with a fenced in area for storage. The laundry was provided with coin operated washers and dryers. The entire area has been damaged in the fire.

View of common laundry facilities located in the basement.

*New floor treatment is required. Replace and repaint interior walls and ceilings. Renovate the laundry and storage area.*

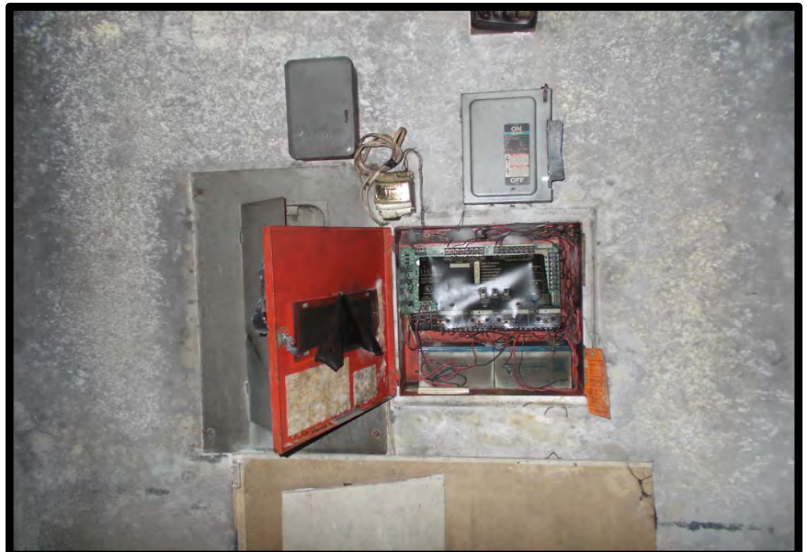
**Photo No. 31**

Fire alarm system will have to be repaired due to fire damage.

View of fire alarm control panel and exterior lighting time clock in basement.

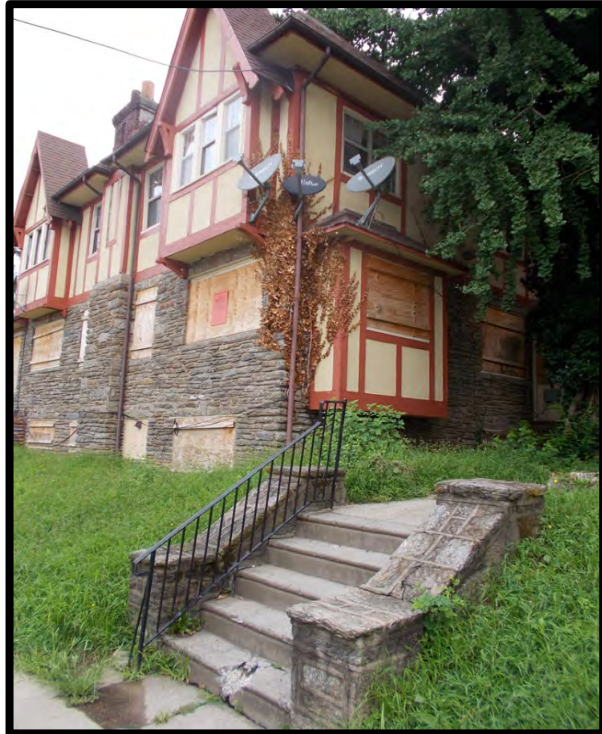
**Photo No. 48**

The north 1st floor unit is accessed via exterior stair from the north side walkway leading east from Vernon Road. Most stairs are in good to fair condition. Repair of stairs along Blakemore is required.

View of southeast corner of the building and exterior concrete stairs from Blakemore St.

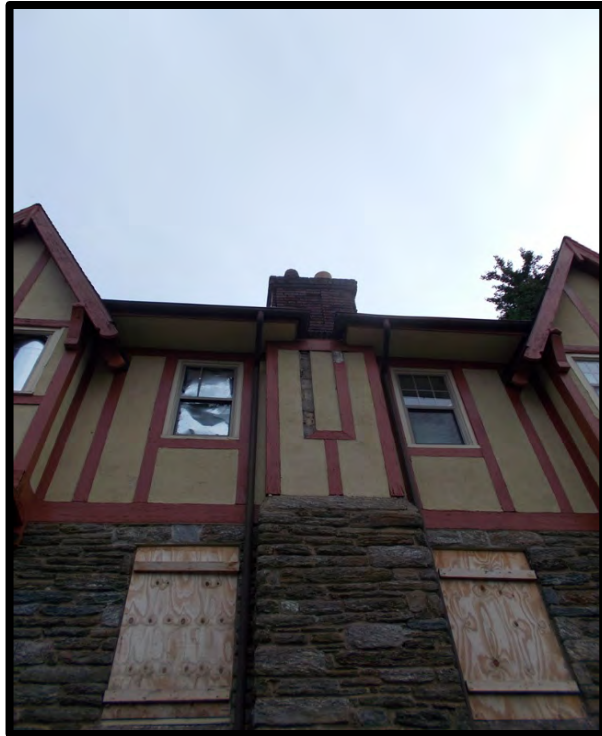
**Photo No. 50**

View of second Fl of south façade. Note missing piece of wood trim.

*Repair wood trim and paint to maintain it in serviceable condition. Replace exfoliated steel window lintels.*
