Germantown/Mount Airy Properties

Physical Conditions and Needs Assessment

Premises C

5429-43 Lena Street

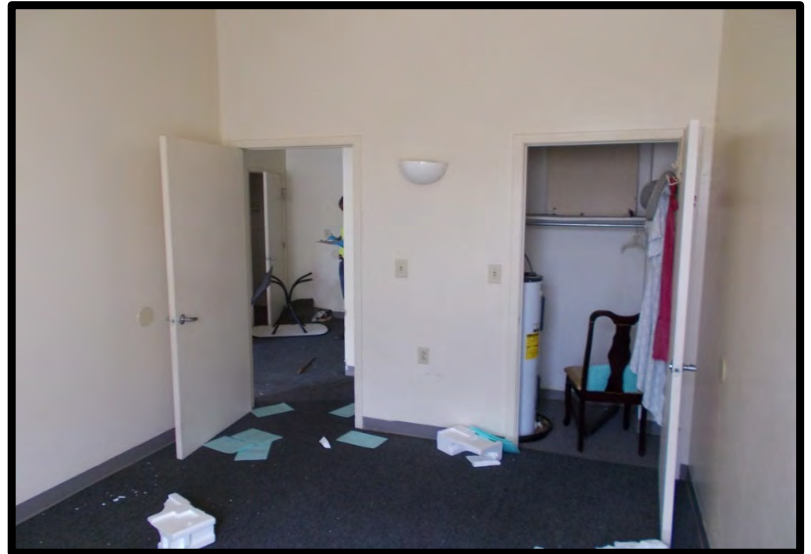
Photo No. 11

Typical apartments include an abandoned above ceiling electric hot water heater in the closet of the master bedroom. Depending on the unit the hot water heater and flue connections are in excellent to poor conditions.

View of typical apartment bedroom entry and closet. Note electric domestic hot water heater installed in closet. Typical in all units.

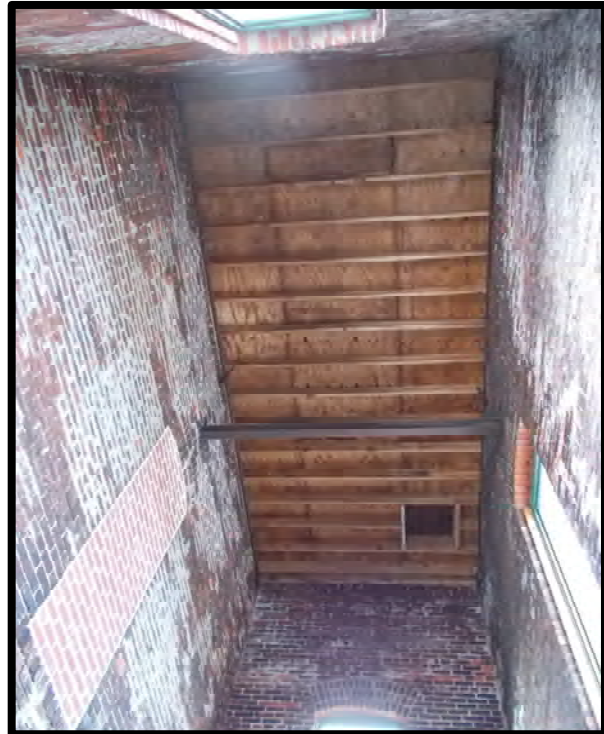
Photo No. 22

View looking up at South stair tower roof framing.
Note access ladder to stair tower was missing,
precluding access to stair tower roof.

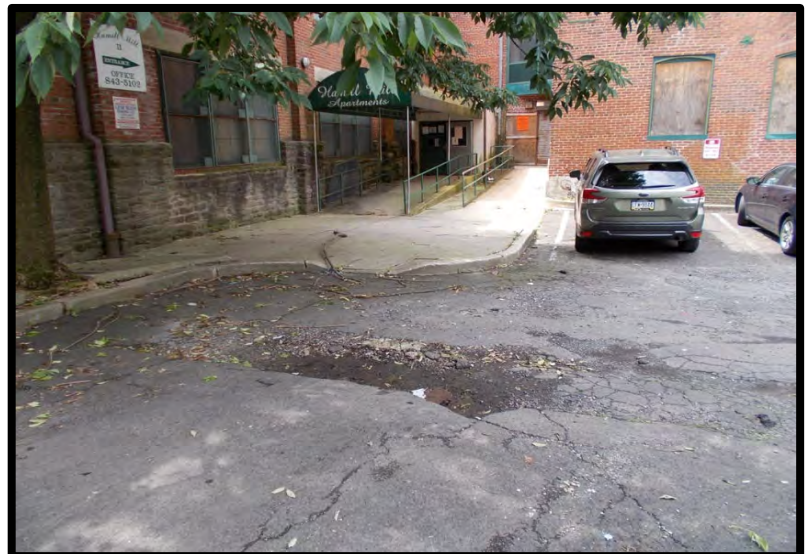
Photo No. 74

There is a parking lot adjacent to the building off of Church Lane. Curbs and pavement appear to be in fair condition. There is overgrown vegetation overtaking the pavement and coming through the curb. There appears to be at least one pot hole in the asphalt.

View of large pothole and concrete curbing, southeast portion of property.

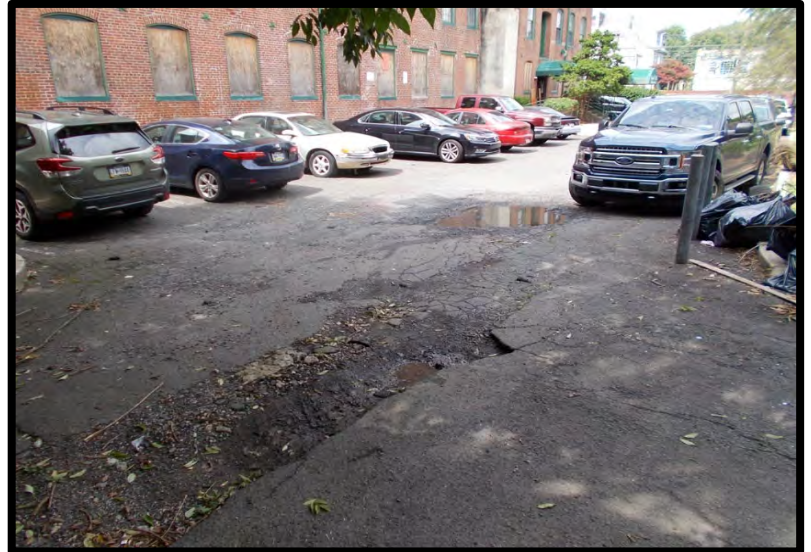
Photo No. 75

Panning right from previous photo. Puddle is actually an additional large pothole.

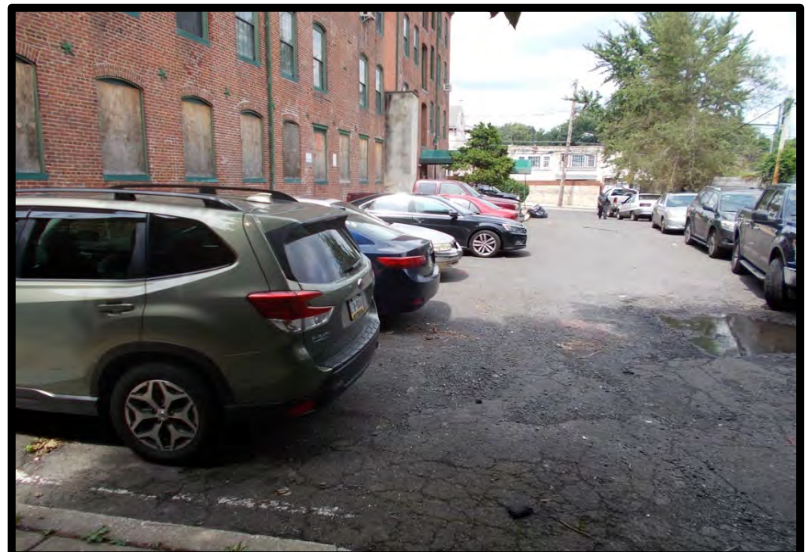
Photo No. 76

Additional view of east parking lot with large pothole and poor paving.
