Germantown/Mount Airy Properties

Physical Conditions and Needs Assessment

Premises D
60-74 Collom St
Philadelphia, PA 19144

March 2021

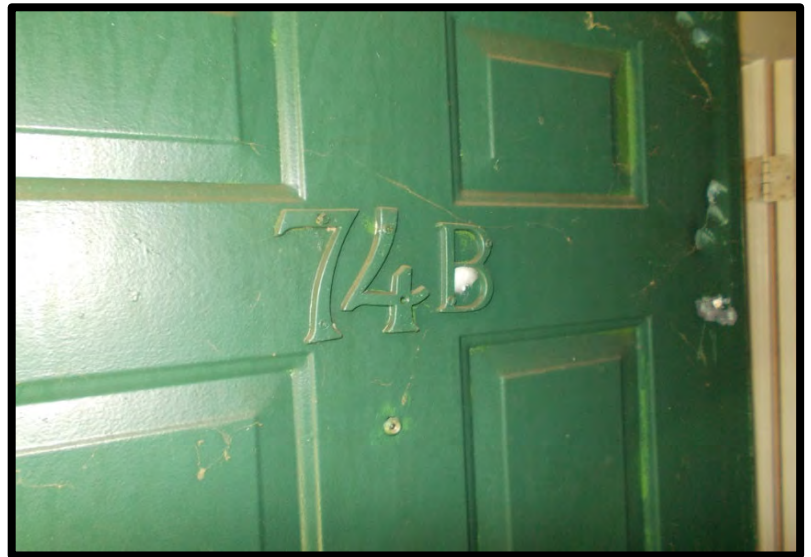
Photo No. 196

| Division | Capital Expense Category | Description / Comments | Condition | Action | EUL (yr) | Effective Age (yr) | RUL (yr) | Quantity | Unit of Measure | Unit Cost | Total Cost | Critical Repairs | Year 1 12 Month | Year 2 | Year 3 |
|---|---|---|---|---|---|---|---|---|---|---|---|---|---|---|---|
| | Unit 74B | Half wall at stair removed; fall hazard | Poor | Repair | 35 | 20 | 15 | 10 | LF | \$8.00 | \$800 | | | | |

View of second floor stairs, damaged wall in living room and view of hallway leading to rear.

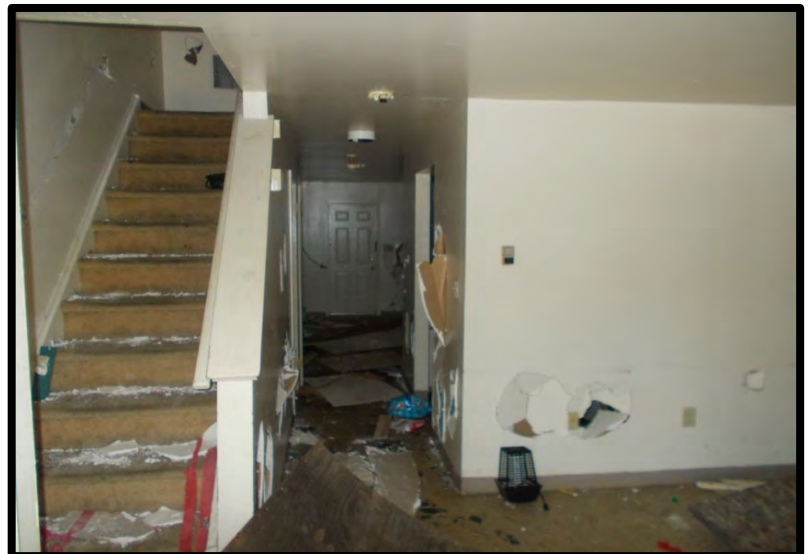
Photo No. 197

View of damaged gypsum wallboard at stair to second floor.

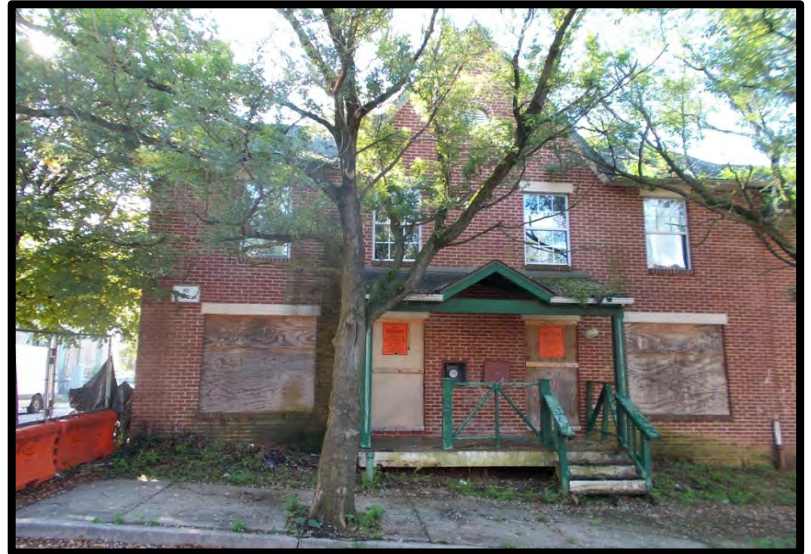
Photo No. 1

Each unit had an interior wood stair from the first to second floor. The stair structure in all units was sound. New carpeting for the stair should be provided. The entry porch and stairs are generally in poor condition throughout the complex. Stairs from grade and porch decking should be replaced throughout.

| Division | Capital Expense Category | Description / Comments | Condition | Action | EUL (yr) | Effective Age (yr) | RUL (yr) | Quantity | Unit of Measure | Unit Cost | Total Cost | Critical Repairs | Year 1 12 Month | Year 2 | Year 3 |
|---|---|---|---|---|---|---|---|---|---|---|---|---|---|---|---|
| | | Covered lean-to porch (columns, wooden porch; missing leaders) | Poor | Full replacement | 20 | 20 | 0 | 7 | EA | \$2,500.00 | \$17,500 | \$17,500 | | | |

Photo depicts court yard elevation (front) of units 64B (left) and 66A (right). Note full replacement of the entry porch and stairs is required. Typical.

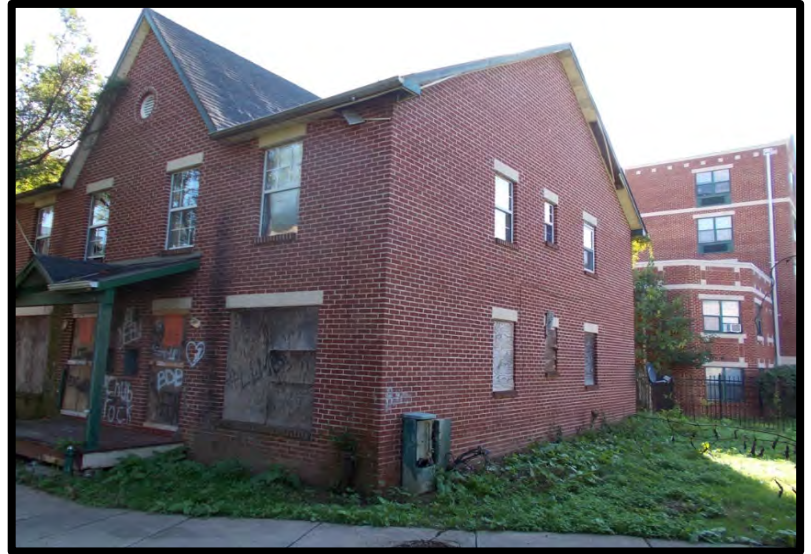
Photo No. 25

| Division | Capital Expense Category | Description / Comments | Condition | Action | EUL (yr) | Effective Age (yr) | RUL (yr) | Quantity | Unit of Measure | Unit Cost | Total Cost | Critical Repairs | Year 1 12 Month | Year 2 | Year 3 |
|---|---|---|---|---|---|---|---|---|---|---|---|---|---|---|---|
| | | Soffits and fascias | Poor | Replacement of all soffit vent areas including rakes | 20 | 20 | 0 | 600 | LF | \$13.00 | \$7,800 | \$7,800 | | | |

View of south façade of unit 74B. Note
missing/damaged rake and eaves.

Roofs should be replaced within the complex, including shed entry porch's. Repair replace missing soffit and fascia trim. Aluminum gutters and downspouts should be replaced as part of the roofing work.

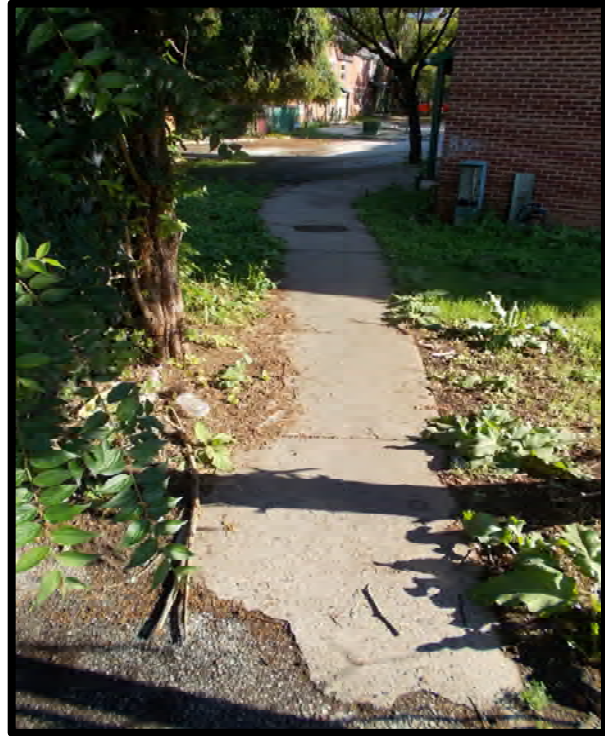
Photo No. 27

View of damaged sidewalk along the south side of property.

Sidewalks within the property and along Lena and Collom Streets have areas of heaved concrete sections. These should be removed and replaced in conjunction with tree root pruning. Also noted were open valve cover boxes in the sidewalks that are tripping hazards. These should also be replaced.

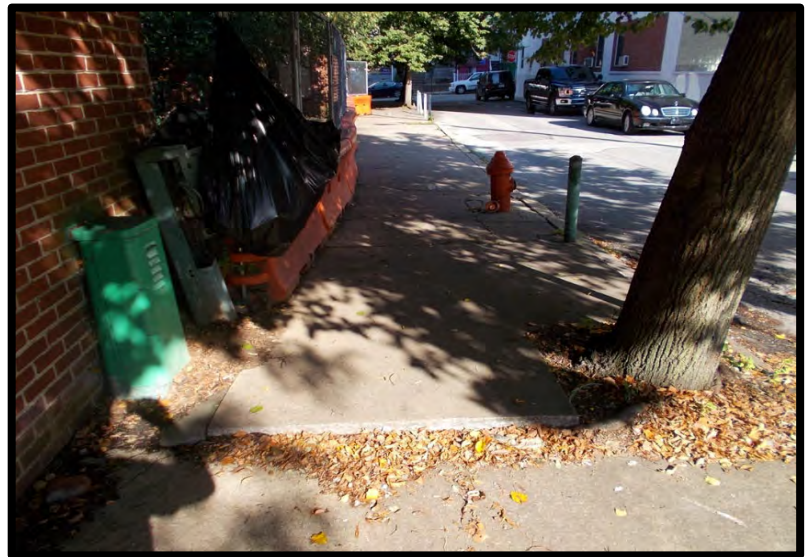
Photo No. 36

| Division | Capital Expense Category | Description / Comments | Condition | Action | EUL (yr) | Effective Age (yr) | RUL (yr) | Quantity | Unit of Measure | Unit Cost | Total Cost | Critical Repairs | Year 1 12 Month | Year 2 | Year 3 |
|---|---|---|---|---|---|---|---|---|---|---|---|---|---|---|---|
| Concrete | | Heaved sidewalk due to root growth and displacement (many areas) | Poor | Demo and replacement | 50 | 30 | 20 | 500 | SF | \$12.00 | \$6,000 | | | | |

Depicts heaved sidewalk along Lena St.

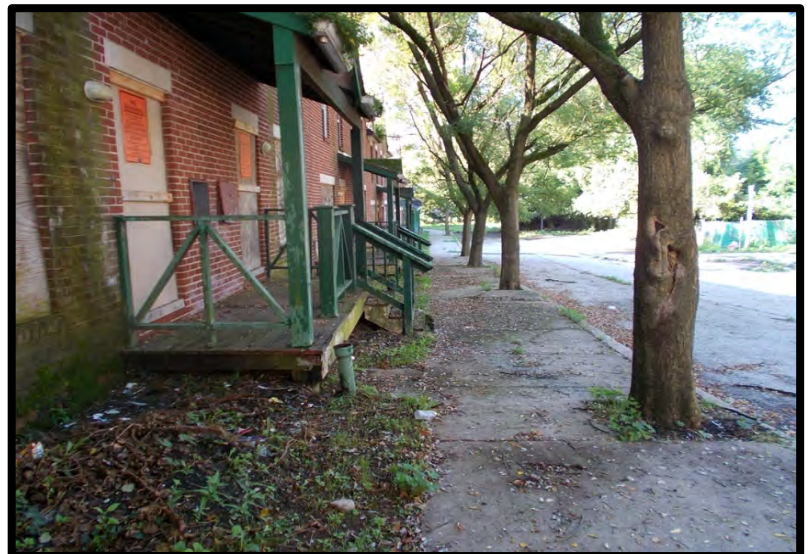
Photo No. 37

View looking south along east side of court yard. Note
heaved sidewalk between 664A and 66B. Also
depicted is missing leader from porch roof (typical).

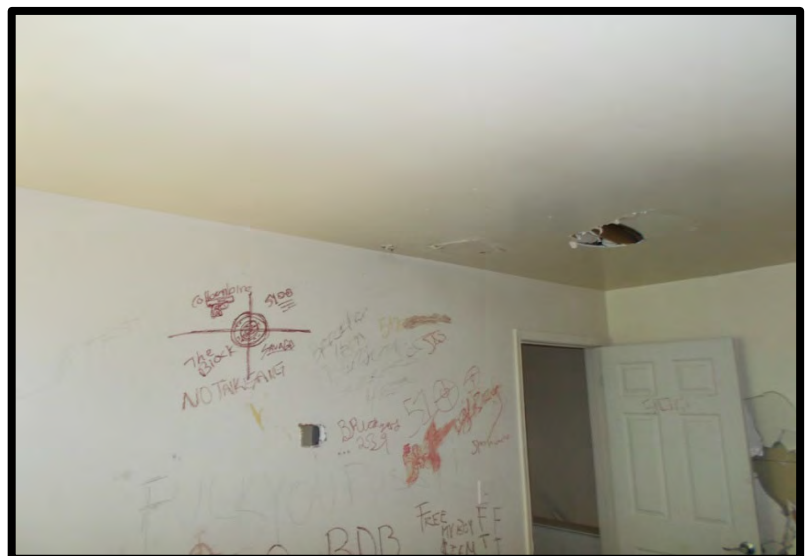
Photo No. 53

View of damaged ceiling above master bedroom entry.

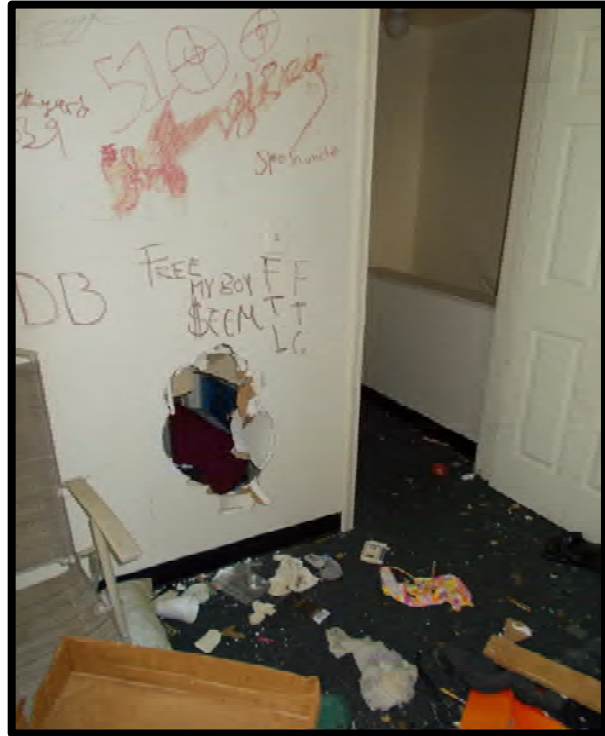
Photo No. 54

Panning down from previous photo. Damage to
gypsum wallboard adjacent to bedroom entry.
