# Germantown/Mount Airy Properties

## Physical Conditions and Needs Assessment

### Premises F

### 36 E. Wister

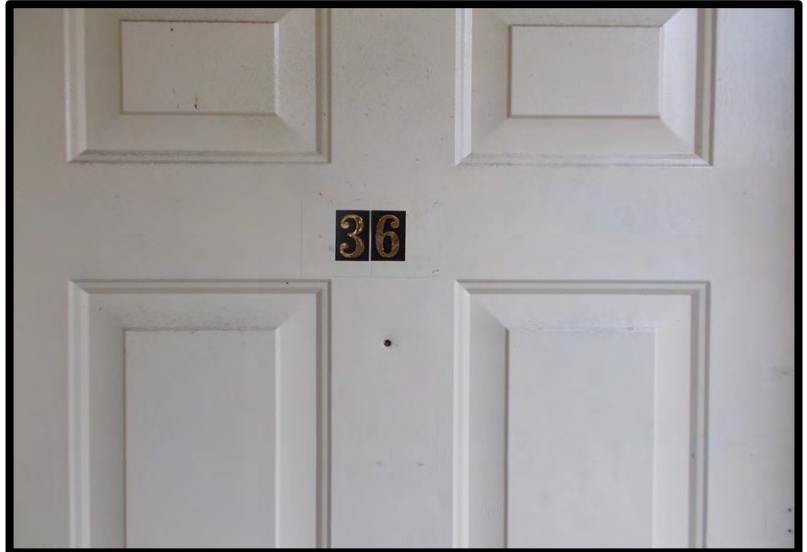
**Photo No. 1**

Depicts entry door.

*Replacement of doors should be considered for security and energy efficiency.*

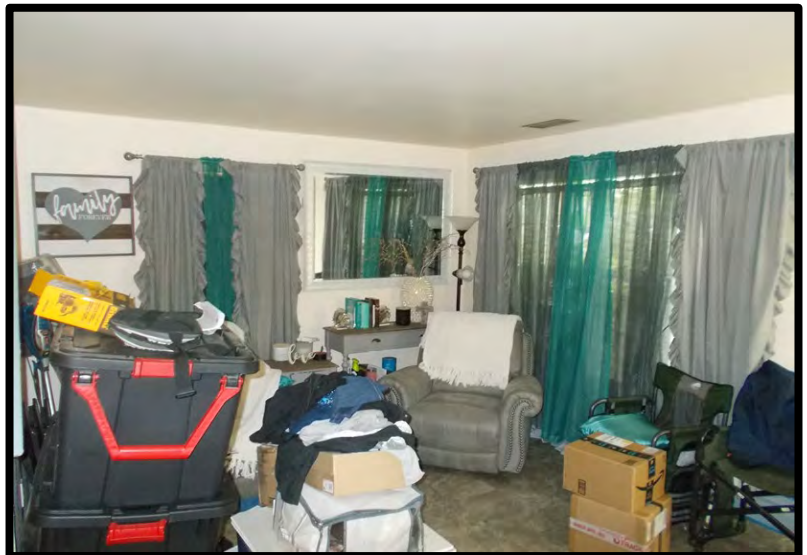
**Photo No. 2**

View of living room.

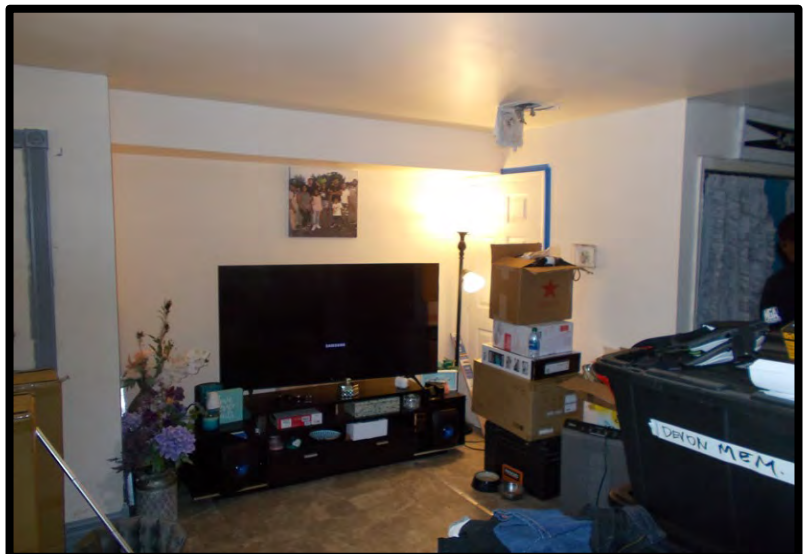
**Photo No. 3**

Panning 180 degrees from previous photo. Additional view of living room area.

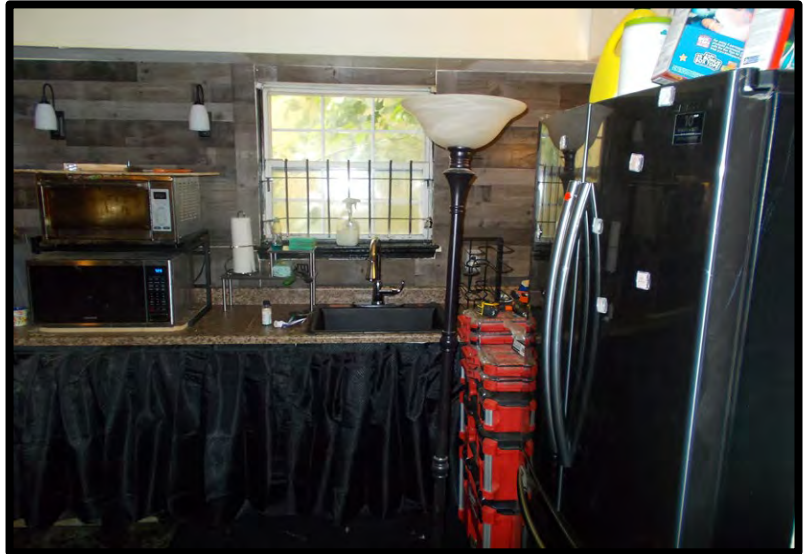
**Photo No. 4**

View of kitchen.

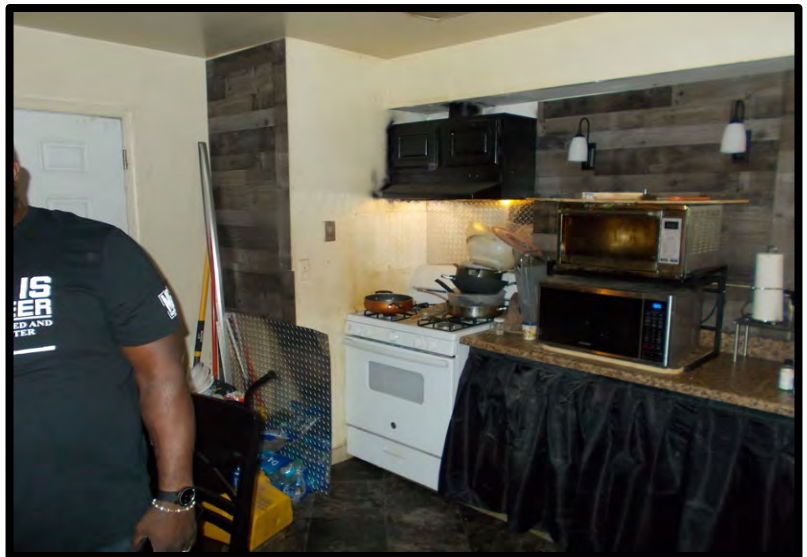
**Photo No. 5**

Panning left from previous photo. Additional view of kitchen.

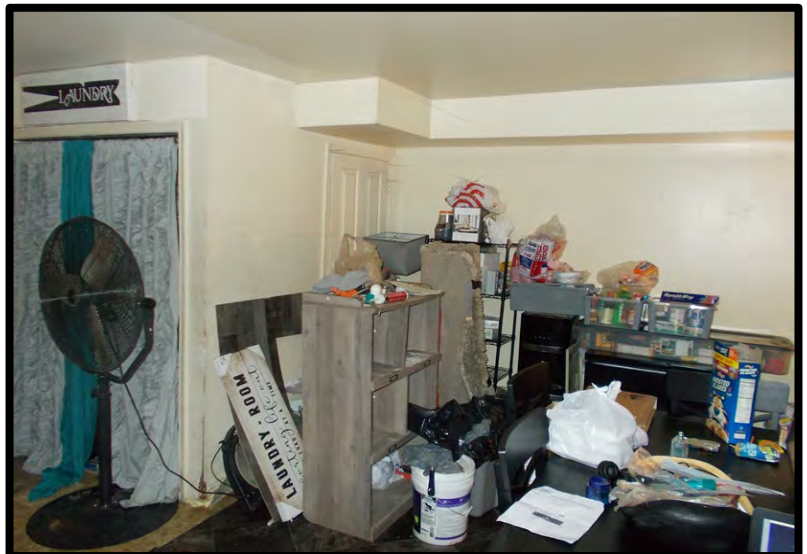
**Photo No. 6**

Panning left from previous photo. View of dining area and washer/dryer closet on left.

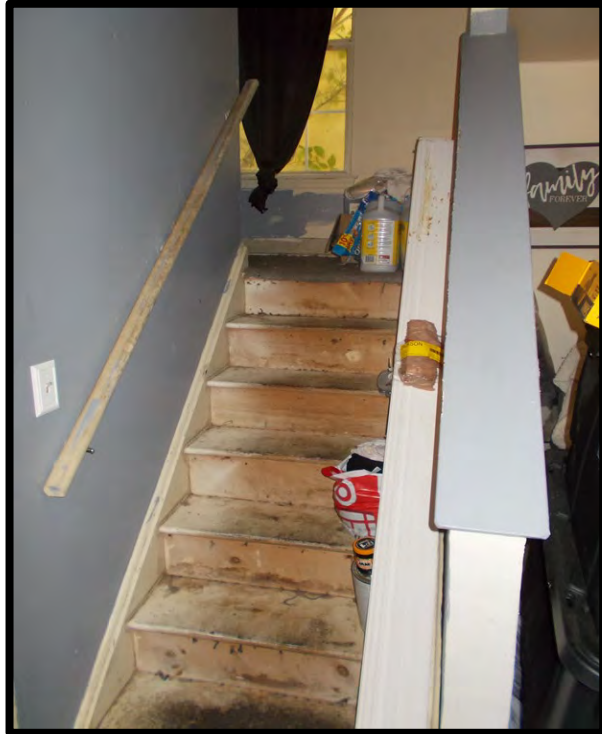
**Photo No. 7**

View of stairs leading to second and third floors.

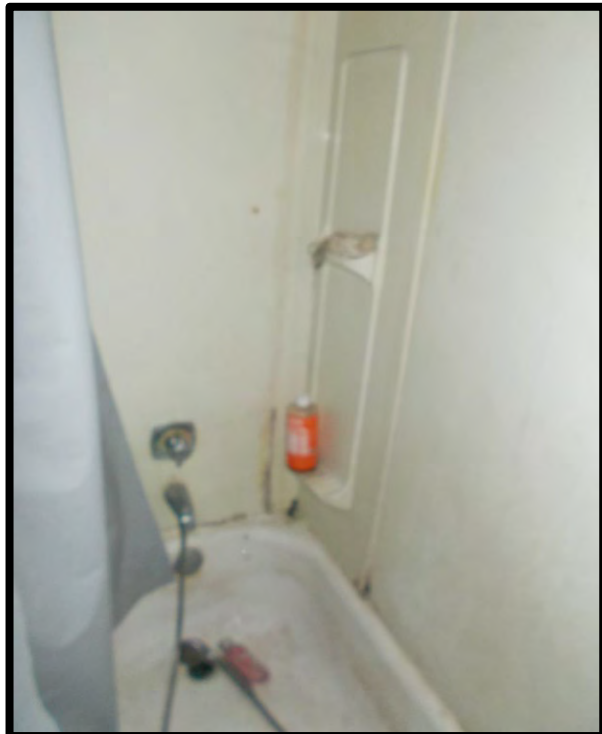
**Photo No. 8**

The second floor bathroom appears to have an upgraded vanity. The original tub and fiberglass surround were still in place. The surround and tub will likely need to be replaced in due course.

*There was some evidence of water infiltration around the surround in the second floor bathroom.*

Depicts view of bathtub and shower surround at second floor bathroom.

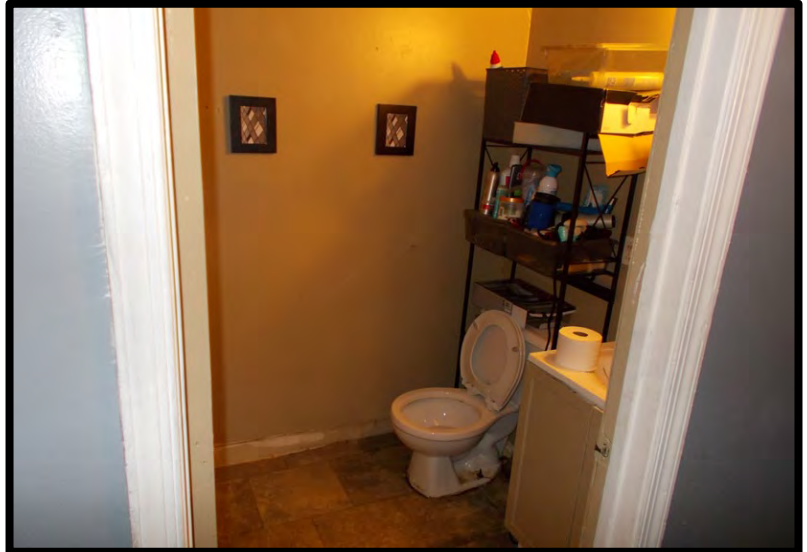
**Photo No. 9**

Depicts view of second floor bathroom.

*Replacement of the bathroom flooring is recommended.*

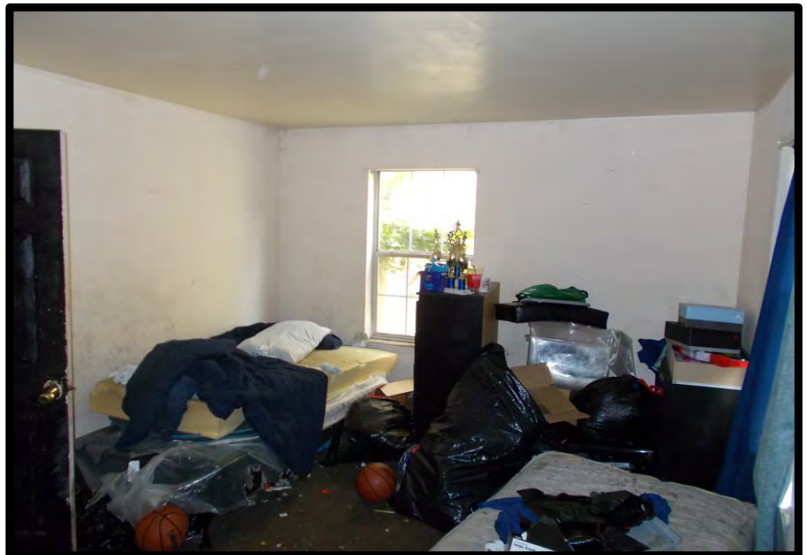
**Photo No. 10**

Depicts view of bedroom at second floor.

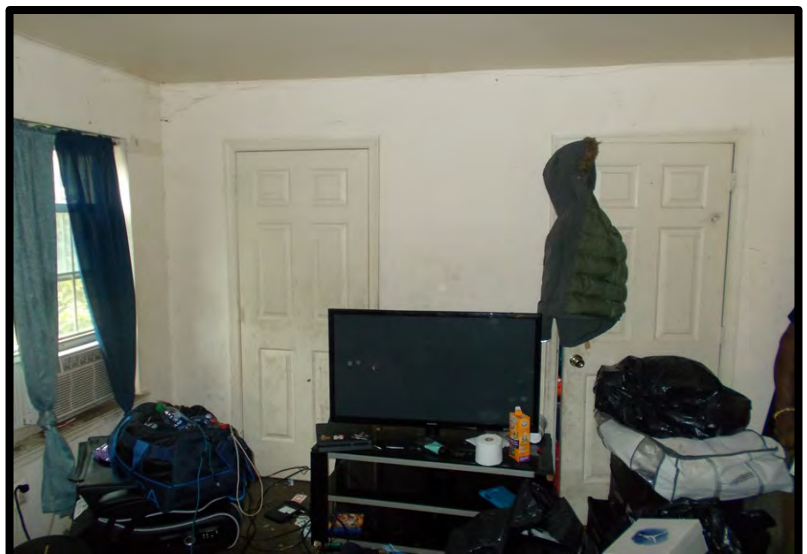
**Photo No. 11**

Depicts view of bedroom closets.

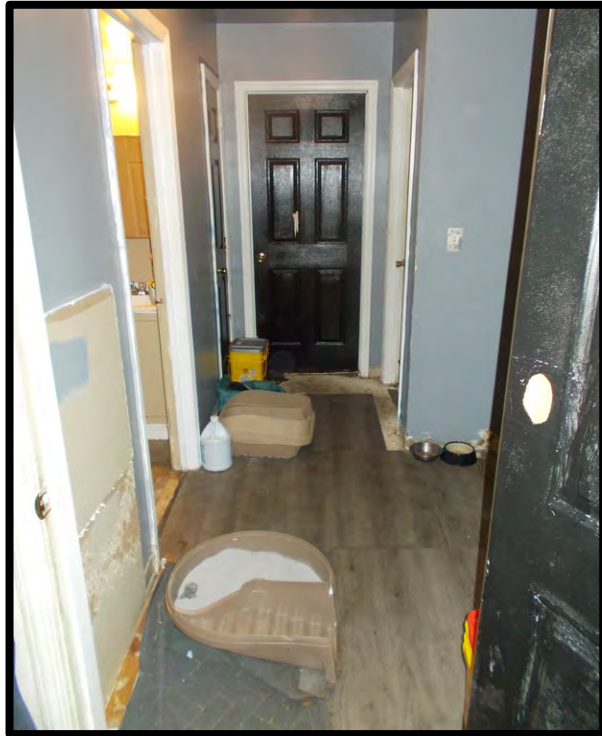
**Photo No. 12**

Depicts hallway at second floor landing.

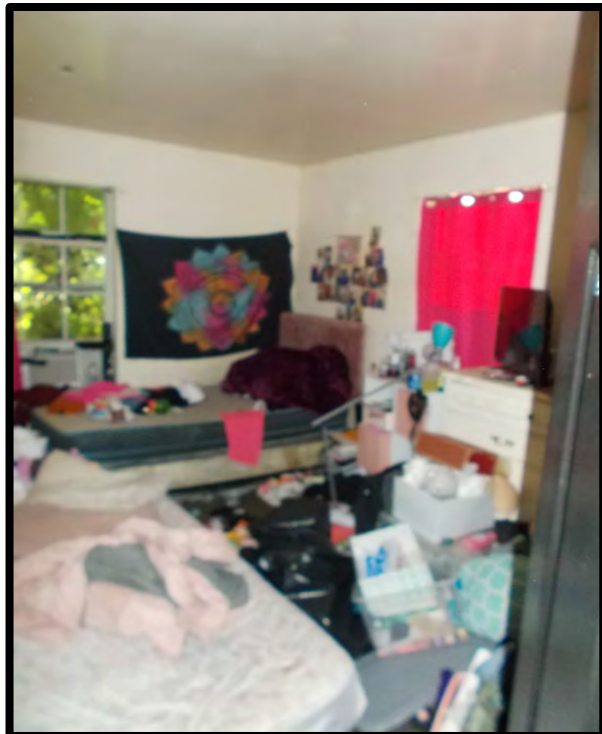
**Photo No. 13**

Depicts view of second bedroom at second floor.

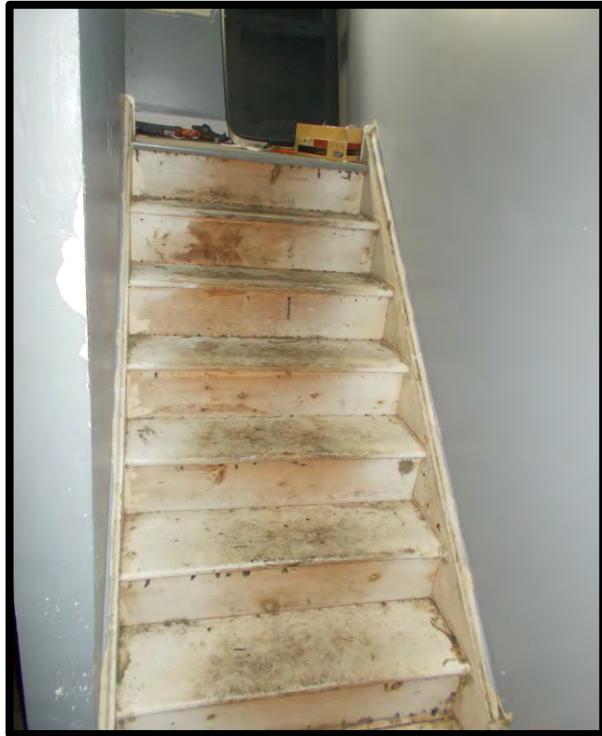
**Photo No. 14**

The staircase is of wood construction. Carpeting along the stairs has been removed. The handrail from the second to third floor is missing and requires replacement.

Depicts stairs leading to third floor. Note railing at stair has been removed.

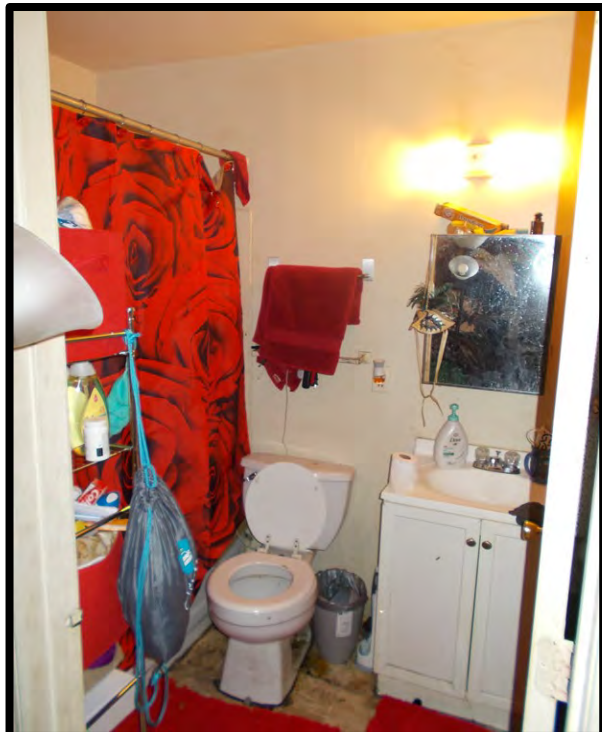
**Photo No. 15**

Depicts view of third floor bathroom.

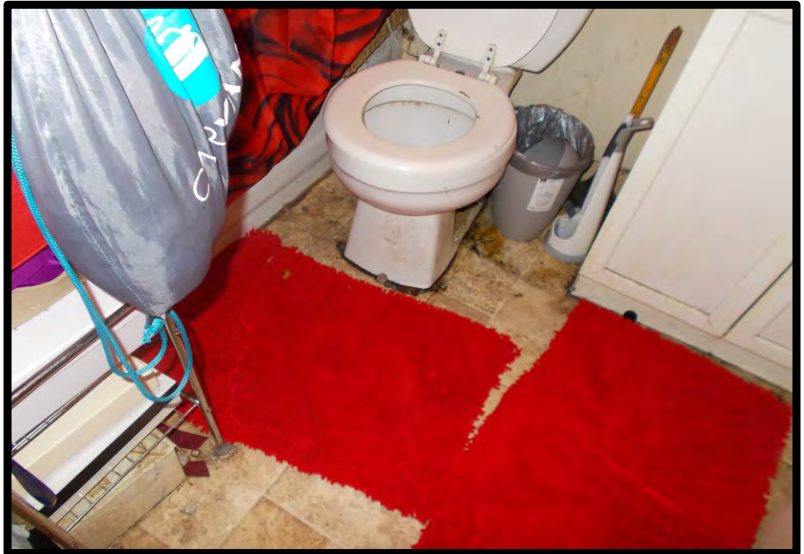
**Photo No. 16**

Panning down from previous photo. Closer view of water closet.

*Fixtures should be replaced for better performance.*

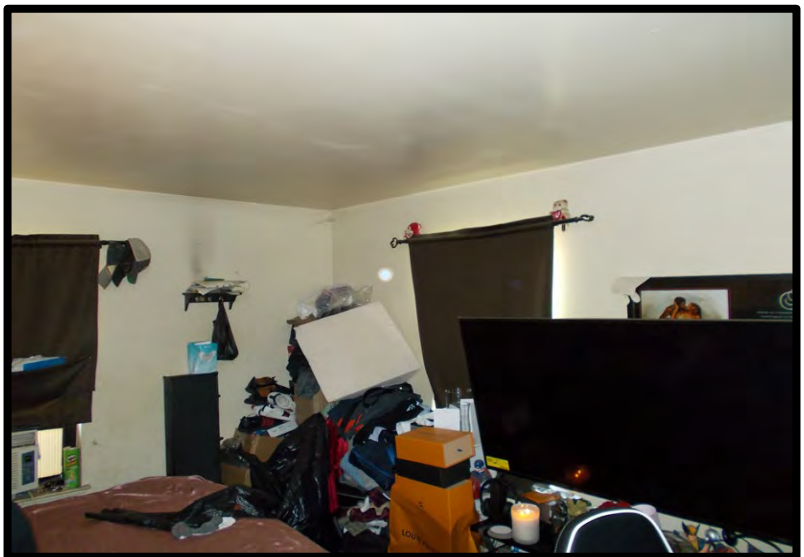
**Photo No. 17**

View of master bedroom located at third floor.

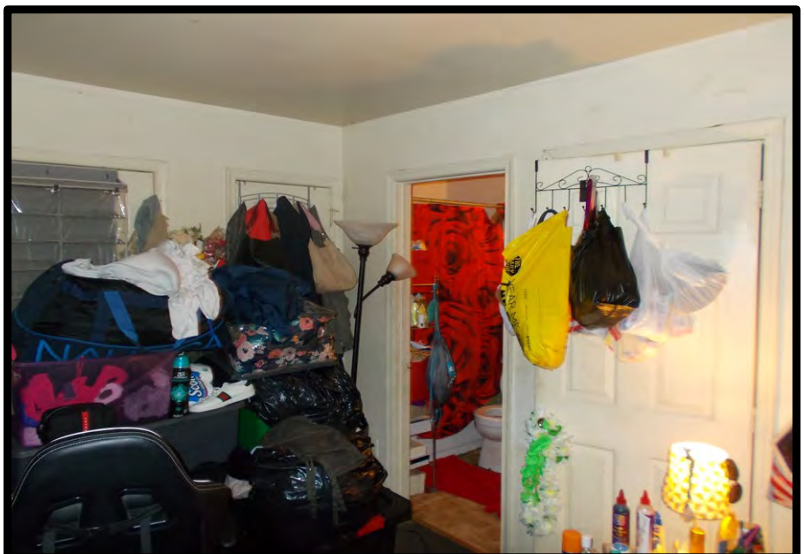
**Photo No. 18**

View of master bedroom closets and entrance to master bathroom.

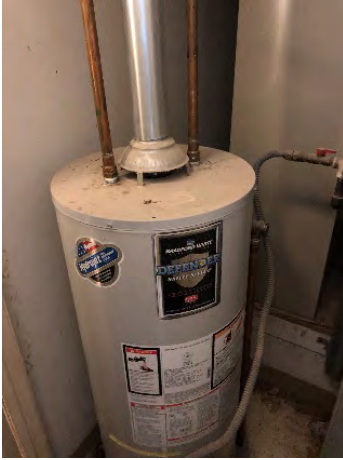
Domestic hot water is provided by a gas fired 30- gallon tank type water heater located in the unit. Domestic water heater by Bradford White is in an excellent condition.

Hot water heater fairley

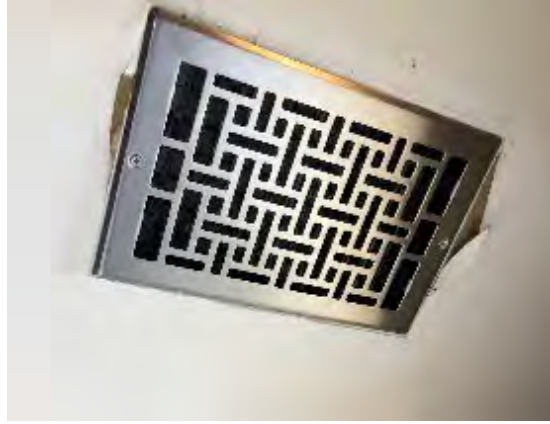
Supply grill

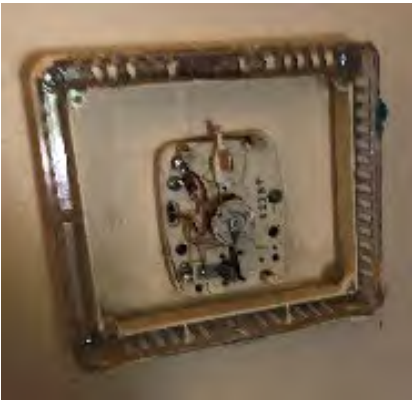
Thermostat was defaced and should be replaced.

Thermostat with exposed wire

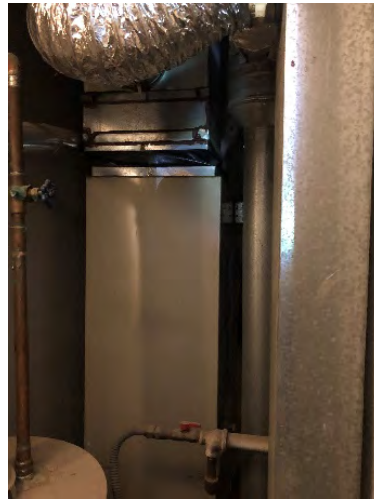
This house is designed to be heated via gas fired vertical furnace. This is a forced air, heating only unit. Furnace flue is connected adequately. Furnace is in good condition.

Side of furnace

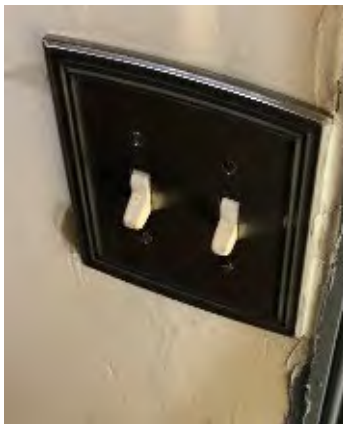
Light switch in good shape
