# Germantown/Mount Airy Properties

## Physical Conditions and Needs Assessment

### Premises G

**38 E. Wister St**

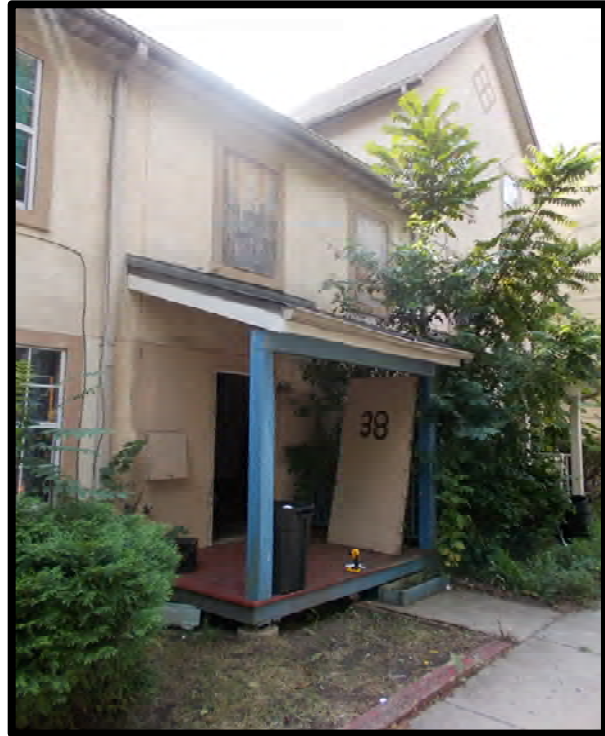
**Photo No. 1**

Depicts front entry porch for 38 Wister Street.

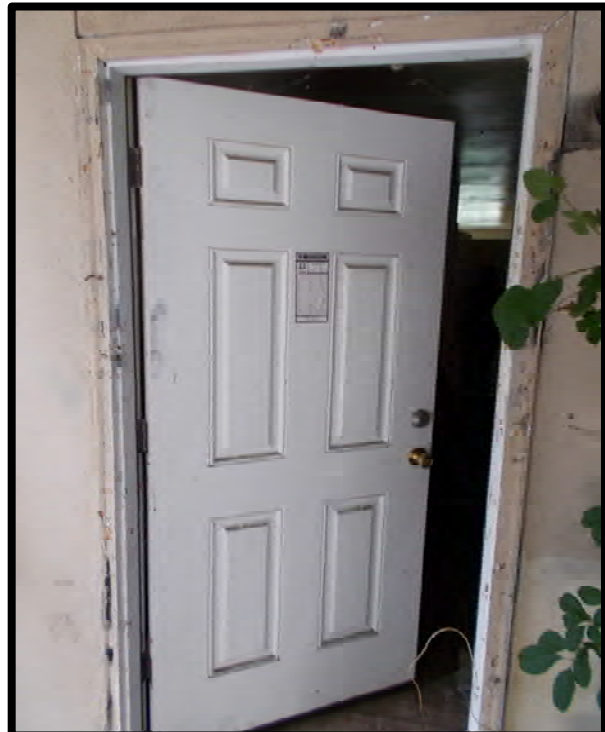
**Photo No. 2**

Exterior door to the building appear to be a 6-panel fiberglass door, it is fairly new and in good condition.

Depicts front entry door. This door appears to be new.

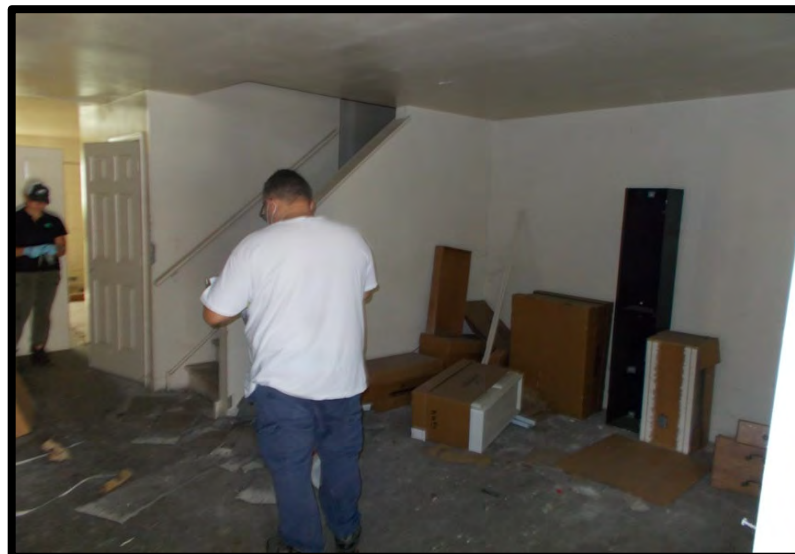
**Photo No. 3**

Depicts living room and stair to upper floor. New cabinets were noted and it appears that the unit was under renovation.

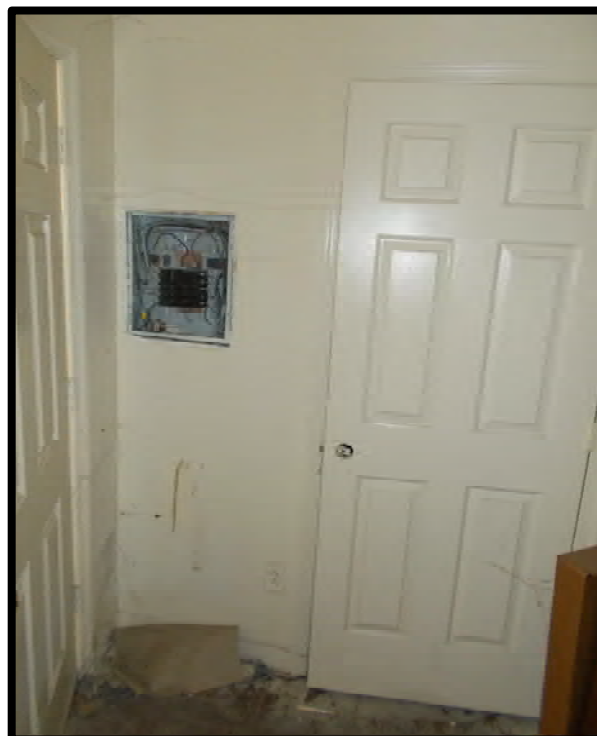
**Photo No. 4**

3.4.4.1 Service, Metering, Distribution Panels  
Electrical panel was missing a cover

Depicts apartment electrical panel behind entry door. Closet door is for coats and meters.

*Replacement panel cover required.*

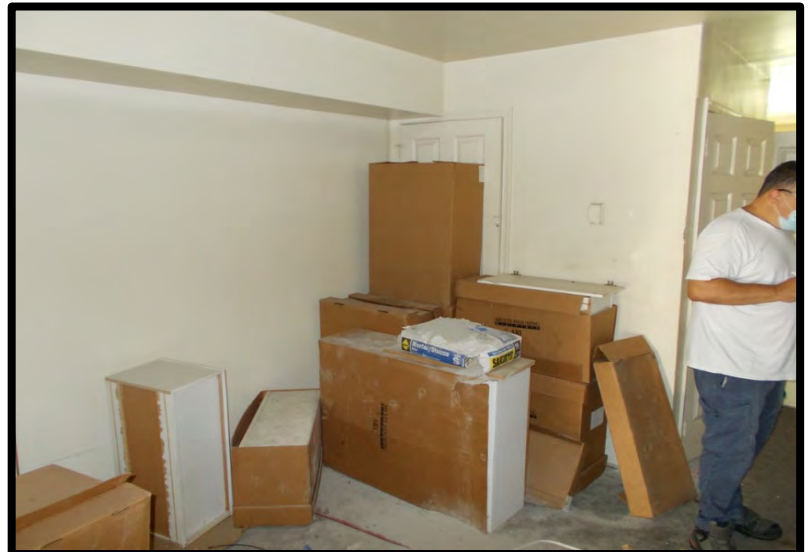
**Photo No. 6**

Panning left from Photo No. 3. Depicts additional view of living room and new cabinets awaiting installation.

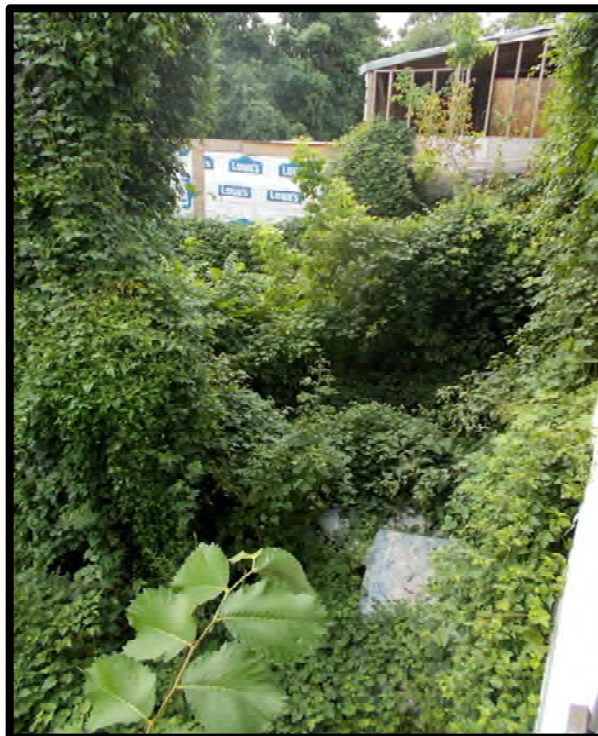
**Photo No. 17**

Depicts view of overgrown rear yard looking south.

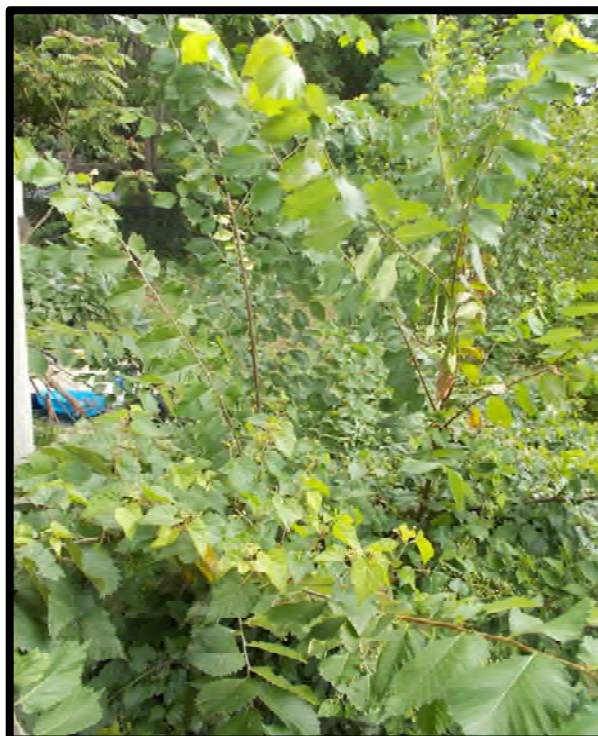
**Photo No. 18**

View of overgrown rear yard looking north along  
Wister Street properties.

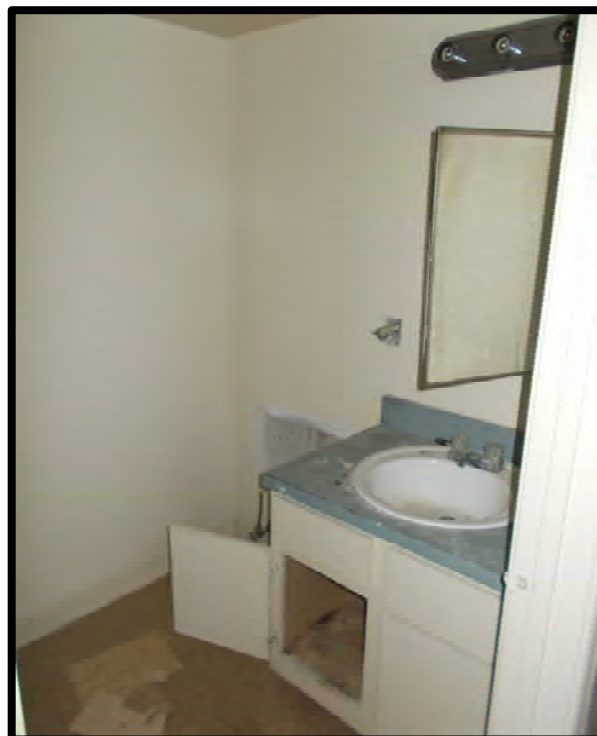
**Photo No. 20**

Both the second and third floor bathrooms consist of wood frame vanity, top mounted sink, water closet, bathtub and fiberglass surround. It appears that the vanity has been recently painted; however, the P-lam countertop was in poor condition. It appeared that the bathtub was serviceable condition. The water closet was not mounted but rather was located in the bathtub.

View of water closet location and lavatory.

*Replace all bathroom fixtures and vanities.*

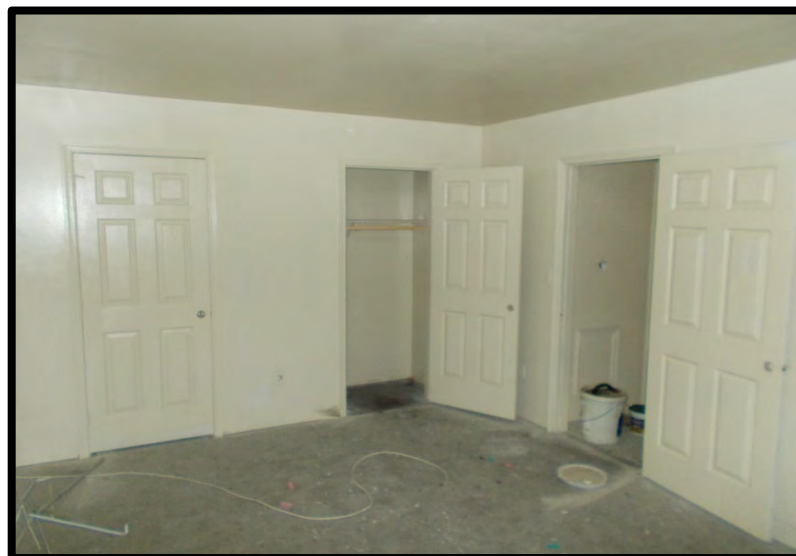
**Photo No. 24**

Panning 180 degrees from previous photo. View of bedroom closets and entry door on right. Again, it appears that the rooms were freshly painted.

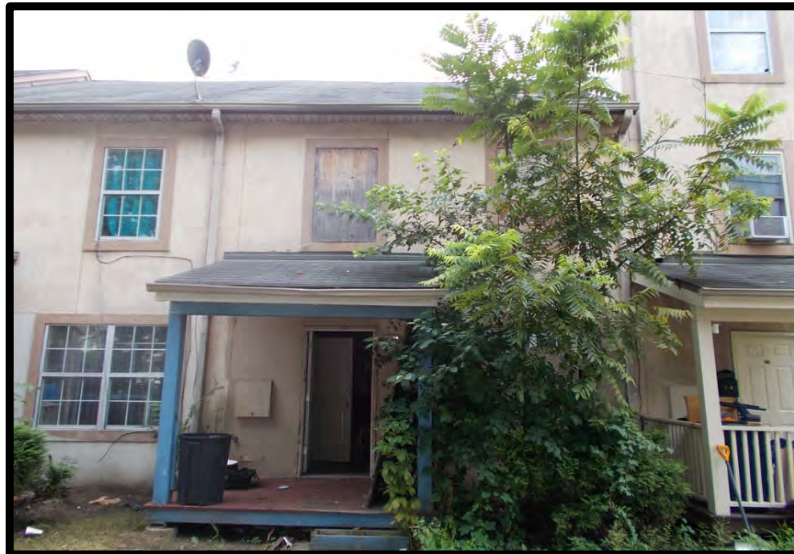
Depicts overall view of front of 38 Wister Street including entry porch. Note railing is missing upon entry to porch.

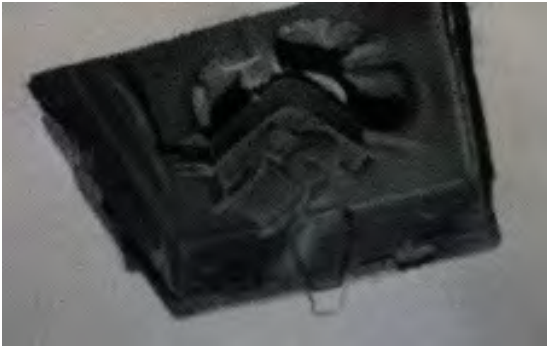
Exhaust fan not working
