Germantown/Mount Airy Properties

Physical Conditions and Needs Assessment

Premises H

40 E. Wister St

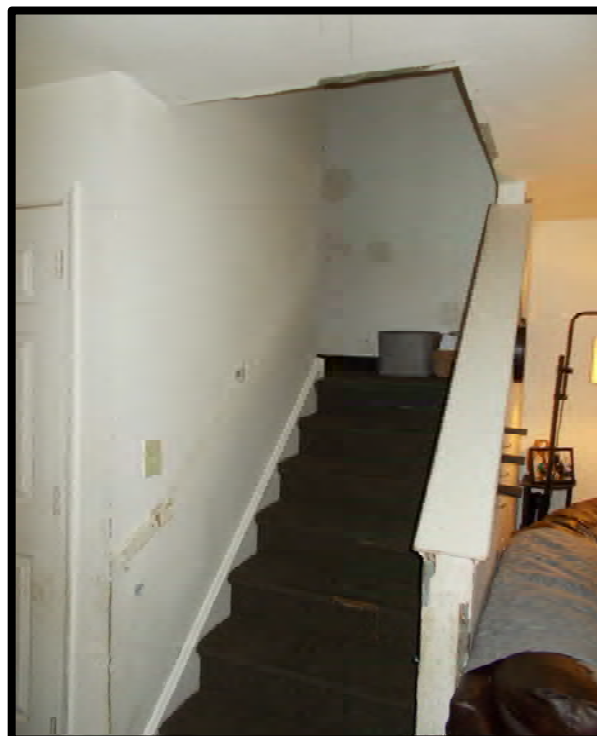
Photo No. 4

The handrail at the stairs leading to the second floor is missing and needs to be replaced.

View of stairs to second and third floor bedrooms.
Note handrail is not longer present.

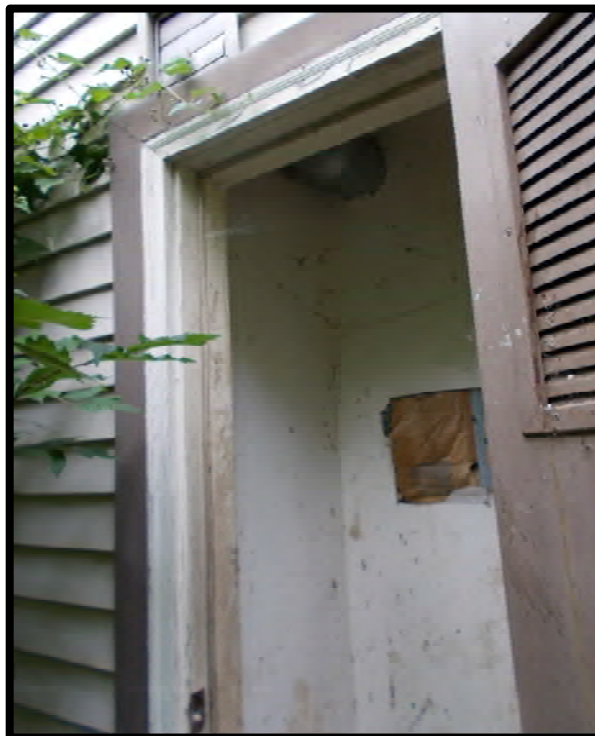
Photo No. 12

The door has a louver finish and is in poor condition. This closet should be secured.

Depicts rear mechanical closet that is no longer used at rear of building.

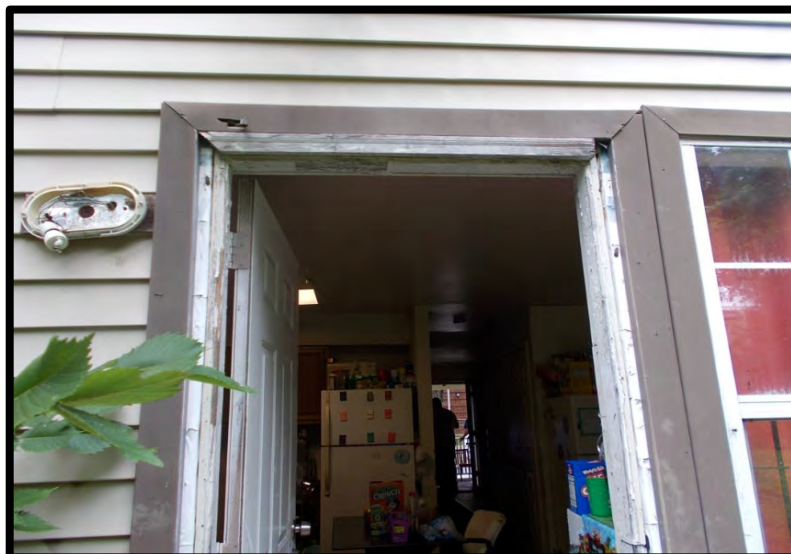
Photo No. 13

The wooden door and trim around the rear door is in poor condition and should be replaced.

Depicts rear entry door to 40 East Wister Street.

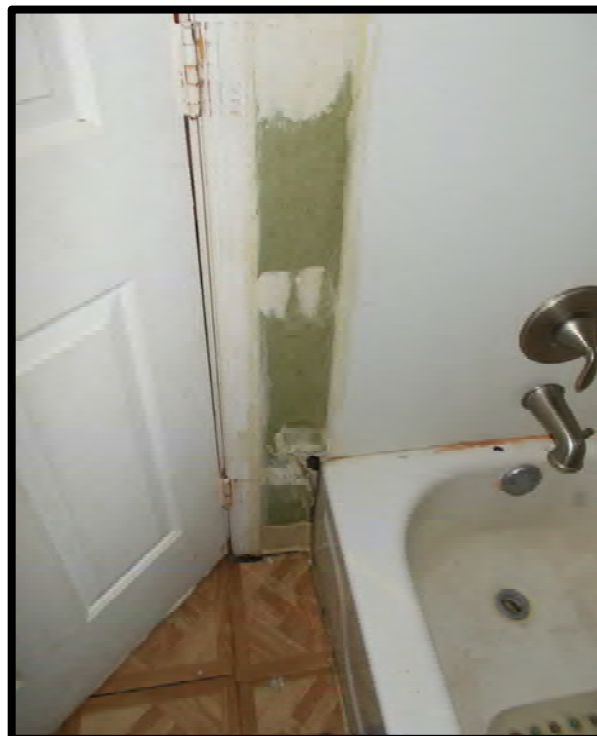
Photo No. 17

Close up view of lower section of bathtub and bathtub surround. There is evidence that water penetrates at joints and may cause a leak below.

Replace fiberglass tub surrounds.

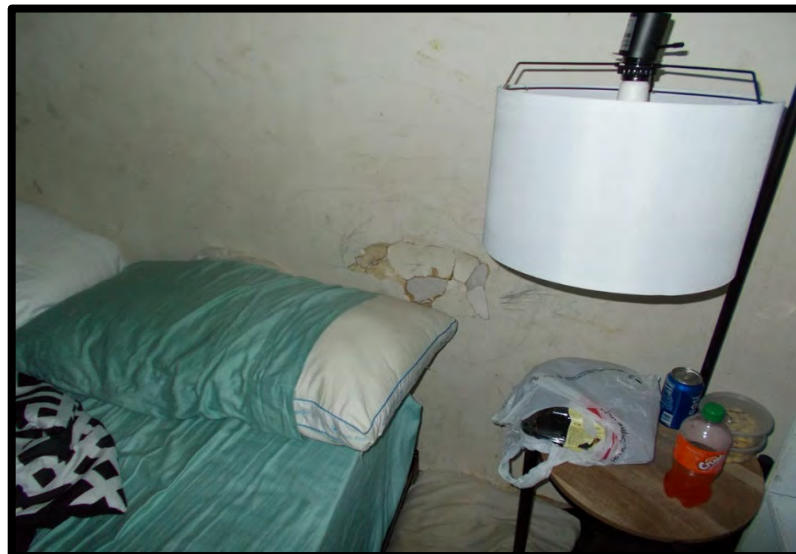
Photo No. 20

Depicts damaged drywall in bedroom #3.

*General repair and painting of sheetrock walls and ceiling is required.
Paint along the stove area along walls and ceiling is required in the kitchen.
A self-adhesive vinyl tile is provided in the bathroom and is in poor condition.
Previous repairs around the bathtub indicate water leakage. A hole was noted adjacent to the bathtub which would allow water to infiltrate into the first-floor ceiling.
There is gypsum wallboard damage behind the bed in the third bedroom which will require repair.
There is damage to the ceiling at the entry of the master bedroom on the third floor.
The railing to the third-floor bedroom requires repair of the gypsum wallboard.
General repairs to the gypsum walls are required along the stair.*

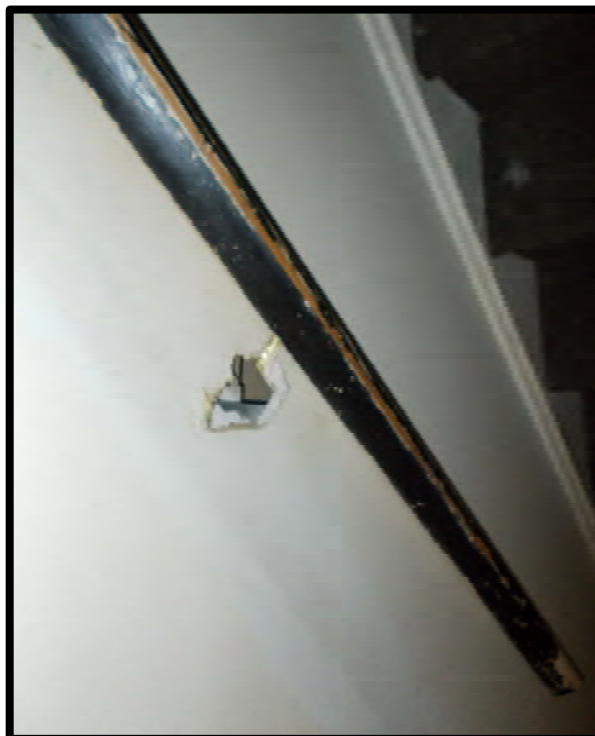
Photo No. 23

The railing to the third-floor bedroom has been damaged and will require re-anchoring and repair of the gypsum wallboard.

Depicts damaged anchorage of the handrail.
Handrail is no longer secure.

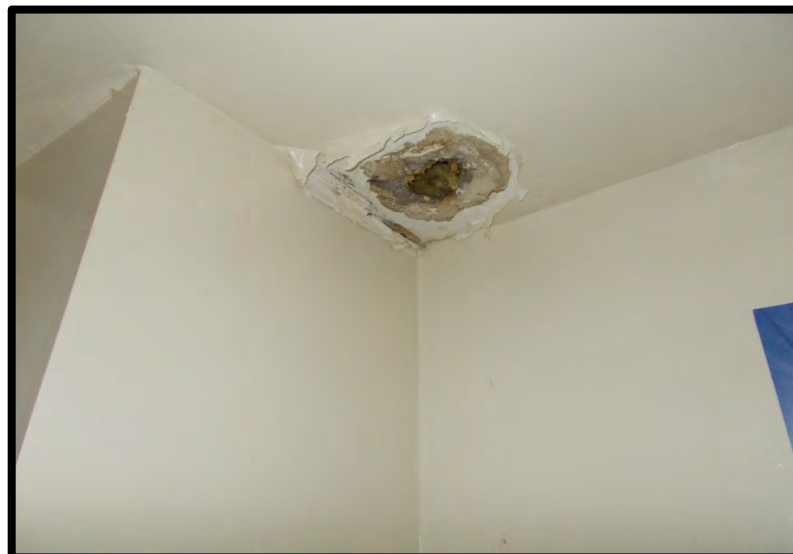
Photo No. 25

Depicts damaged ceiling and probable water infiltration at third floor bedroom.

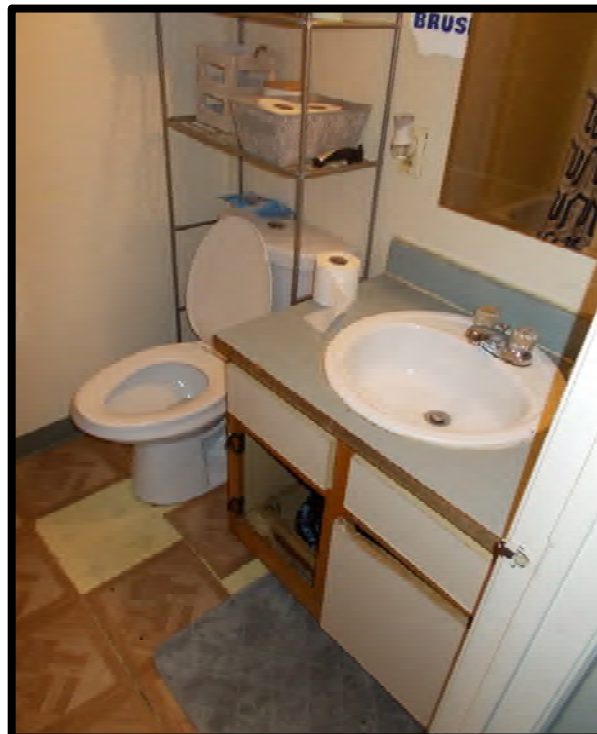
Photo No. 26

Depicts third floor bathroom vanity and water closet with missing door.

*Kitchen appears fairly new and in good condition.
Replace wood vanity cabinet at both bathrooms.*

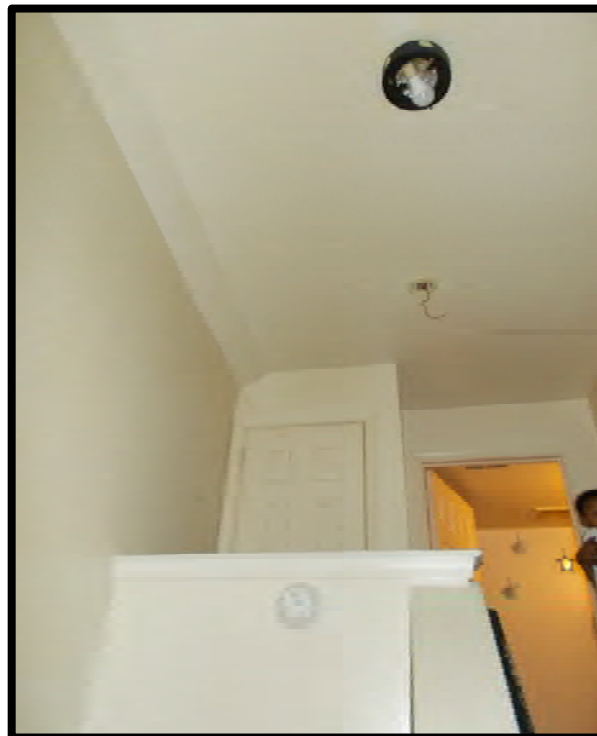
Photo No. 28

View of lighting and missing smoke detector located at top of third floor.

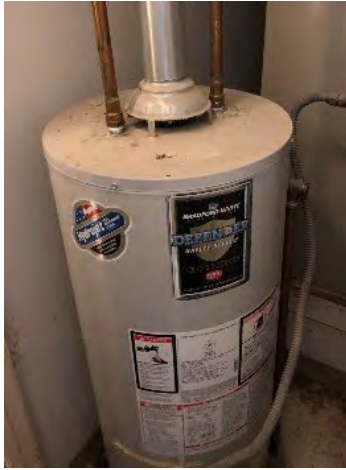
Domestic water heater is in excellent condition.

Hot water heater fairley.

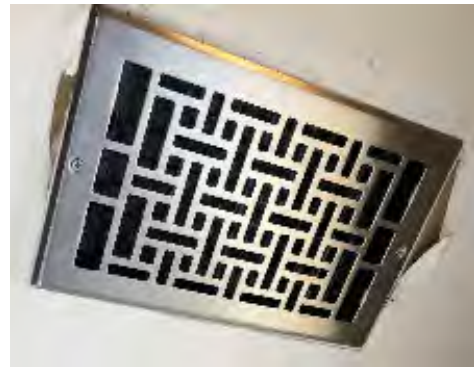
Supply grill.

All supply and return grilles should be replaced, as well as all filters.

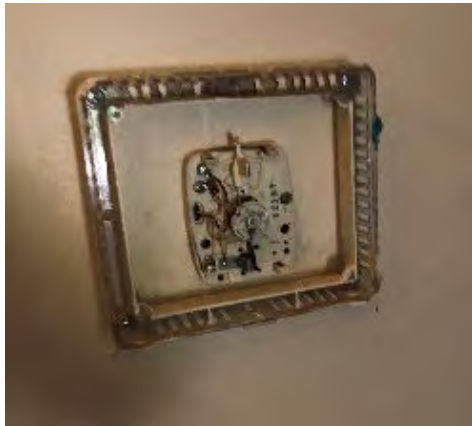
Thermostat was defaced and should be replaced.

Thermostat with exposed wire.

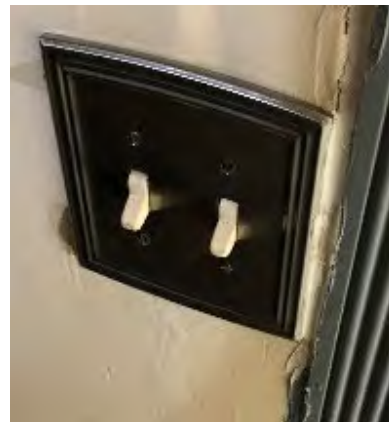
Light switch in good shape.
