Germantown/Mount Airy Properties

Physical Conditions and Needs Assessment

Premises H

42 E. Wister St

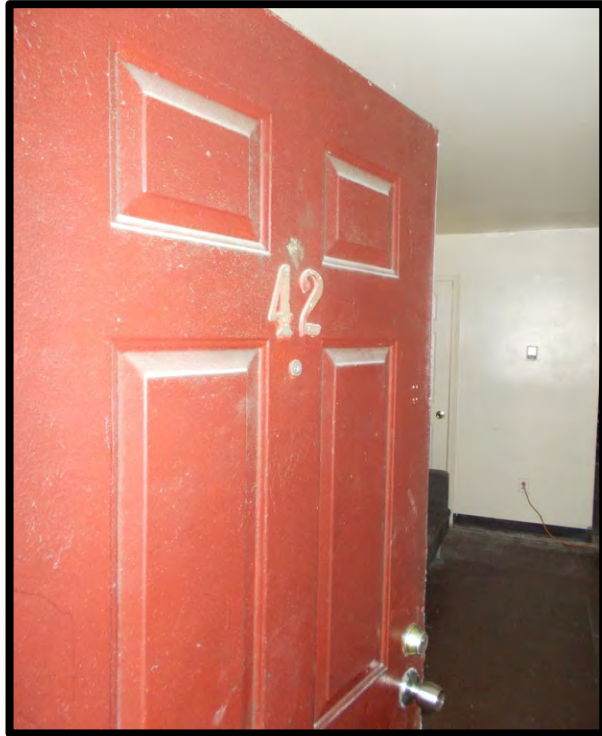
Photo No. 1

Depicts entry to Unit 42.

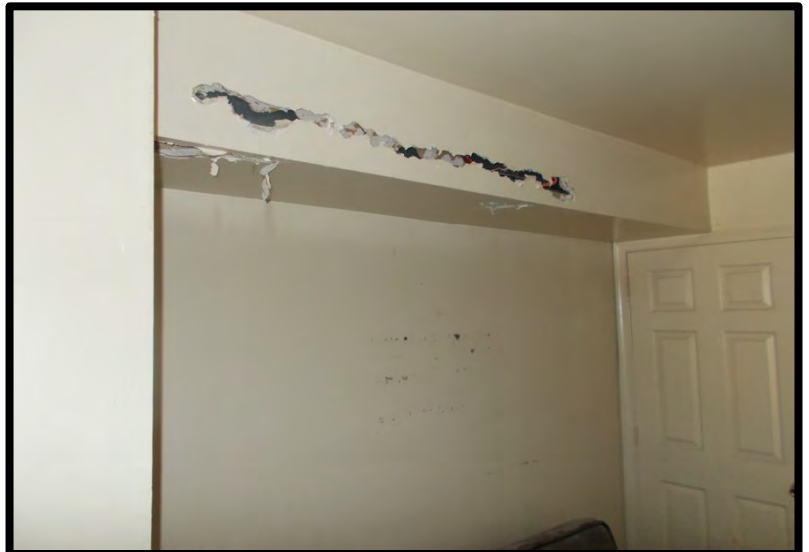
Photo No. 2

View of soffit upon entry within the living room.

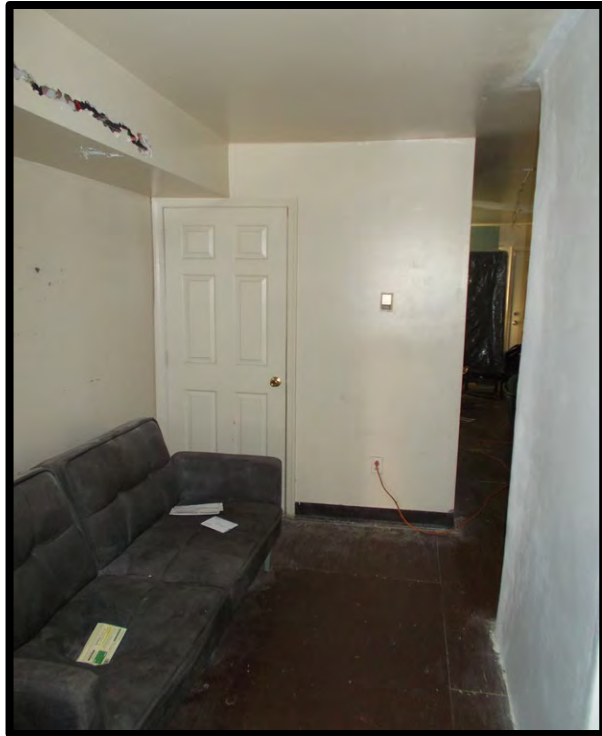
Photo No. 3

Overall view of entry within unit. Closet in the foreground is a mechanical closet which houses a hot water heater.

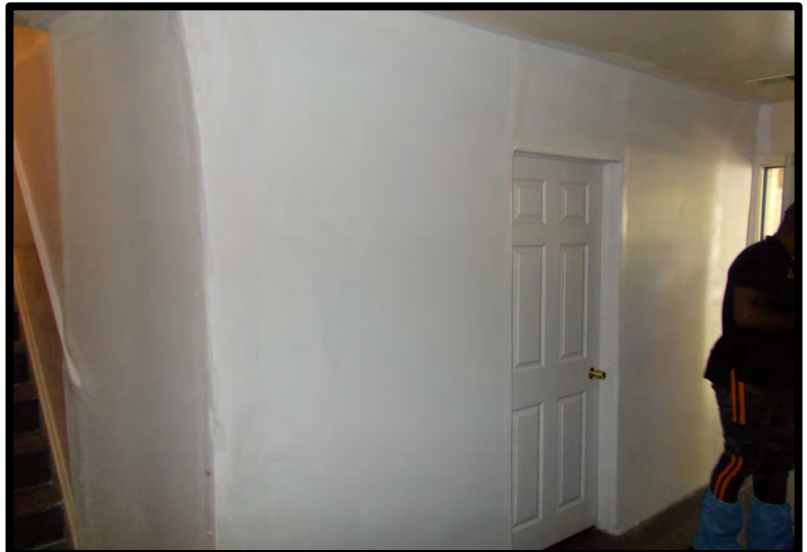
Photo No. 4

View of constructed gypsum wallboard partition where the living room should be. This living room has been converted to a bedroom.

Remove unauthorized construction and repair surrounding finishes.

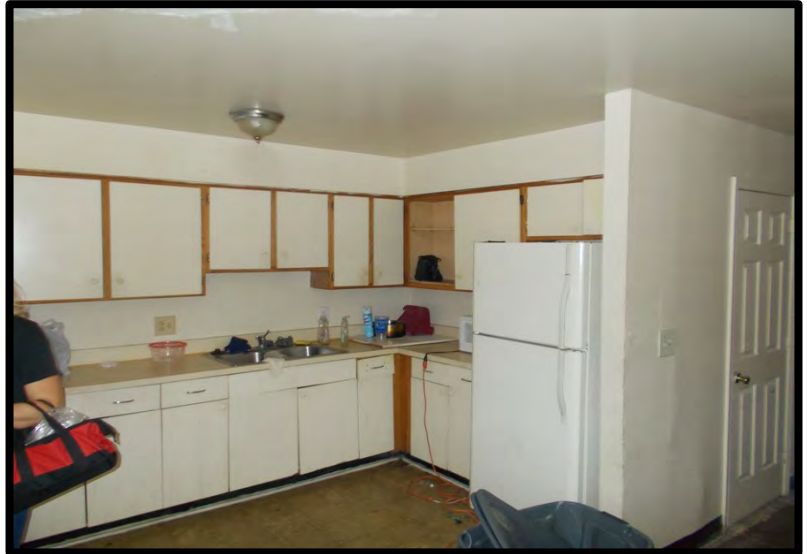
Photo No. 5

Kitchens consist of wood cabinets, plastic laminate countertop. All kitchen finishes are in poor condition.

View of kitchen at rear of dwelling.

Replacement of the cabinets and the countertop is recommended.

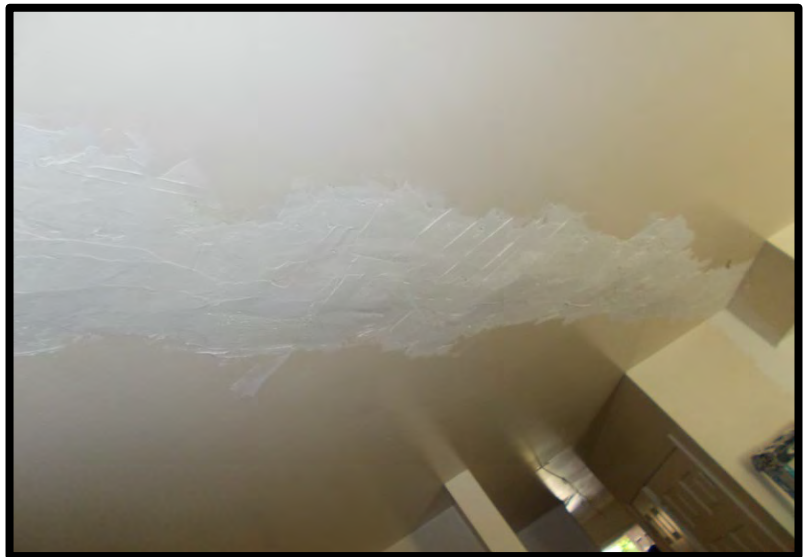
Photo No. 6

View of poorly repaired ceiling within the kitchen/
dining area.

Repairs to the wall and ceiling are suggested.

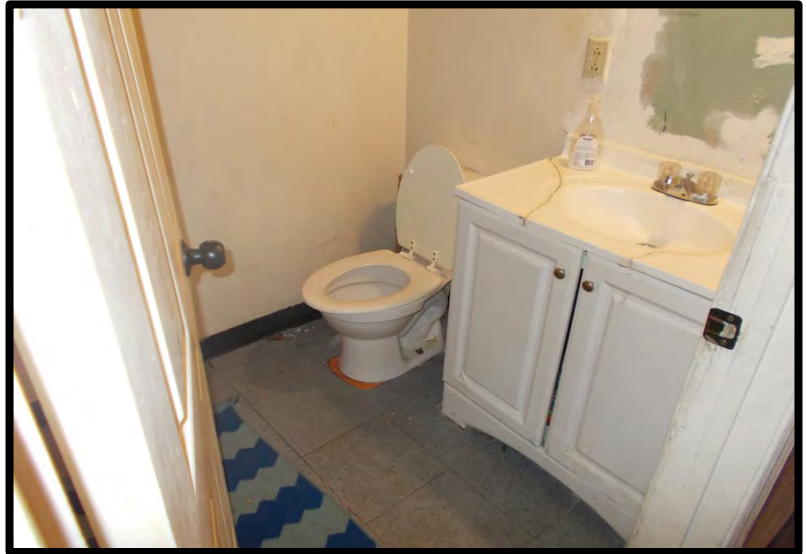
Photo No. 12

Panning down from previous photo. View of water closet, bathroom flooring and vanity.

New flooring is recommended.

Replace damaged vanity tops.

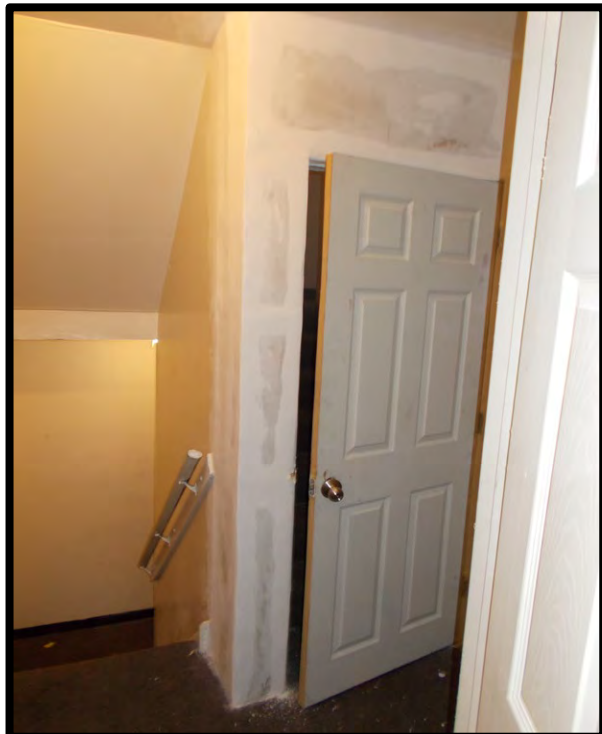
Photo No. 15

View of constructed partition and doorway leading to third floor. Note that in other buildings of same type, this is an open stair to the third floor.

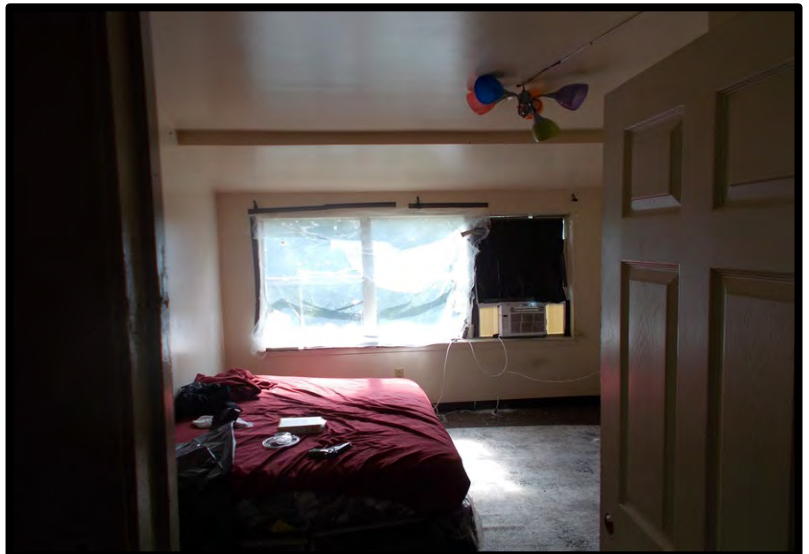
Photo No. 17

The third-floor rear bedroom windows were severely damaged. New glazing and/or frame will be required to repair.

View of rear bedroom at third floor. Note that the windows at the rear have been broken due to a tenant dispute.

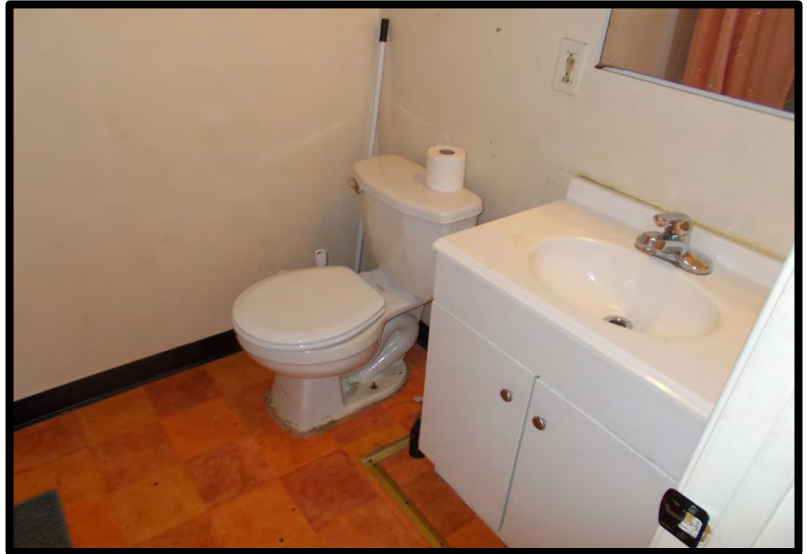
Photo No. 20

Panning down from previous photo, additional view of
water closet, vanity and flooring.

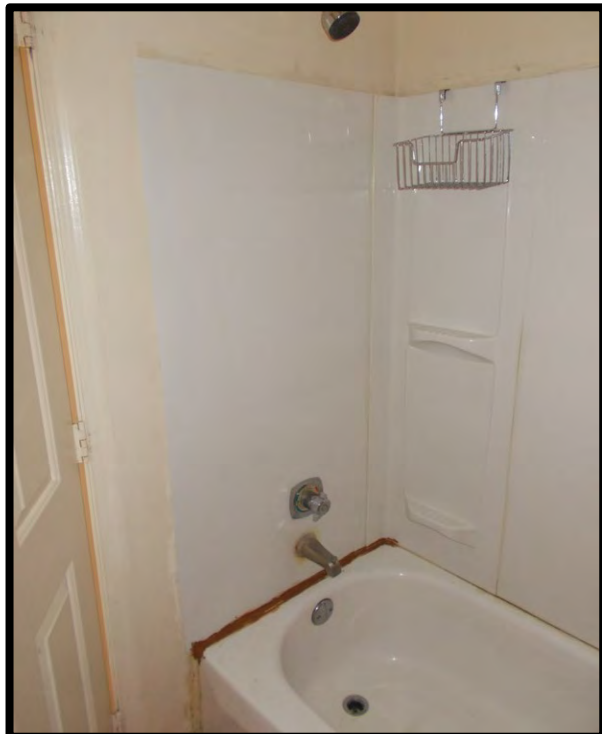
Photo No. 21

View of bathtub and fiberglass surround with poorly
caulked joint at intersection of bathtub and surround.

It is recommended that the bathtub and surround be recaulked to maintain water tightness.

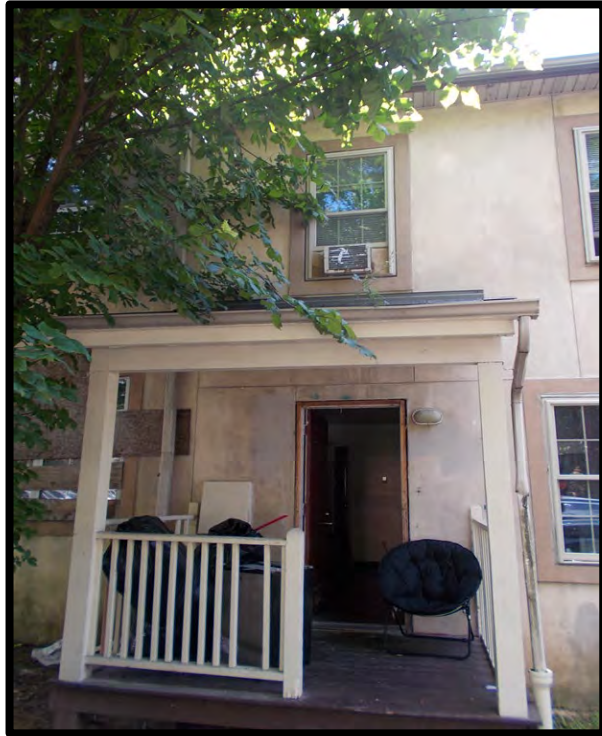
The entry porch appears to be in fair condition with some missing pickets.

Overall view of building exterior and entry porch.

Replacement of missing pickets is recommended.

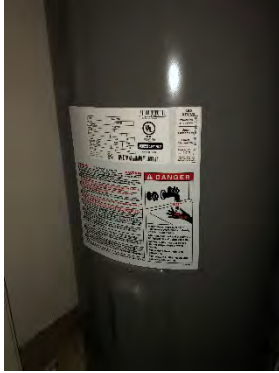
Hot water heater

Domestic hot water is provided by a gas fired 30- gallon tank type water heater located in the unit. Domestic water heater by Bradford White is in an excellent condition.

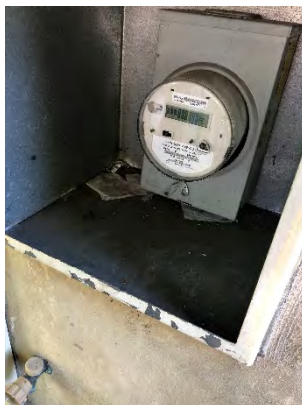
Electric Meter

This building has 60amp 120/240 panels powered by PECO meters for lighting and power, service to the building is in poor to good condition.

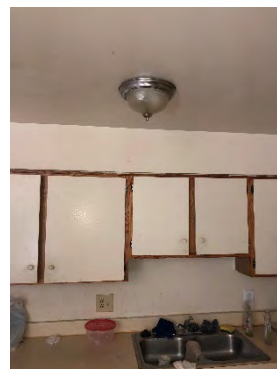
Kitchen light and sink

The kitchen fixtures and specialties appear to be in poor condition and should be replaced.

Replace light fixtures in kitchen and bathroom.

Replace damage kitchen faucet.
