# Germantown/Mount Airy Properties

## Physical Conditions and Needs Assessment

### Premises H

**44 E. Wister St**

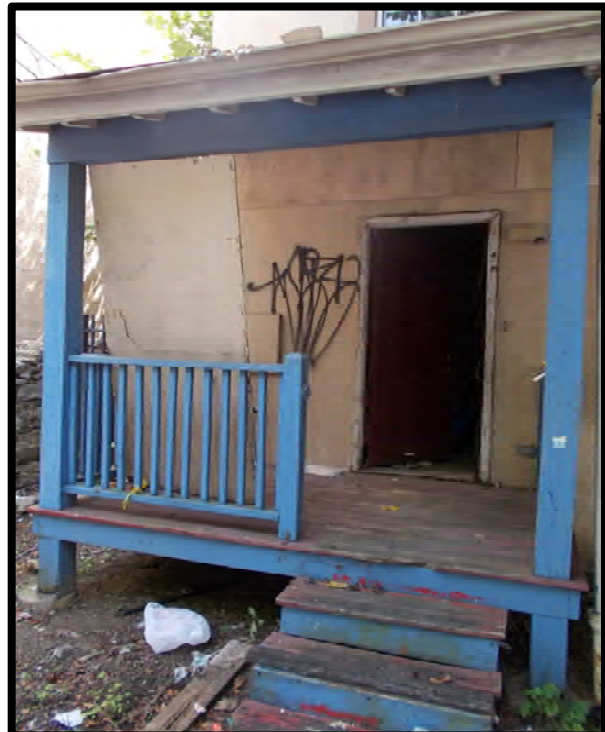
**Photo No. 2**

*The porch appears to be in poor condition and will require replacement at a minimum of deck boards and missing handrail.*

Depicts entry porch and entry door.

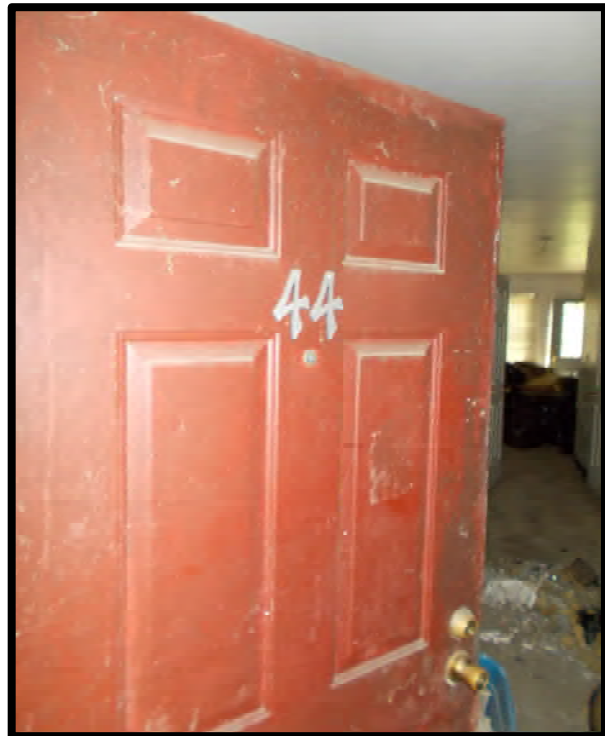
**Photo No. 3**

The door to the rear yard appears to have been bent due to forced entry; replacement is required. Replacement of front entry door is also required.

Depicts entry door.

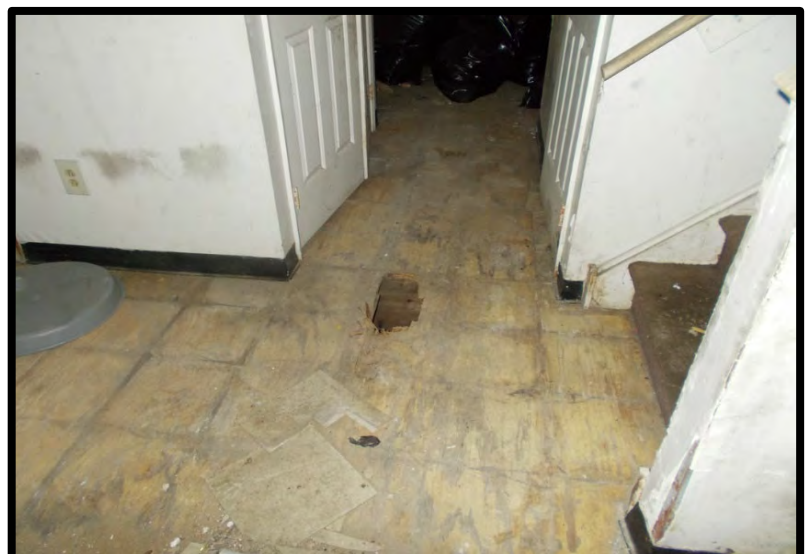
**Photo No. 7**

*A weak spot was noted in the sub-flooring immediately in front of the stairs to the second floor; it collapsed under observers weight. A portion of the sub-floor will require replacement and investigations in other sections that may or may not be sound.*

Depicts location of weakened sub-floor.

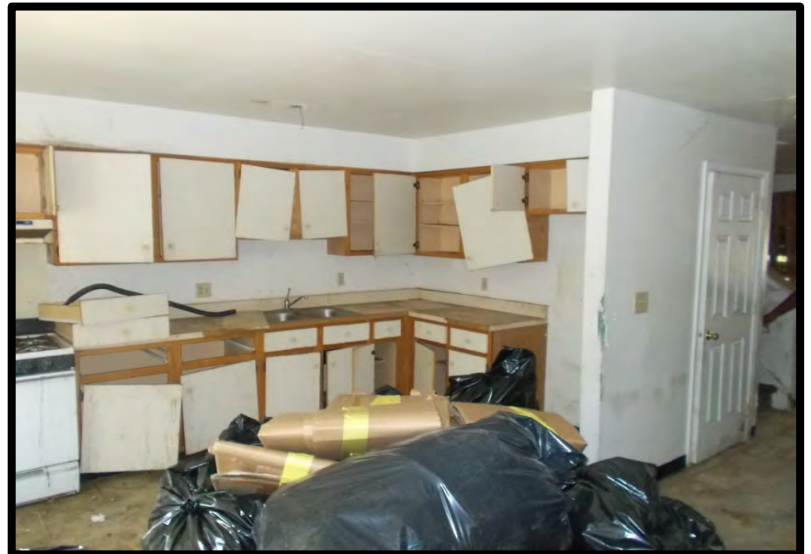
**Photo No. 8**

*The refrigerator was missing. Replacement of kitchen and all kitchen appliances is required.*

*Replacement all millwork, casework, cabinets and countertops in the kitchen is required.*

Depicts kitchen.

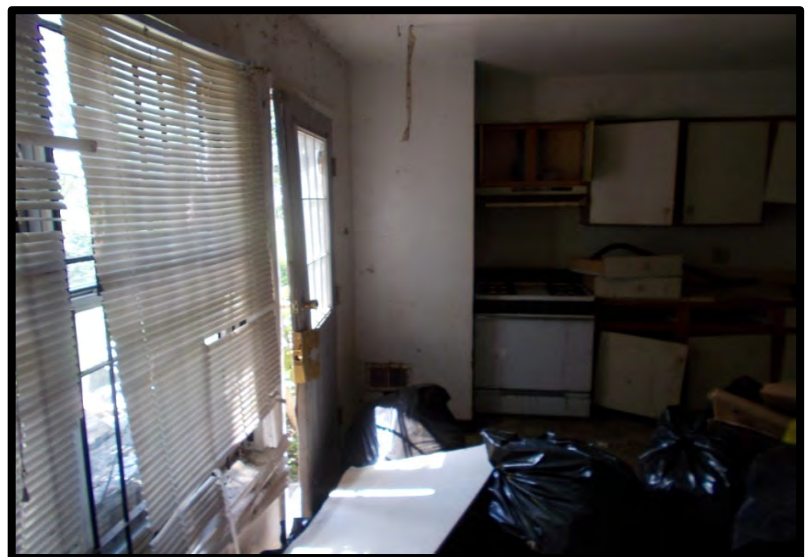
**Photo No. 9**

*Rear door is bent and will need to be replaced.*

Depicts additional view of kitchen and rear door to rear yard from dining room.

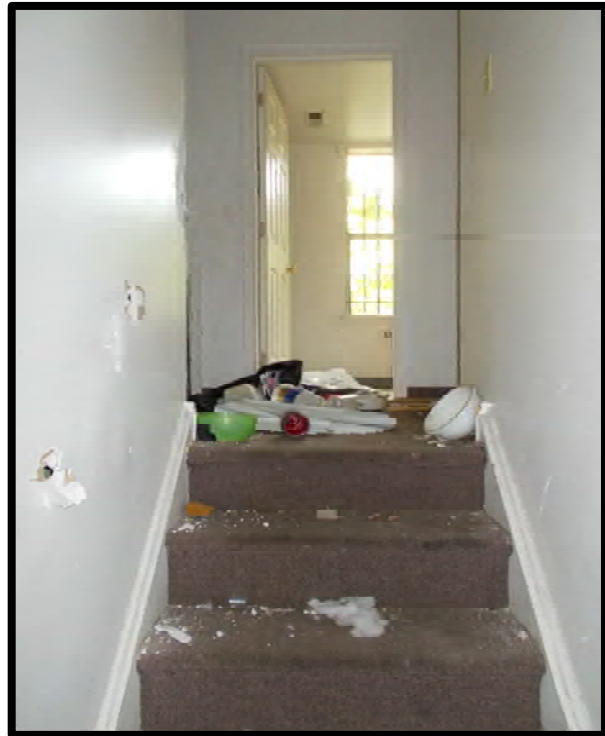
**Photo No. 13**

*There is a missing handrail on the stairs to the front porch. A new handrail should be installed. The handrail to the second floor has been damaged and/or removed and replacement is required.*

View at top of stairs to second floor. Note handrail has been forcibly removed.

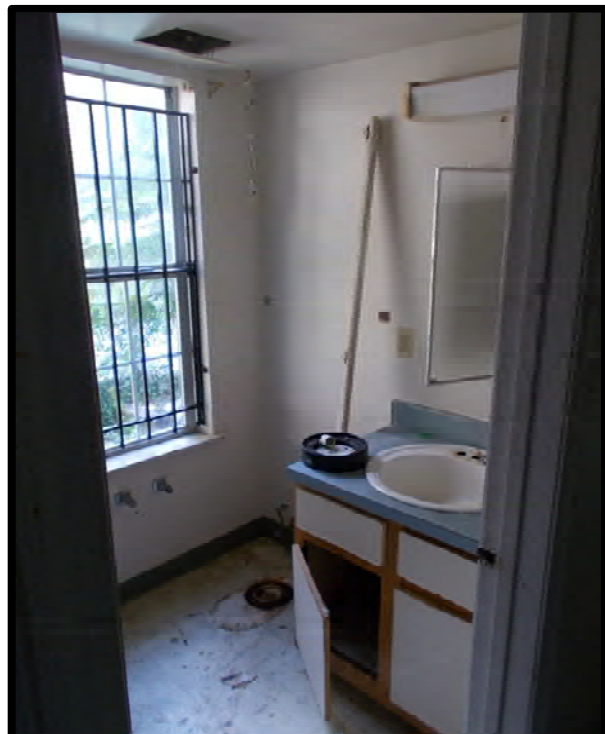
**Photo No. 16**

*All finishes in the second floor bathroom should be replaced.*

View of second floor bathroom.

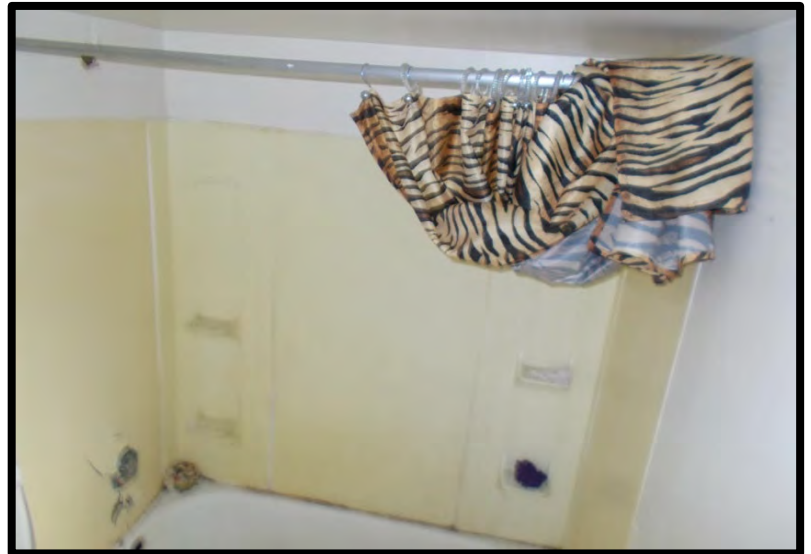
**Photo No. 17**

*The bathtub and fiberglass surround are in poor condition and will require replacement.*

Panning 180 degrees from previous photo. View of  
bathtub surround at second floor bathroom.

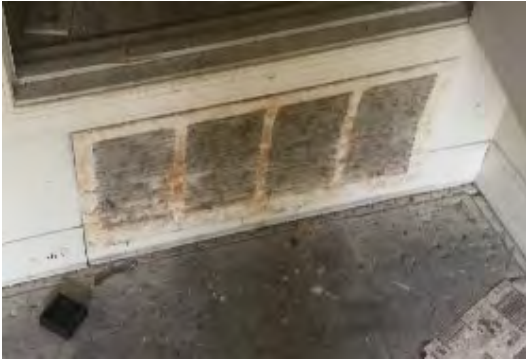
Return grill

*All filters, supply and return grilles should be replaced.*

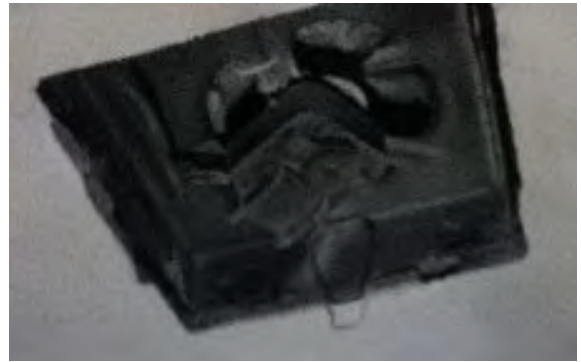
Exhaust fan not working

Replace kitchen and bathroom exhaust fans.

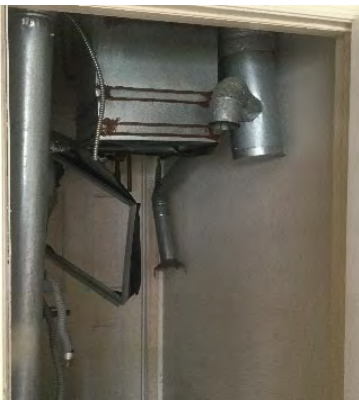
*Furnace flue is connected adequately and seems to be in good condition.*

Furnace closet
