# Germantown/Mount Airy Properties

## Physical Conditions and Needs Assessment

### Premises I

**63 E. Wister St**

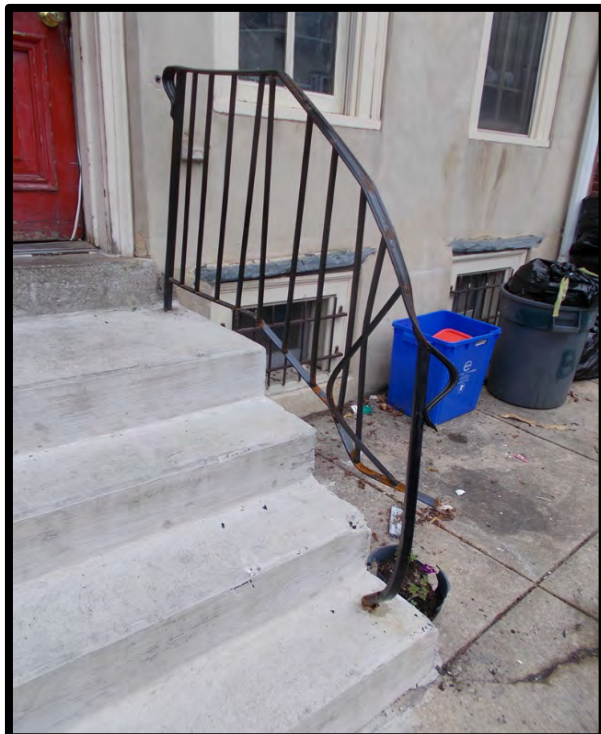
**Photo No. 2**

Access to the site is from Wister Street. Entrance to the building is via concrete steps leading to a door approximately 3.5 feet above grade. The concrete steps appear to be recently built due to previous vehicular damage. There is a wrought iron railing to the right of the stairs.

*The wrought iron railing is bent and rusted and should be replaced.*

Depicts view of recently repaired front entry steps and damaged railing.

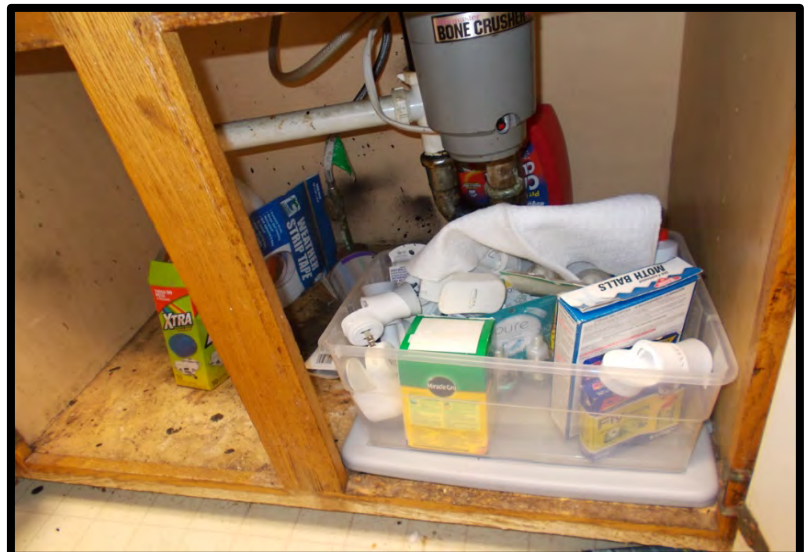
**Photo No. 6**

*UNIT A - It was noted that the kitchen sink leaks excessively which has rotted the base cabinet below.*

Depicts view beneath kitchen sink. There is a known plumbing issue and drainage problems with the sink.

*Replacement of the wooden cabinets and the plastic countertop is required.  
There are drawer faces missing from the kitchen.*

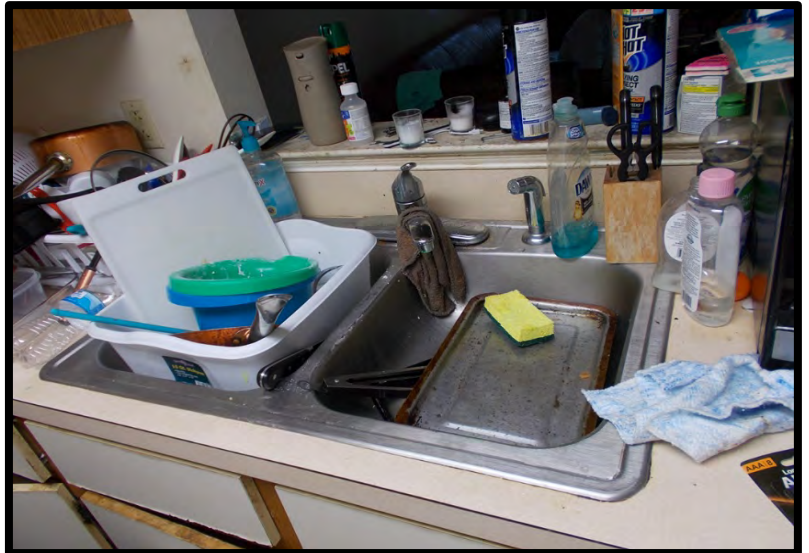
**Photo No. 7**

Depicts view of kitchen faucet which leaks during operation.

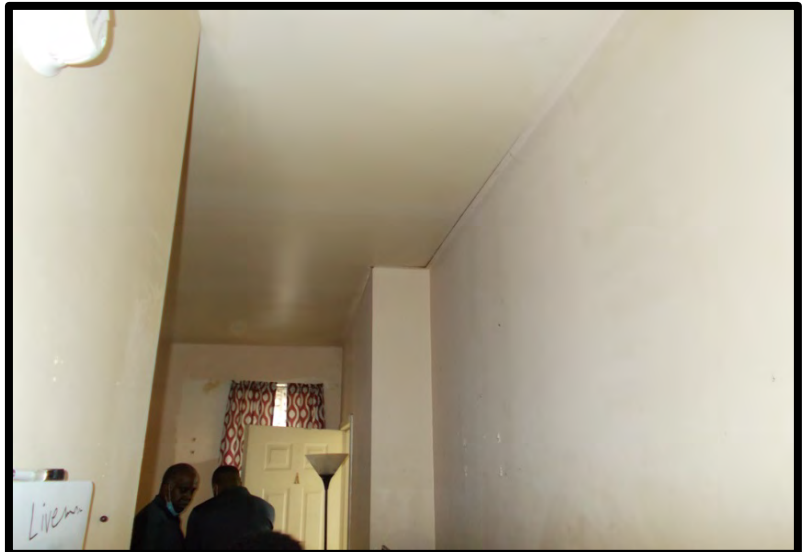
**Photo No. 10**

*Evidence of water infiltration along the ceiling in the living room was noted.  
Additional sanding and painting is required to the previous repairs of the bathroom ceiling above the bathtub*

View of ceiling in Unit A at living room. There is noted water staining along the ceiling near stairs.

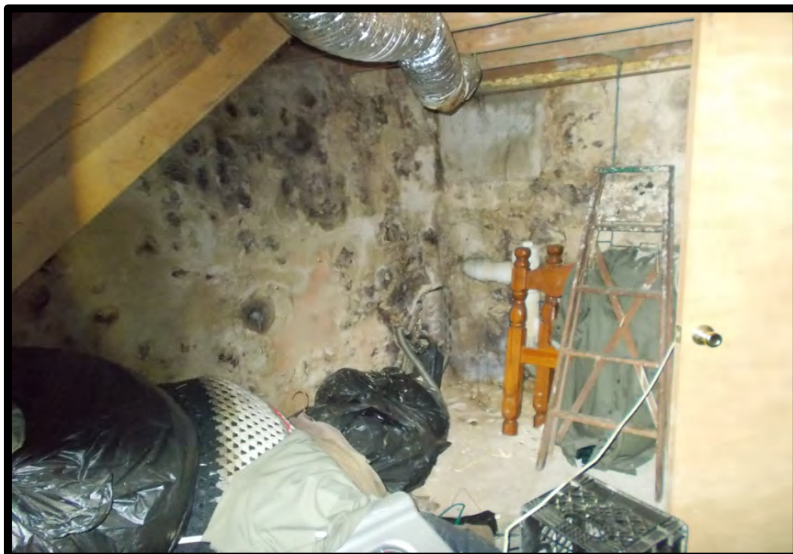
**Photo No. 17**

Depicts rear wall of basement behind stairs with a large evidence of mold growth.

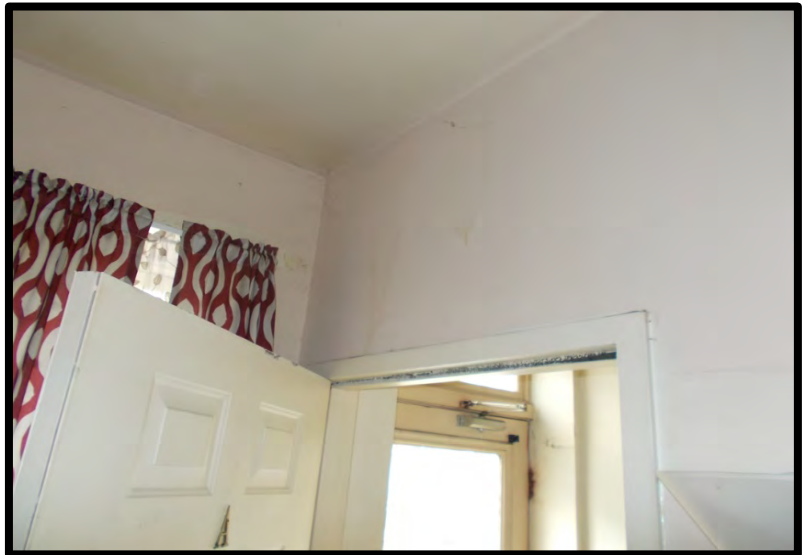
**Photo No. 22**

View of water staining above apartment entry door.

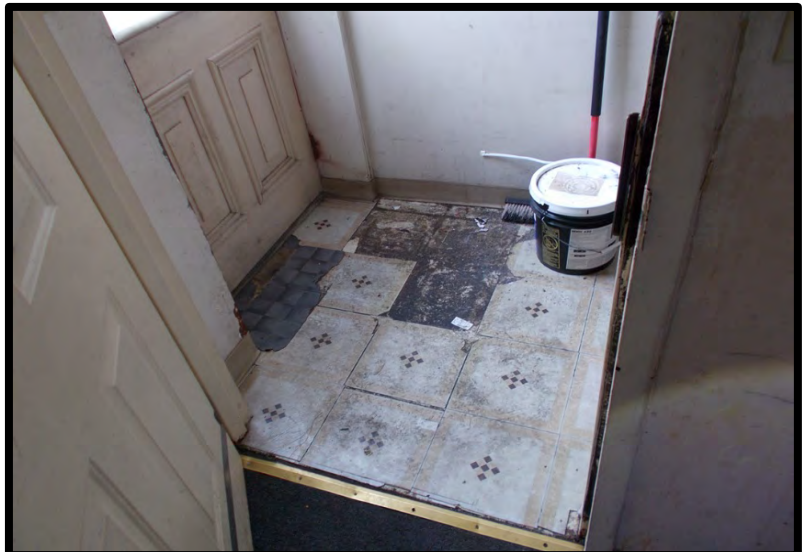
**Photo No. 23**

A common area hallway at the entry has what appears to be 12" x12" vinyl tile over sub-floor. The floor is missing several tiles and is generally in very poor condition.

View of common entry floor tile condition.

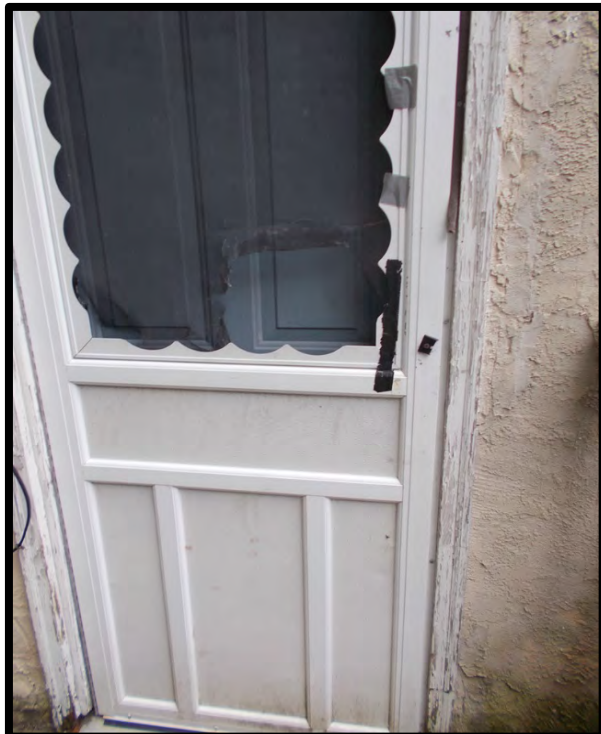
**Photo No. 25**

The storm door at the rear yard facing Unit A is a 6-panel vinyl clad door and appears to be in fair condition. Entrance to the building is via concrete steps leading to a door approximately 3.5 feet above grade. Entry to Unit B is off the first floor lobby.

Detailed view of storm door at rear.

*Replacement of the storm door should be considered.*

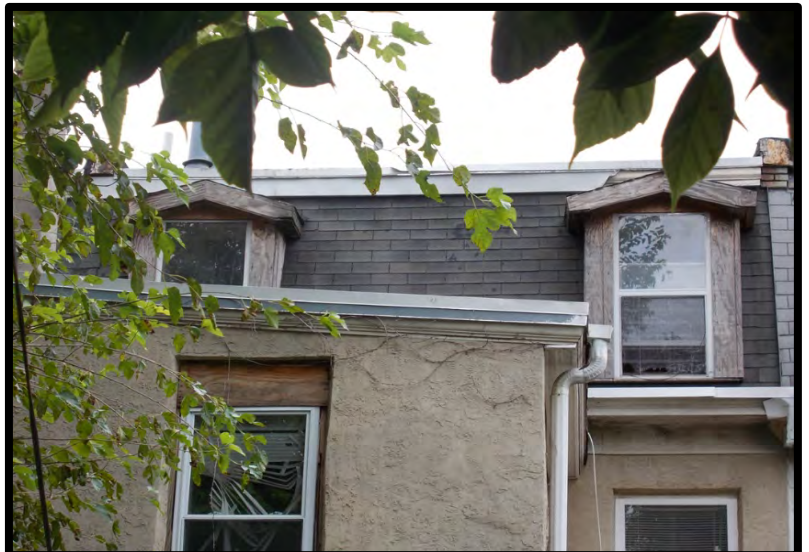
**Photo No. 29**

The roof appears to be of a slate finish in fair condition. The third-floor dormers at the rear of the building are wood and appear to have been repaired or reconstructed at some point. The wood is unfinished and left to the weather. The third-floor finish also appears to be 3-tab shingle, a vertical installation with vinyl trim. It appears that the leak to the lower bedroom is at the intersection of the second-floor roof and third floor exterior wall.

Detailed view of third floor roof and windows.

*The wood should either be painted and/or clad for weather resistance and any rotten materials should be replaced.*

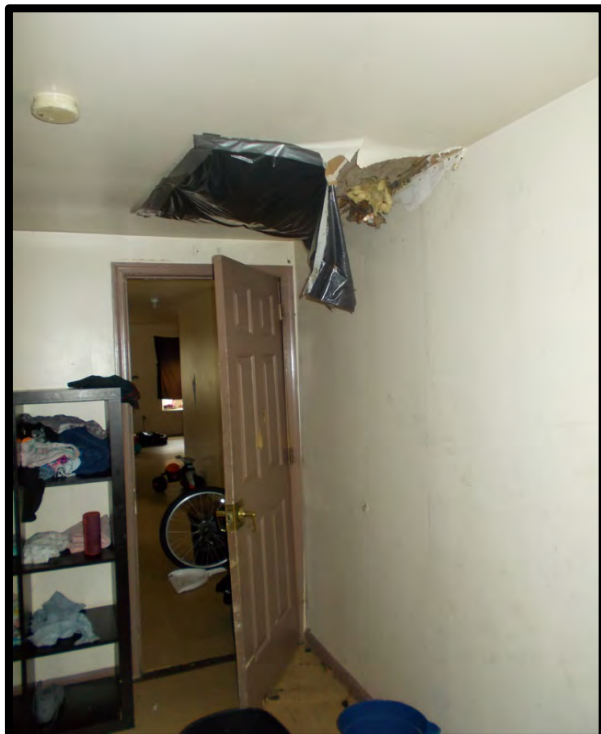
**Photo No. 44**

UNIT B - There is damage to the wall along the hallway outside of the kitchen. The second-floor bedroom has a portion of ceiling above the entry door that has been taped off due to water leakage. General condition of the rear bedroom is poor. There is a leak in the lower bedroom at the intersection of the second-floor roof and third floor exterior wall. The bedroom at the front of the third floor appears to have typical finishes.

View of bedroom entry and damaged ceiling above.

*Repair the wall along the hallway outside of the kitchen on the second floor is recommended.  
The second-floor bedroom ceiling above the entry door has partially collapsed due to water damage and needs to be investigated and repaired.  
All flooring finishes in the rear bedroom has been removed due to excessive damage and will require new sub-floor and repairs to the walls.  
The front bedroom will require new flooring.*

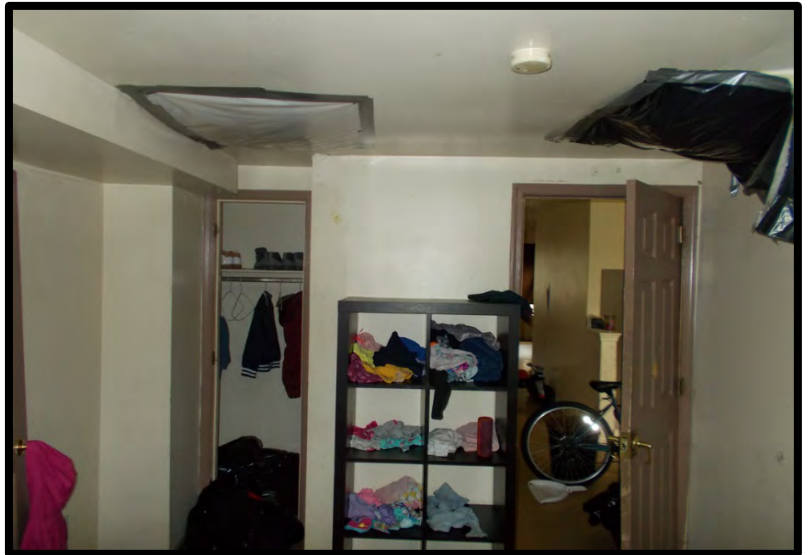
**Photo No. 45**

Panning left from previous photo. Depicts view of bedroom entry and warped areas of ceiling indicating water infiltration.

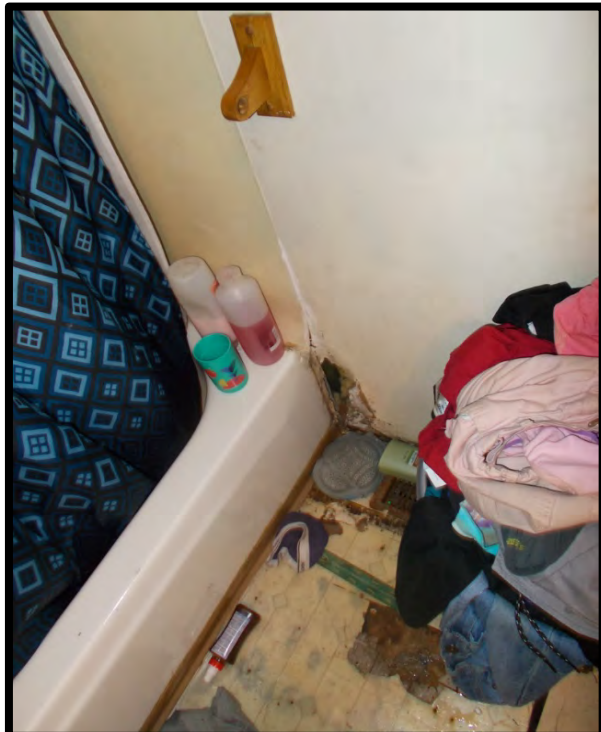
**Photo No. 53**

Depicts water infiltration at bathtub and joining  
surround at the third floor bathroom.

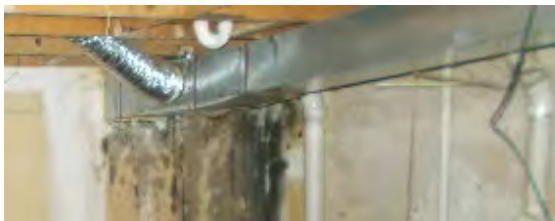
Duct damage.

*All supply and return grills should be replaced.*
