Germantown/Mount Airy Properties

Physical Conditions and Needs Assessment

Premises J

50 E. Collom St
Philadelphia, PA 19144

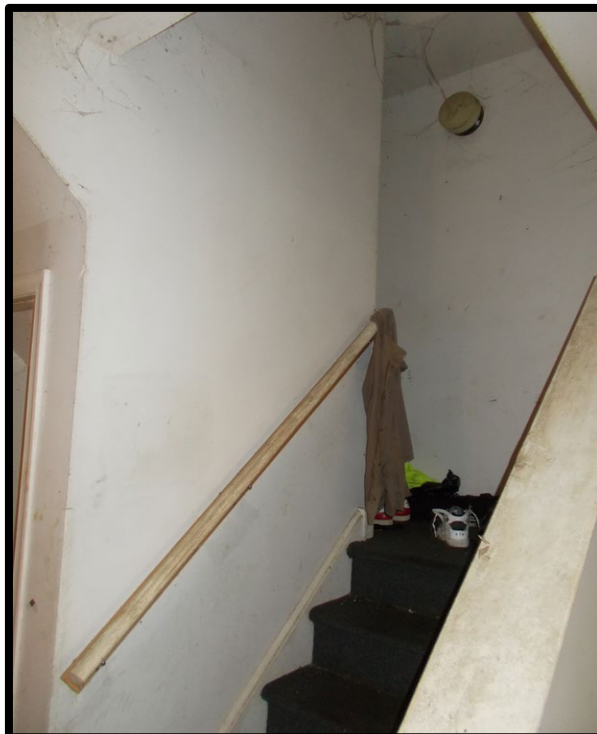
Photo No. 2

The staircase was carpeted wooden staircase in fair condition.

Depicts view of stairs leading up to the second floor.

Replacing the carpets is recommended.

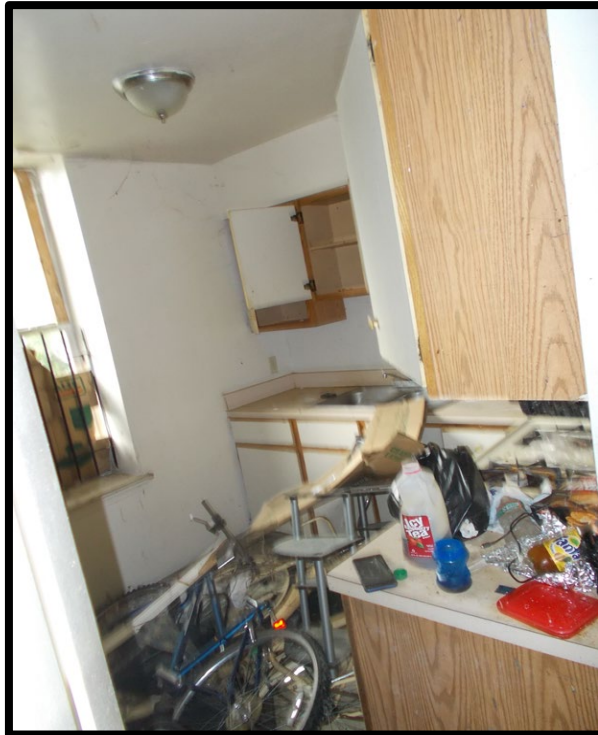
Photo No. 3

The fixtures were in poor condition and require replacement.

Cabinets are in poor condition and should be replaced.

Depicts interior view of kitchen.

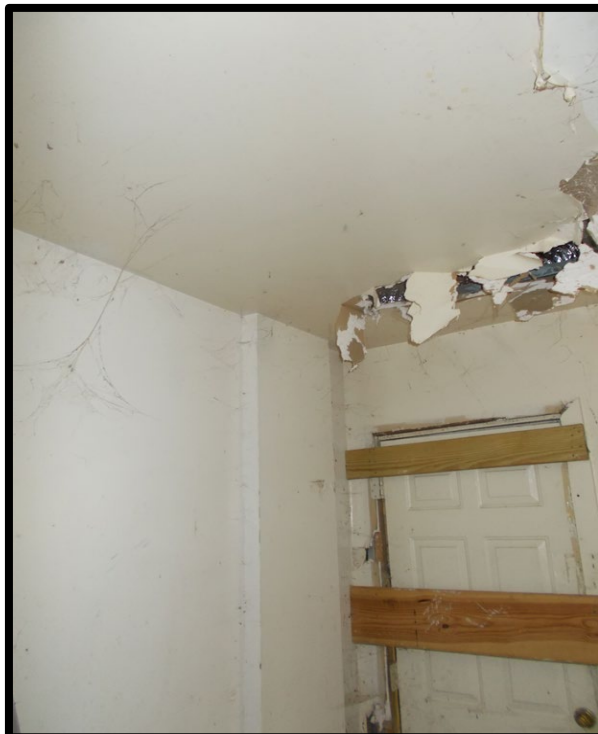
Photo No. 4

Repairs to drywall ceilings and walls is required throughout the dwelling unit.

Depicts view of the rear yard door and damage to second floor ceiling above.

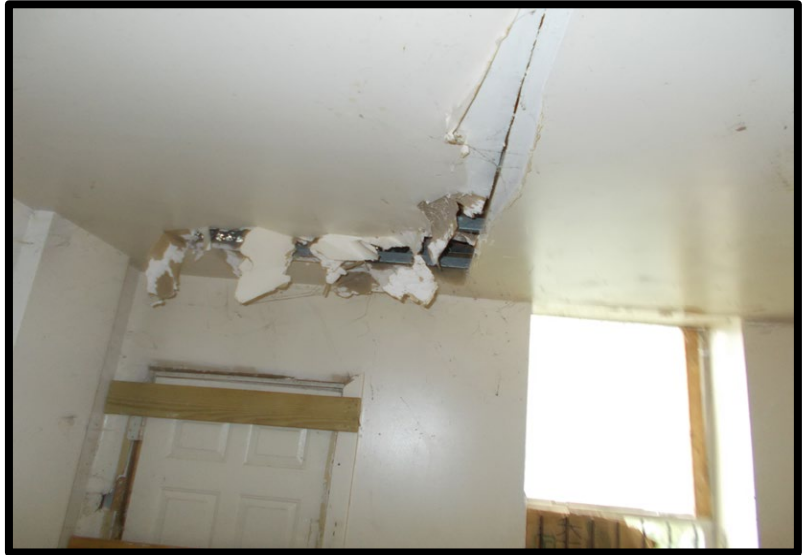
Photo No. 5

Additional view of damaged ceiling above dining room
at rear of first floor.

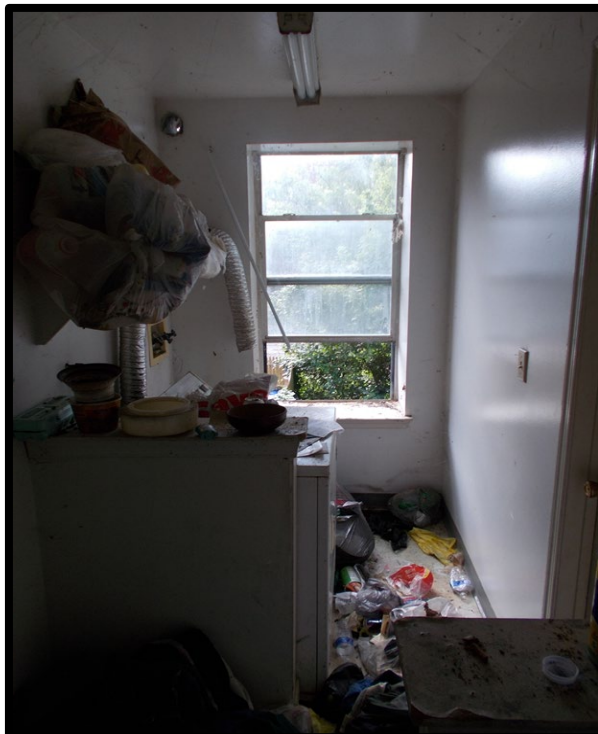
Photo No. 8

Second floor rear portion of the dwelling consists of a washer/dryer.

In general appliances are in poor condition and should be replaced.

View looking rearward from second floor. This location is set up for a washer/dryer area.

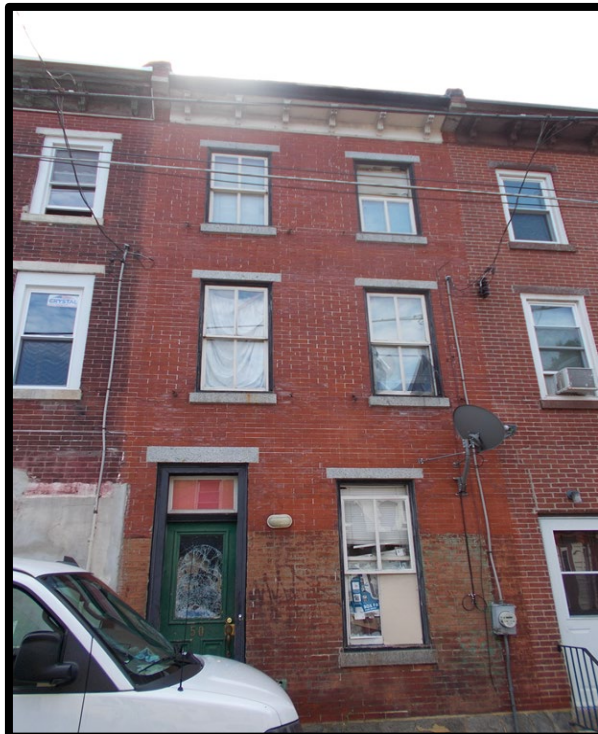
Photo No. 17

The door and transom appear to be original in nature and may require repair, paint and/or replacement in the near future.

The exterior brick masonry appears to be in good condition with repointing, some cleaning and repair work required.

The wooden cornice requires some repair work.

The windows appear to be original wood windows.

View of front exterior of building from Collom Street.

Replacement of windows should be considered for security and energy efficiency.
