Germantown/Mount Airy Properties

Physical Conditions and Needs Assessment

Premises K

56 E. Collom St

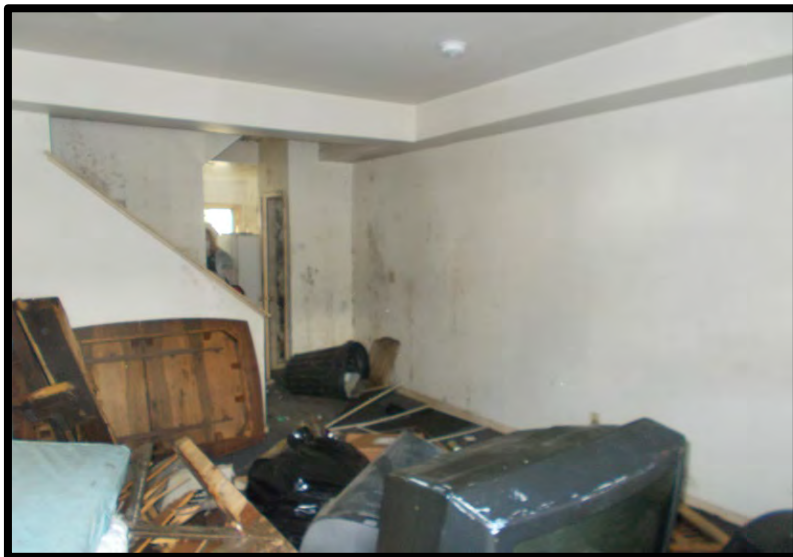
Photo No. 1

Excessive mold was noted at the stair in the basement.

Depicts view of first floor living room as seen from building entry. Note extensive mold towards the rear of the dwelling.

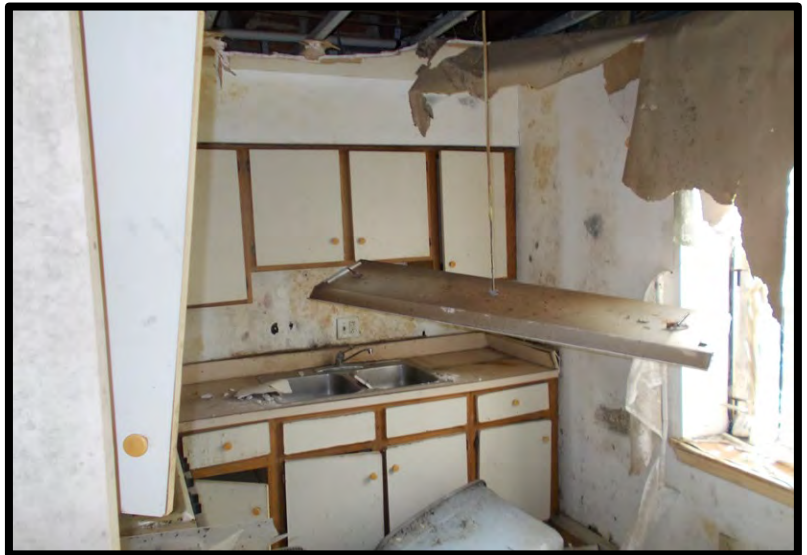
Photo No. 4

Interior finishes consist of gypsum board ceilings and walls. Floor finishes consist of carpet with a 4" vinyl base in poor condition and will require replacement. The ceiling above the kitchen has collapsed due to unknown reason. Interior doors are 6-panel wood in poor condition

Excessive mold was noted at the stair, basement and kitchen area. All gypsum board on the walls and ceiling will require removal and replacement.

Cabinets and countertop are in poor condition and should be replaced.

Depicts view of kitchen at rear of first floor. Note extensive damage to the ceiling and wall gypsum board. The kitchen cabinets are wood with a plastic laminate top and need to be replaced.

The kitchen is in poor condition and will require full replacement.

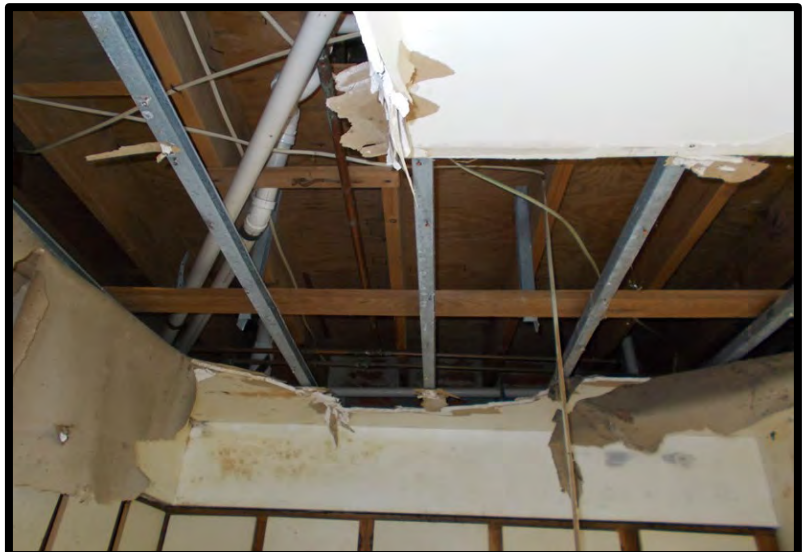
Photo No. 5

Panning up from previous photo. Detailed view of second floor framing and damaged ceiling gypsum board.

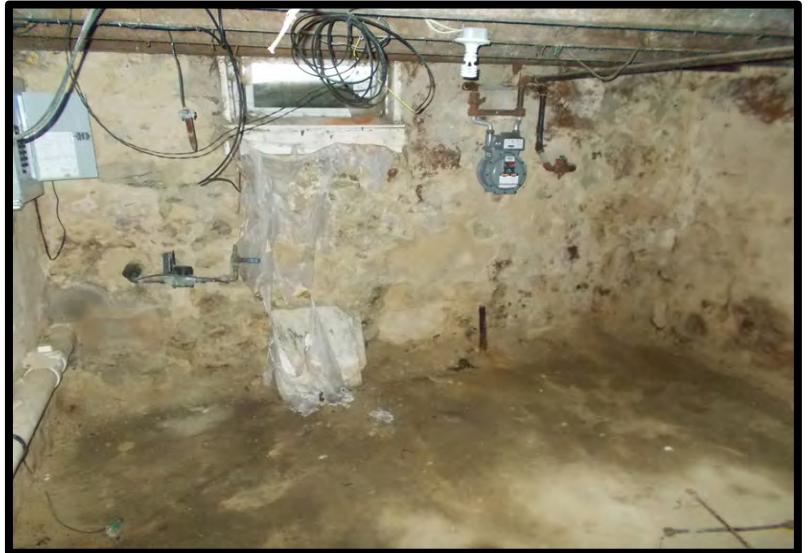
Photo No. 8

View at front of basement. Note the water service has been cut immediately after the water meter. Also visible in the photo is the main electric panel for the building on the left and the gas meter located on the right.

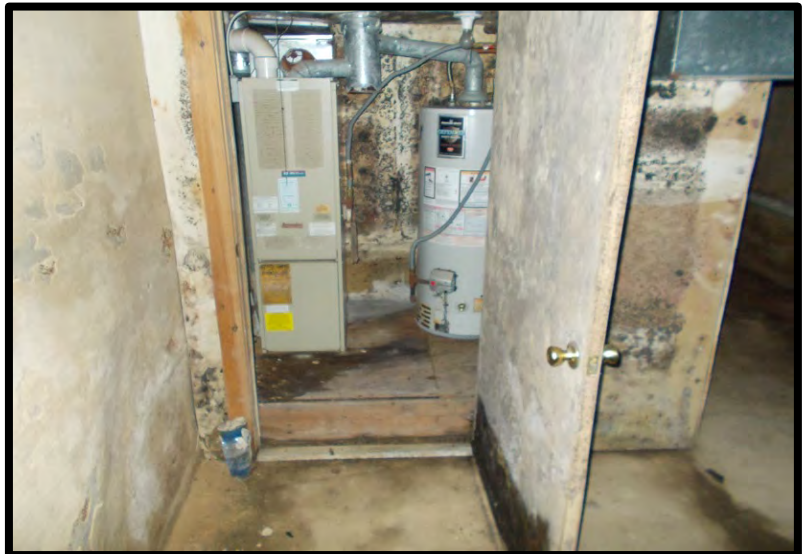
Photo No. 9

View of mechanical room in basement. This room contains a hot air furnace as well as a gas fired hot water heater. All ductwork is run exposed in the basement feeding the first floor and upper floors.

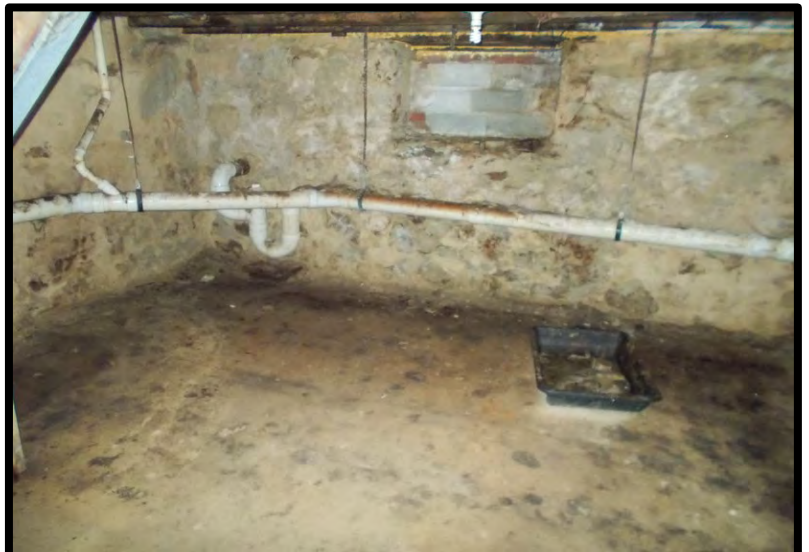
Photo No. 10

View at rear of basement. View also indicates existing PVC sanitary lines.

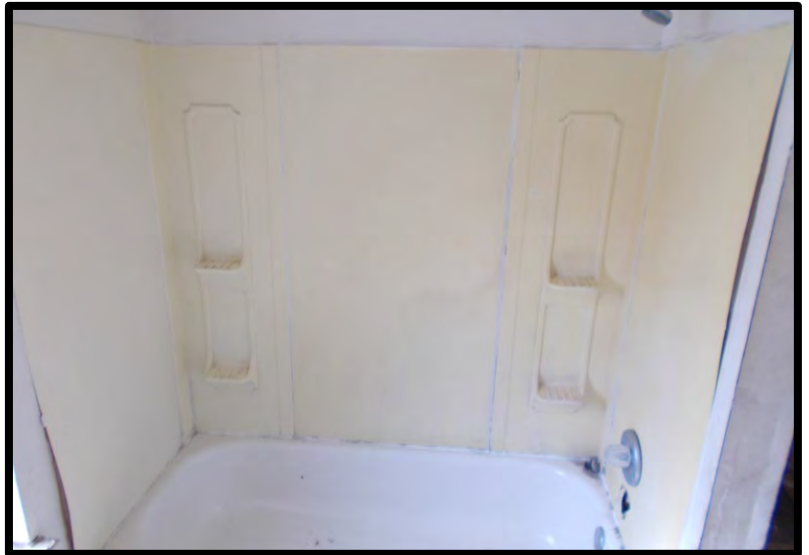
Photo No. 15

The bathroom on the second contained a lavatory, water closet and bathtub. Typical bathroom finishes consist of vinyl tile in poor condition with evident areas of repair. The water closet appears to be in fairly new and in good condition. The wood lavatory and plastic laminate countertop is in poor condition. The bathtub and fiberglass surround are also in poor condition and will require replacement.

Overall view of second floor bathtub and fiberglass surround.

Entire bathroom should be replaced.

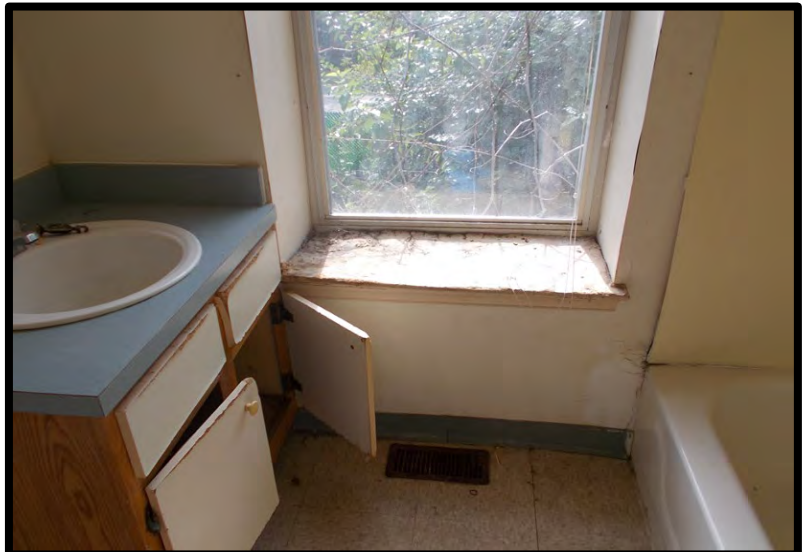
Photo No. 16

It appears that all windows throughout the building have been replaced with a vinyl window replacement. All interior window sills throughout the building are wood and are in poor condition.

Detailed view of second floor bathroom vanity and wood window sill.

Replacement the wood window sills is required.

Replace wood lavatory and plastic laminate countertop.

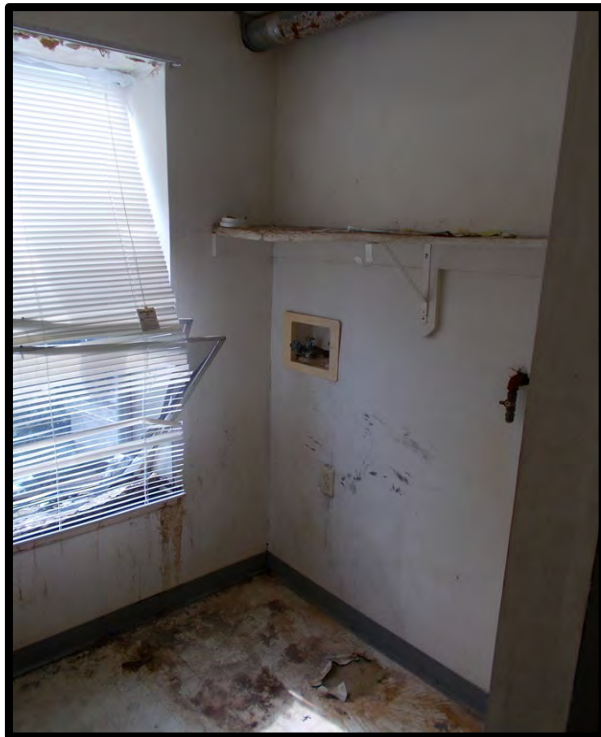
Photo No. 17

Full replacement in the washer/dryer area is required. Evidence of previous water damage was noted.

View of washer/dryer area and hook up at rear of second floor adjacent to the bathroom.

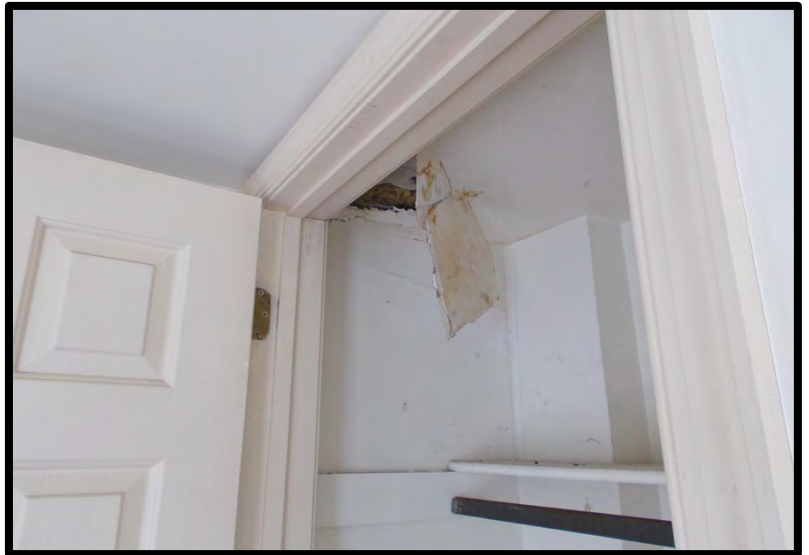
Photo No. 25

Water infiltration in the closet of the rear bedroom on the third floor indicates that the roof should be repaired or replaced.

Two hall closets are located at the top of the stairs in the hallway area. There was a water infiltration ceiling damage in the closet ceiling of the rear third floor bedroom.

View of damaged ceiling in bedroom closet from
water infiltration.

Replace/Repair the ceiling in the closet of the rear third floor bedroom.

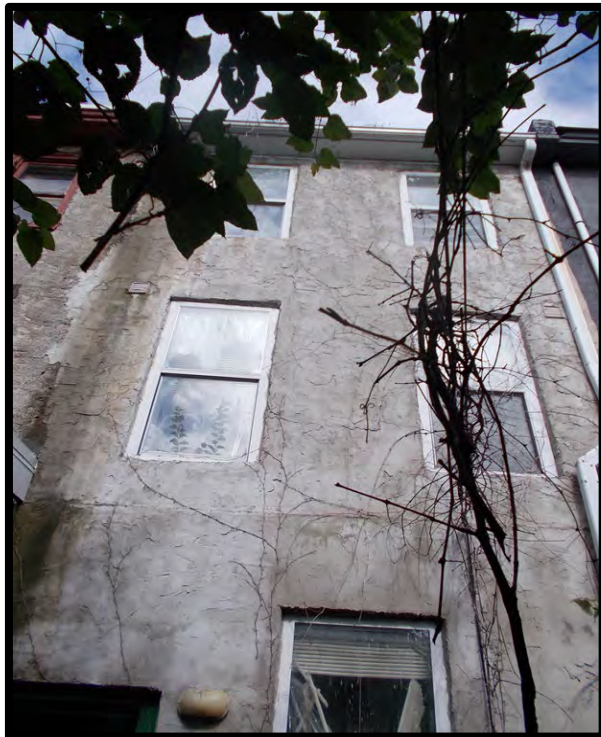
Photo No. 28

The exterior façade of the building is brick masonry veneer with a wooden cornice. The rear of the building consists of a cementitious parged coat finish which is in fair condition. It is unknown what substrate is behind the parged coat.

View looking at rear elevation of structure. Structure appears to have a cementitious parged coat.

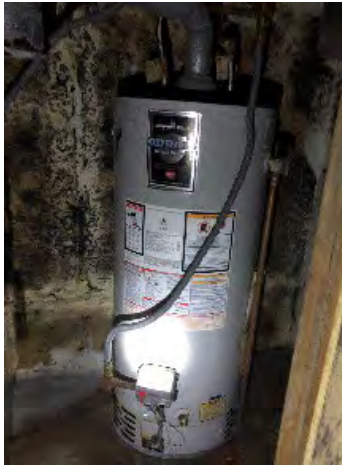
Domestic hot water is provided by 30-gallon hot water tank manufactured by Bradford White. Could not prove function but was in good visual condition.

Hot water heater located in basement.

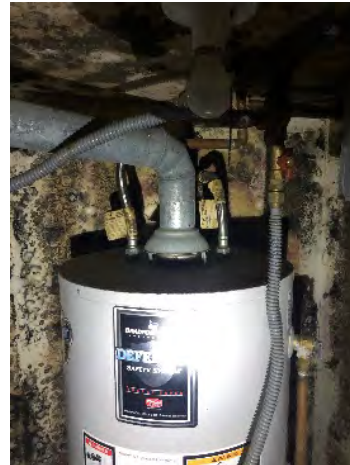
Top of hot water heater in good condition.

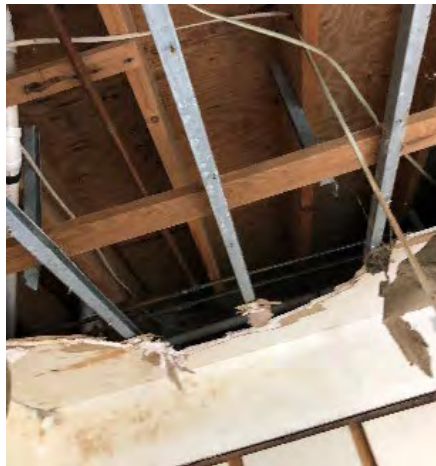
Damaged kitchen ceiling.
