Germantown/Mount Airy Properties

Physical Conditions and Needs Assessment

Premises L

45 E. Garfield Street

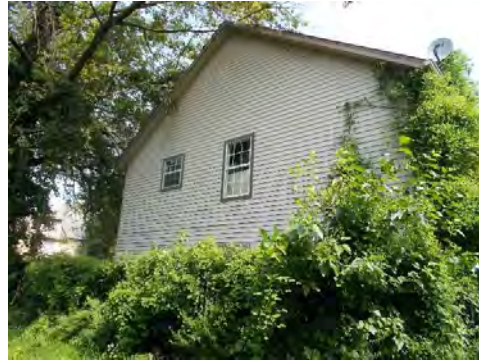
There are overgrown shrubs and weed trees at the front, side and back of the building.

View of left side of building at unit 45 showing overgrown fencing along property line.

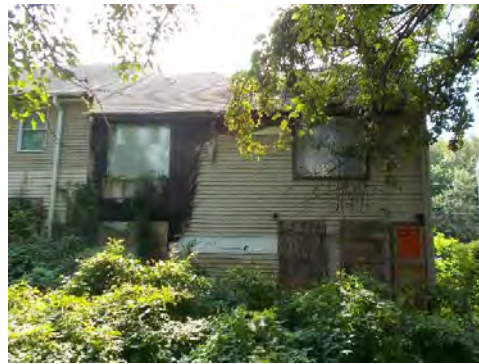
A large area of the rear vinyl siding was melted along with damaged sheathing. Vinyl siding on the side of the building is in poor condition due to neglect and fire damage.

Overall view at the rear of units 45 and 47. Note visible fire damage at rear of unit 45.

It is anticipated that the entire rear portion will need to be stripped to bare studs and new sheathing and siding to be replaced. Vinyl on the side of the building should also be replaced.

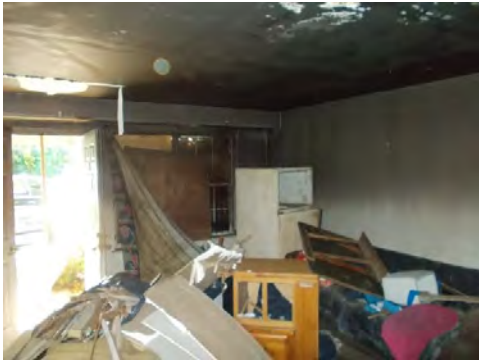
View looking at living room. Unit had evidence of previous fire damage.

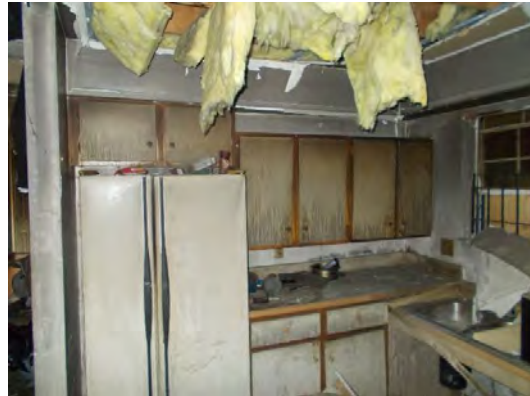
Walls, ceilings and floors are in poor condition.

Additional view of kitchen. Depicts damaged ceiling.

All finishes should be replaced.

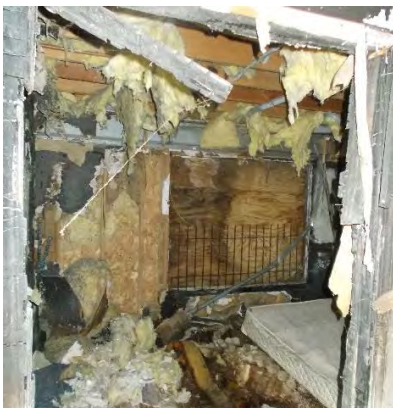
View inside bedroom. Note substantial damage from fire. However, wood framing appears to be in tact.

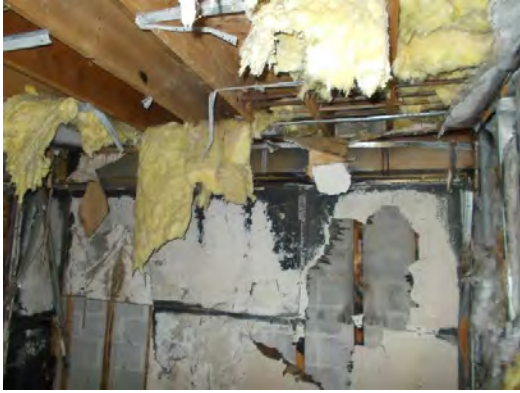
View of damaged area along party wall. Note no damage to the masonry party wall was evident.

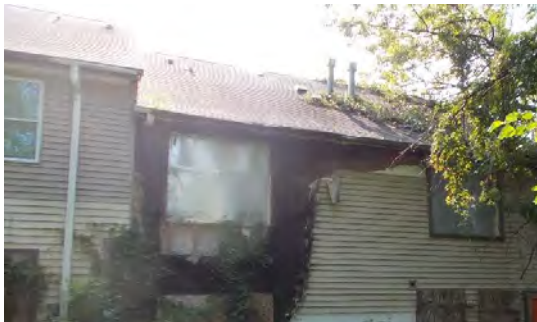
Visual evidence from street level shows roof damage and missing shingles. Immediate roof repair and replacement required to maintain weather tight building envelope.

View of fire damage at the rear and damaged roof of units 45 and 47.

Main roof and entry canopy roof shingles should be replaced. New gutters, fascias and downspouts will need to be installed.

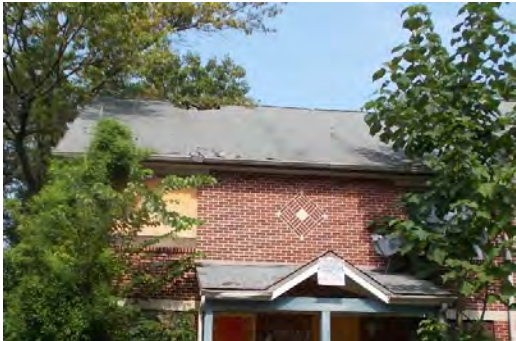
The asphalt shingle roof appears to be a 3-tab version in fair to poor condition and requires immediate repair and replacement to maintain building enclosure in a weather tight condition.

View of fire damage on the roof at the front of units 45 and 47.
