Germantown/Mount Airy Properties

Physical Conditions and Needs Assessment

Premises M

47 E. Garfield Street

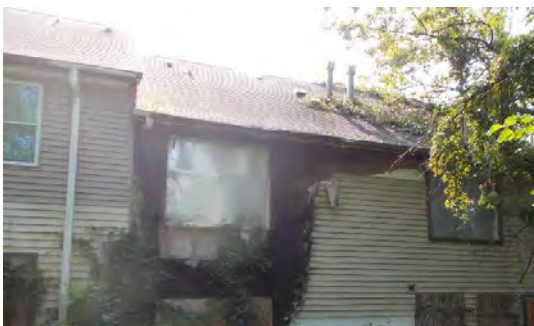
A large area of the rear vinyl siding was melted along with damaged sheathing. Vinyl siding on the side of the building is in poor condition due to neglect and fire damage.

View of fire damage at the rear and damaged roof of units 45 and 47.

It is anticipated that the entire rear portion will need to be stripped to bare studs and new sheathing and siding to be replaced. Vinyl on the side of the building should also be replaced.

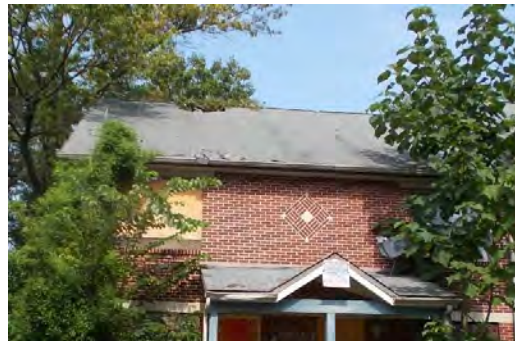
There are substantial holes in the main roof. Ceilings in living room, kitchen, front and rear bedroom are severely damaged and collapsed. The asphalt shingle roof appears to be a 3-tab version in fair to poor condition and will require replacement in the immediate future.

View of fire damage on the roof at the front of units 45 and 47.

Main roof and entry canopy roof shingles should be replaced. New gutters, fascias and downspouts will need to be installed.

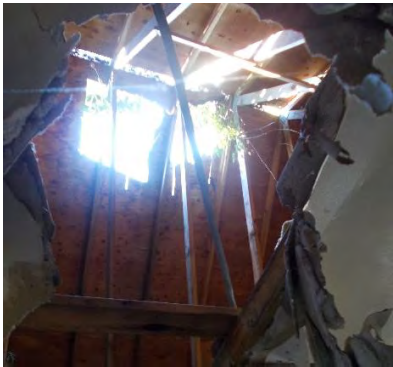
View of damaged ceiling and roof open to elements.

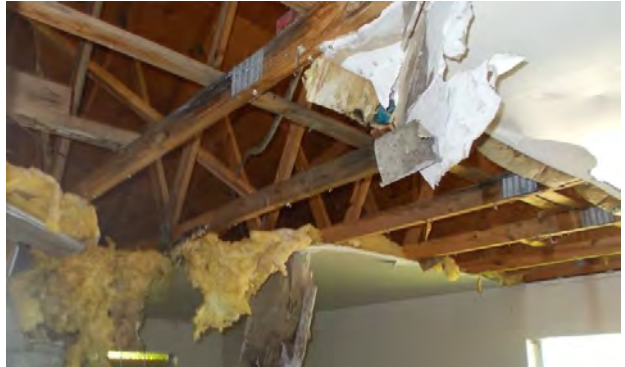
Depicts view of ceiling at living area. View is looking towards front of dwelling.

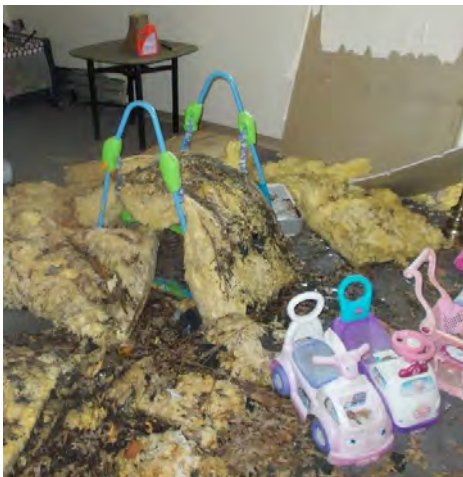
Insulation has suffered from exposure to the elements and should be replaced.

View of gypsum wallboard and insulation that has fallen from the roof trusses above.

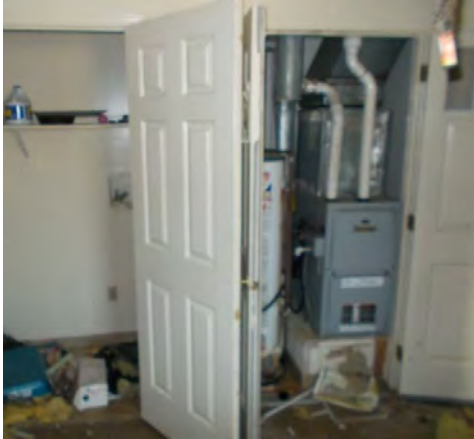
A 30 gallon hot water heater was visible and in bad condition.

Depicts view of installed hot air furnace and water heater as well as washer/dryer closet facing the kitchen area.

Hot water heater should be replaced.

Furnace should be replaced due to age.

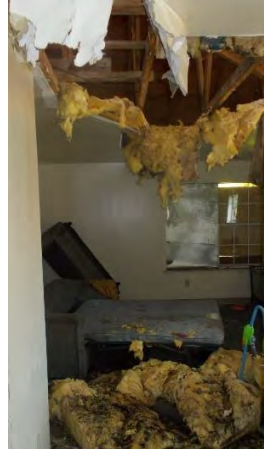
View looking into bedroom. View of collapsed ceiling, wallboard and insulation.

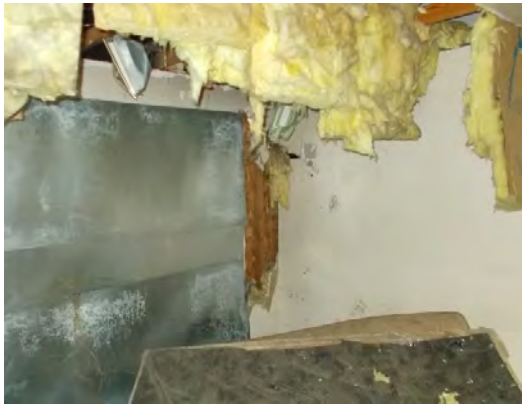
Detailed view of ceiling and exterior wall within bedroom.

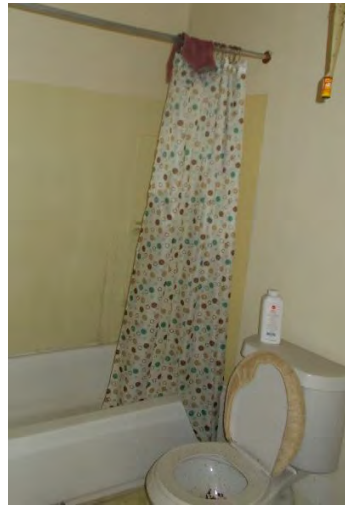
The bathroom consists of a wood and plastic laminate vanity with top mount sink as well as a water closet, bathtub and fiberglass shower surround. The bathtub and water closet appear to be in good condition.

View of bathtub and surround as well as water closet at bathroom with unit.

Bathtub surround and lavatory should be replaced.

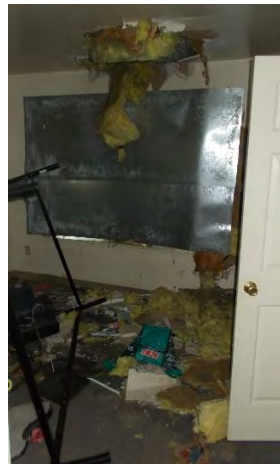
View looking into master bedroom from hallway. Evidence of additional ceiling collapse visible.

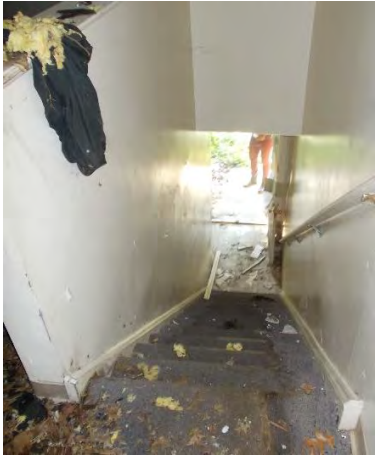
Stairs to the second floor unit appear to be wood construction with carpet and a single handrail in poor condition.

View looking down entry stairs to apartment entry door at grade.

Carpeting and handrail should be replaced.
