Germantown/Mount Airy Properties

Physical Conditions and Needs Assessment

Premises N

51 E. Garfield Street

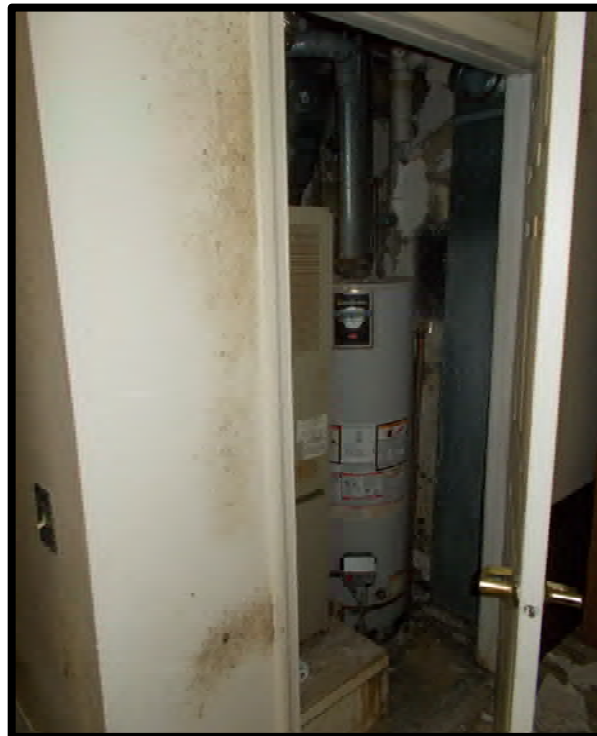
Photo No. 39

Domestic hot water is provided by a gas fired 30- gallon tank type water heater located in the unit. Flues are adequately connected, but there is visible water and corrosion damage on the hot water heater itself.

View of mechanical closet with installed hot air furnace and gas-fired water heater.

It is recommended that the hot water heater should be replaced.

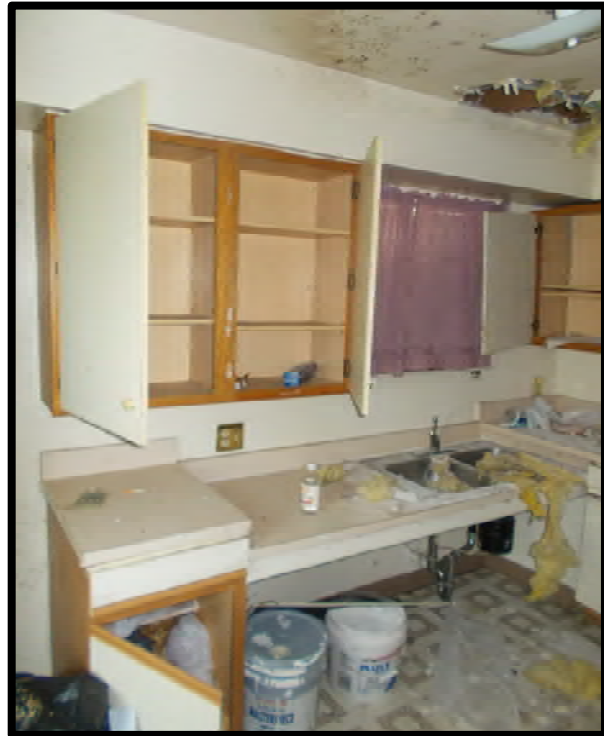
Photo No. 41

Kitchen fixtures and appliances are in poor condition.

Panning left from previous photo. View of kitchen and kitchen sink that was made handicap accessible.

All kitchen fixtures and specialties should be replaced.

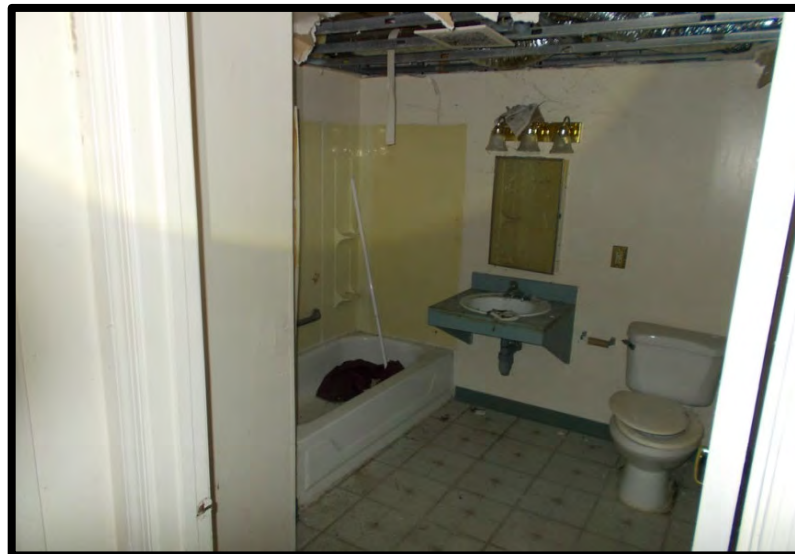
Photo No. 47

The bathroom ceiling was completely removed and will require replacement.

View of main bathroom area with handicap sink, water closet and bathtub. Note ceiling has been removed.

Bathroom fixtures, water closet, bathtub, sinks and lavatories should be replaced.

All bath fixtures and specialties should be replaced. Grab bars need to be installed per code requirements.

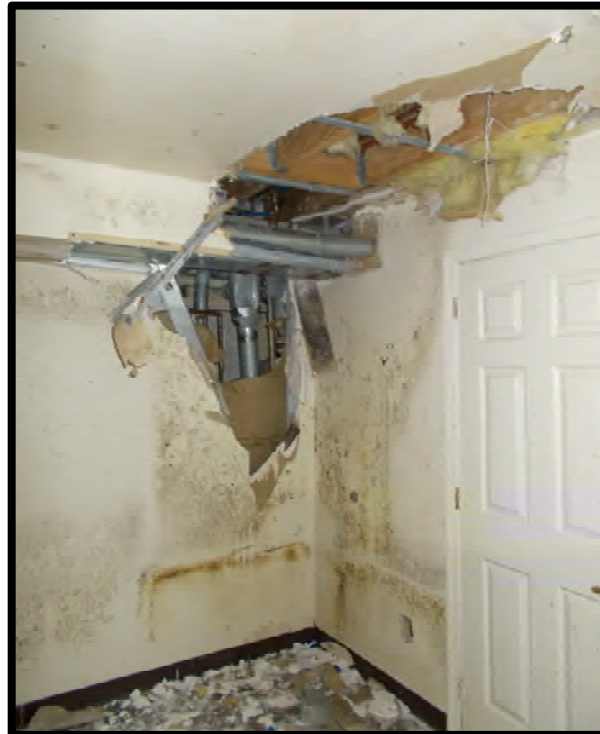
Photo No. 51

Evidence of ceiling damage was noted throughout, as well as damage to the walls due to copper piping being removed. The dwelling exhibited some mold issues throughout.

Panning right from previous photo. Depicts damaged wall and ceiling within bedroom.

All finishes should be replaced.

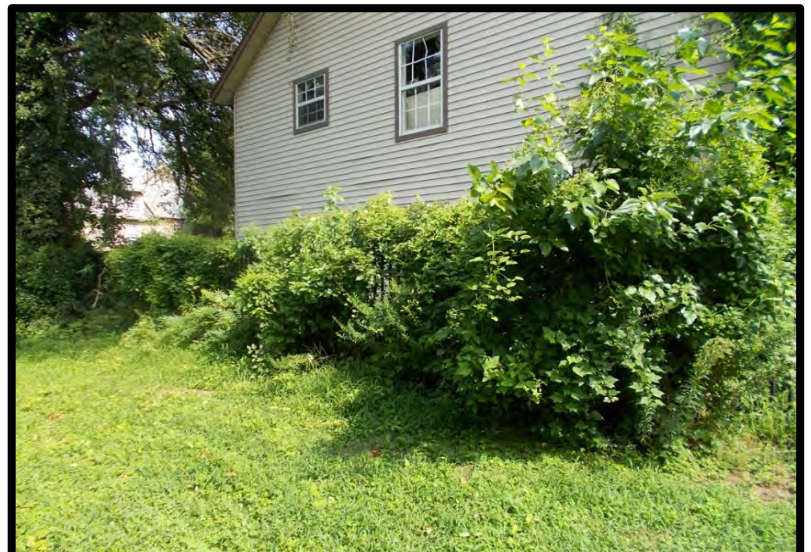
Photo No. 57

The wrought iron fencing along the perimeter of the lot appears to be in good condition with vegetative growth that should be removed.

Panning down from previous photo. View of overgrown fencing along property line.

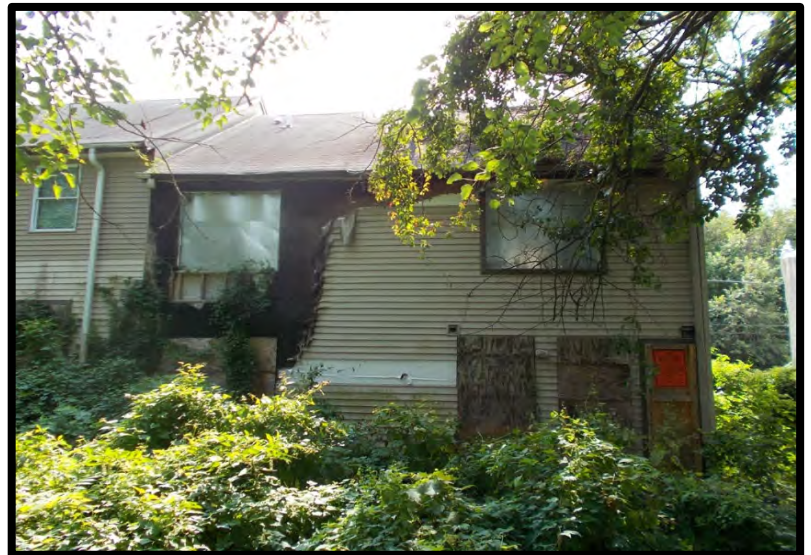
Photo No. 61

A large area of the rear vinyl siding was melted along with damaged sheathing on connecting dwellings 45 and 47 E Garfield St. Vinyl siding on the side of the building is in poor condition due to neglect and fire damage.

Overall view at the rear of units 45 and 47. Note visible fire damage at rear of unit 45.

Vinyl on the side of the building should be replaced.

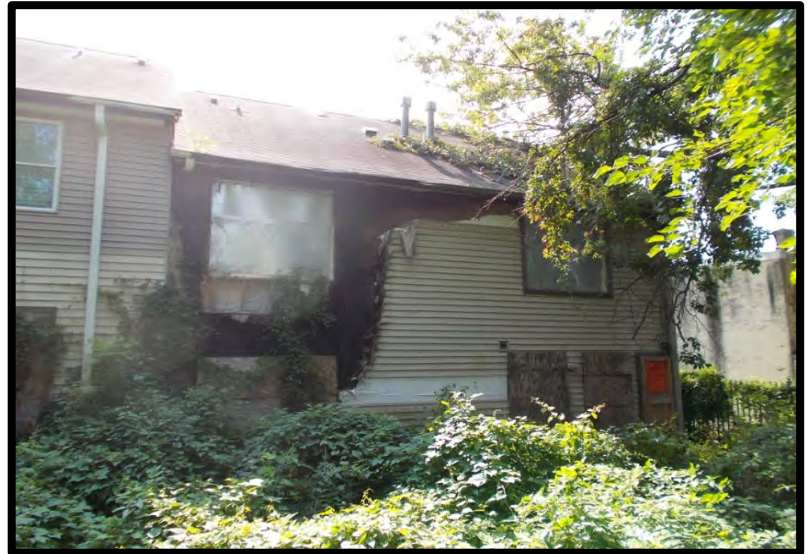
Photo No. 63

Additional view of fire damage at the rear and damaged roof of units 45 and 47.

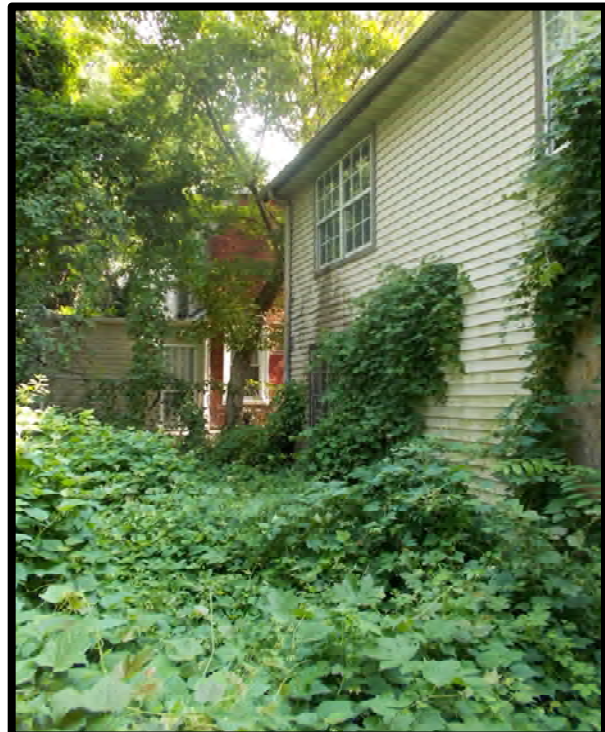
Photo No. 64

Depicts close up view of overgrown rear yard and rear façade of unit 51.
