# Germantown/Mount Airy Properties

## Physical Conditions and Needs Assessment

### Premises O

**67 E. Church Lane**

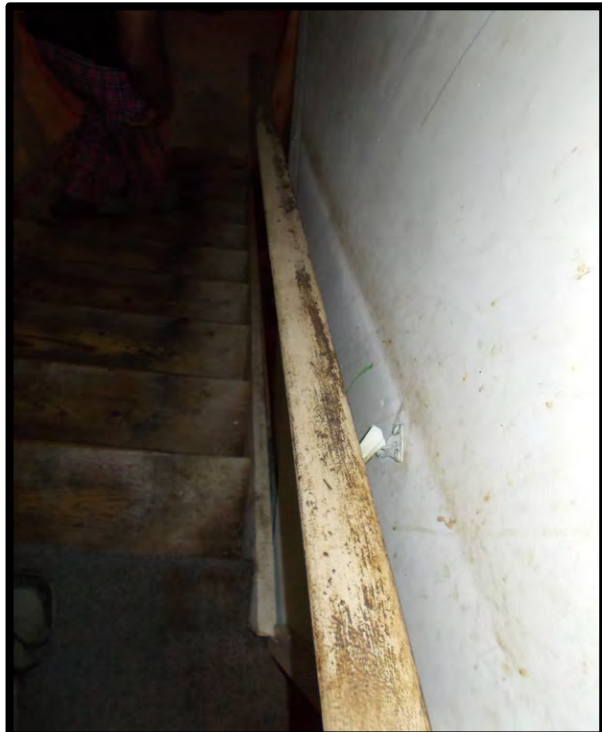
**Photo No. 4**

Depicts view of basement stairs from first floor. Note handrail has been damaged and will require repair.

Interior stairs are wood construction with wooden handrail. Handrail to basement requires repair to maintain proper anchorage. A carpet runner is provided from the first to second floor. The remainder of the stairs are carpeted.

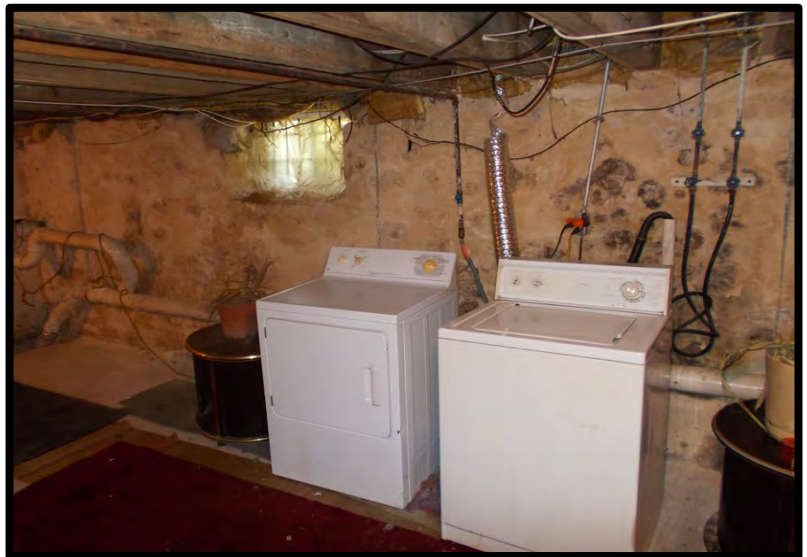
**Photo No. 6**

Depicts view of washer/dryer hook up at basement. Note damaged dryer venting allowing fumes to vent back into the basement.

Kitchen and bathroom exhaust fans were none functional and should be replaced. Replace dryer vent in basement.

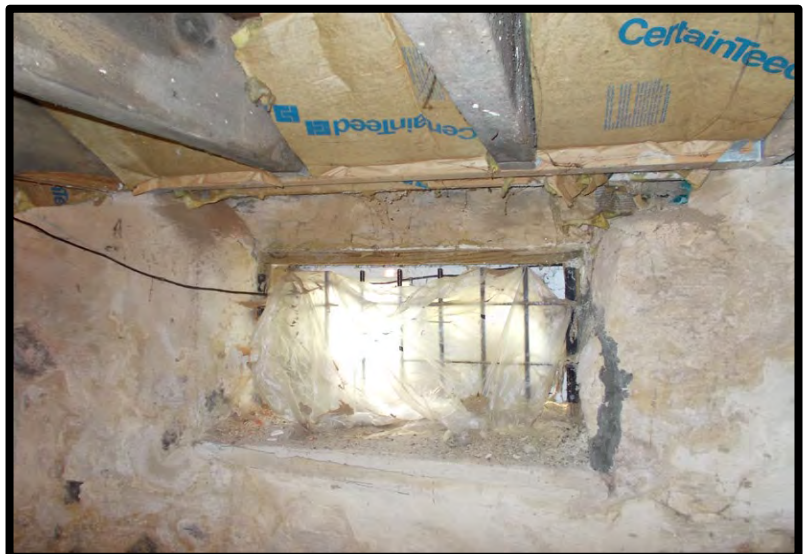
**Photo No. 7**

Foundations are parged stone in good to fair condition. Repairs to the wall are required to close entry points to critters, especially around basement window.

Depicts view of window leading to side yard. Note portion at top right will require patching.

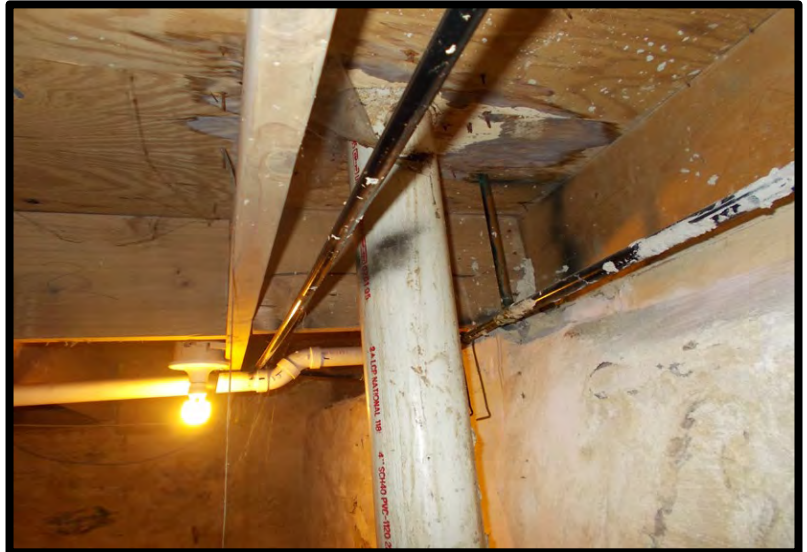
**Photo No. 10**

The dwelling is wood framed with wood subfloor. Visible structure from the basement indicated overall good conditions, however areas under the kitchen and bathroom were noted to have water damage. Additional investigation and possible replacement of subfloor may be required.

Depicts view of damaged subfloor from bathroom above. Repair of subfloor is required.

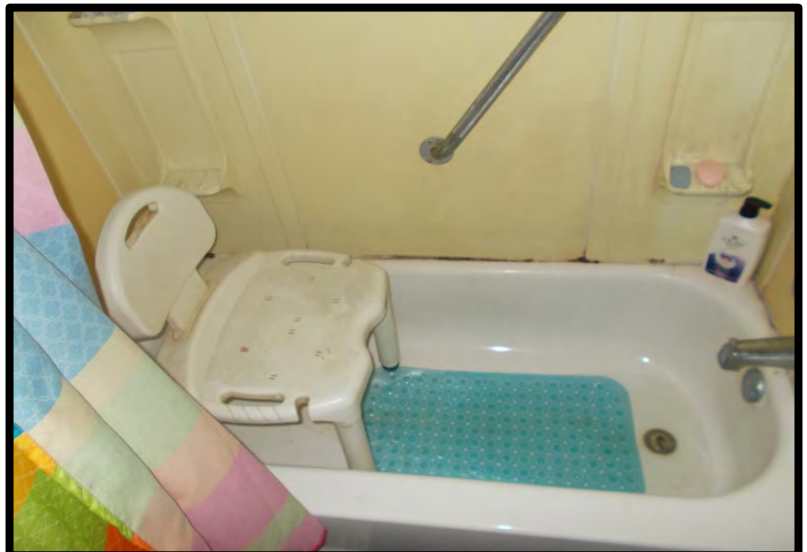
**Photo No. 18**

Depicts overall view of bathtub and fiberglass surround.

*Replace fiberglass tub surrounds, first floor water closet and both bathroom vanities.*

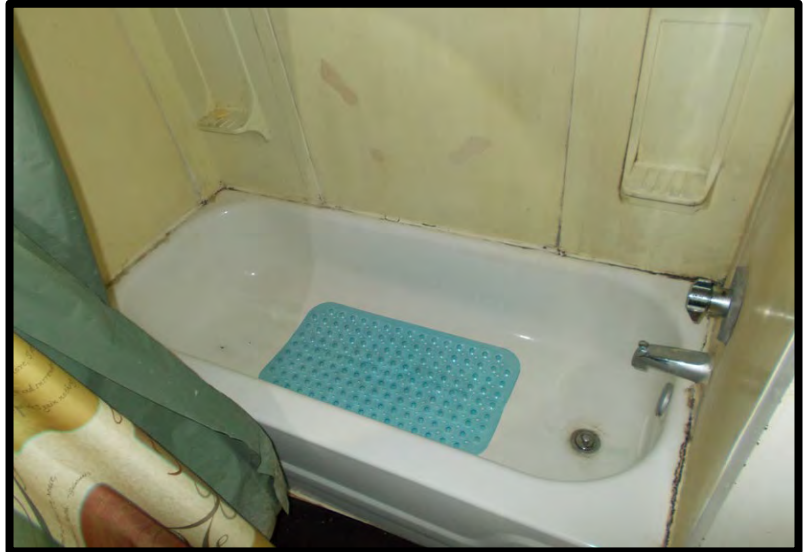
**Photo No. 29**

View of second floor bathroom tub and fiberglass surround.

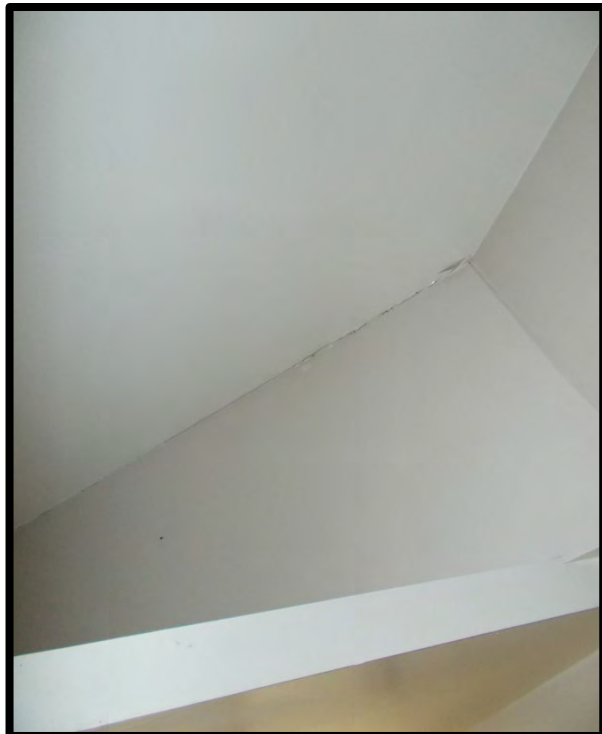
**Photo No. 43**

Depicts crack at gypsum ceiling within third floor attic.

*General condition of the units is good. General painting and some crack repair in drywall is required. Determine pronounced urine smell in front second floor hallway.*

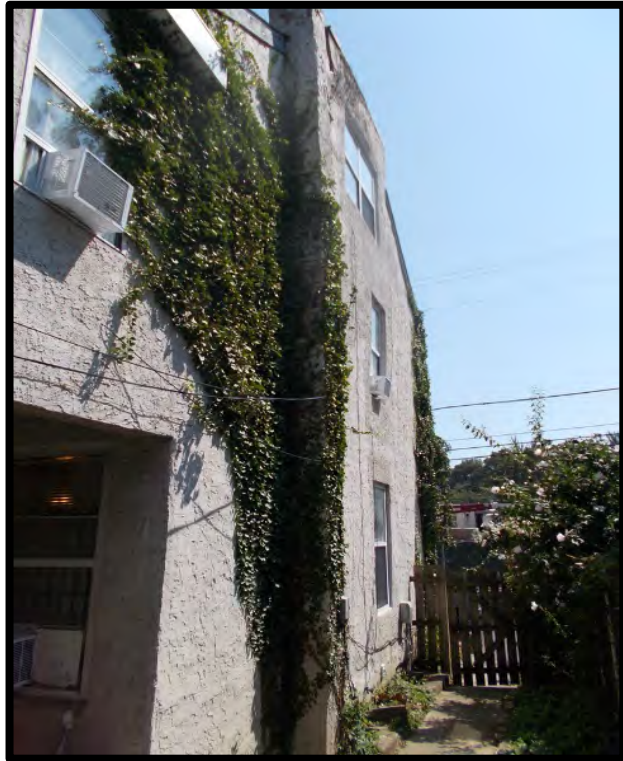
**Photo No. 44**

The dwelling has a stucco exterior over an unknown substrate. The cornice is of wood construction and may require repair. Up close inspection was not possible due to lack of access. General condition of the stucco is good to fair. Ivy and other vegetative growth should be removed from the exterior walls. Repair portions of exterior as required including area above entry porch.

View looking east along south side elevation. View depicts cementitious stucco exterior finish and ivy growth.

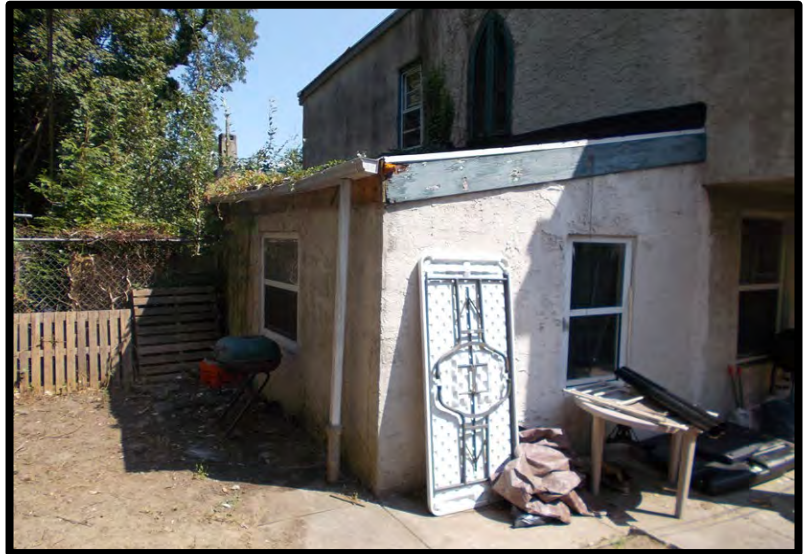
**Photo No. 46**

Roofs were visible from grade level only. The main roof consists of 3 tab asphalt shingles that are at the end of their useful life. The rear roofs over the second and first floor portions appear to be single ply EPDM roofing. The roof over the entry porch appears to be flat seamed metal. Aluminum gutters conduct storm water to aluminum downspouts. Damaged gutter was noted at the rear of the first floor portion.

Depicts view of rear bedroom located at the first floor.  
Note substantial vegetative growth within gutter.

*Roofs should be replaced on all portions, including shed entry porch and rear low slope sections. Repair/reline built in gutter. Replace damaged section of gutter and downspout.*

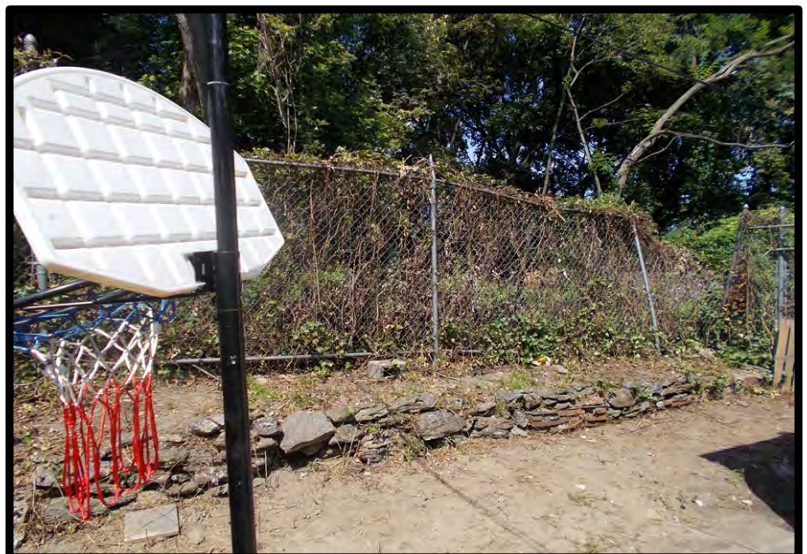
**Photo No. 48**

The rear yard is mostly paved over with concrete. A small rock wall is located near the back of the lot. Repointing and/or setting of the stone wall is required. Rear yard should be cleaned of dirt and debris. Ivy was noted growing on the side of the dwelling. This should be removed to avoid additional damage to the facade.

Depicts rear chain link fencing and partial stone retaining wall at rear yard.

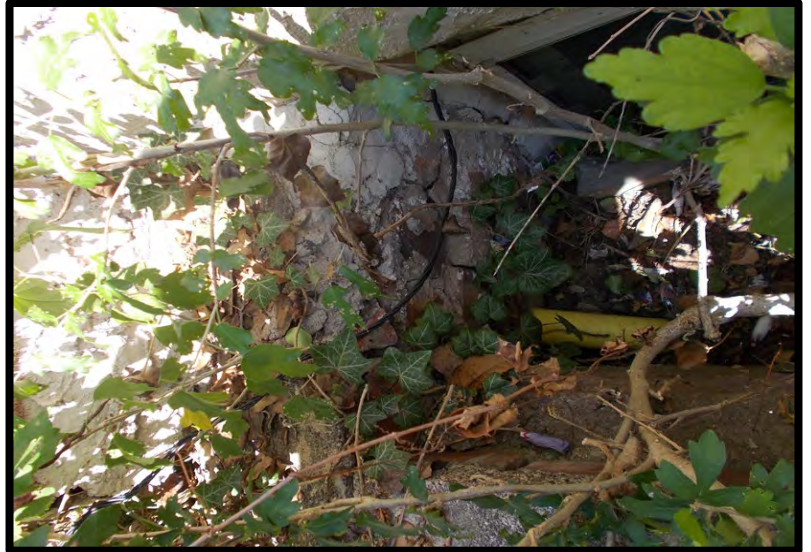
**Photo No. 49**

Depicts view of basement window that requires repair as noted previously.
