Germantown/Mount Airy Properties

Physical Conditions and Needs Assessment

Premises P

83 E. Church Lane

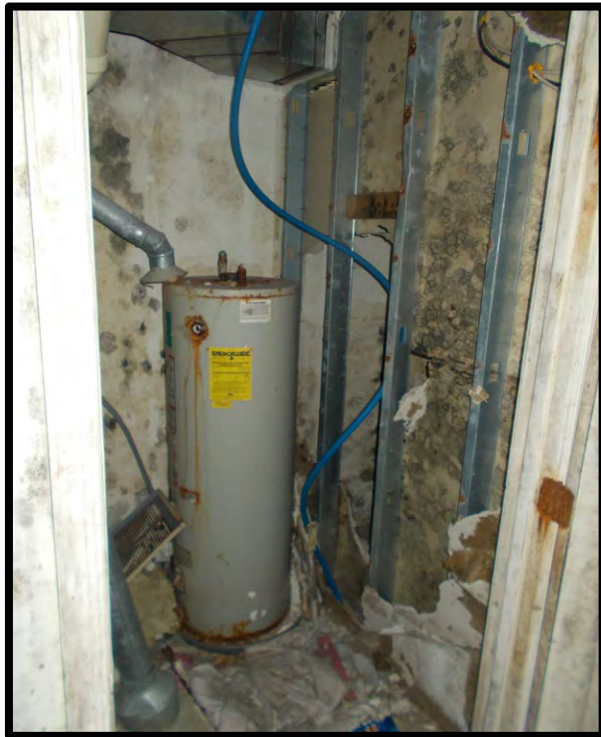
Photo No. 10

Depicts interior view of mechanical room and
previously installed hot water heater.

The water heater needs to be replaced.

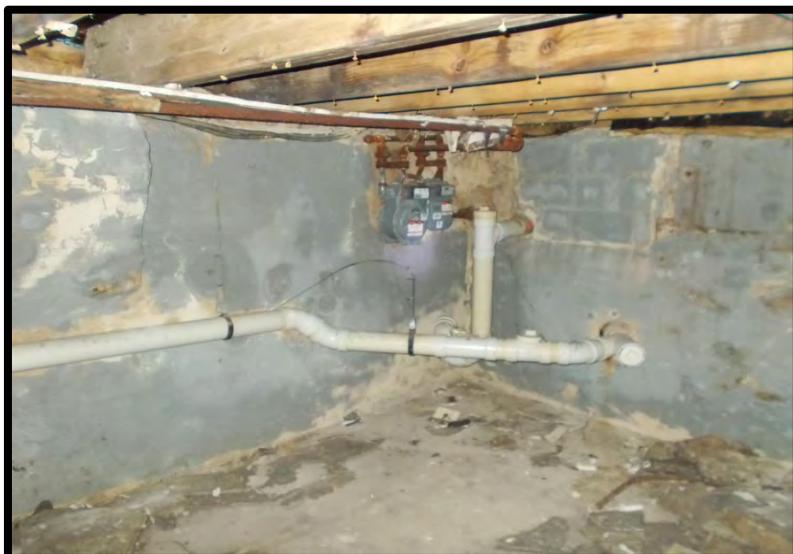
Photo No. 23

Panning right from previous photo looking at front right corner of basement. Right wall is front wall of building. Two (2) gas meters are located within this space as well as the sewer and stormwater discharges from the building.

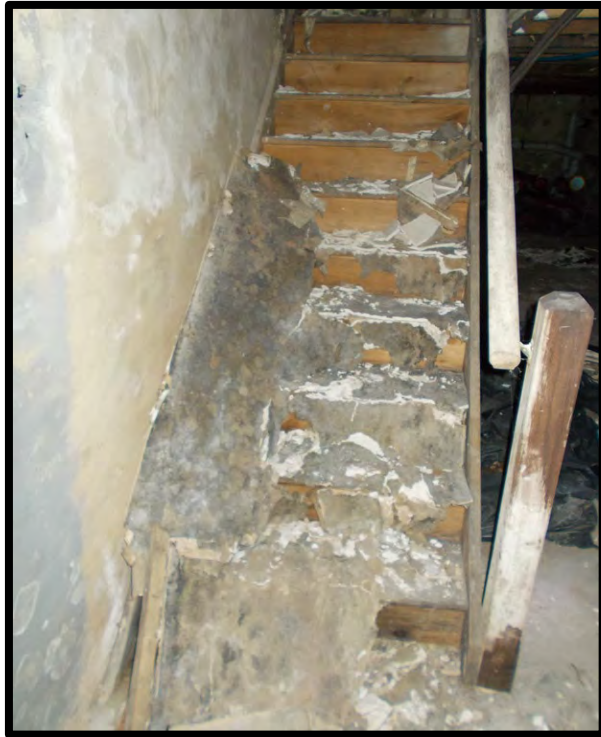
Photo No. 24

View of collapsed gypsum board on basement stairs
at basement level.

Replace carpet on third floor stair. Replace stair carpet to second floor with a more durable material such as rubber tread and riser covers. Repair of bottom of basement stair may be required due to moisture damage. Add handrail at top of third floor stair.

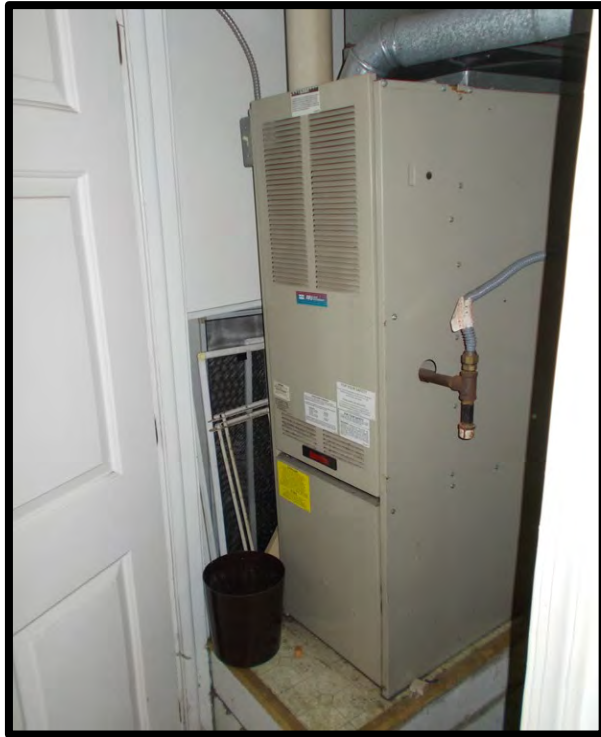
Photo No. 37

This unit is designed to be heated via RPJ gas fired vertical furnace, existing equipment is in poor condition.

View of mechanical closet and installed hot air furnace.

Replace the heating equipment.

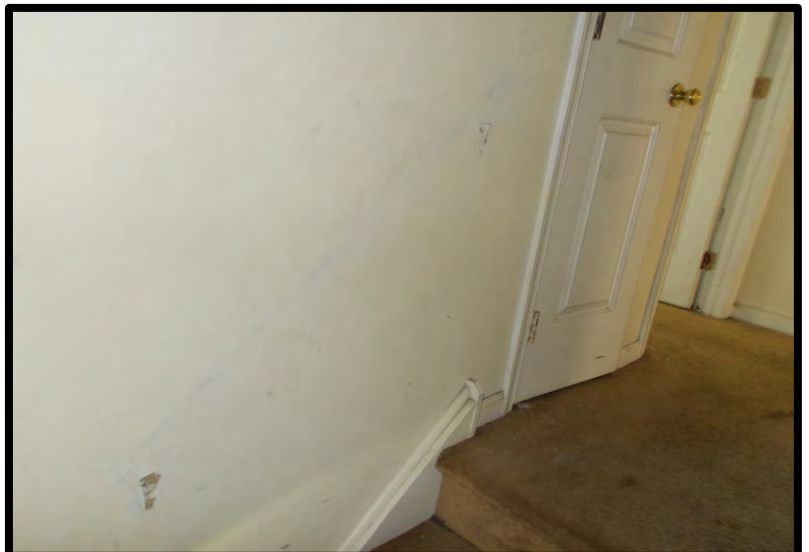
Photo No. 44

Depicts missing handrail located at top portion of third floor stairs.

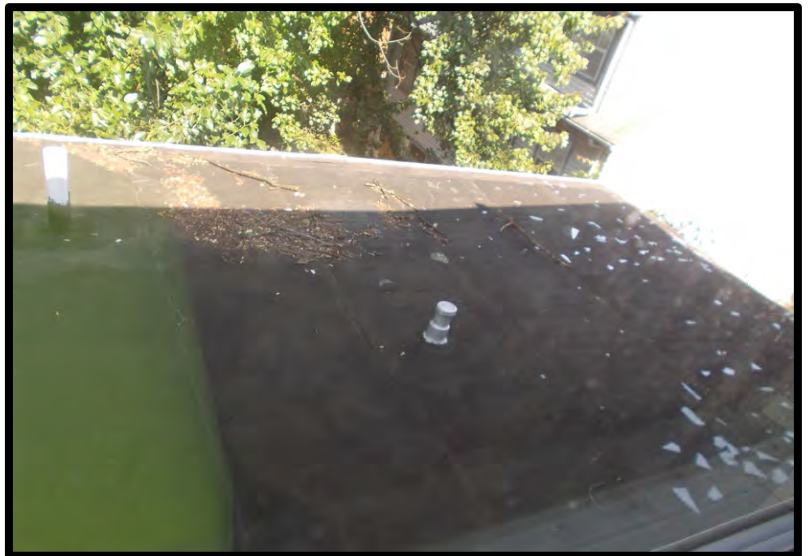
Photo No. 48

Roofs were visible from grade level and third floor only. The roofs appear to be EPDM in poor condition. Access for detailed inspection was unavailable. Perimeter gutters and downspouts are provided at the rear of the building. It is presumed that there is a built in gutter behind the cornice.

View of flat roof over second floor as seen from third floor window.

Roofs should be replaced in their entirety along with all gutters, downspouts and gutter liners.

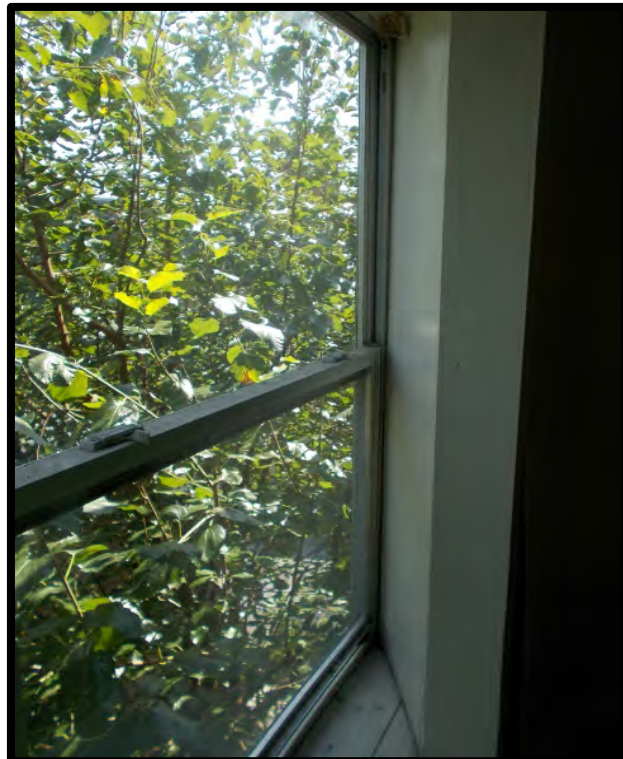
Photo No. 51

Panning left from previous photo showing odd wall at rear window within bathroom.

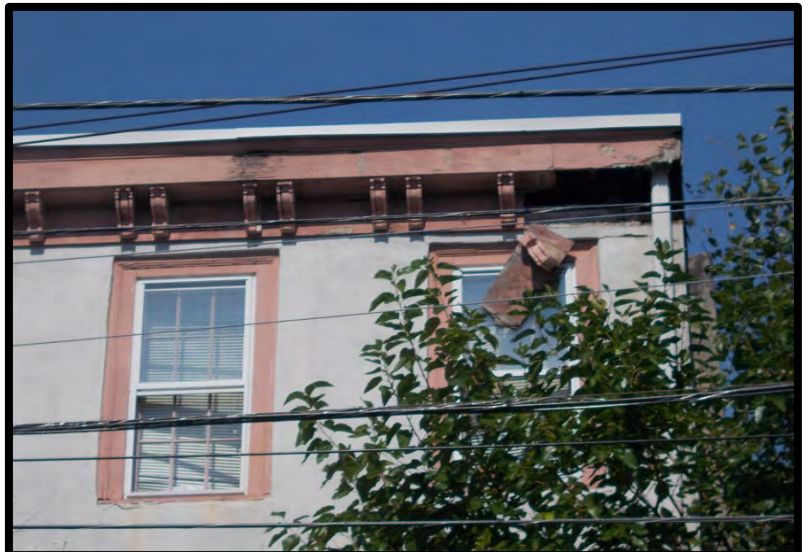
Photo No. 59

The front, side and rear exterior facades of the building appear to have a stucco parged coat finish. The front façade also has a wood cornice at roof level. Elements of the cornice were noted as dislodged and some elements that may need to be repaired due to rot.

View of rotted cornice at third floor. This should be secured to keep from injuring persons and/or property.

Repair wood cornice and paint to maintain it in serviceable condition. Clean stucco of algae growth and repair as needed.

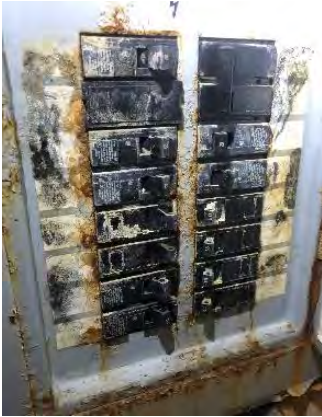
Each unit has a 60-amp 120v single phase electrical panel for lighting and power outlets which is in very poor condition. Electricity was not working in the units during inspection.

Damaged electrical panel.

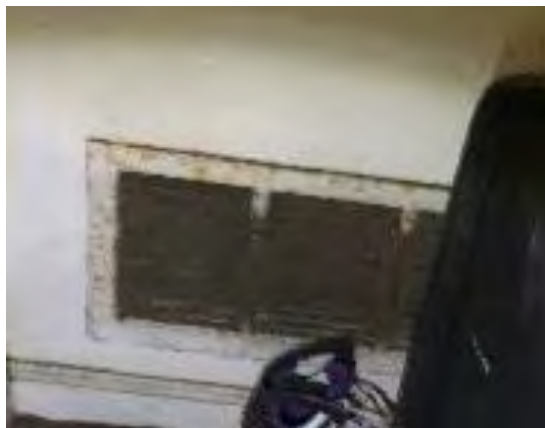
Return grill damaged.

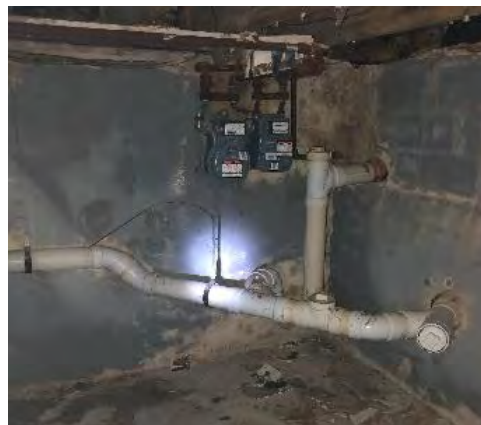
Incoming gas service from PGW is intact and in poor condition.

Gas meter and sanitary piping.
