Germantown/Mount Airy Properties

Physical Conditions and Needs Assessment

Premises Q

85 E. Church St

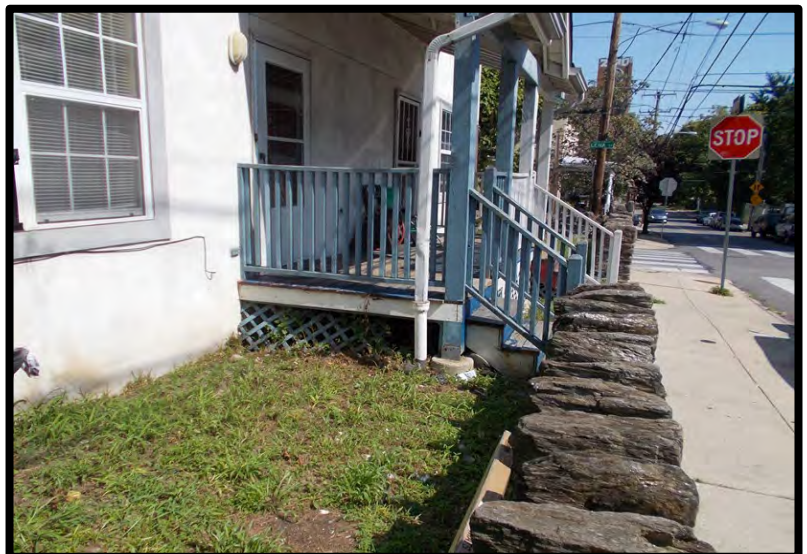
Photo No. 5

*The porch is in fair condition. Some decking replacement at the shared patio and stairs is likely required.
A new storm door should be provided at the rear entrance.*

Depicts view of the entry patio/porch.

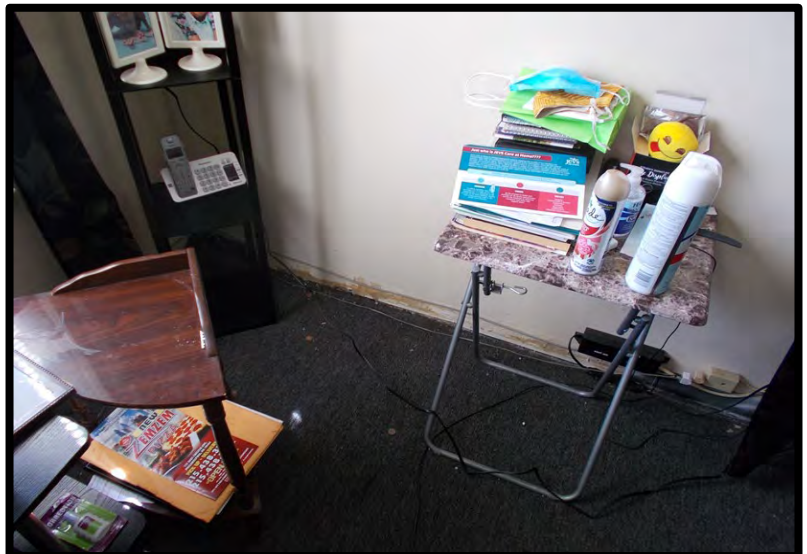
Photo No. 8

Some elements of missing vinyl baseboard was noted and will require replacement.

Depicts missing baseboard along the south wall of the living room.

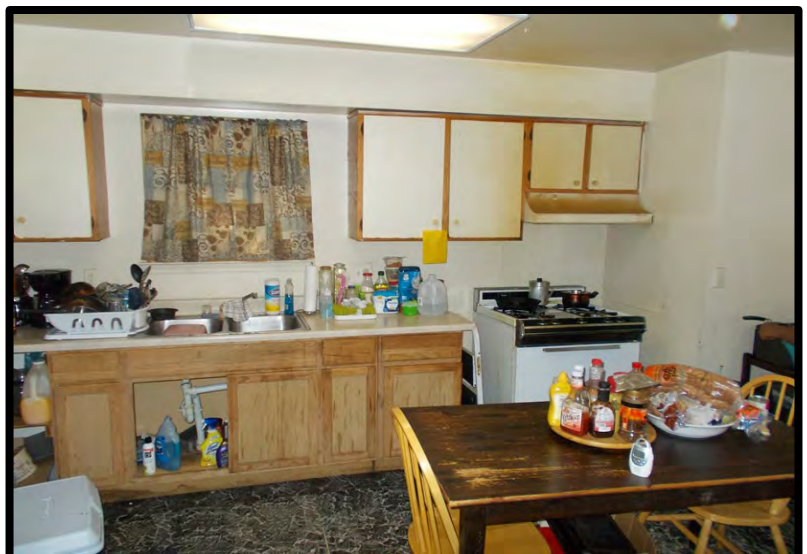
Photo No. 11

The kitchen is equipped with wooden cabinets and plastic laminate countertop in fair to poor condition. It was also noted that the rear backsplash of the countertop did not sit flush against the back wall.

Depicts view of kitchen at rear of first floor. Note missing cabinet door as well as rust and grease staining on vent cabinets and ceiling above range.

Repair and/or replacement of cabinets and laminate countertop is recommended.

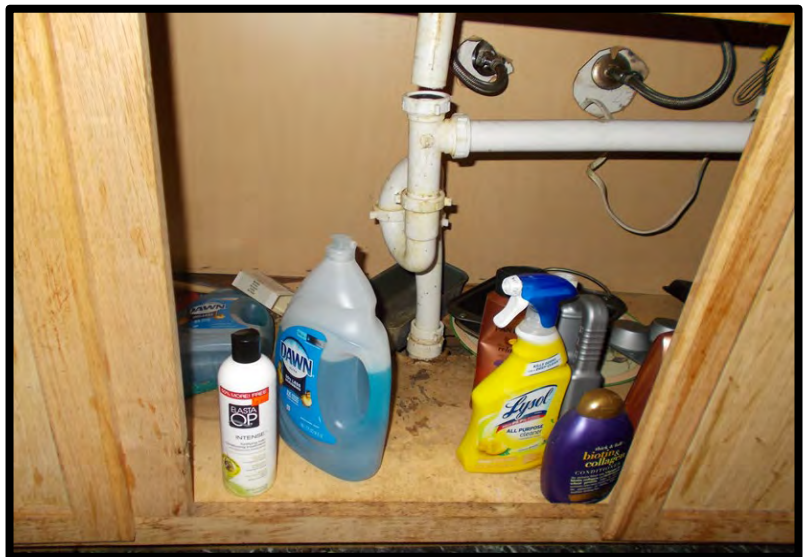
Photo No. 13

It was noted at the time of inspection that the kitchen drain pipe was not attached to the P-trap allowing water to spill onto the cabinet floor and/or the sub-floor below.

Depicts view of misaligned and disconnected plumbing waste at kitchen sink leading to probable water damage of cabinets and floor.

Kitchen drain pipe should be repaired as soon as possible to avoid any further damage.

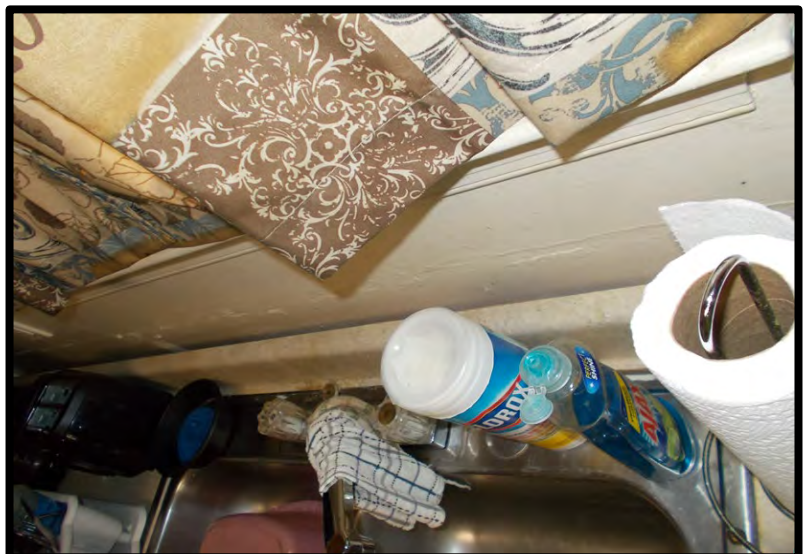
Photo No. 14

Depicts gap at rear of kitchen countertop at exterior wall.

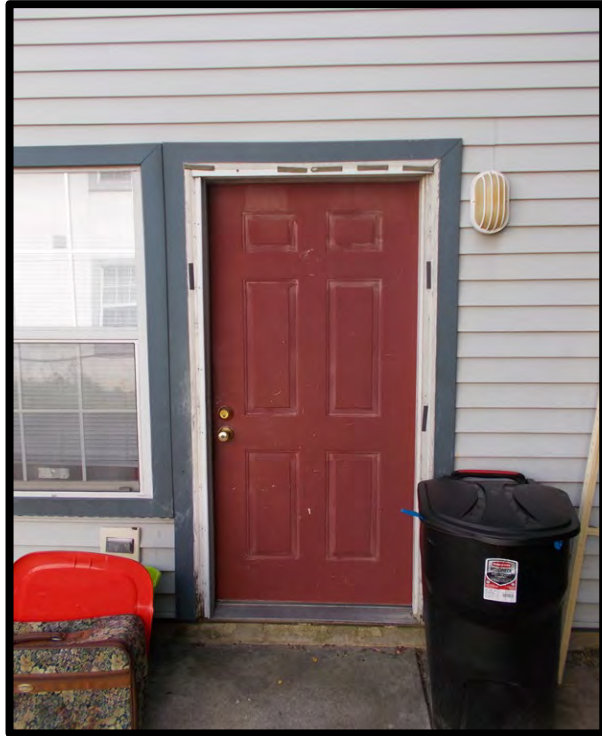
Photo No. 19

Entry and rear yard doors appear to be six panel metal doors in good condition. Front door has a storm door, the rear storm door is missing and should be replaced.

Depicts overall view of rear yard exterior entry door.

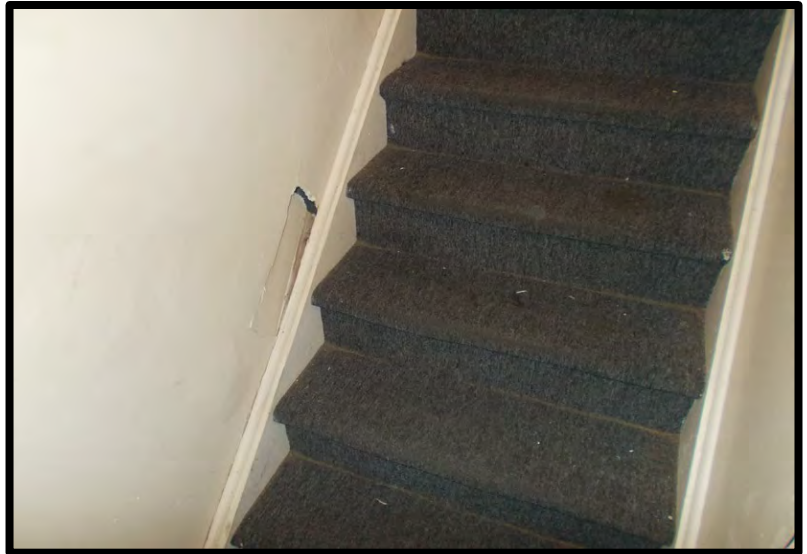
Photo No. 21

Depicts damaged gypsum wallboard at stairs leading to second floor.

Repair the gypsum wallboard between the first and the second floor.

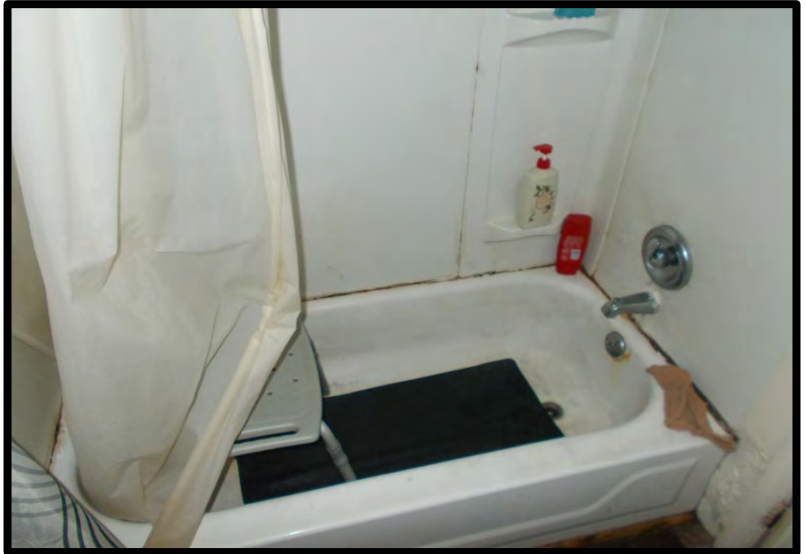
Photo No. 23

The bathroom is outfitted with a wood and plastic laminate vanity, floor mounted tank-style water closet and a bathtub with fiberglass surround. General condition of the vanity and bathtub are poor, and replacement is recommended. It also appears that poor caulking between the fiberglass surround and bathtub may allow water to bypass the tub.

Panning right from previous photo. Depicts overall
bathtub and fiberglass tub surround.

Replace the vanity and the bathtub in all the bathrooms.

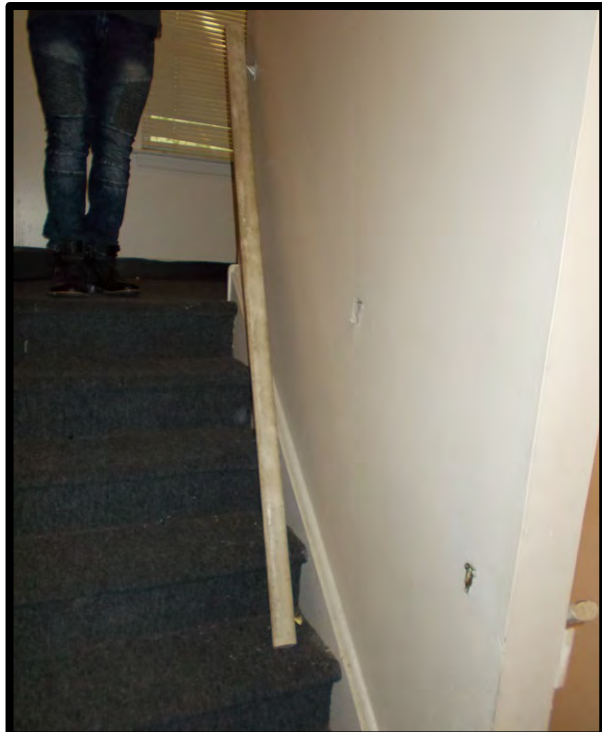
Photo No. 30

Communication between floors is via a wood stair which is carpeted. Stair to the third floor has a broken handrail that is no longer attached to the wall.

Depicts view of stairs leading to the third floor. Note handrail is no longer attached and will require replacement and/or re-anchorage.
