Germantown/Mount Airy Properties

Physical Conditions and Needs Assessment

Premises R
87 E. Church Lane
Philadelphia, PA 19144

March 2021

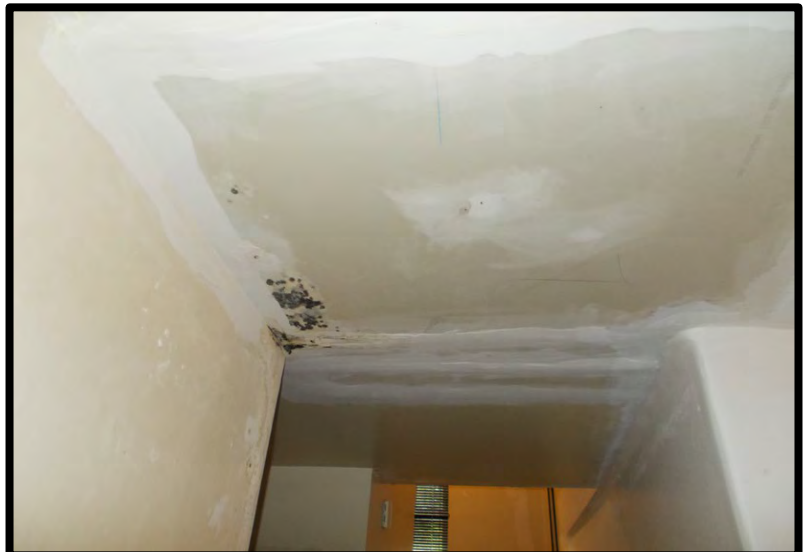
Photo No. 9

Mold was noted in the ceiling at the first floor below the bathroom. It is likely that water leakage from the upstairs bathtub is responsible for damage to the ceiling and the mold.

Depicts view of mold from presumably bathroom above. Note ceiling has been repaired poorly.

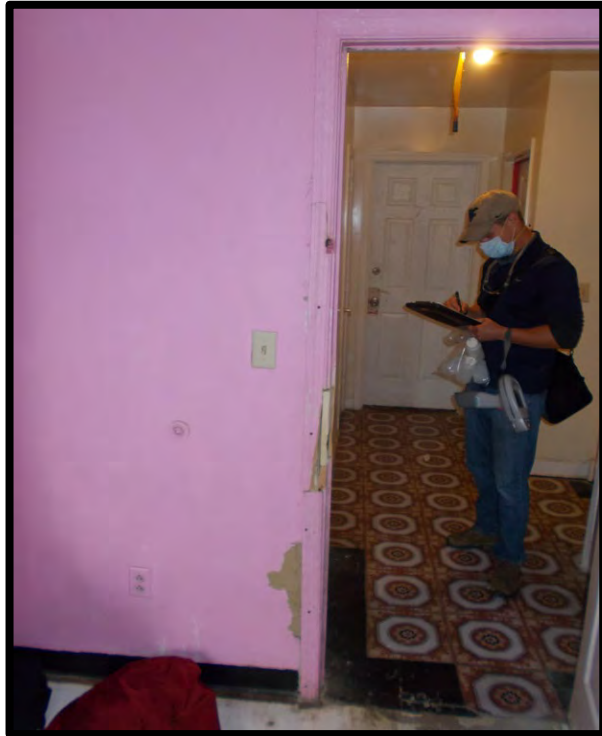
Photo No. 16

Typical finishes throughout consist of gypsum board ceilings and walls. Floor finishes throughout the unit are a mix of vinyl self-adhesive tile and carpeting. Interior doors are 6-panel wood doors with knob-type hardware. There is evidence of rust on the metal hinges as well as poorly maintained door casings.

View of bedroom entry in poor state of door molding.

Repair and/or replacement of door casings is recommended. Some replacement of door and/or door hardware will be warranted.

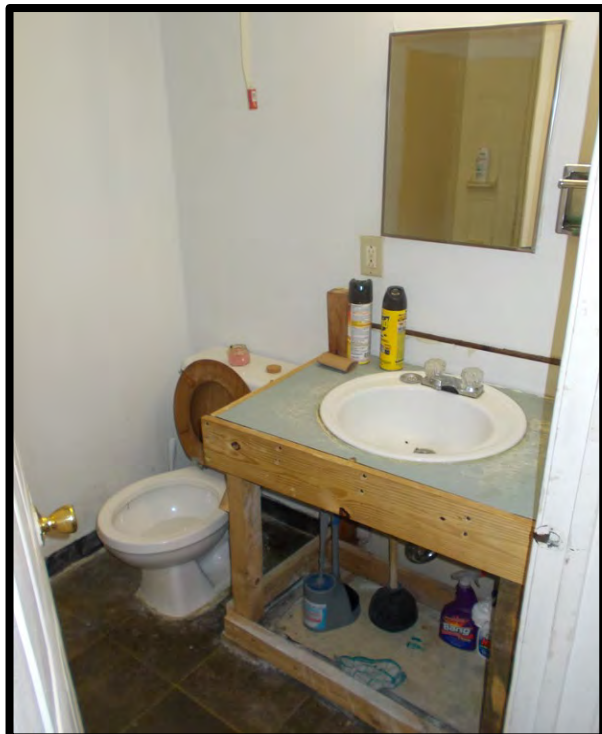
Photo No. 17

The second-floor bathroom vanity has been replaced with an in-built lumber-type vanity. Replacement with a true bathroom vanity is required.

View of makeshift constructed vanity at second floor bathroom.

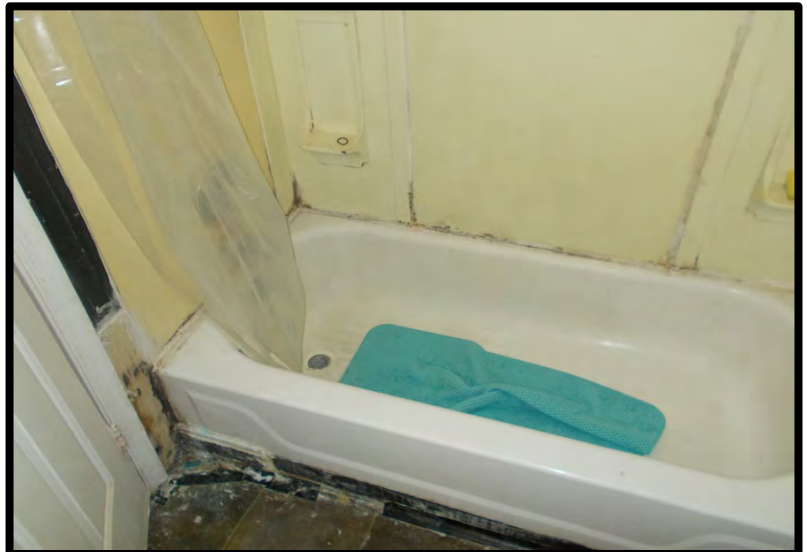
Photo No. 19

Additional view of bathtub and surround. Note evidence of water infiltration in and around bathtub and fiberglass surround.

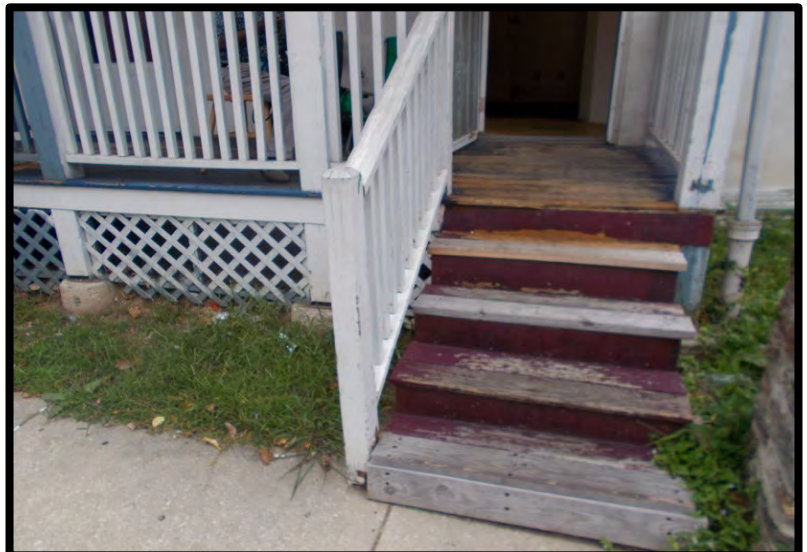
Photo No. 36

The condition of the entry porch is fair to poor. Stair and decking replacement is recommended.

Depicts overall view of porch stairs and porch.

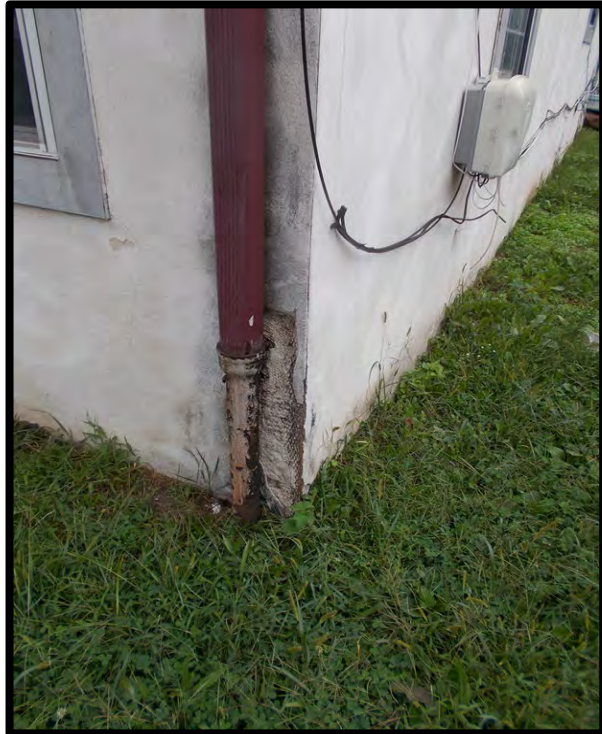
Photo No. 39

Scouring around the cementitious stucco around the downspout was noted.

Depicts detailed view of downspout and cast iron boot. There is evidence of water scouring of the cementitious stucco exterior possibly caused by a blocked or partially blocked storm line.

Cleaning the stormwater piping below grade to make sure it is free flowing is recommended. Repair of the exterior afterword will be required.

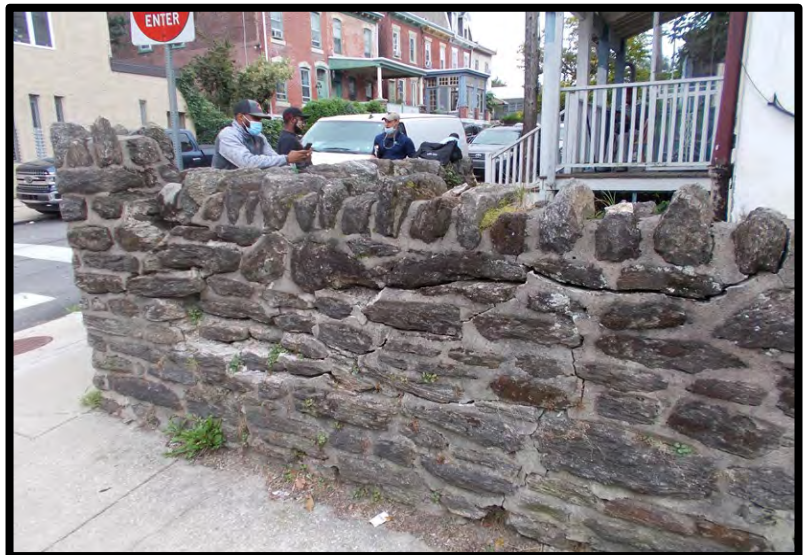
Photo No. 42

The stone retaining wall located on the Lena Street and East Church Lane sides is showing signs of serious damage. Large portions of the wall are loose, possibly from previous vehicular impact. Rebuilding of the wall and repointing is required.

Depicts stone wall along Lena Street. Repair and repointing is required.

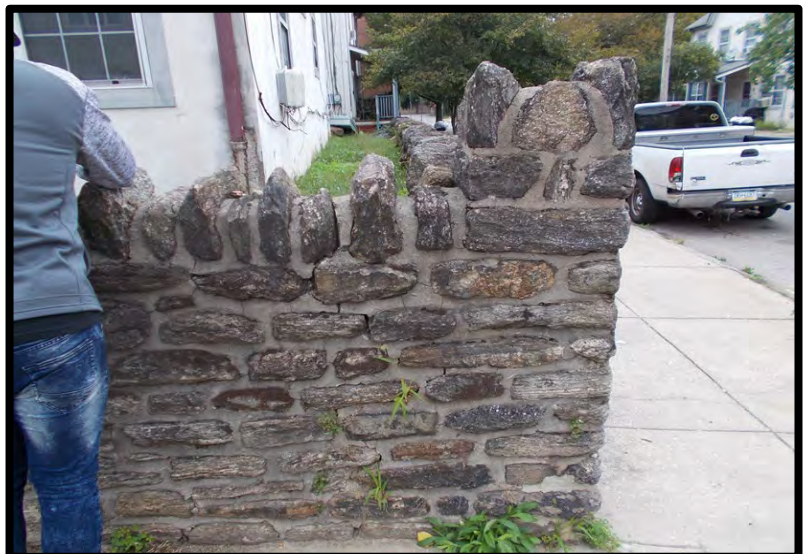
Photo No. 43

View of retaining wall as seen from East Church Lane. Repair and repointing is required.

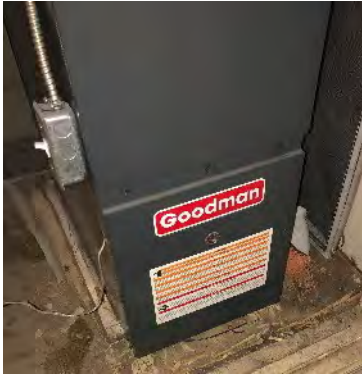
Brand new gas fired furnace.

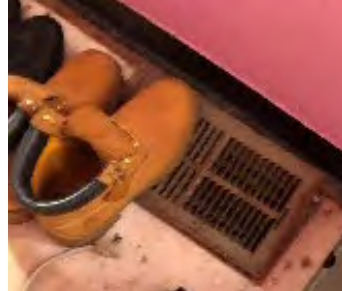
Typical supply in good shape.

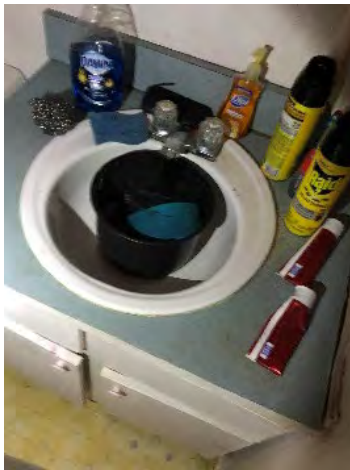
Bathroom sink in good shape.

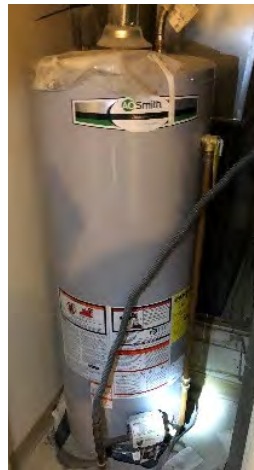
Brand new gas hot water heater.

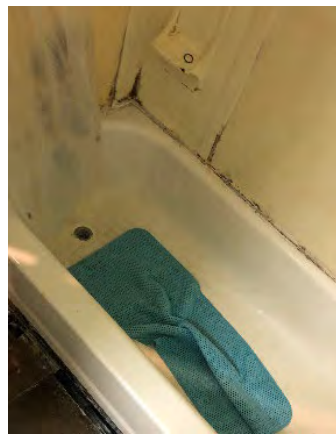
Bath tub; dirty but in good shape.
