Germantown/Mount Airy Properties

Physical Conditions and Needs Assessment

Premises S

117 W. Manheim St

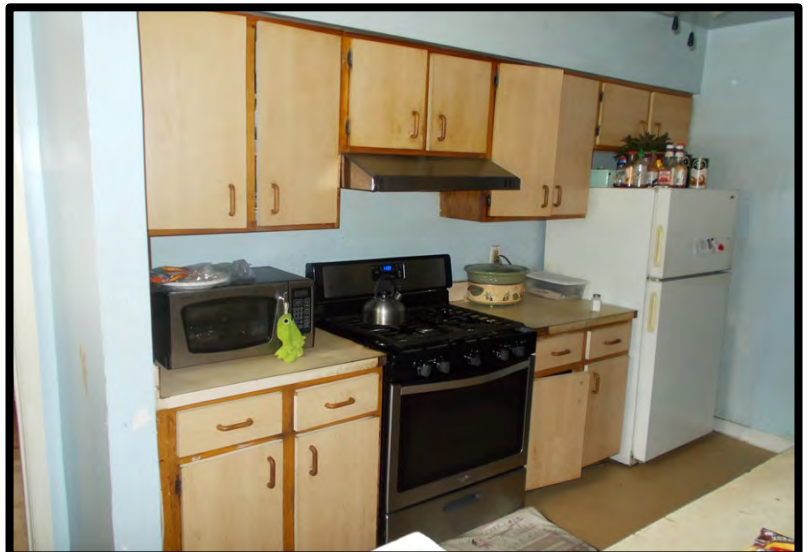
Photo No. 11

The kitchen consists of wood cabinets and plastic laminate countertop. The condition is fair to poor.

View of kitchen cabinets and countertop.

Replacement of wood cabinets and plastic laminate countertop is highly recommended.

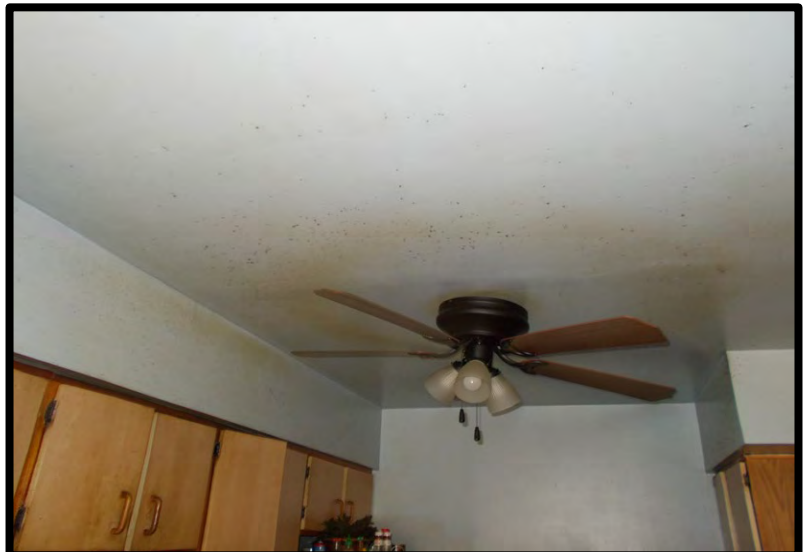
Photo No. 13

A ceiling fan located in the kitchen has grease staining around the ceiling.

View of ceiling and ceiling fan located in the kitchen.

Installation of a recirculating fan hood is highly recommended.

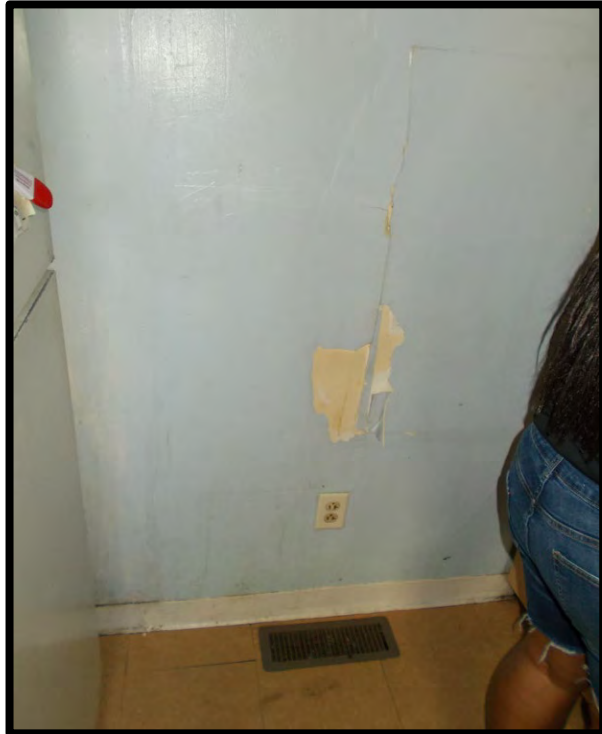
Photo No. 14

View of damaged wall at kitchen.

Repair of the gypsum assemblies is required

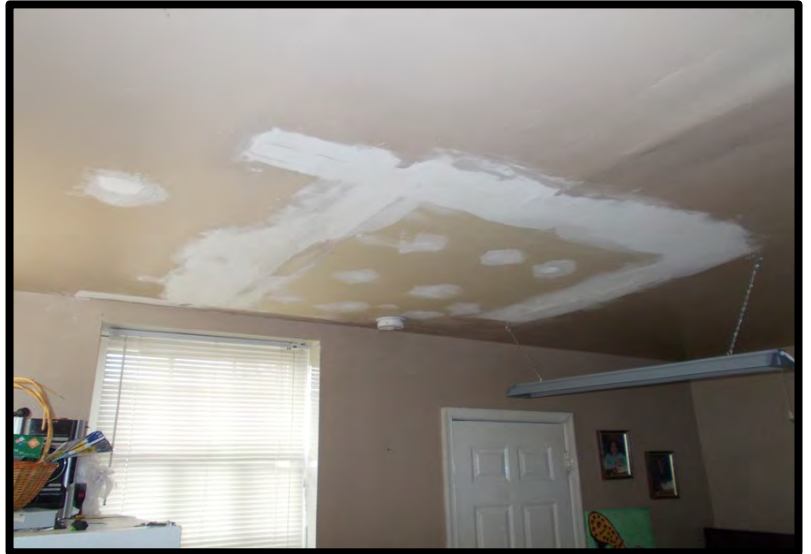
Photo No. 16

View of repaired ceiling in rear room first floor.

Additional repair and finishing is required for the ceiling and wall on all the floors.

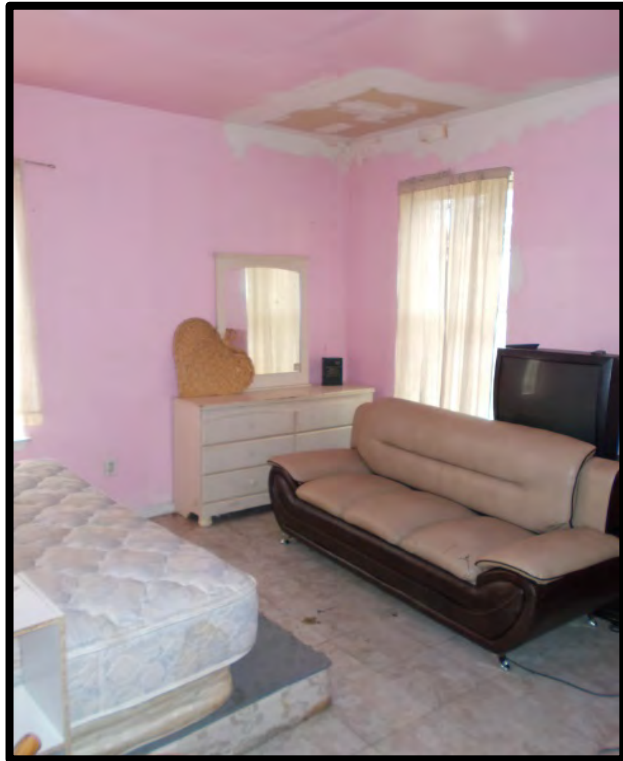
Photo No. 23

View of rear bedroom second floor. Note previous repair to ceiling and wall.

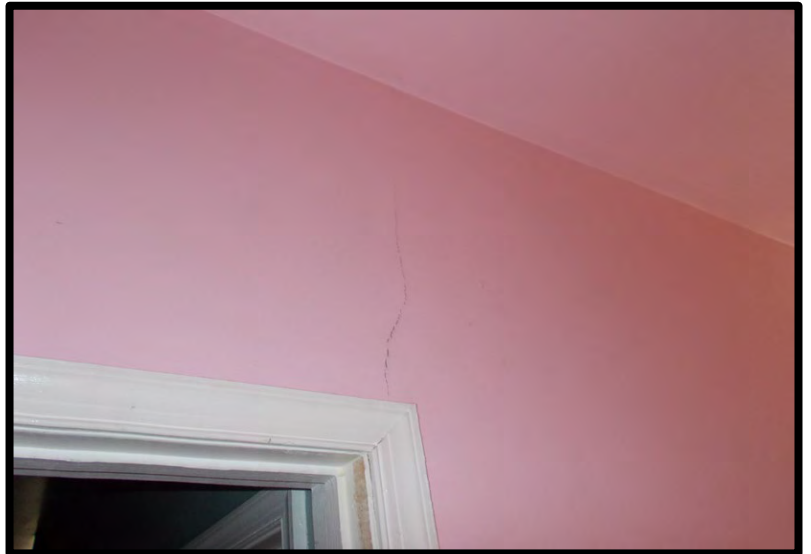
Photo No. 25

View of crack located above door.

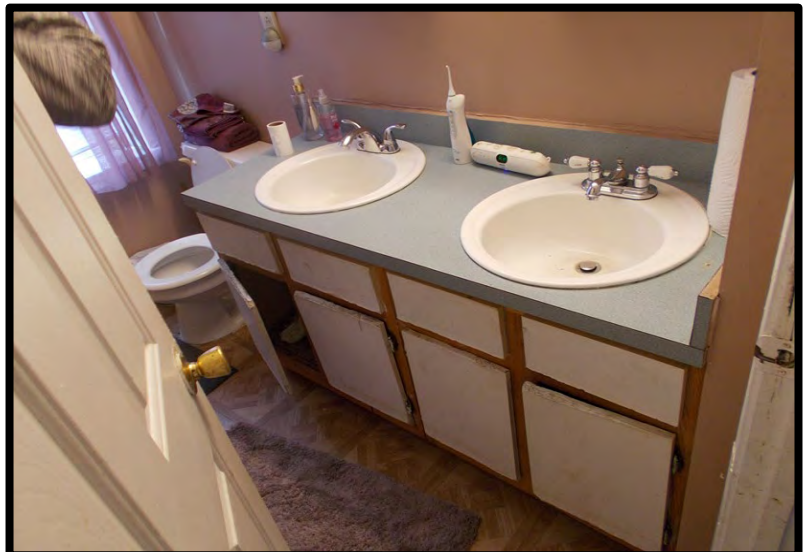
Photo No. 30

Detailed view of bathroom vanity.

Replacement of the vanity and sinks is recommended.

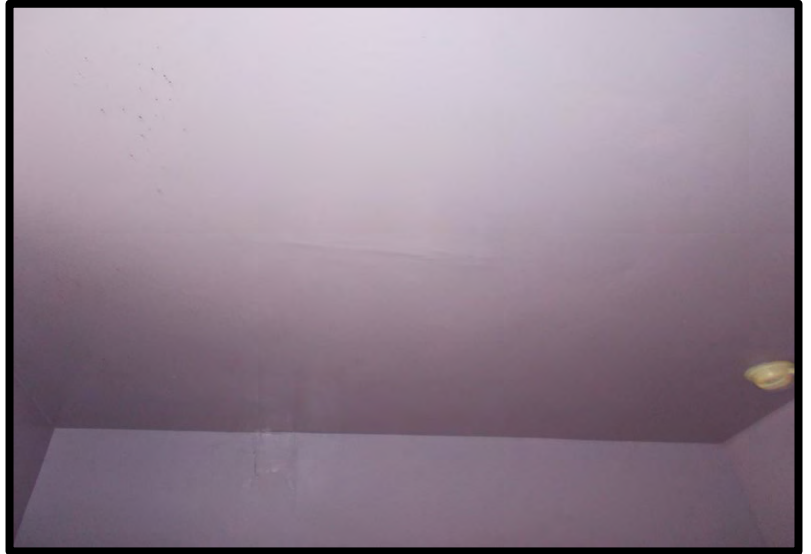
Photo No. 37

View of bedroom ceiling with signs of damage and possible water infiltration.

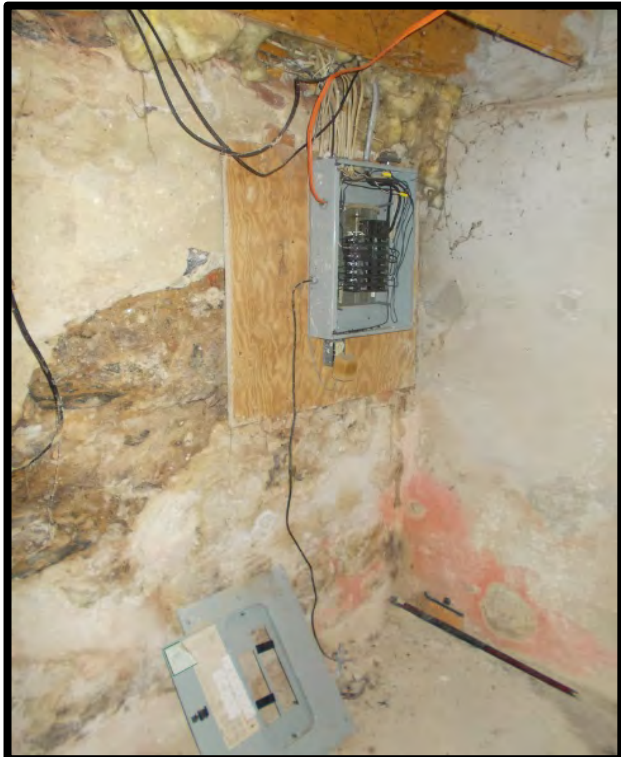
Photo No. 46

Primary electric service and meter looked in good condition. Secondary electrical service consists of a 60amp 120/240-volt single phase, for power outlets and lights. Looked to be old. One Panel was open with no cover.

View of apartment electric panel with cover removed.
Cover was removed previously and not so during
inspection.

House electric panel should be replaced.

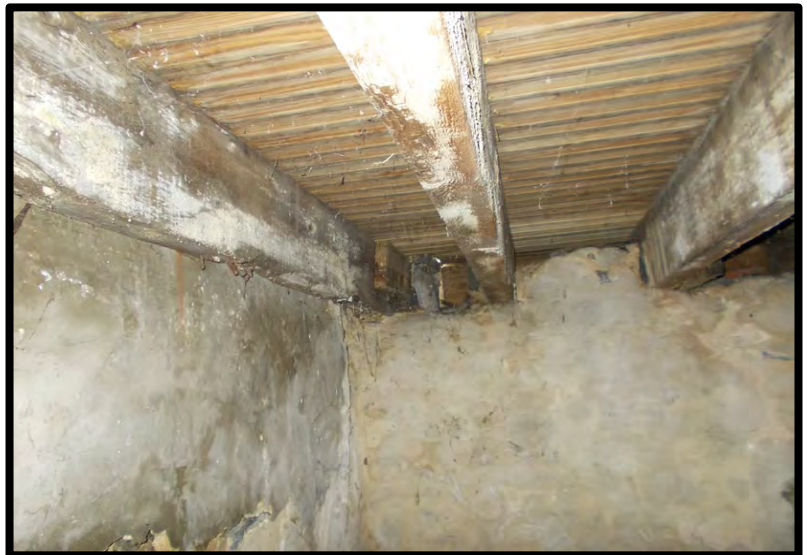
Photo No. 52

The structure is wood framed load bearing construction. The foundation appears to be stacked stone with no insulation on the interior. Multiple open gaps were found below the porch and around the existing windows.

Depicts large open void in wall allowing animals and other critters to enter below porch.

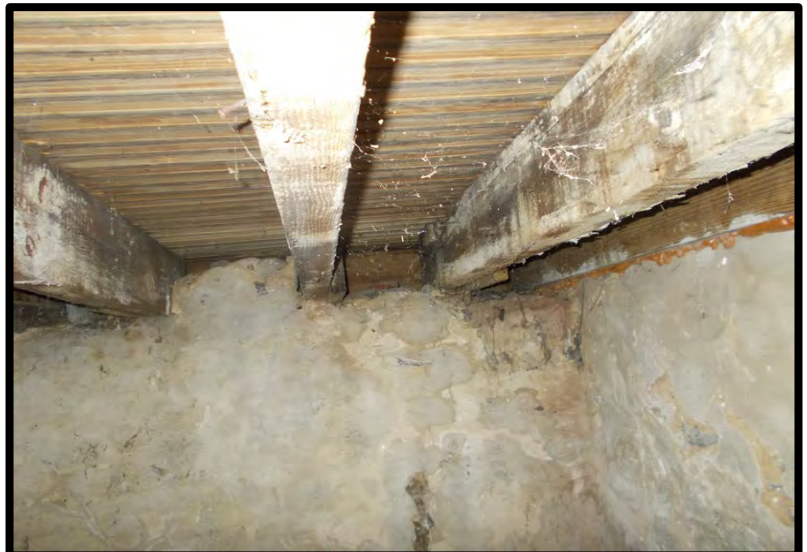
Photo No. 53

Panning right from previous photo. Similar void was noted.

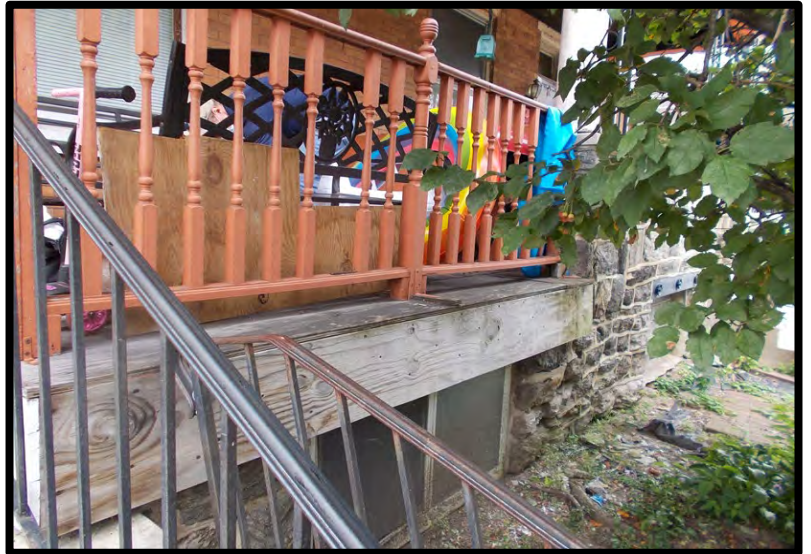
Photo No. 58

An entry porch is located over a partial basement. Wrought iron railings are provided along the front entry stairs which are in fair to poor condition. A section of stairs is missing and has been replaced with a temporary wooden railing that does not meet code. A wooden guardrail and pickets are provided at the top of the porch. There are some pickets that are missing and are required to be replaced.

View of missing picket and unfinished wood at entry porch.

*Replacement of the railing with code compliant permanently fixed type should be considered.
Painting of the porch framing, and recladding of the porch fascia should be considered.*

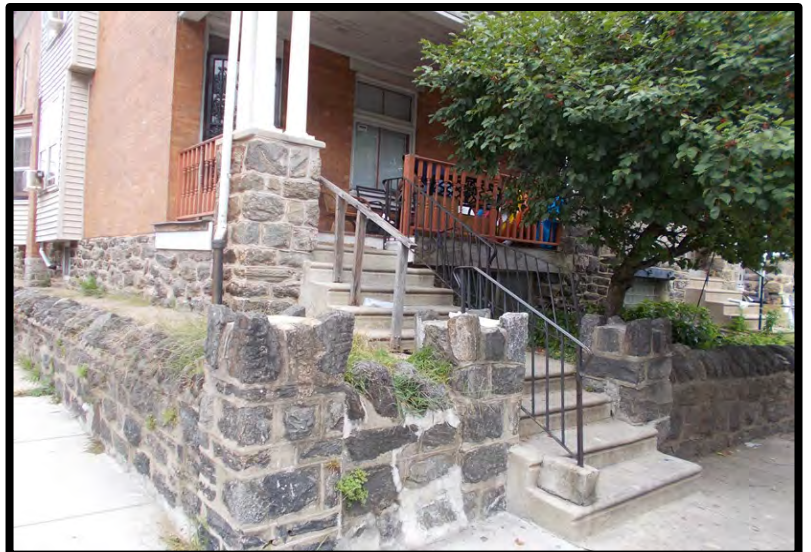
Photo No. 59

Overall view of stairs and makeshift railing at dwelling entry.

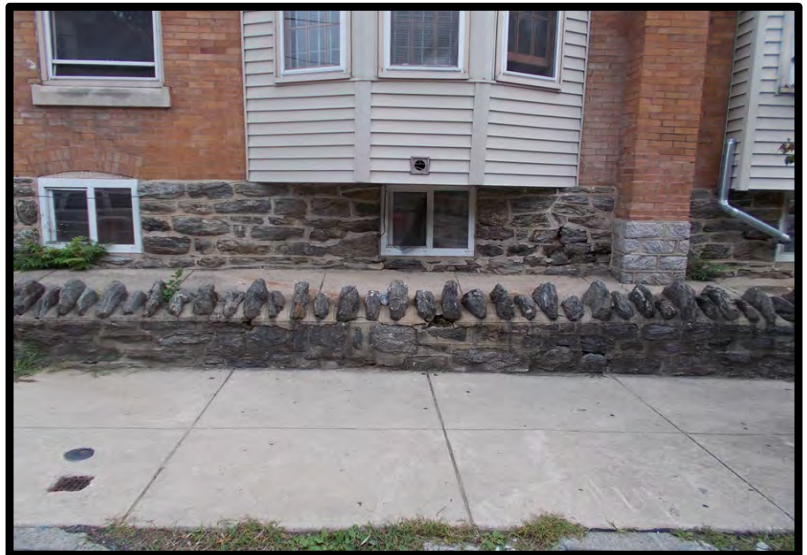
Photo No. 63

This unit is designed to be heated via Carrier gas fired vertical furnace. This is a forced air, heating only system which is visibly in good condition. Gas-fired equipment is vented through the sidewall; however, the flue is not terminated with proper clearances to adjacent construction. Flue system connection to the furnace is adequate and seems to be in good condition.

View of basement windows and stone retaining wall at sidewalk. Note flue pipe in the background does not meet code and should be extended properly with proper clearances.

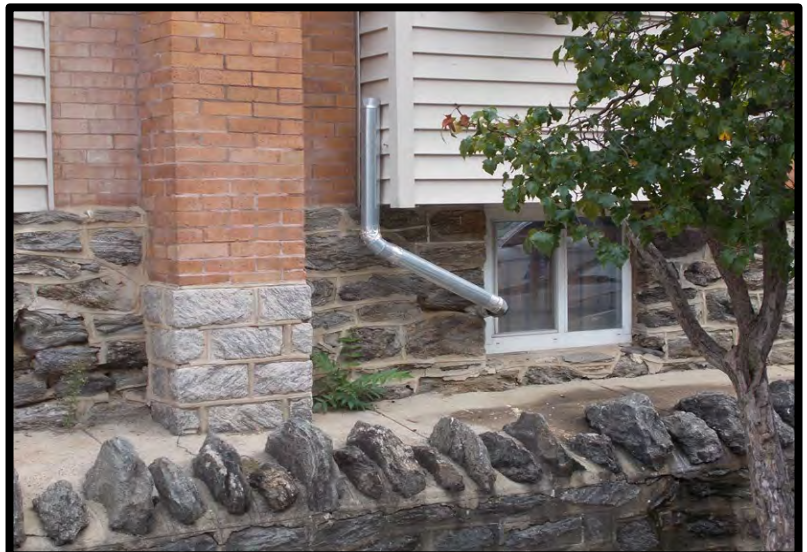
Photo No. 64

Detailed view of flue pipe missing cap and improperly terminated.

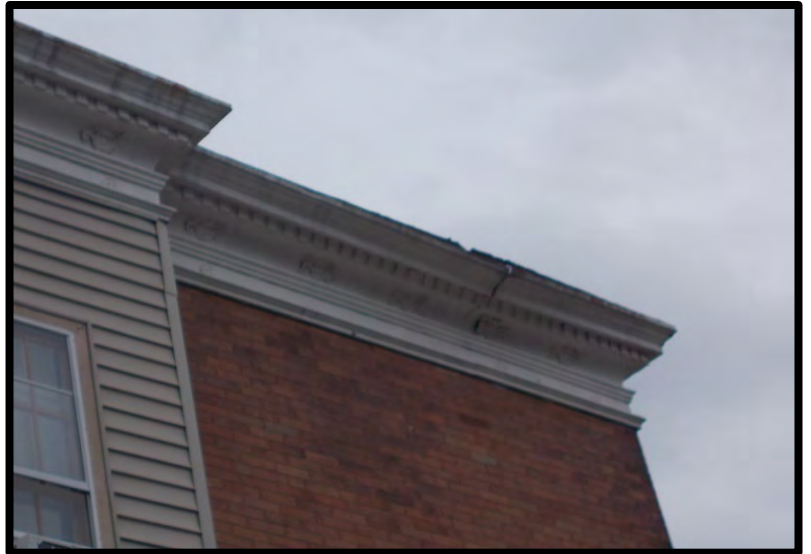
Photo No. 65

Exterior walls are brick veneer over what looks to be wood framing. The building has an ornate wood cornice system above the second floor. There are signs of damage visible from the exterior and a portion of the cornice along Marion Street at the front of the structure has a noticeable separation. The brick masonry along the front facade was found to be in generally good to fair condition. A portion of repointing is required above the first floor towards the roof near the chimney along Marion Street where open cracks were visible. The masonry at the rear façade was in poor condition. It is unclear whether water is cascading from the roof and washing the face of the structure. Evidence of spalled unit masonry and open joints were visible.

View of wood cornice along Marion Street at front
corner of building. Note separation in the cornice.

*Extensive repair of rotted wood cornice is required.
Repointing and repair work of masonry on all facades is required.*

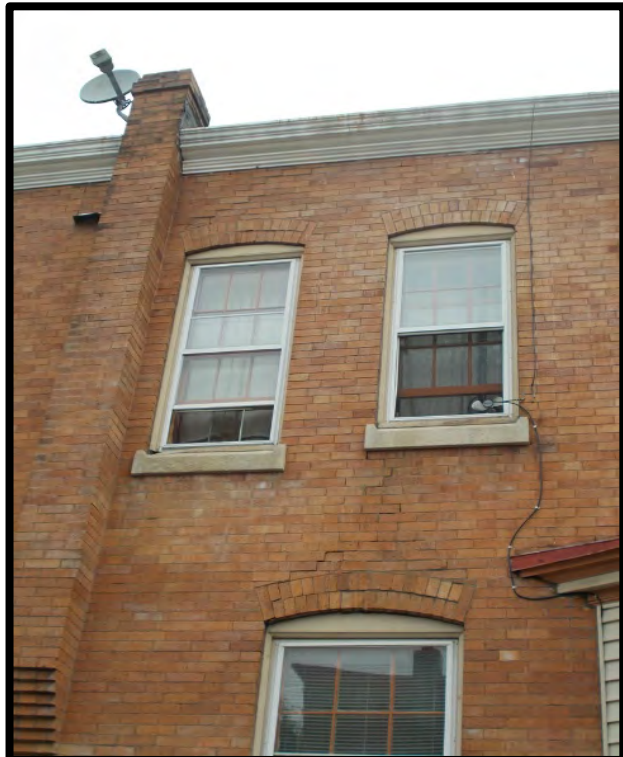
Photo No. 66

View of cracked brick masonry along Marion Street.

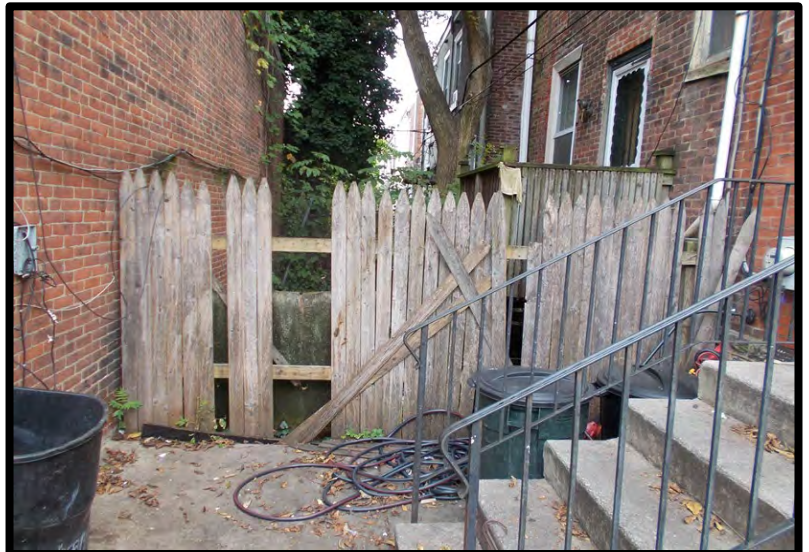
Photo No. 70

Depicts damaged fencing along property line.

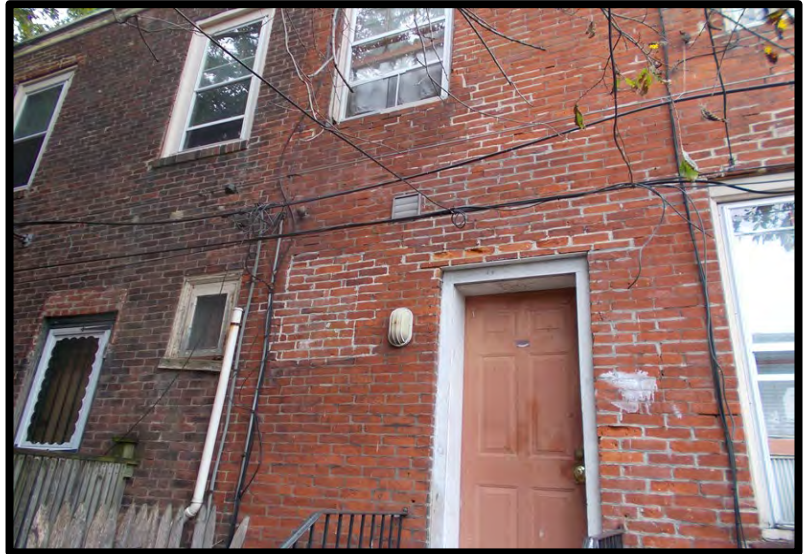
Photo No. 71

Detailed view of corroded brick masonry as well as open brick masonry joints at rear of structure.

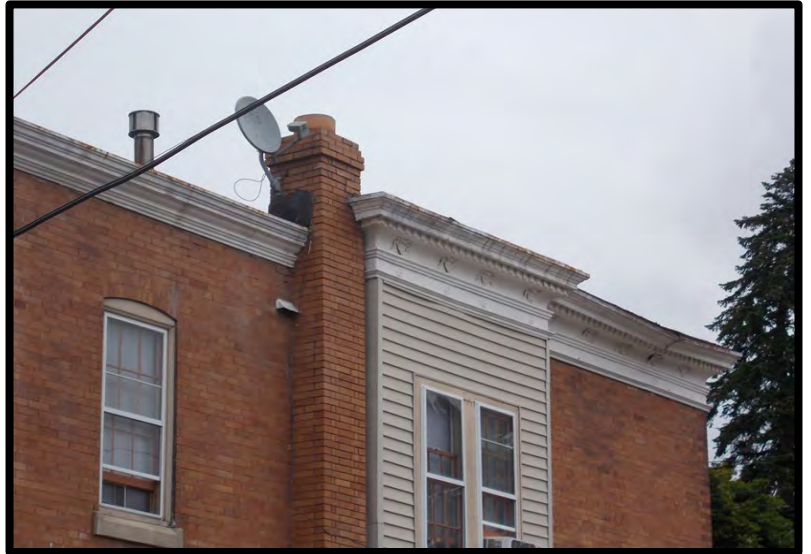
Photo No. 74

Depicts closer view of wood cornice along Marion Street at front of structure. Note significant dip in cornice.

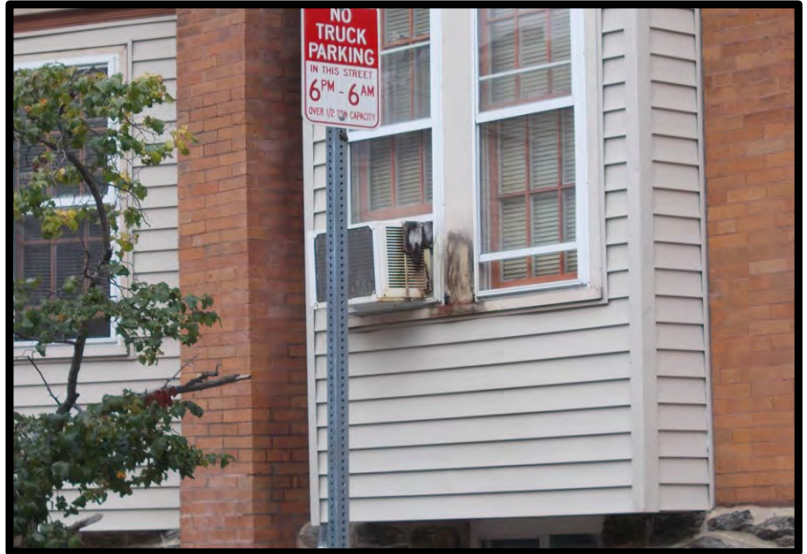
Depicts damage along Marion Street at first floor.

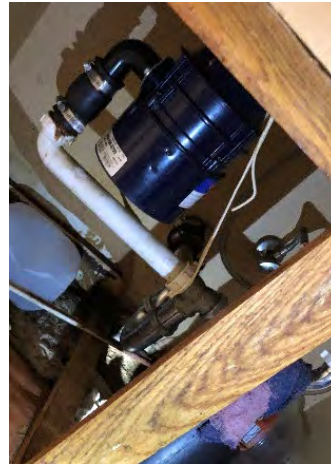
There was a leak underneath the kitchen sink.

Kitchen faucet with leak.

Repair of piping under the kitchen sink is required. Evidence of prior and ongoing leakage was noted as well as damage to the base cabinet.

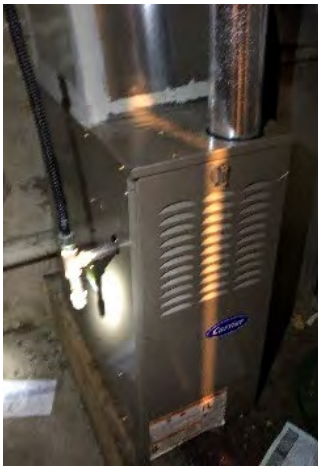
Gas fired furnace.

Replacement of the furnace and the thermostat is recommended as they are antiquated.
