Germantown/Mount Airy Properties

Physical Conditions and Needs Assessment

Premises T

4949 Germantown Avenue

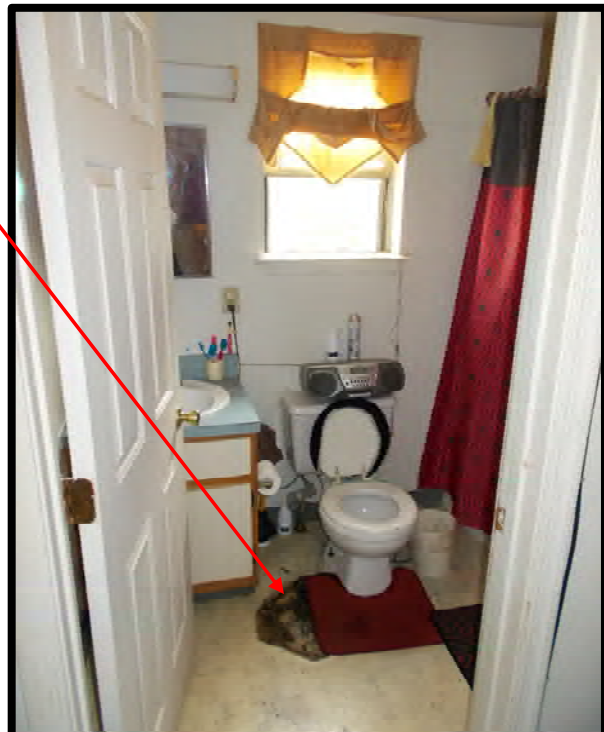
Photo No. 30

Unit C - Kitchen floor is in poor condition and should be replaced. Flooring around the toilet is weak and spongy, immediate replacement is recommended.

View of 3rd Floor bathroom. Note, floor in front of and surrounding toilet is suspect and appears weak. Immediate replacement highly recommended.

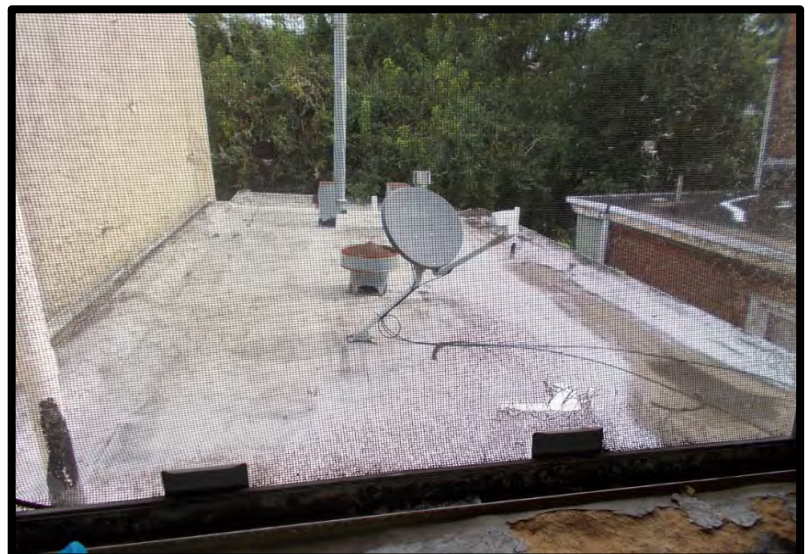
Photo No. 33

The second floor roof appears to be aged and at the end of its useful life. The roof was finished with an aluminized coating. The condition could not be assessed as there was no access. Rooftop structures consist of some aged metal exhaust fans which would require replacement if and when mechanical systems are upgraded.

View of 2nd Fl roof as seen from Bedroom #2.

Second floor roof is at the end of its useful life. Rooftop fans should be replaced.

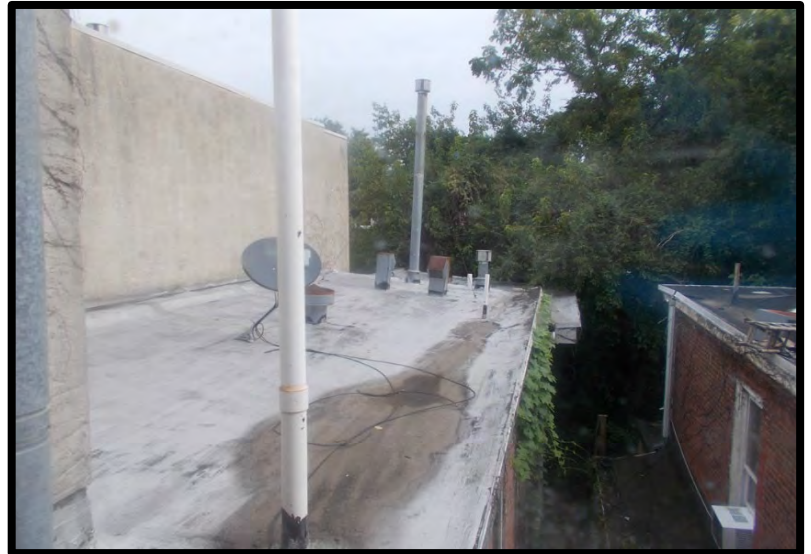
Photo No. 36

Additional view of lower roof.

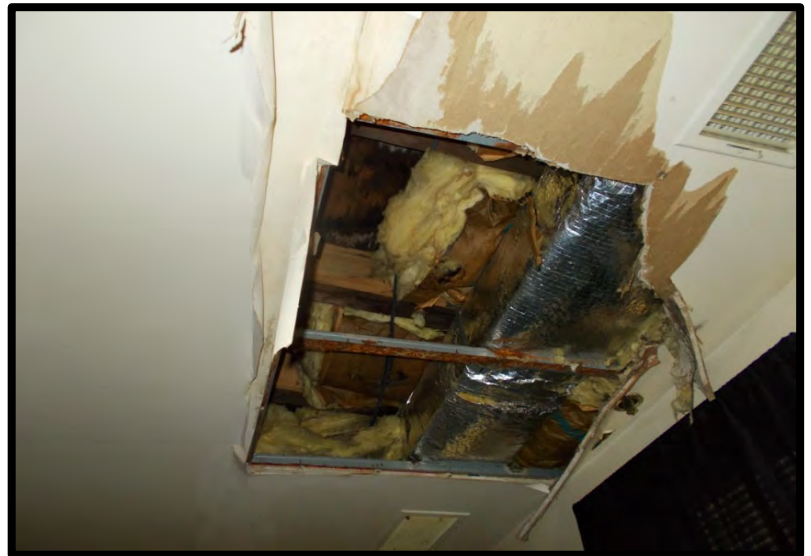
Photo No. 41

Unit B - There is evidence of water damage on the living room floor and above the entry door to the unit. Ceiling and flooring should be replaced after leak above has been repaired.

View of 2nd Fl. Ceiling partial damaged from water leakage above.

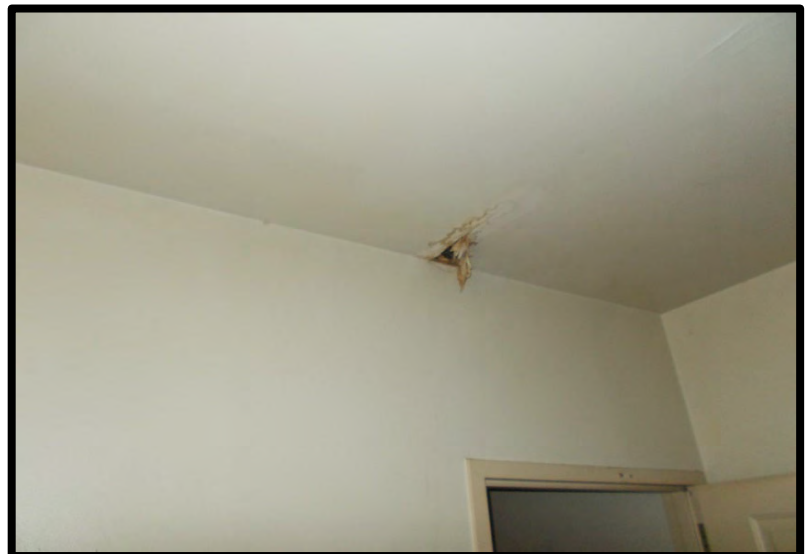
Photo No. 42

View of ceiling image above Unit B apartment entry door.

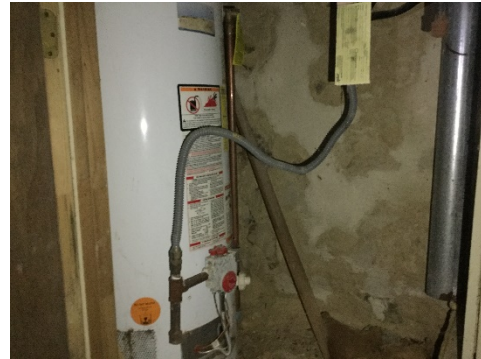
Unit A - Water heater shows visible corrosion and should be replaced.

Hot Water heater.

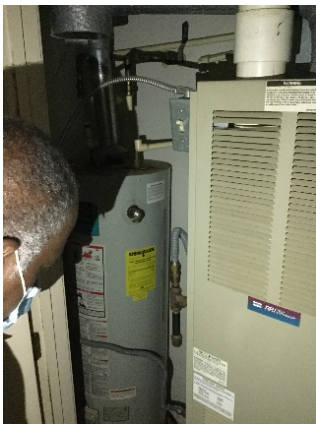
Unit C - Has two water heaters, one of which is damaged and should be replaced.

Hot water heater damaged.

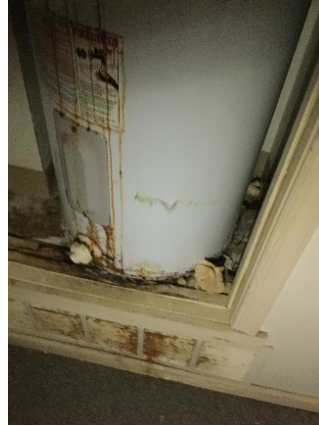
Hot water heater damaged.
