# Germantown/Mount Airy Properties

## Physical Conditions and Needs Assessment

### Premises U

**4951 Germantown Ave**

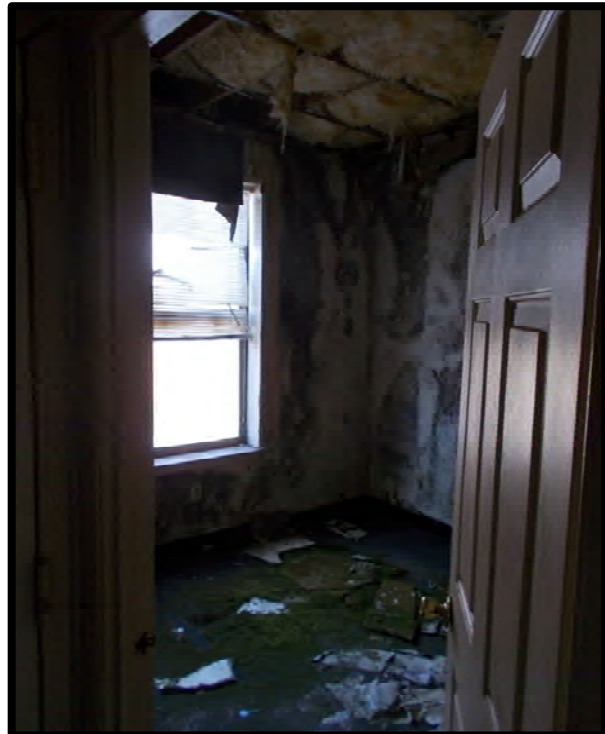
**Photo No. 22**

*Unit B - Excessive mold located in bedroom #1 as well as ceiling collapse. Moss is growing on the floor and the structure appears soft and unsound. Portions of the bathroom ceiling have collapsed and will require replacement. A portion of the ceiling and wallboard collapsed inward by kitchen/living room corner, as well as large water staining along the floors, wall and remaining ceiling. Bedroom #2 ceiling has collapsed and large amounts of mold and mildew due to water infiltration. A fresh coat of paint is required.*

View into bedroom #1 immediately to the left of entry.  
Note floor was spongy and unsafe to walk on.

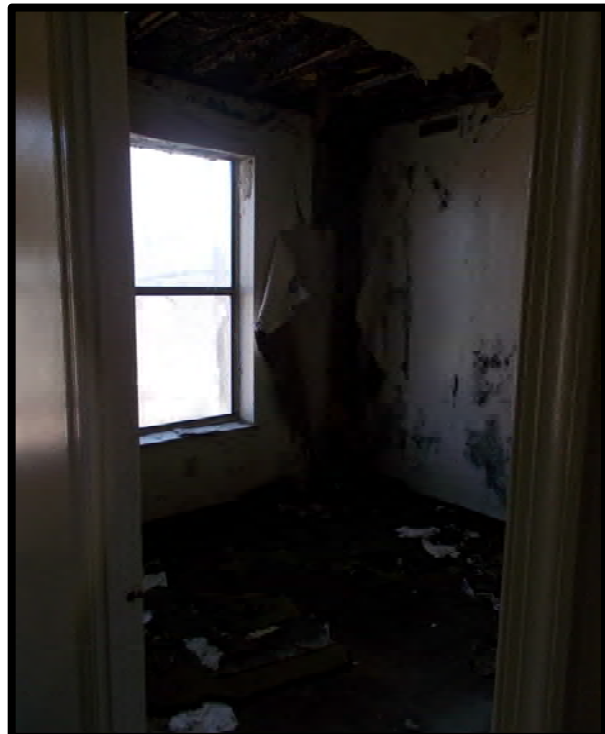
**Photo No. 49**

*Unit C - Extensive water damage in bedrooms #1 and #2, as well as kitchen/living room area. Investigation and correction of water infiltration is a priority in order to maintain the structural integrity of the building.*

View of bedroom #1 also evidence of severe water  
infiltration from roof.

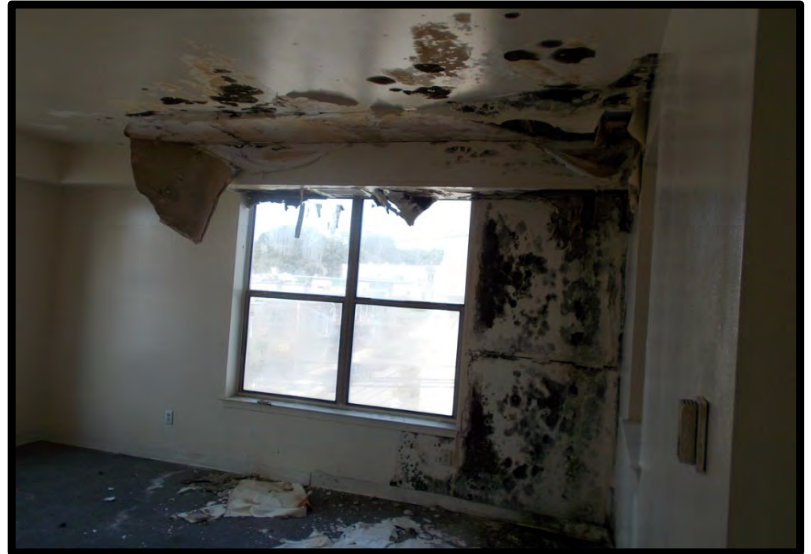
**Photo No. 54**

View of living room at kitchen demising wall.  
Evidence of water infiltration from roof visible with  
extensive damage at exterior wall.

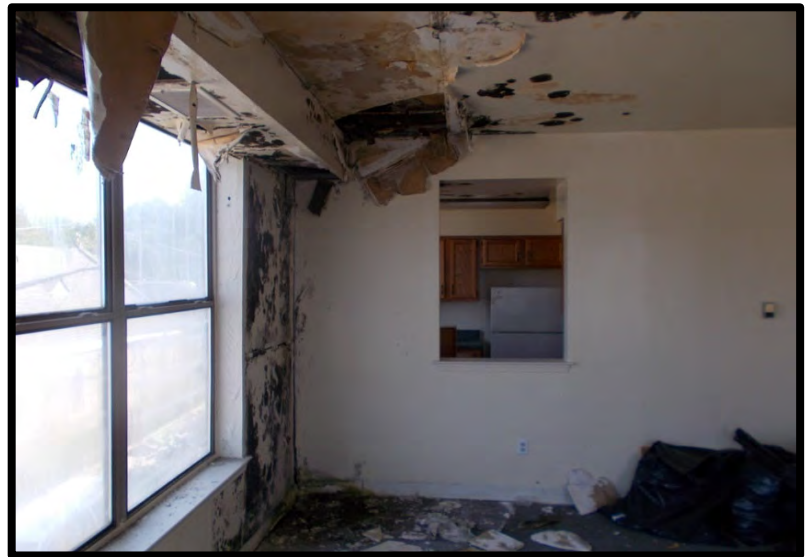
**Photo No. 55**

Additional view of same corner in previous photo.  
Note floor at this corner junction was soft and unsafe.

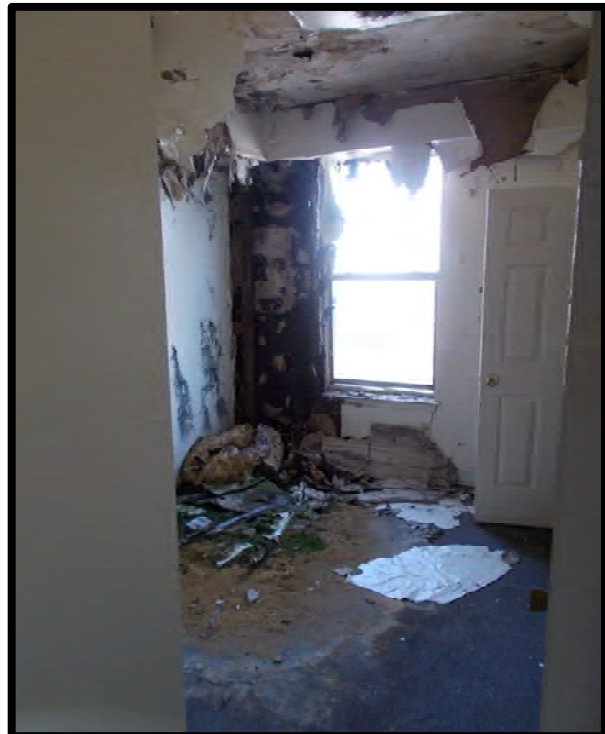
**Photo No. 60**

Depicts bedroom #2 with extensive damage from water infiltration at roof.

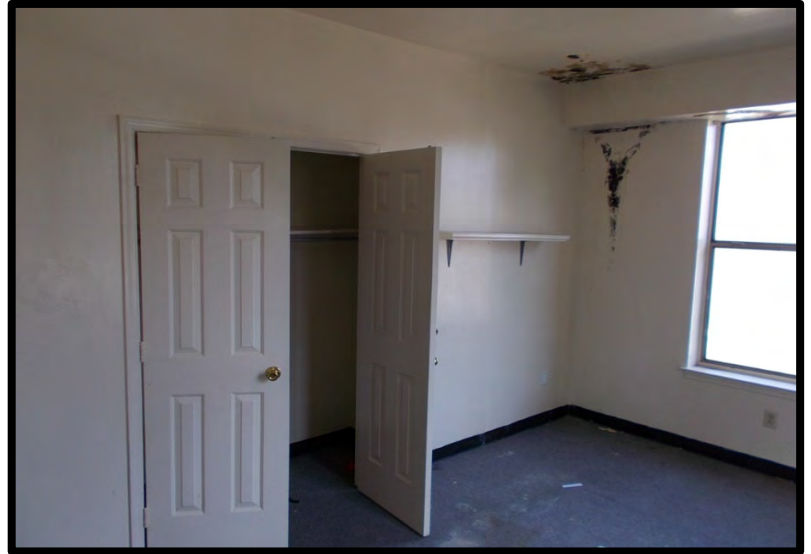
**Photo No. 61**

Depicts master bedroom closet. Some evidence from water infiltration was noted in corner of exterior wall.

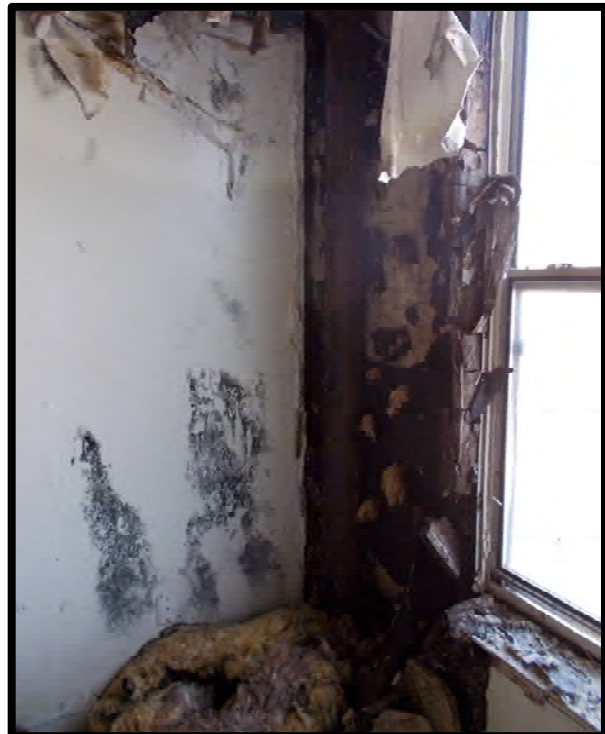
**Photo No. 64**

Close up view of exterior wall damage at bedroom #2.

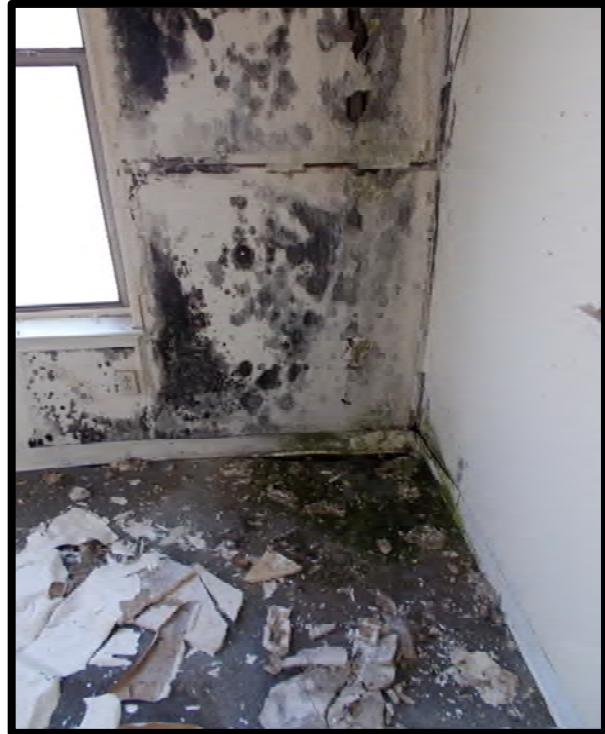
**Photo No. 65**

View of exterior wall at bedroom #1 showing evidence of water infiltration and saturation.

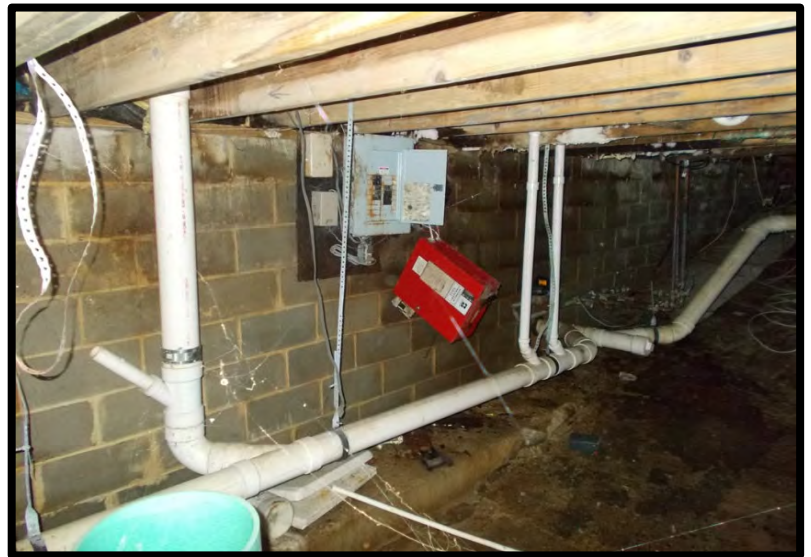
**Photo No. 68**

Panning left from previous photo. View of fire alarm control panel located in basement.

*Replacement of the fire alarm control panel is needed.*

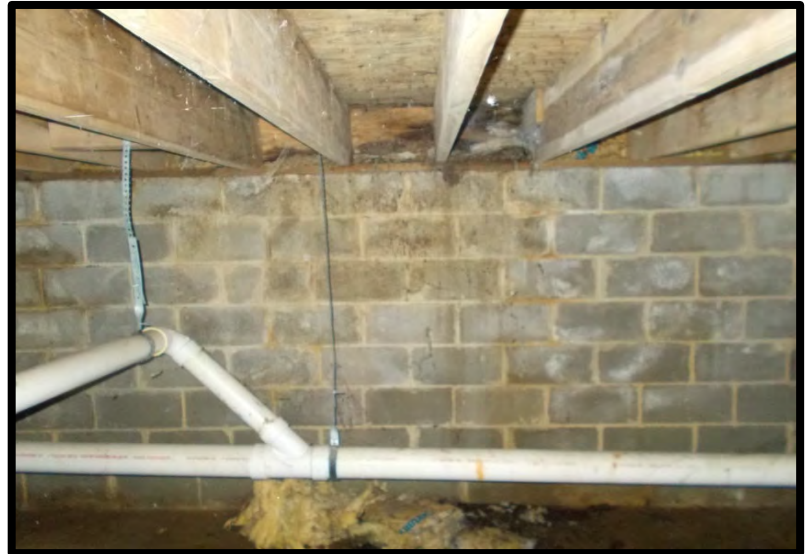
**Photo No. 70**

*The basement shows evidence of water infiltration in the area of the two (2) downspouts with large water staining along the CMU exterior wall.*

Depicts signs that water infiltration has been cascading from roof to basement level.

*Immediately address roof drainage to avoid additional structure damage.*

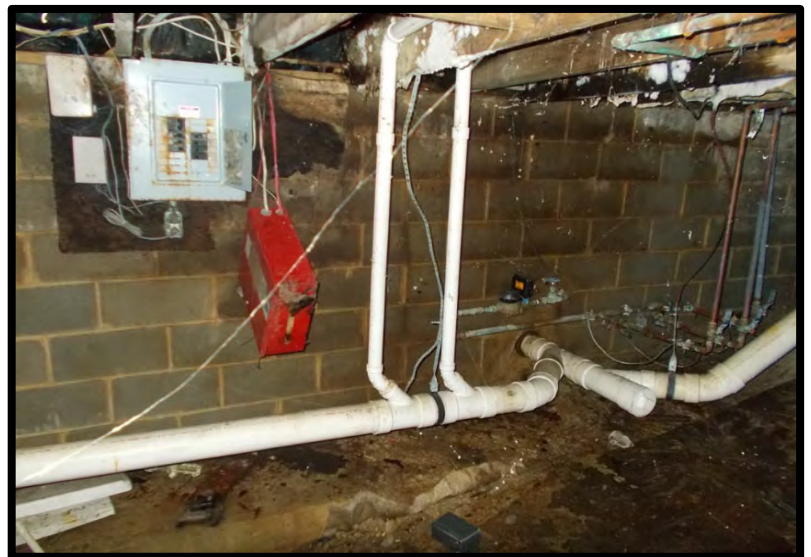
**Photo No. 71**

Depicts fire alarm control panel and water infiltration from roof above at second bedroom location.

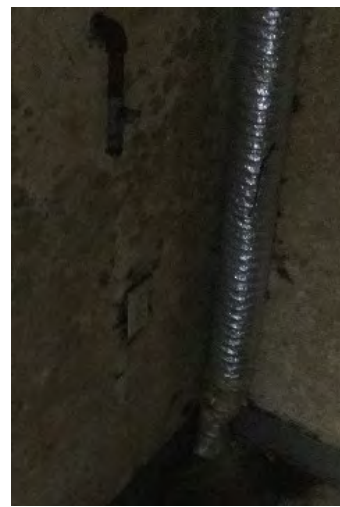
Duct damage.

*All units - All ductwork should be cleaned and furnaces should be replaced.*
