# Germantown/Mount Airy Properties

## Physical Conditions and Needs Assessment

### Premises V

**5417 Lena St**

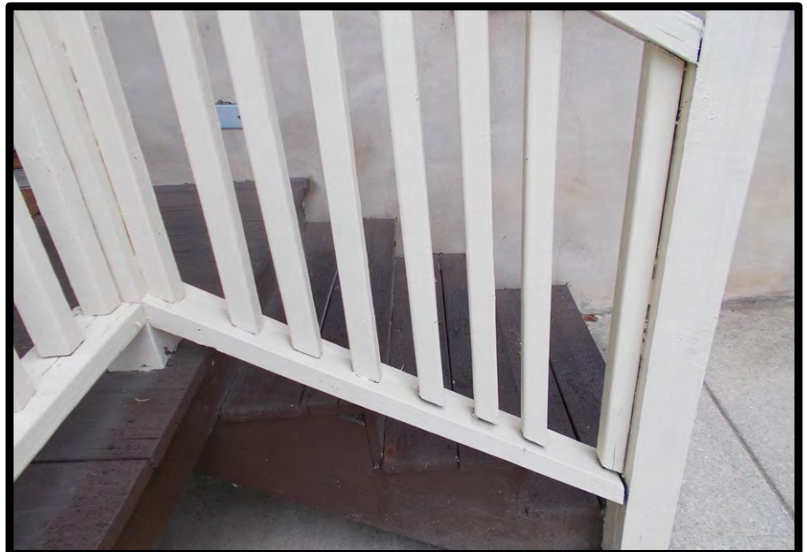
**Photo No. 2**

All the floors are connected with a wooden staircase. It was noted that the spindles at the stairs leading to the second-floor entry are loose and unevenly spaced.

Depicts detailed view of pickets at handrail not attached. Also depicted in photo note spacing of the pickets is irregular and should be replaced and resecured.

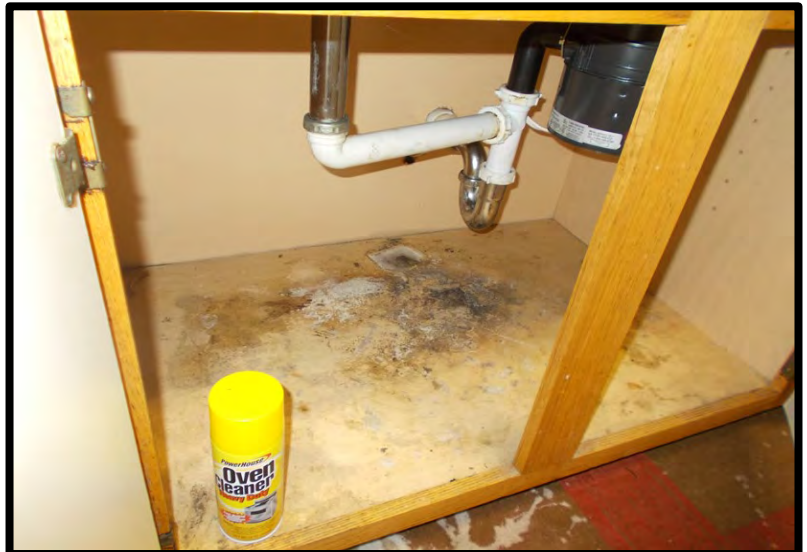
**Photo No. 6**

Depicts view of previous water leakage at the kitchen sink cabinet.

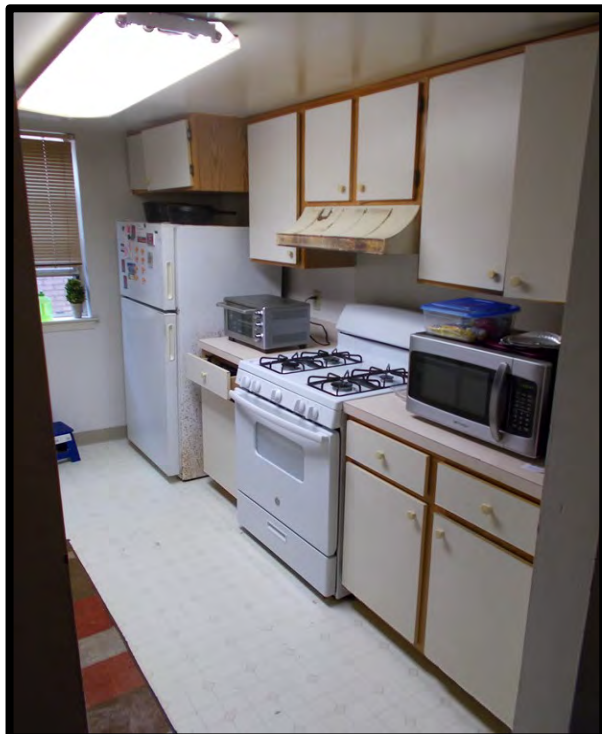
**Photo No. 8**

Panning right from previous photo. Note condition of grease hood.

Replacement of the grease hood is required. Installation of a venting grease hood should be considered in Unit B

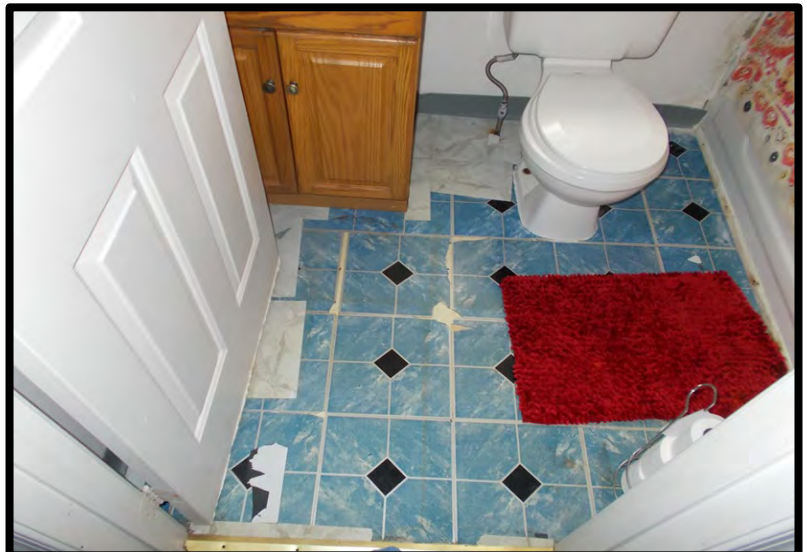
**Photo No. 25**

Additional view of third floor bathroom flooring.

*Replacement of the vanity in the half bathroom should be strongly considered. Replacement of the floor is highly recommended in the third floor bathroom. Replacement of the door on the third floor bathroom should be considered.*

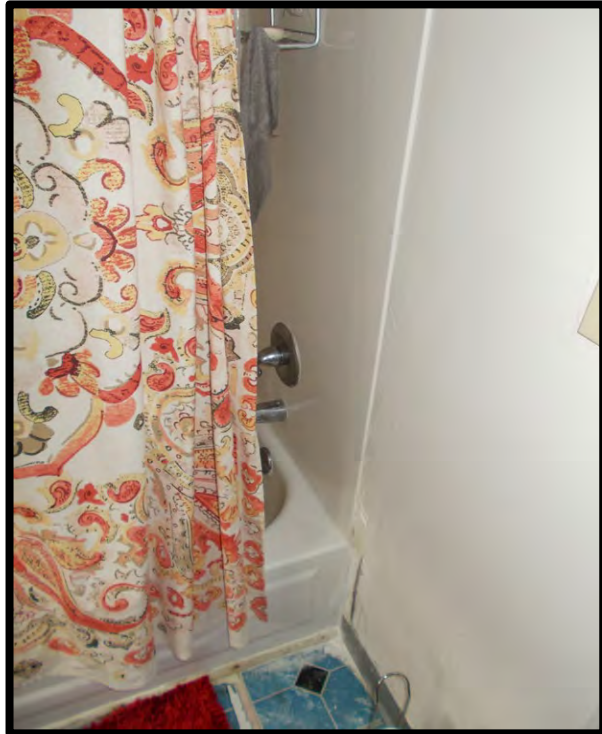
**Photo No. 26**

View of bathtub and fiberglass surround with evidence of water infiltration at bathtub corner.

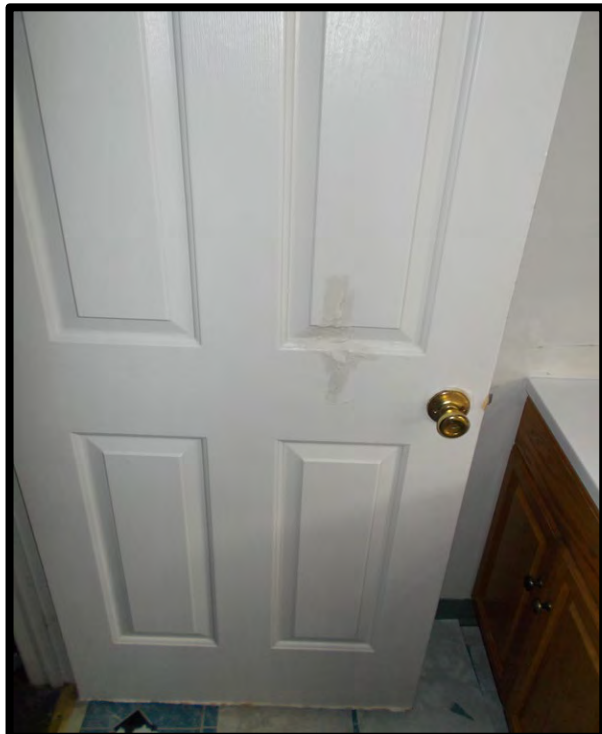
**Photo No. 29**

UNIT B - The half bath consists of a wood cabinet vanity, plastic laminate countertop and top mount sink as well as a floor mounted tank-style toilet. General finishes are fair. Third floor bathroom finishes consist of a newer wood vanity with single integral sink countertop in good condition. The flooring is a vinyl adhesive tile in poor condition. Evidence of water infiltration along the bathtub was also noted. The tub and fiberglass surround appear to be newer and in good condition. The door to the bathroom has been damaged.

View of damaged door to bathroom.

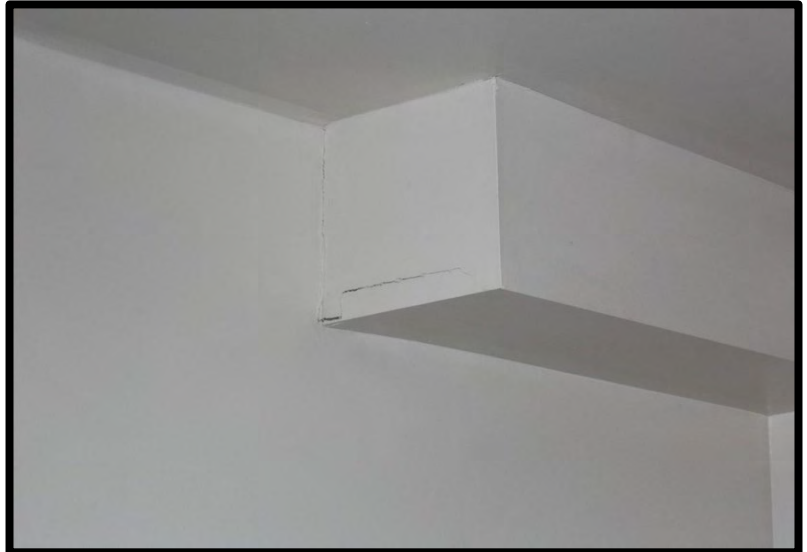
**Photo No. 30**

View of damage at ceiling soffit third floor.

*Repair of the gypsum finishes should be done once source of water infiltration has been addressed.*

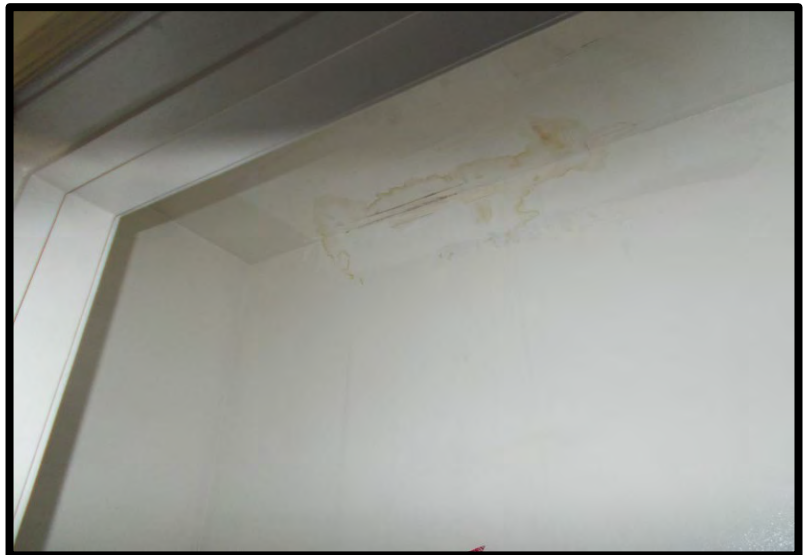
**Photo No. 31**

UNIT B - There was evidence of water infiltration along the ceiling on the third floor over the stairs as well as bedroom and washer/dryer closet. It was also noted that swelling of the wood doors was common along the third floor likely due to water infiltration and high moisture.

View of water infiltration at closet of third floor.

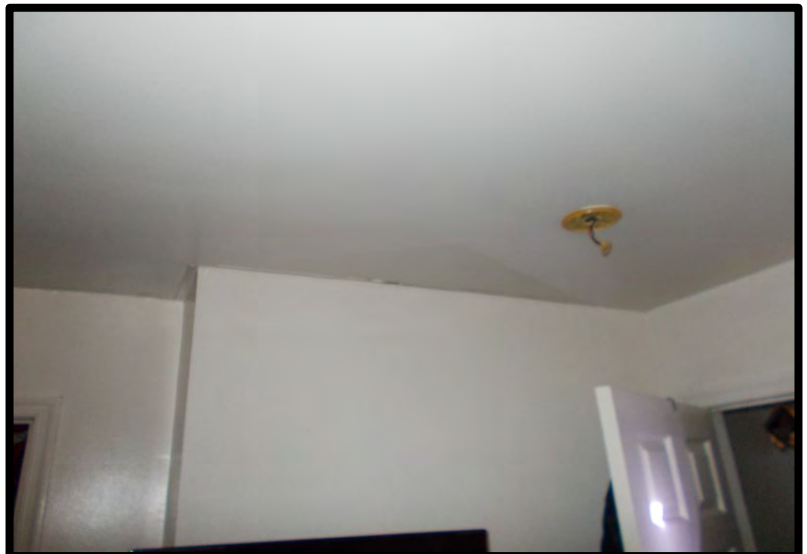
**Photo No. 32**

View of water infiltration at ceiling of third floor bedroom.

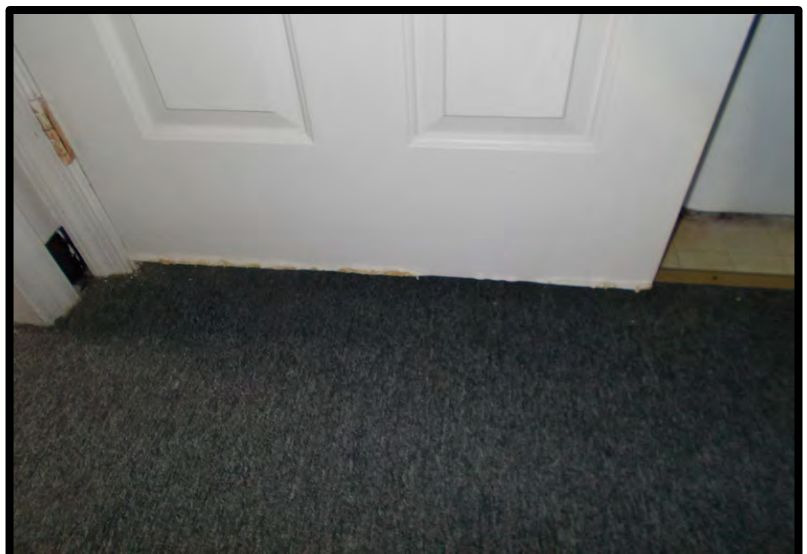
**Photo No. 35**

Depicts rot at bottom of door from moisture. Moisture is also indicative in rusting of door hinges. This is at the washer/dryer closet third floor.

*Replacement of all doors on the third floor are in poor condition and should be replaced.*

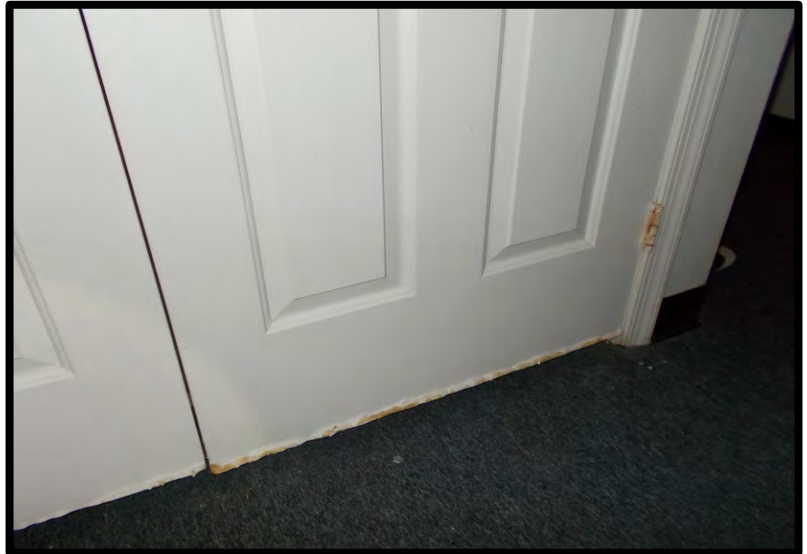
**Photo No. 36**

Additional view of damage to bottom of door from moisture.

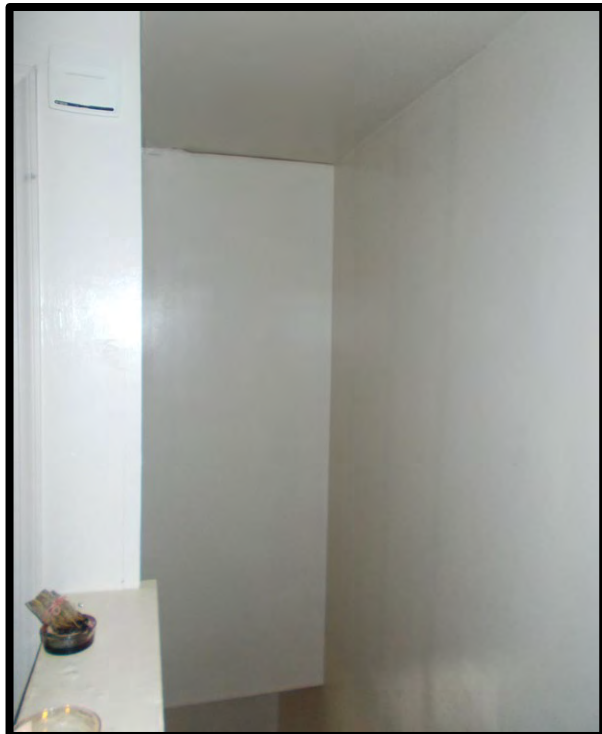
**Photo No. 37**

Depicts view of moisture damage at third floor ceiling above stair.

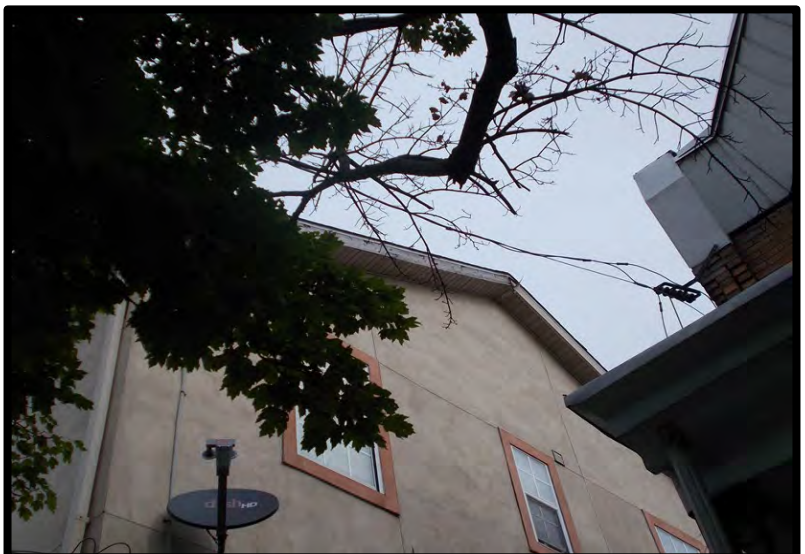
**Photo No. 44**

Detailed view of third floor along right side of property.  
Note missing aluminum trim along fascia.

*Replacement of first floor roof is highly recommended.  
Third floor roof has exhibited signs of water infiltration and replacement with new architectural shingles is required.  
Replacement/Repair of the trim is required.  
Replacement of damaged gutters in their entirety should be considered.*

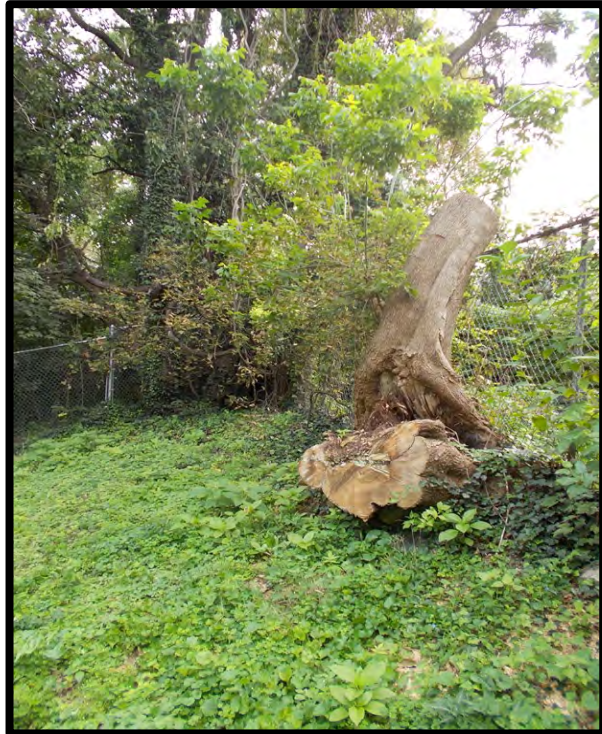
**Photo No. 47**

The building has suffered damage from a fallen tree and has evidence of extensive water damage throughout.

Depicts view of large tree that apparently fell during a previous storm and damaged a portion of the structure.

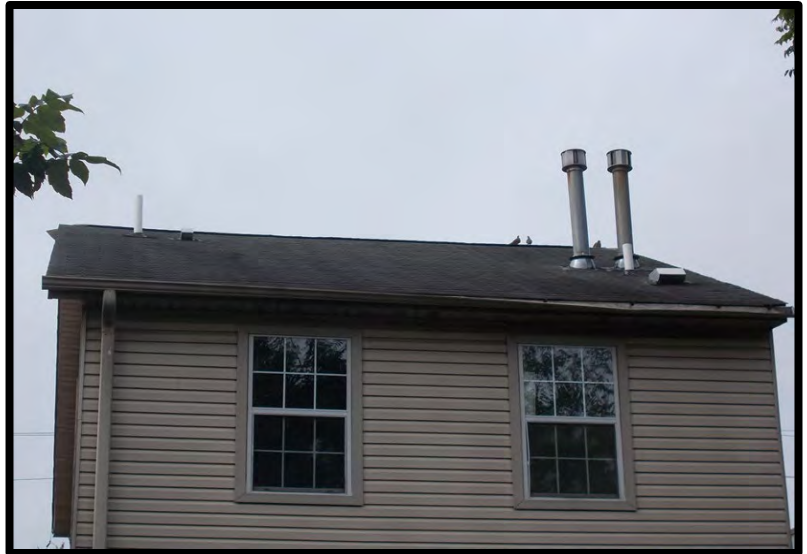
**Photo No. 49**

There is damage to existing gutters.

Depicts detailed view of third floor roof and damaged gutter.

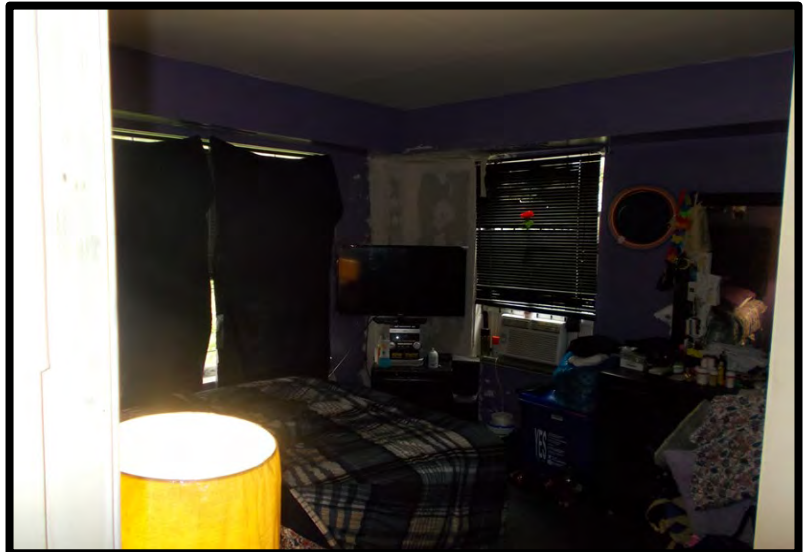
**Photo No. 68**

UNIT A - The first-floor entry and kitchen have a vinyl adhesive floor tile in good condition. The rear bedroom has some wall repair due to a tree that fell on the building. The repair is in poor condition. The second bedroom finishes are generally in good to fair condition.

View of bedroom #1 located at the right rear corner of the apartment. Note repaired damaged to wall from previously mentioned tree fall.

*Additional repairs and/or sanding of poorly executed wall repair in the rear bedroom is required.*

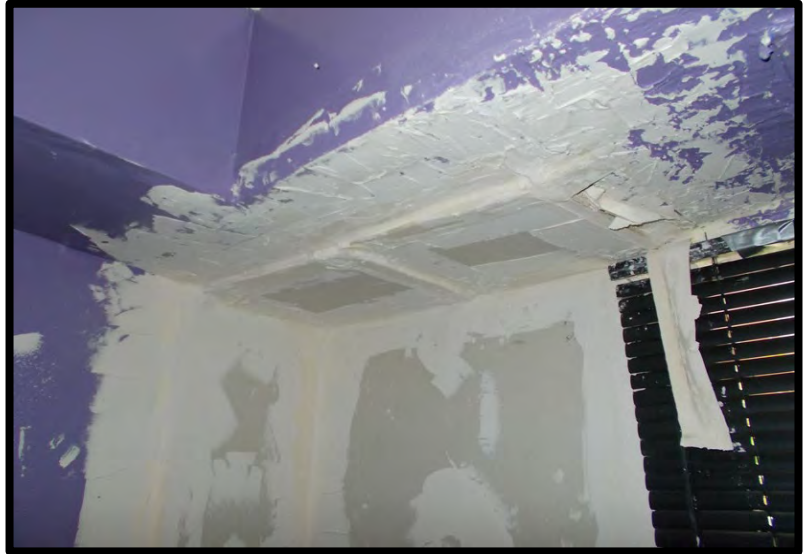
**Photo No. 69**

View of area of repair.

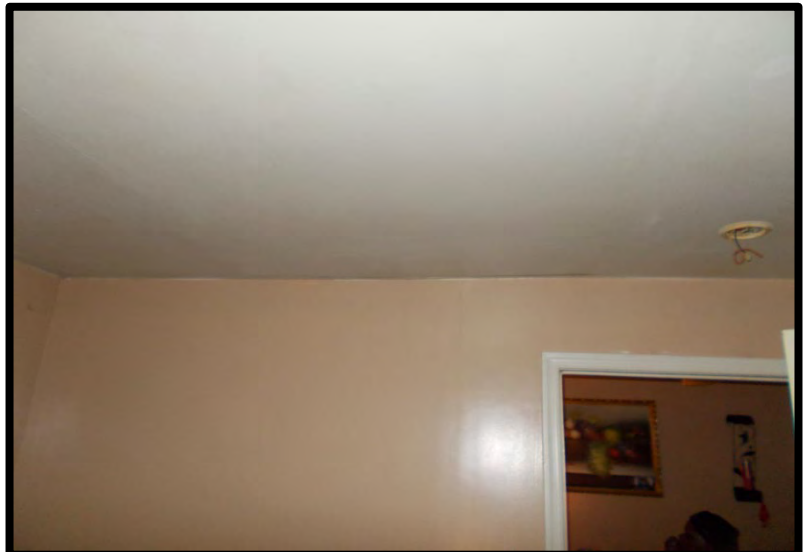
**Photo No. 74**

Depicts view of ceiling damage in bedroom #2.

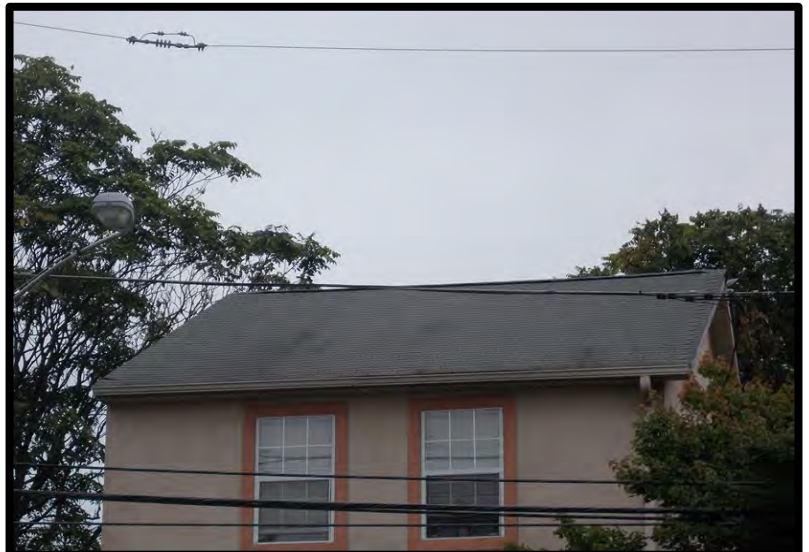
**Photo No. 78**

The roof over the first floor appears to be a granulated sheet. It appears to be in fair to poor condition. The third-floor roof is a 3-tab asphalt shingle, "A" shaped roof in fair to poor condition. Some curling of the shingle was noted. There was evidence of missing trim along the rake. It was observed that the third floor roof had been damaged due to natural hazards. There is damage to existing gutters.

View of third floor roofing from front on Lena Street.
