Germantown/Mount Airy Properties

Physical Conditions and Needs Assessment

Premises W

5513 Lena Street

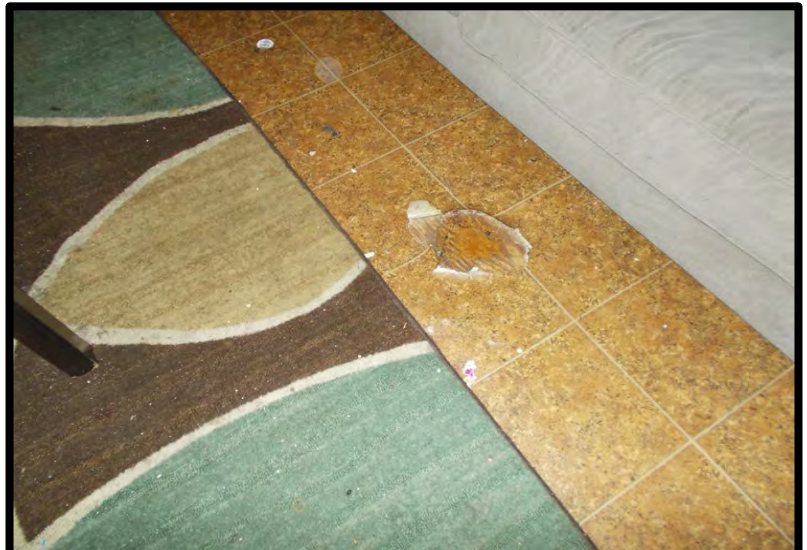
Photo No. 2

The linoleum flooring in the living room has damage adjacent to the couch; there is a large section of peeled up sheet vinyl.

Depicts damaged linoleum floor in living room.

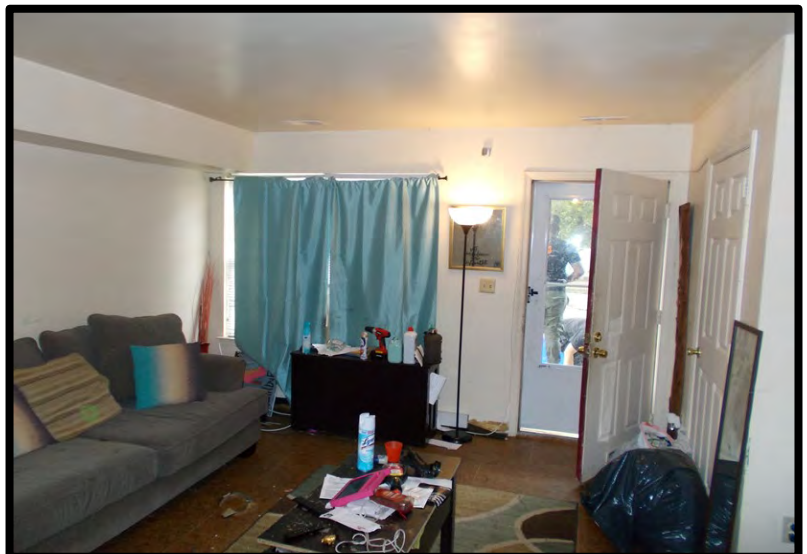
Photo No. 5

View looking at dwelling entry and living room at first floor. Note damaged floor section at the bottom left corner of photo.

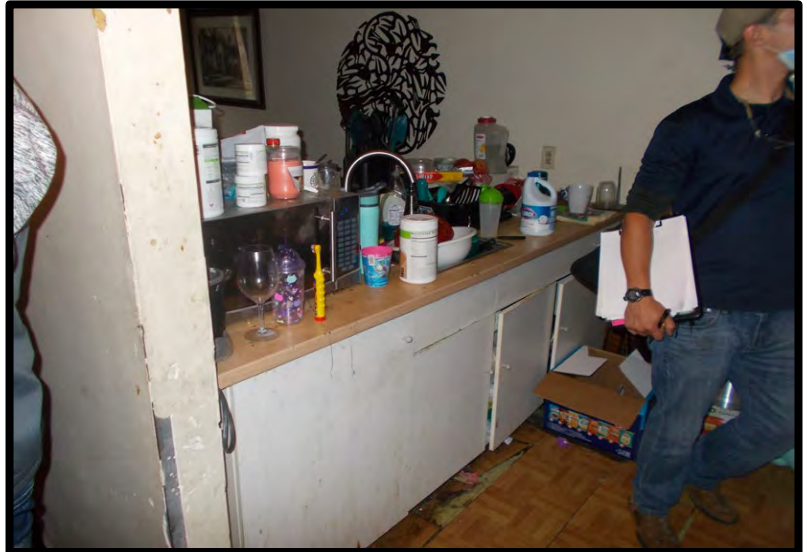
Photo No. 6

Many vinyl kitchen tiles are peeled up and full floor replacement is recommended.

Depicts view of kitchen and damaged vinyl floor tile.

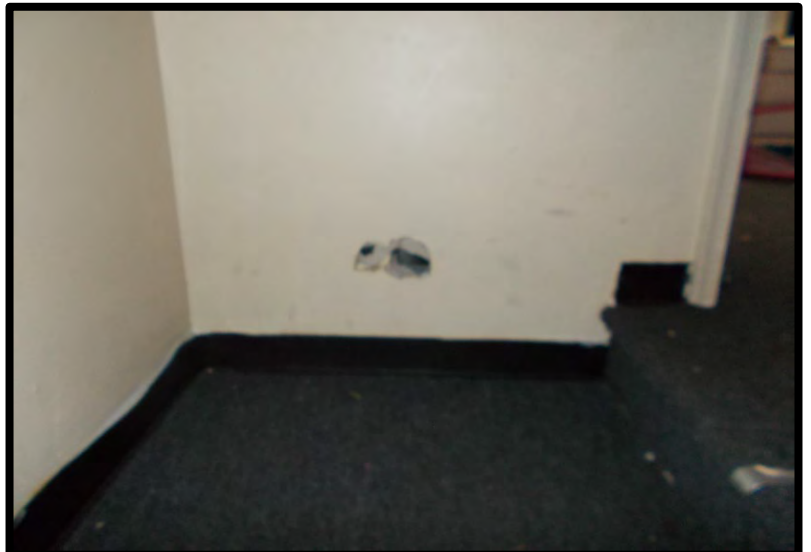
Photo No. 12

Some areas of repairs were noted.

Detailed view of damaged wall at second floor stair landing.

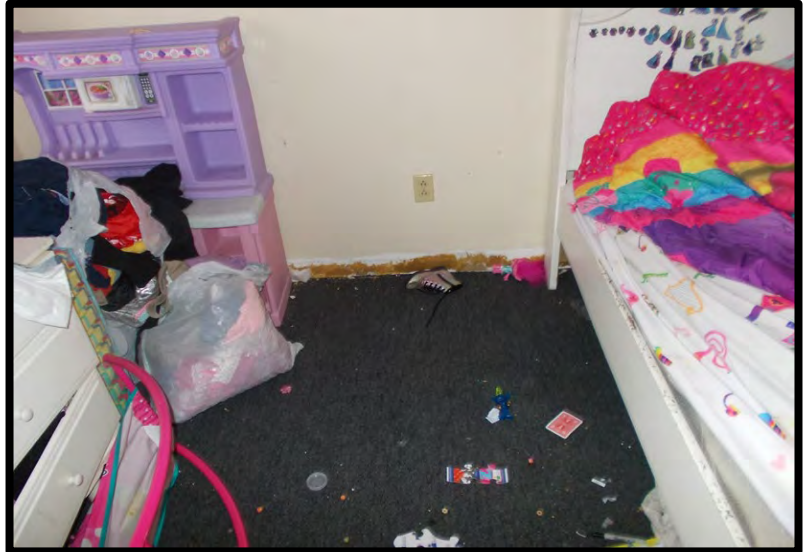
Photo No. 15

View of missing wall base within bedroom.

Areas of missing vinyl base should be replaced.

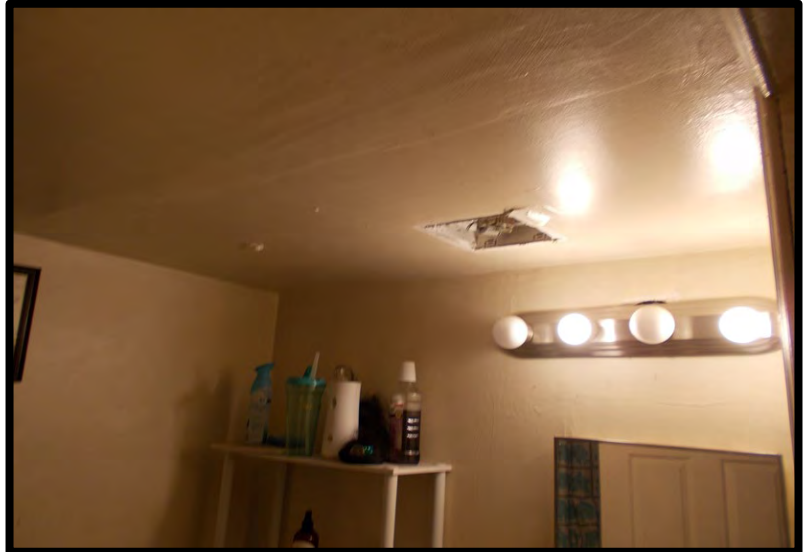
Photo No. 19

Depicts missing ventilation fan in second floor bathroom.

Kitchen and bathroom exhaust fans should be replaced.

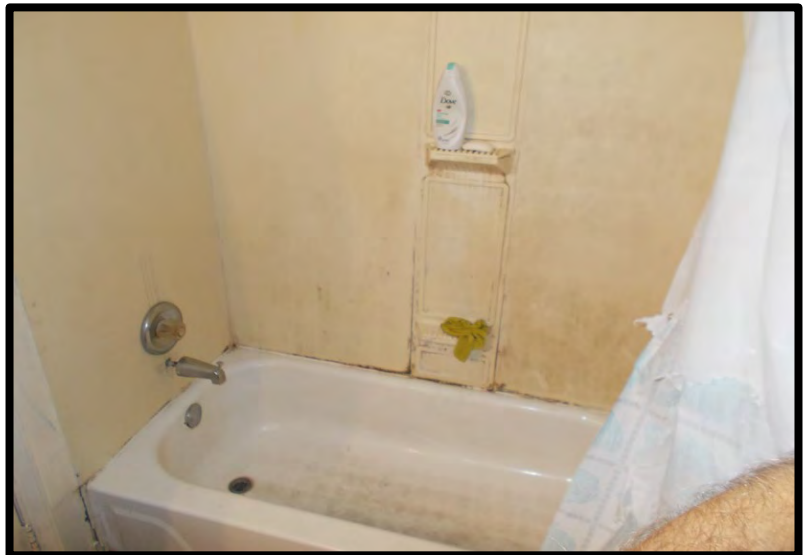
Photo No. 20

Depicts view of bathtub and fiberglass tub surround.

Replacement of all fixtures, including tub and fiberglass surround, is recommended for the second floor bathroom.

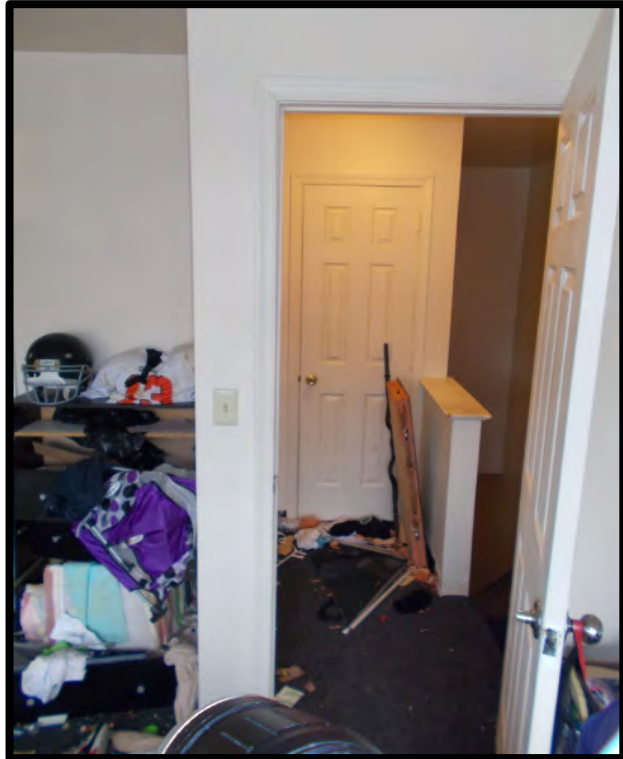
Photo No. 31

Depicts bedroom entry to third floor bedroom. Note missing door knob to bedroom.

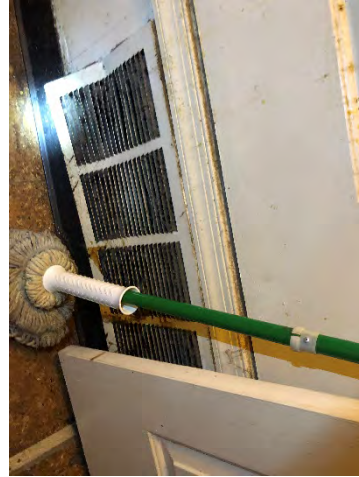
Return vent that needs to be replaced.

All supply and return grills should be replaced.

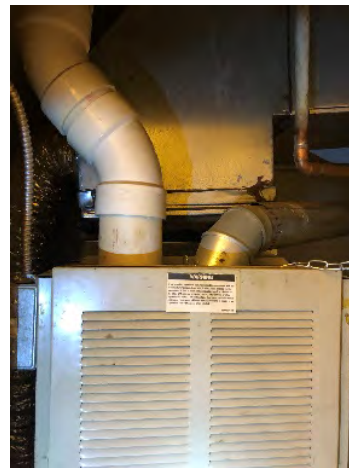
Gas fired furnace in good condition.

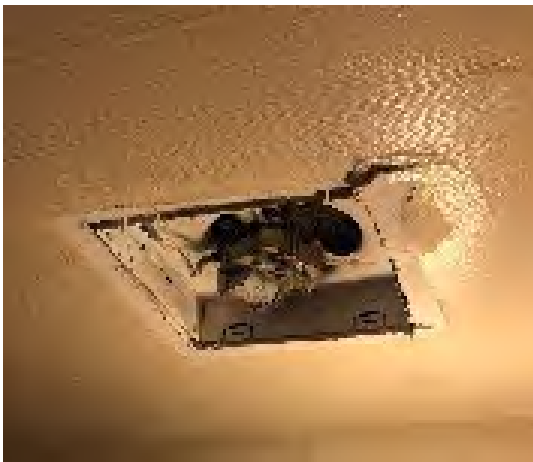
Bathroom exhaust fan (not working).

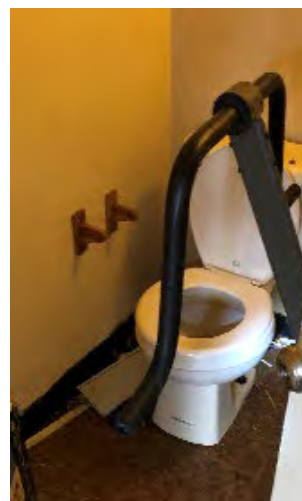
Bathroom on the top floor (not working).
