# Germantown/Mount Airy Properties

## Physical Conditions and Needs Assessment

### Premises X

**5515 Lena Street**

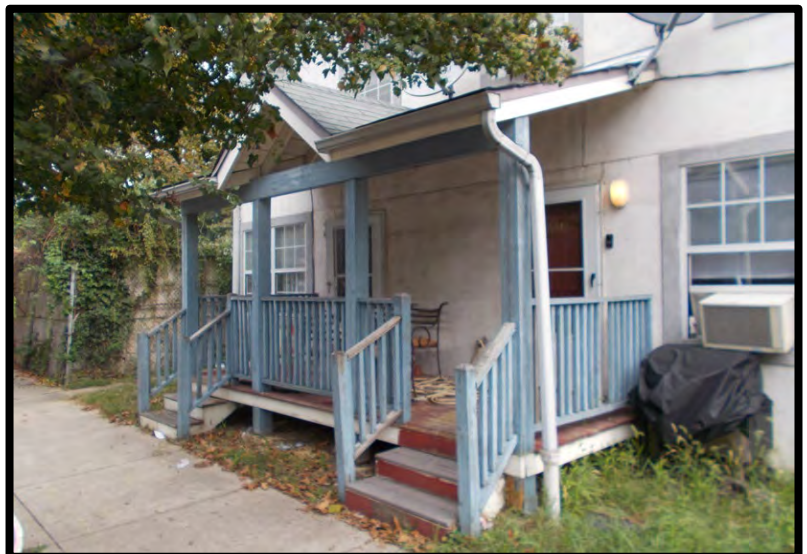
**Photo No. 3**

Access to the building is from Lena Street, three steps up from grade via a front porch. Some decking replacement and painting is required for the shared porch.

Depicts overall view of shared entry porch.

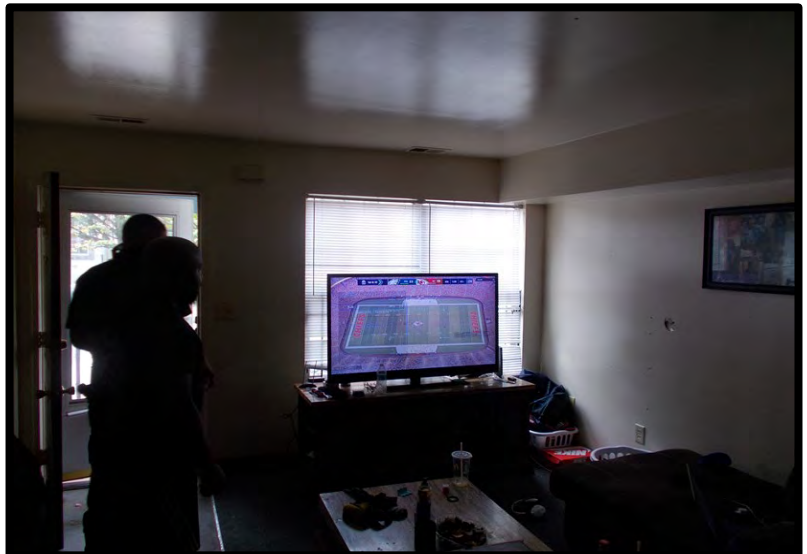
**Photo No. 7**

Panning left from previous photo. Depicts view of dwelling entry in living room. Note damaged portion of gypsum wallboard at right of photo.

*Gypsum board walls and ceilings are generally in good to fair condition. Some minor repairs and general repainting is required.*

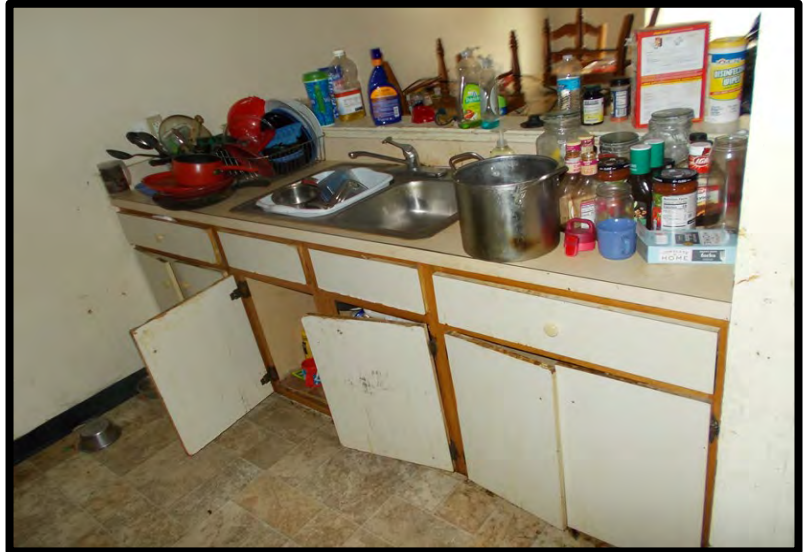
**Photo No. 13**

*The condition of the cabinets and countertop are poor and require replacement*

View of kitchen sink and cabinets.

*Many vinyl kitchen tiles are peeled up and full floor replacement is recommended during time of cabinet replacement.*

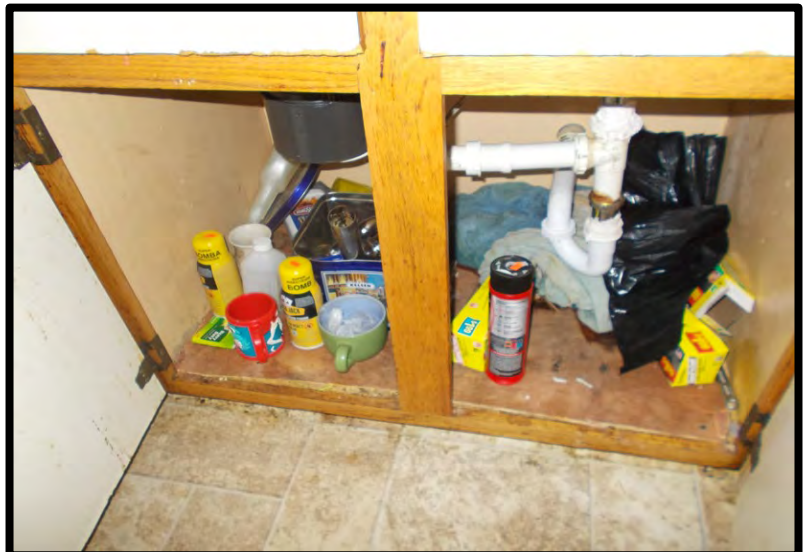
**Photo No. 14**

Domestic water was not able to be assessed. There are issues with the kitchen waste lines. Evidence of poor repair and continuing leakage was noted.

View of underside of kitchen sink with kitchen grinder and waste lines.

*Kitchen waste lines should be repaired/replaced.*

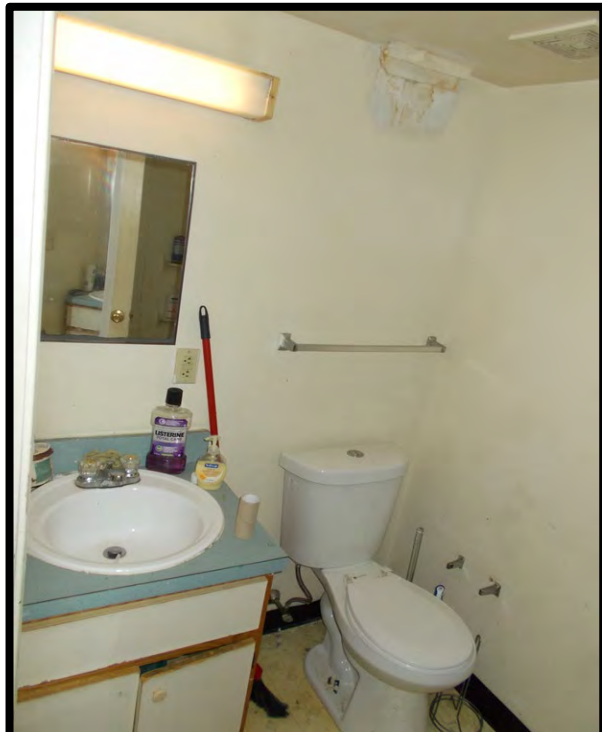
**Photo No. 20**

*Second floor bathroom finishes are poor and will require replacement. Damage was noted at the ceiling above the second-floor water closet due to water infiltration. Source of infiltration should be addressed as soon as possible.*

View of vanity and water closet at second floor bathroom. Note damage to ceiling from probable water infiltration from above.

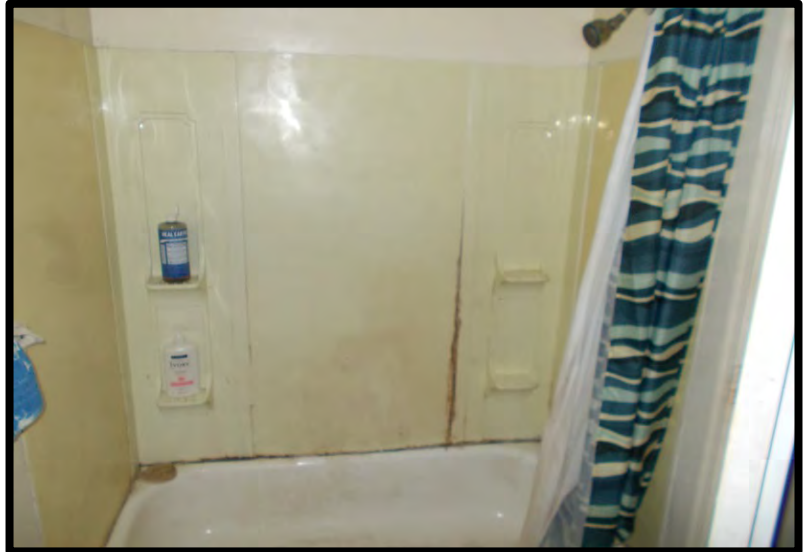
**Photo No. 21**

*The fiberglass bathtub surround at the second floor is in poor condition and should be replaced during the bathroom remodel.*

View of bathtub and fiberglass surround at second floor bathroom.

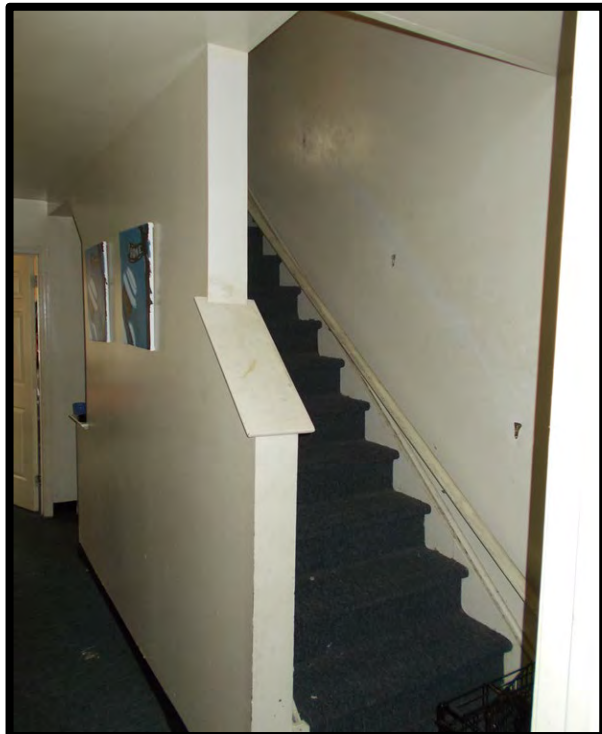
**Photo No. 24**

View of stairs leading to third floor from second floor. Note missing handrail.

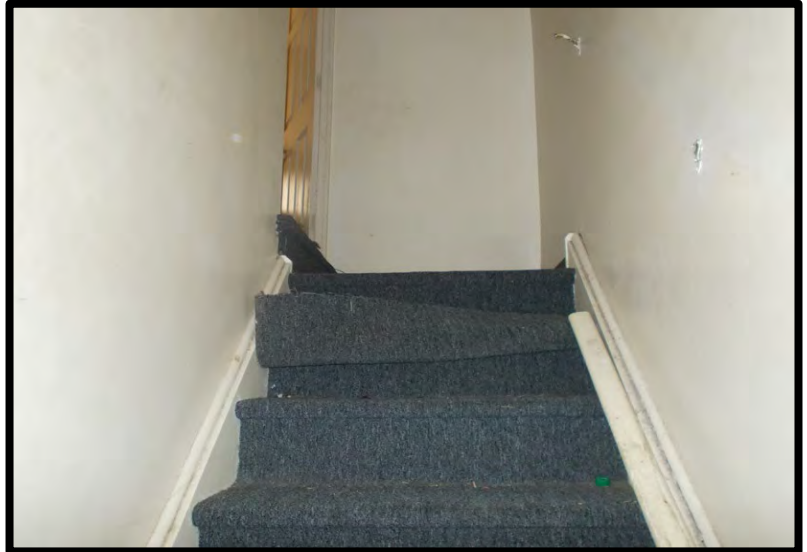
**Photo No. 25**

View of third floor landing and loose carpeting which is a tripping hazard. Also noted is the missing handrail which is laying on the stairs.

*Carpet on the stair to the third floor is no longer attached and may cause a tripping hazard; carpet must be repaired or replaced.*

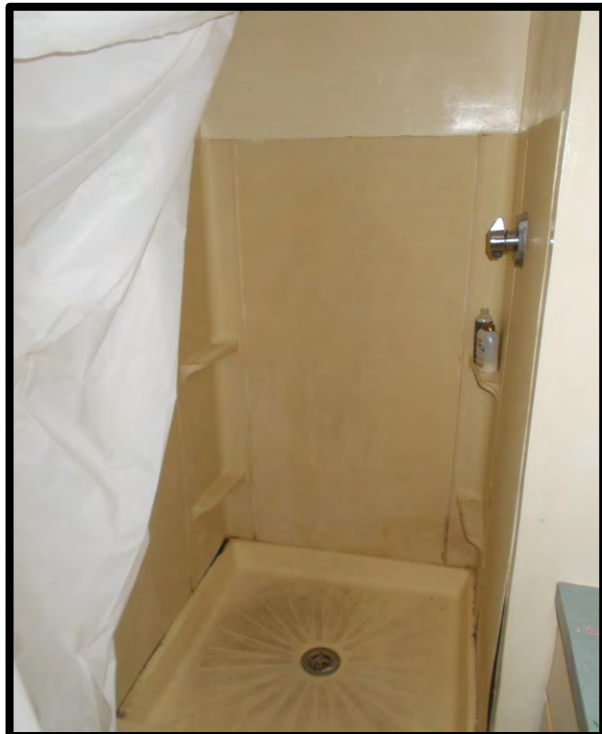
**Photo No. 32**

View of third floor shower.

*Replacement of the vanity and shower surround is highly recommended along with flooring in the third floor bathroom.*

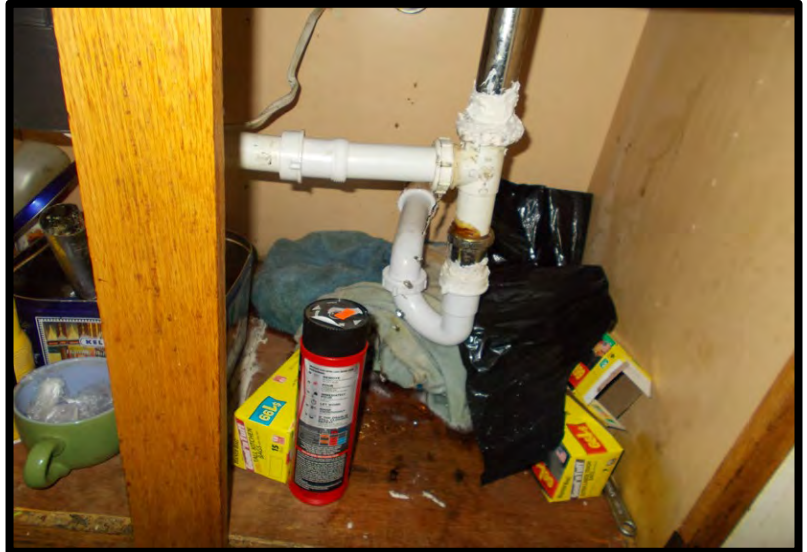
**Photo No. 33**

Detailed view of kitchen plumbing that is obviously leaking and poorly repaired.

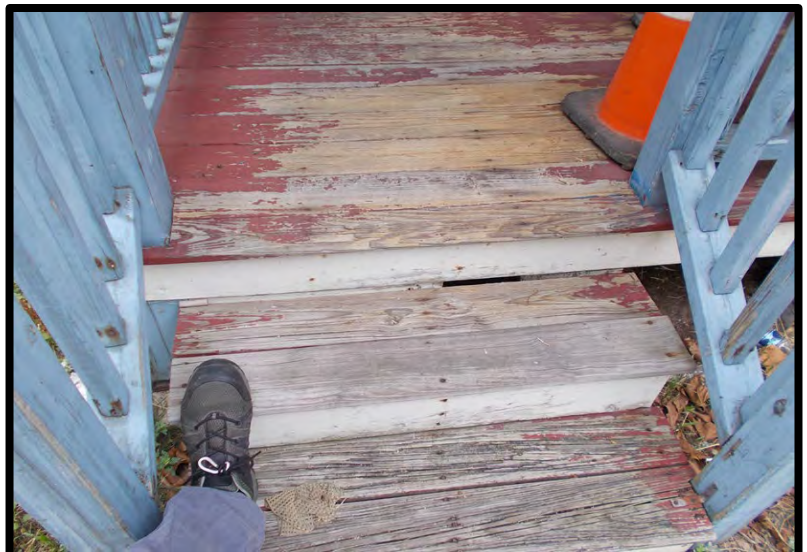
**Photo No. 35**

Detailed view of porch wood stairs from grade.

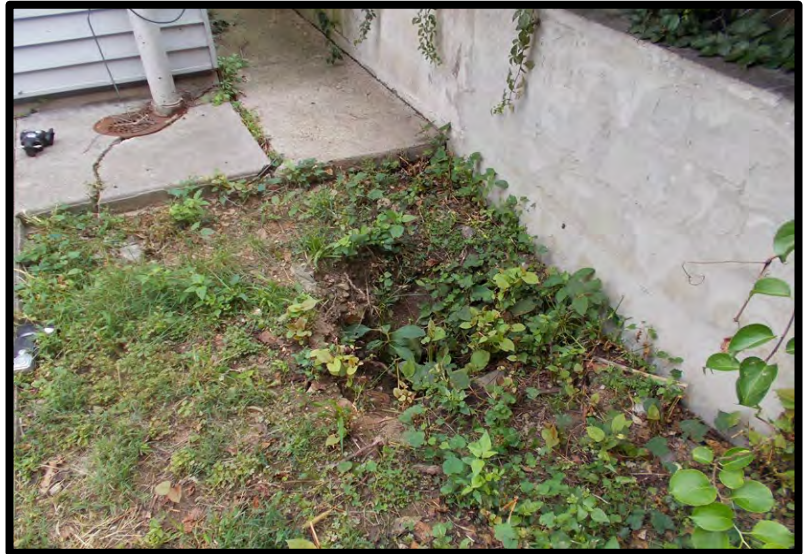
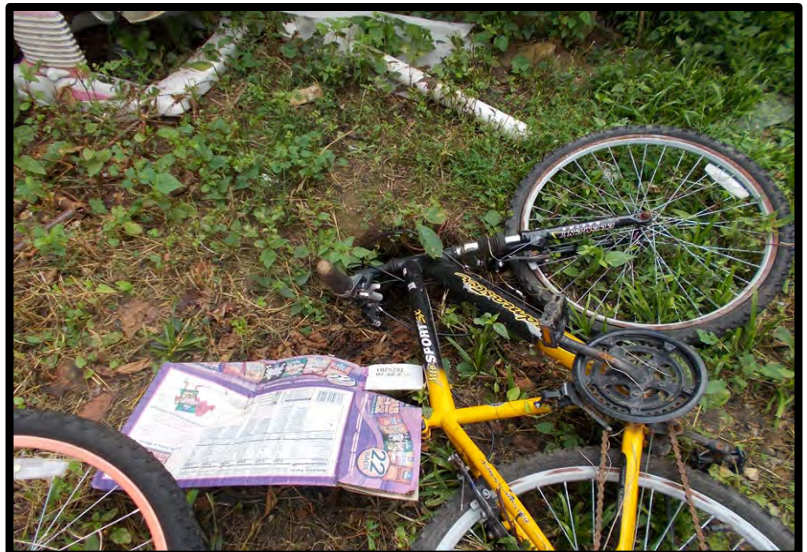
**Photo No. 36**

Two (2) large sink holes were noted in the rear yard. These should be investigated further and could cause a tripping hazard and bodily harm.

View of large sink hole at rear yard.

Depicts additional view of sink hole in rear yard.

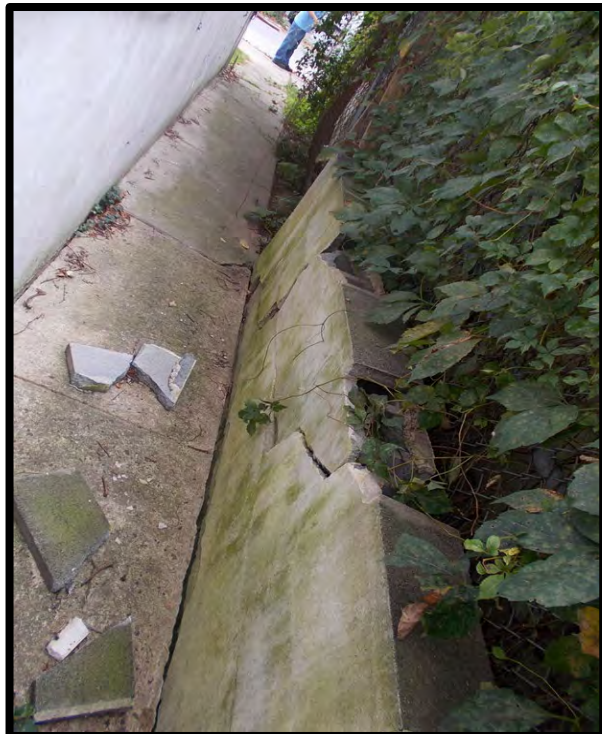
**Photo No. 39**

There appears to be damage to the CMU wall along the left side of the property. It is unknown whether or not this wall belongs to this property or the adjoining property. Aerial imagery suggests the wall may belong to the adjoining property owner. Damaged portions of the wall are laying along the side yard walkway.

Depicts view of CMU wall located on the north side of the property. It is believed that this wall actually belongs to the adjacent property.

*Identify owner of CMU wall and repair/replace.*

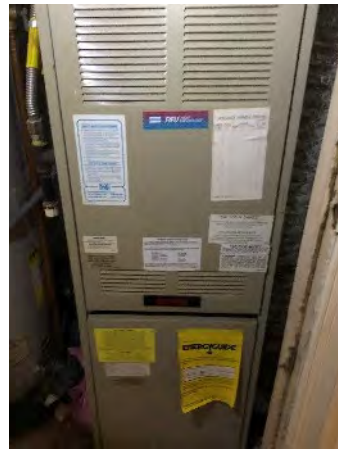
Gas fired furnace in good condition.

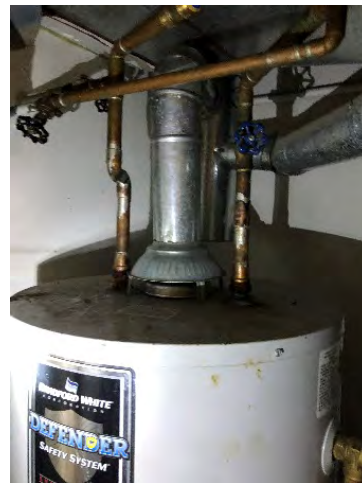
Top of hot water heater in good condition.
