# Germantown/Mount Airy Properties

## Physical Conditions and Needs Assessment

### Premises Y

**5423-27 Lena Street**

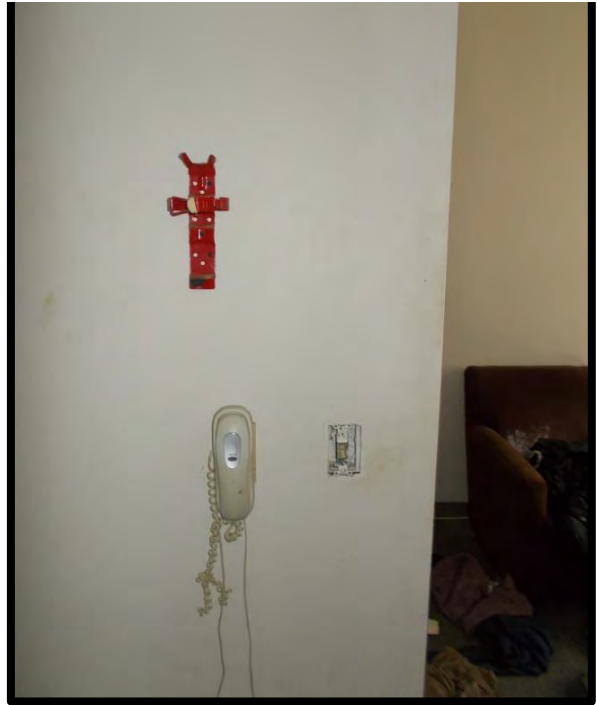
View of missing fire extinguisher, intercom and  
missing light switch cover plate outside kitchen.

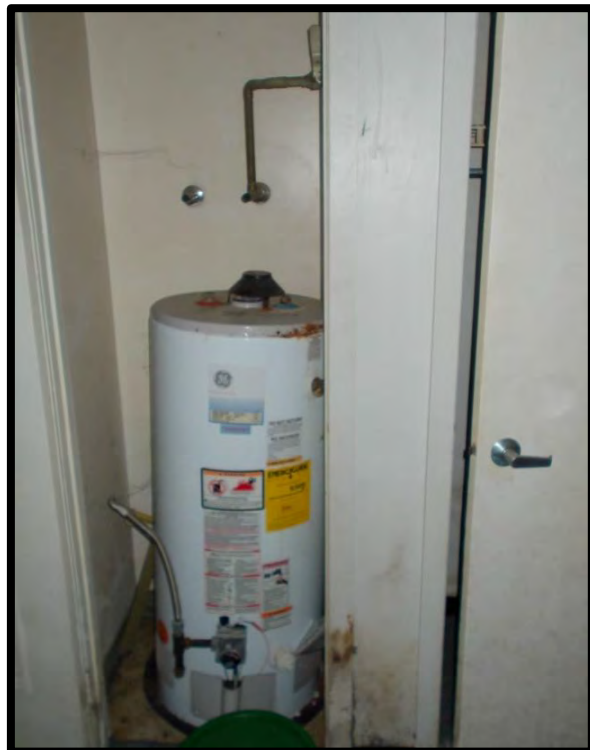
**Photo No. 99**

View of installed hot water heater. Note flue piping is missing.

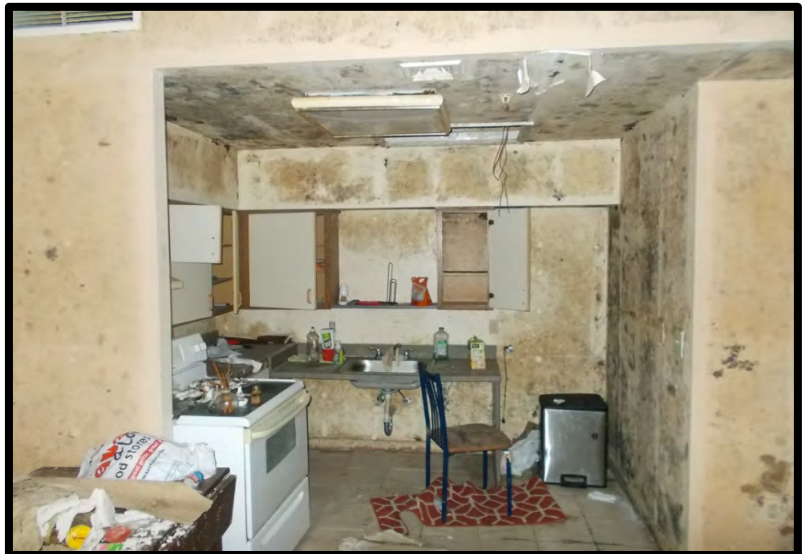
**Photo No. 152**

View of kitchen from living room. Note under cabinets have been removed and counter lowered to ADA height.

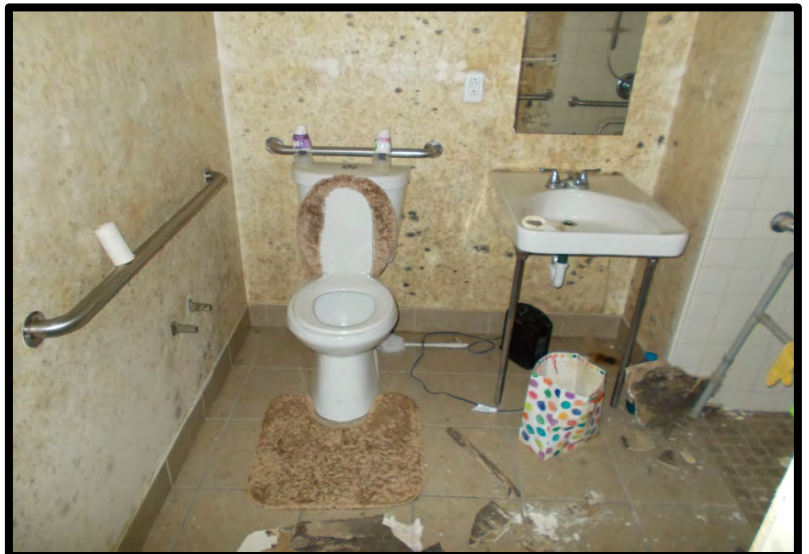
**Photo No. 162**

View of converted water closet and lavatory. Note the rear grab bar does not meet current ADA size of 36" min.

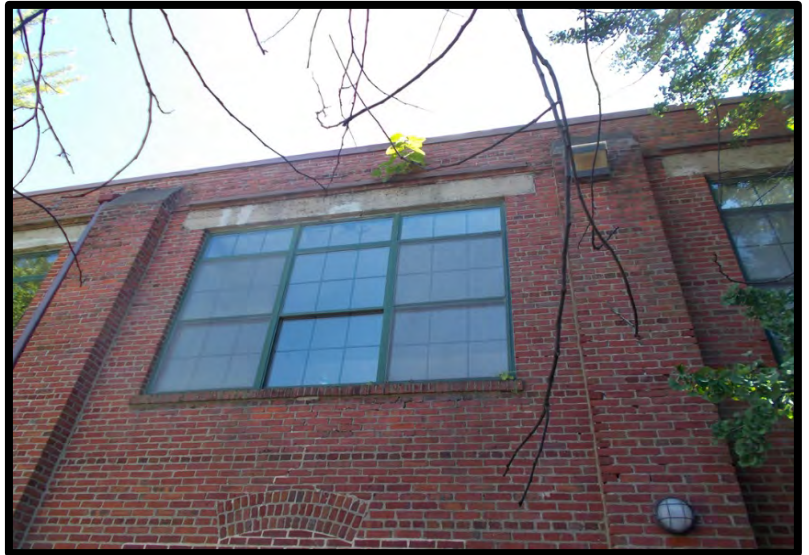
**Photo No. 194**

View of growing vegetation above second floor windows along north side.

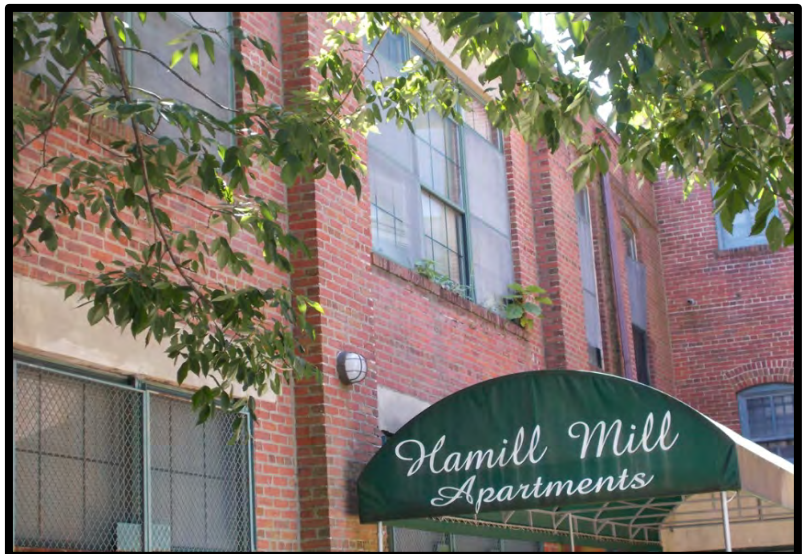
**Photo No. 195**

Additional view of vegetative growth at second floor windows, north side.

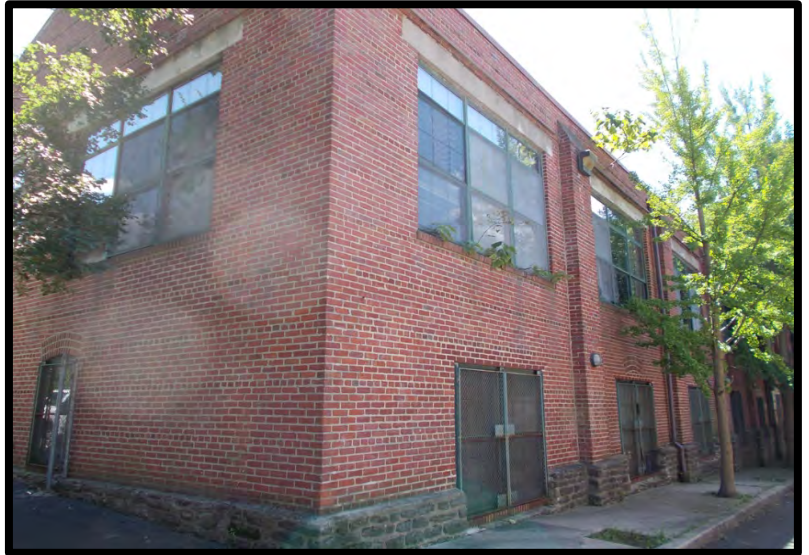
**Photo No. 198**

View of northeast corner of building with vegetative growth at second floor windows along north side.

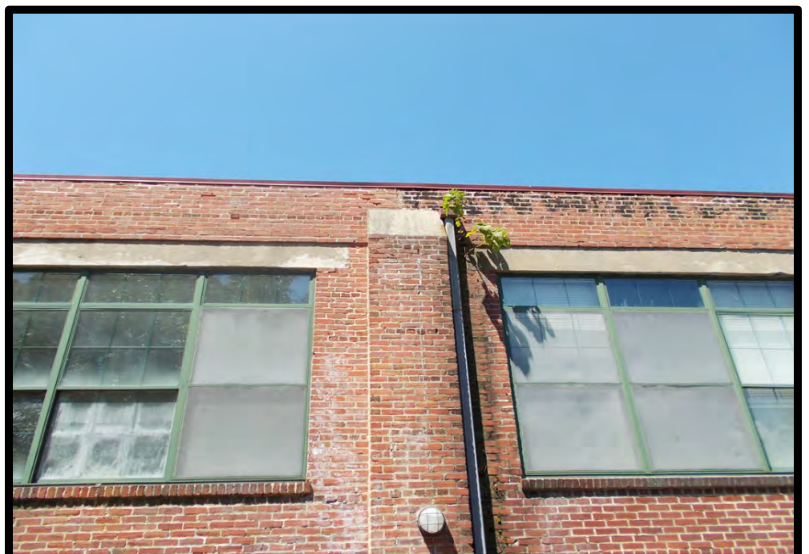
**Photo No. 213**

Detail view of masonry at parapet and along downspout. Evidence of water scouring from storm water was noted.

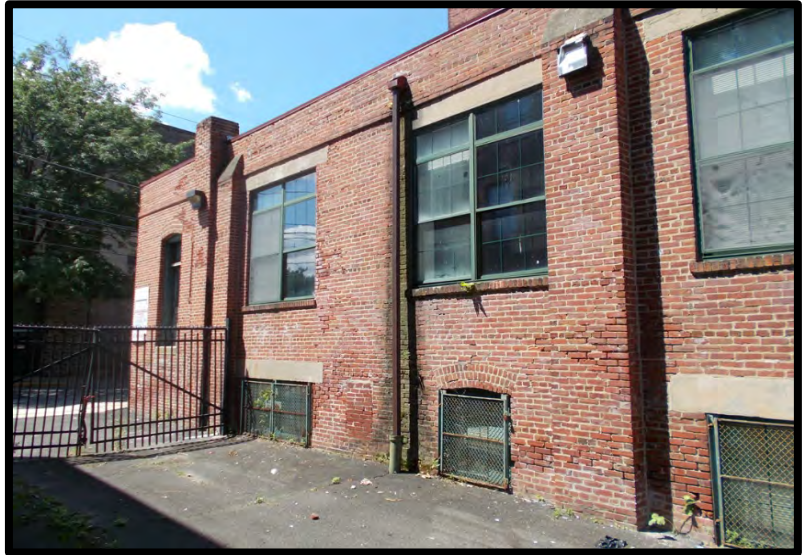
**Photo No. 217**

Detail view of masonry on south façade, west end.  
Brick repointing/repair is required.

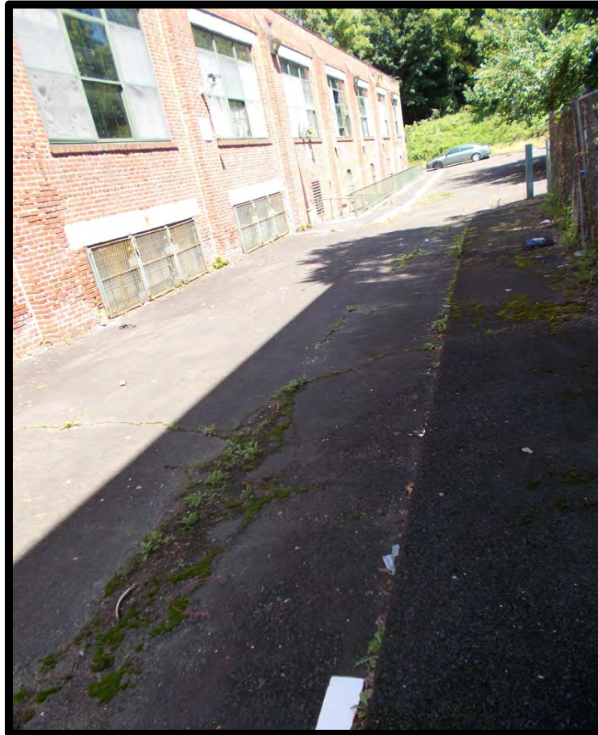
**Photo No. 219**

There is an asphalt driveway that runs the full length of the building and a small area for parking in the back. The asphalt appears to be in fair condition. Asphalt area should be repaved to maintain stormwater flow to catch basins.

View looking east from Lena St. along south side parking area. Note asphalt replacement is required.

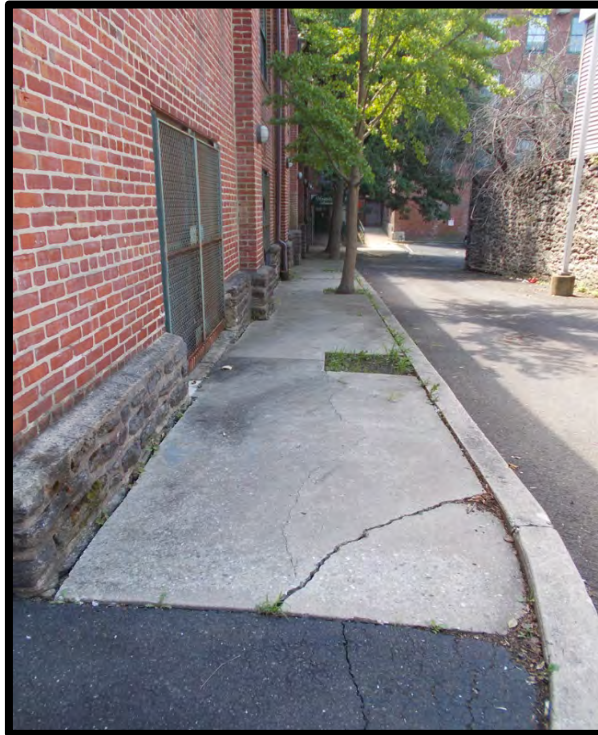
**Photo No. 221**

Curbs and sidewalk in the front of the building appear to be in fair to poor condition. Replace sections of damaged/heaved sidewalks.

View looking west along north side of building. Concrete and asphalt sidewalk will require replacement.
