**Re:** Summary of Test Pit Exploration  
Miles Mack Playground  
Philadelphia, Pennsylvania  
LANGAN Project No.: 220104104

This memorandum presents the results of LANGAN's geotechnical engineering study for the existing retaining wall along the southern boundary of the basketball court at Miles Mack Playground in Philadelphia, Pennsylvania. The purpose of this study was to explore and evaluate the existing retaining wall in an effort to better understand the wall's construction and foundation, as well as to classify the wall's bearing and retained soils. This work was performed in accordance with LANGAN's ASR-2 dated 14 May 2019.

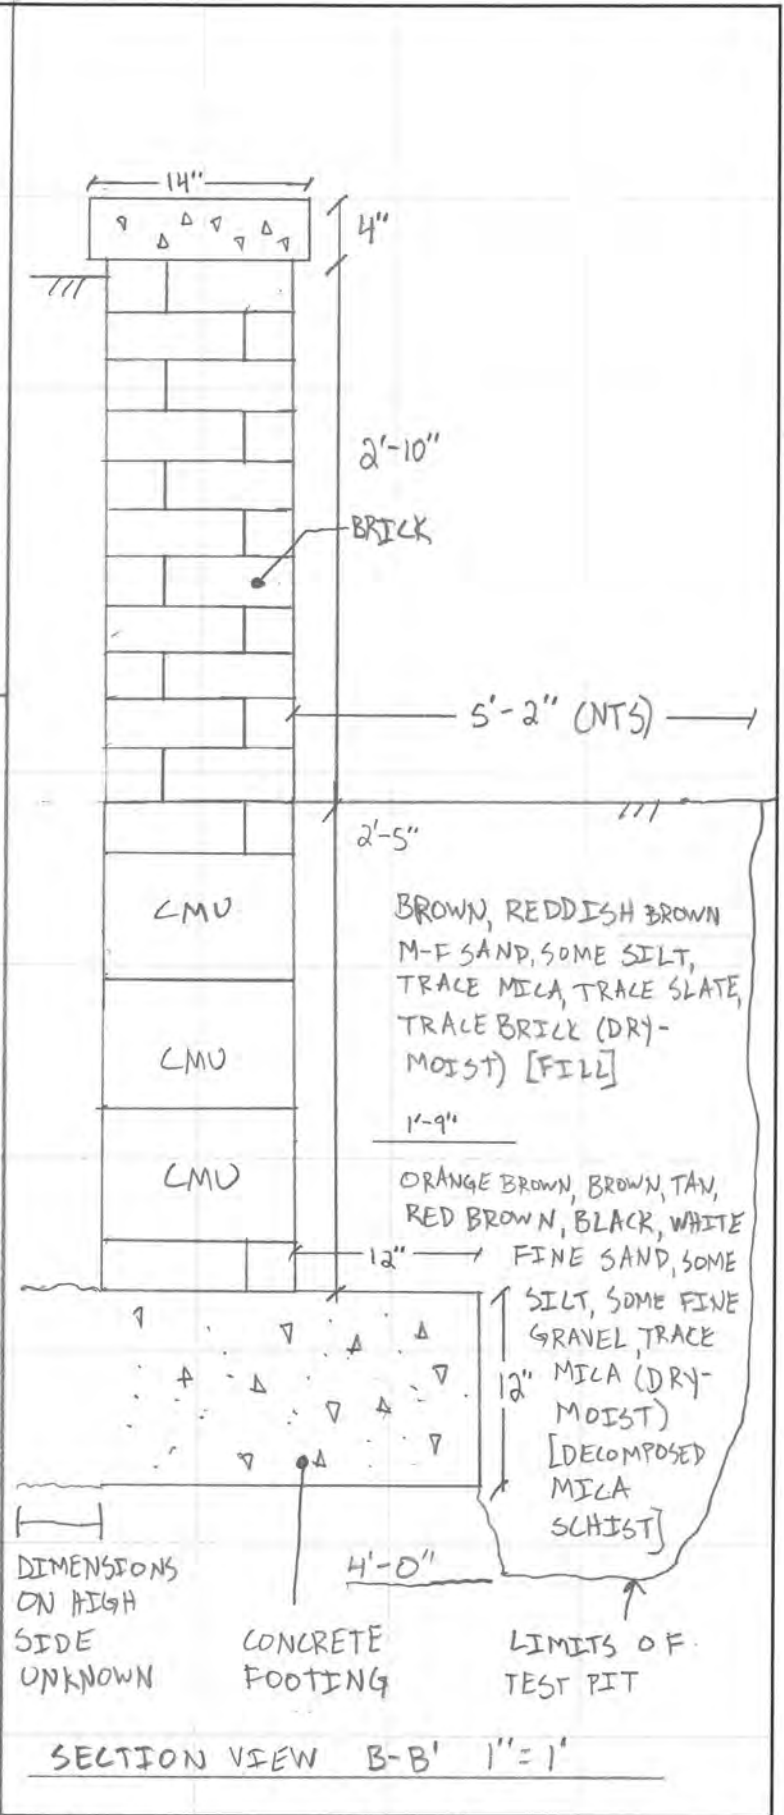
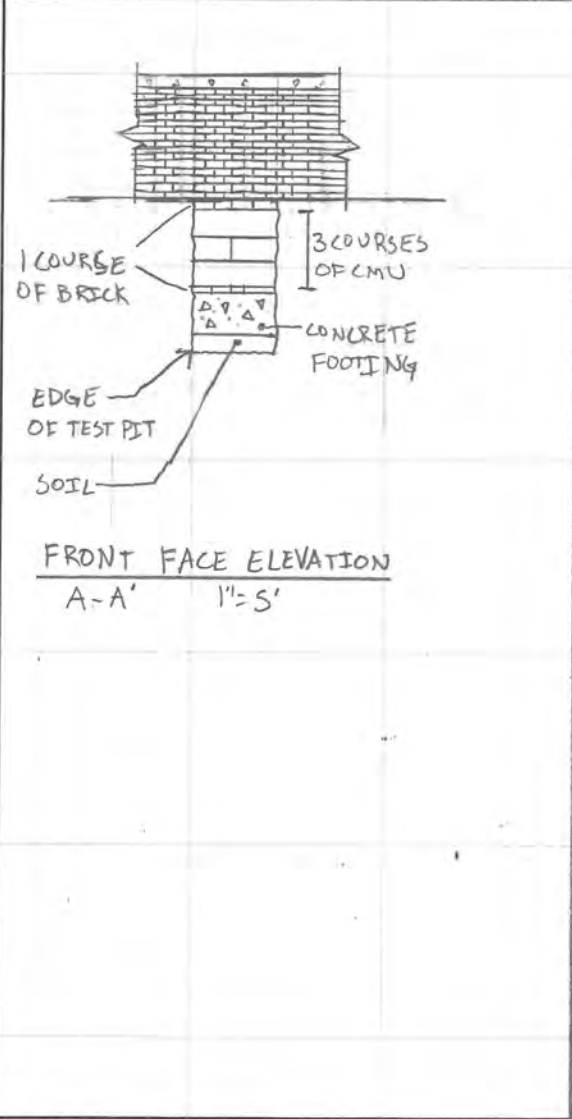
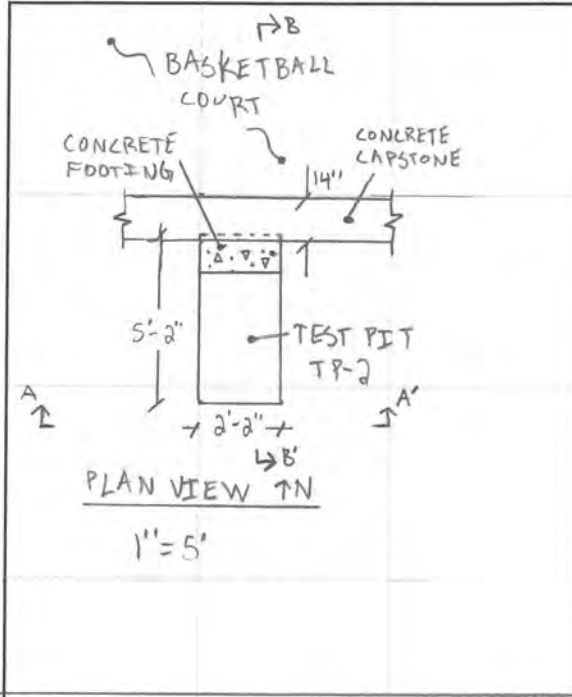
Miles Mack Playground	BY JP	DATE 9/26/19	PROJ. NO. 220104104
TP-2 foundation	CKD.	DATE	SHEET OF

The below-grade portion of the wall beneath the upper brick wall consisted of three courses of concrete masonry unit (CMU) blocks above a single course of brick. The wall was observed bearing on a 12-inch-thick concrete footing. The upper brick wall itself extended below ground surface by a single course of brick before transitioning to the CMU blocks. No structural connection between the lower CMU block wall and the upper brick wall could be discerned. Photographs 1 through 4 in Attachment B depict test pit TP-2.

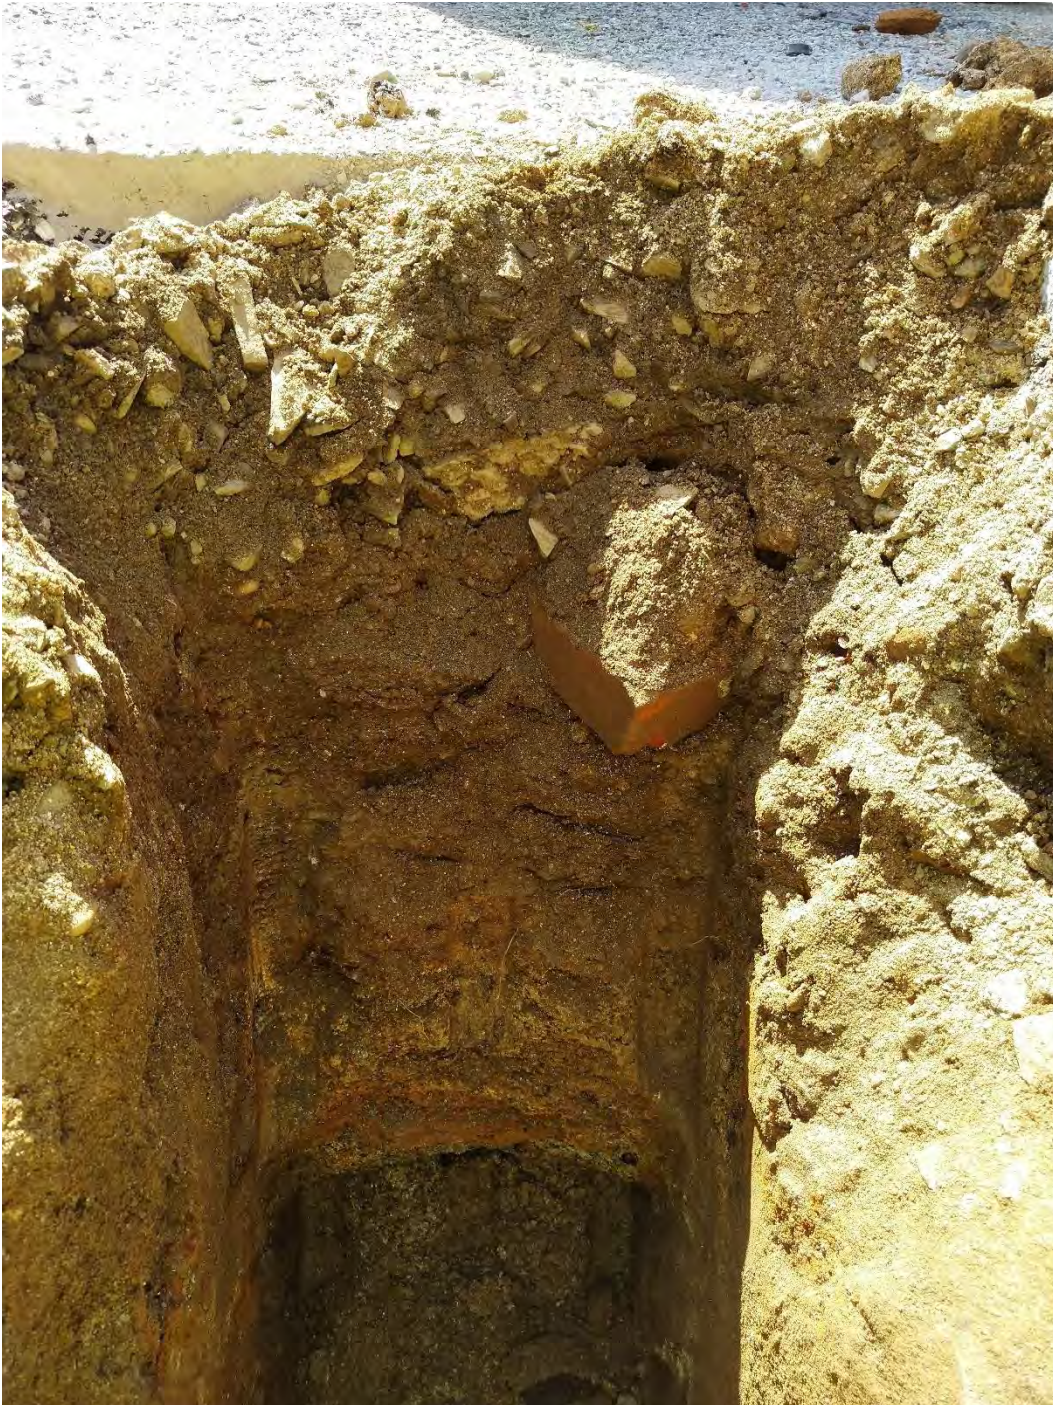
Photo 1: Side of excavation on low side of wall. Brick and fill visible in upper 21 inches.

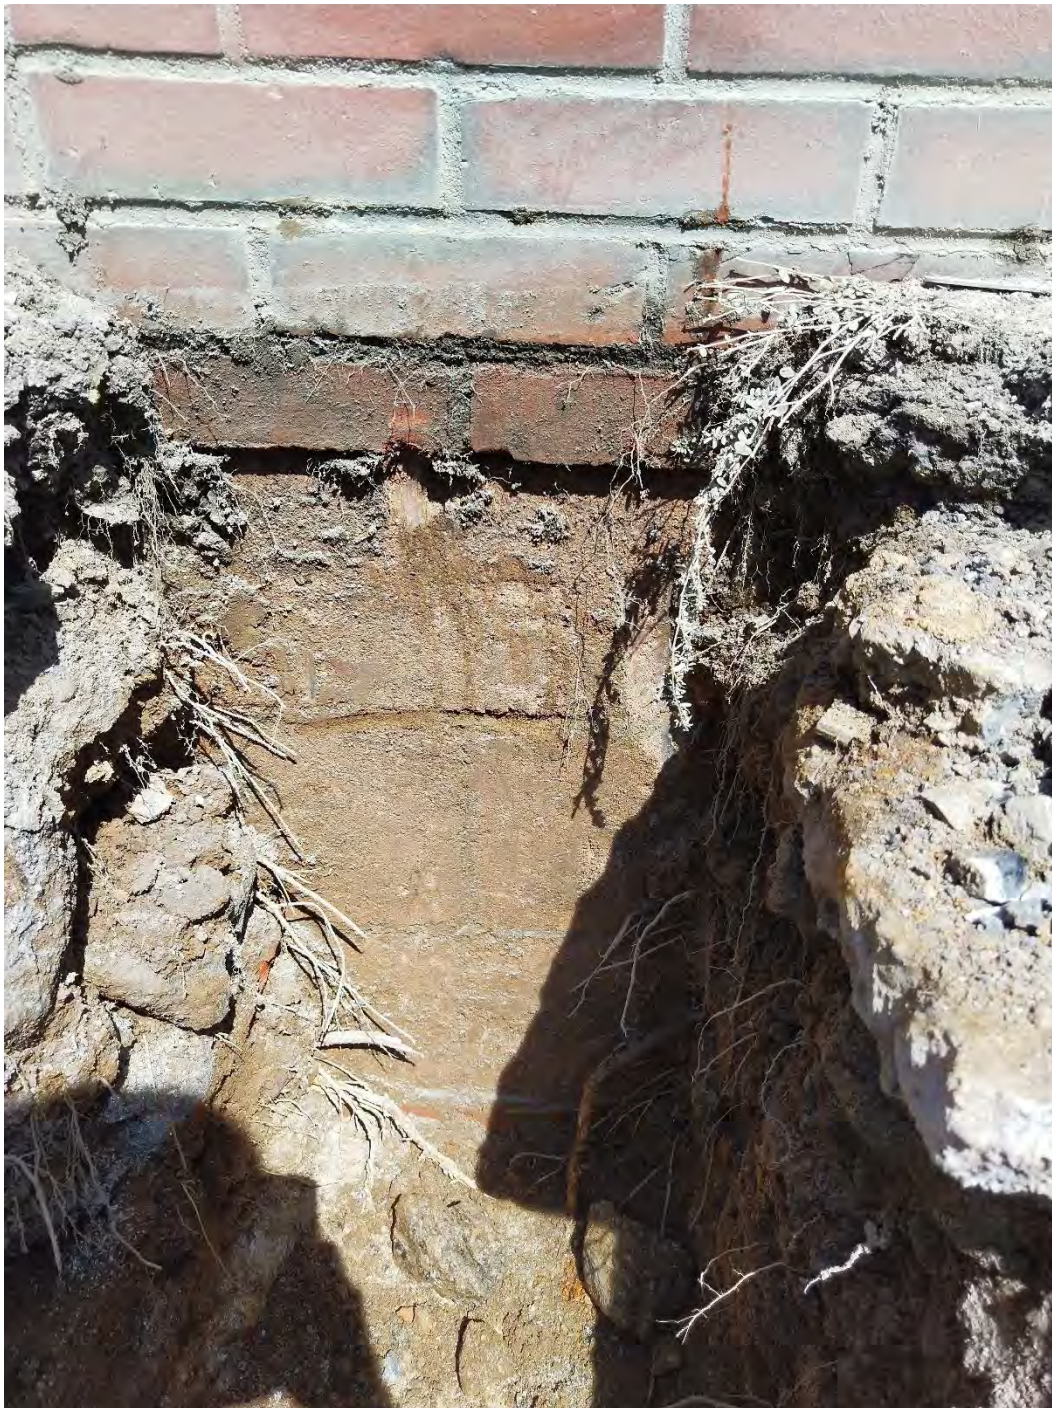
Photo 2: Three courses of CMU block below above-ground brick wall, on top of one course of brick, on top of concrete footing

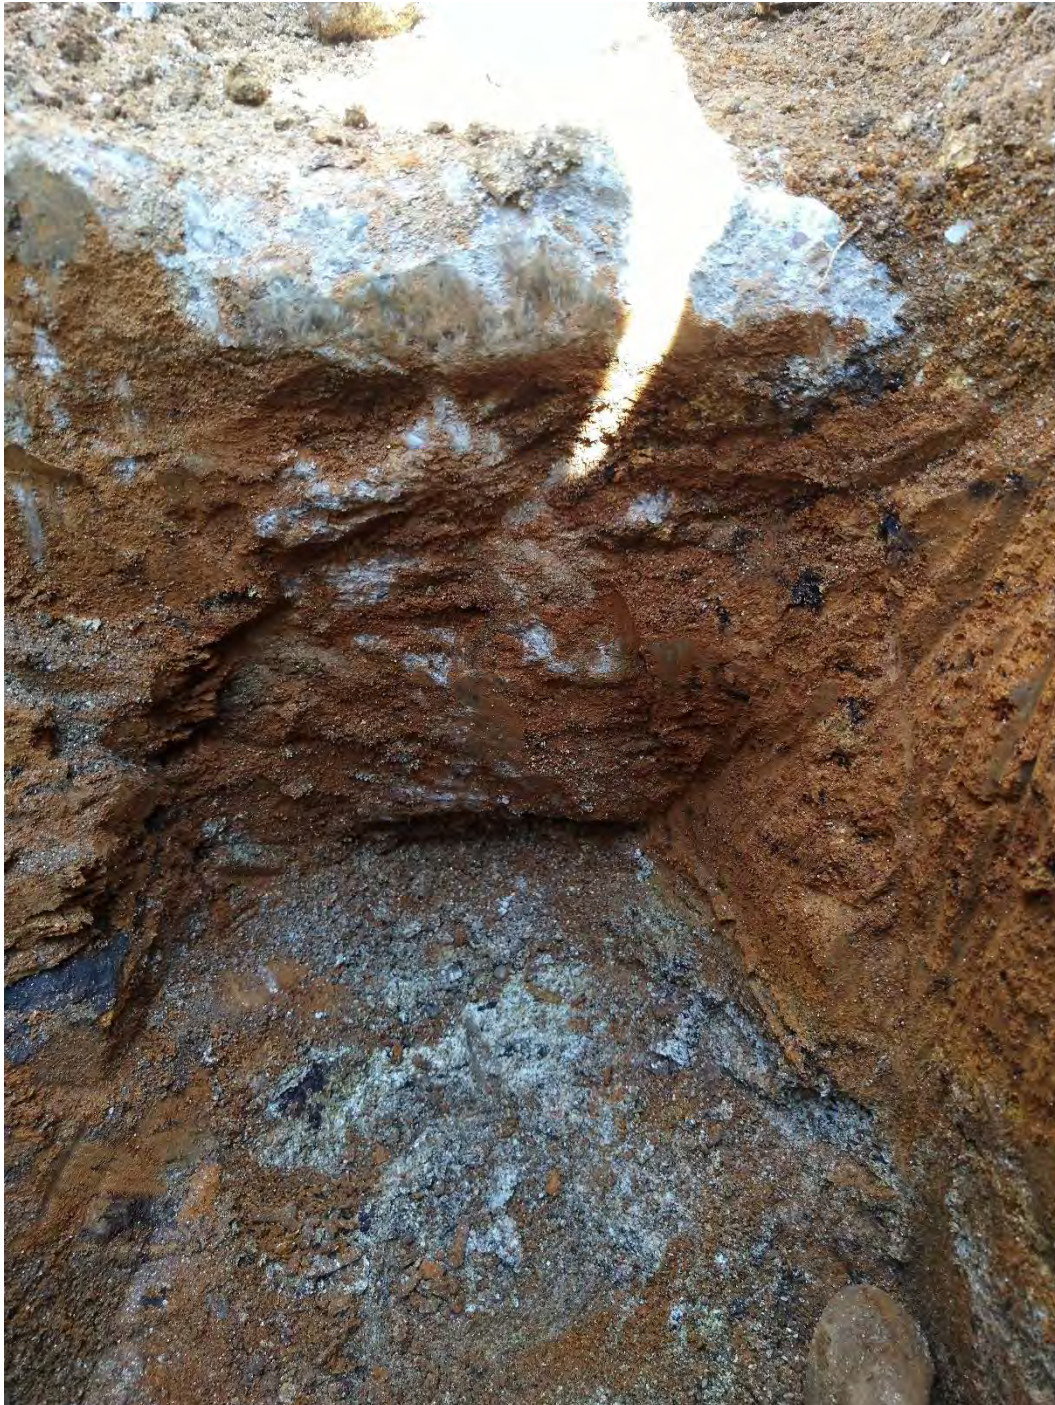
Photo 3: Concrete footing, 12 inches thick and 12 inches protrusion from face of block wall

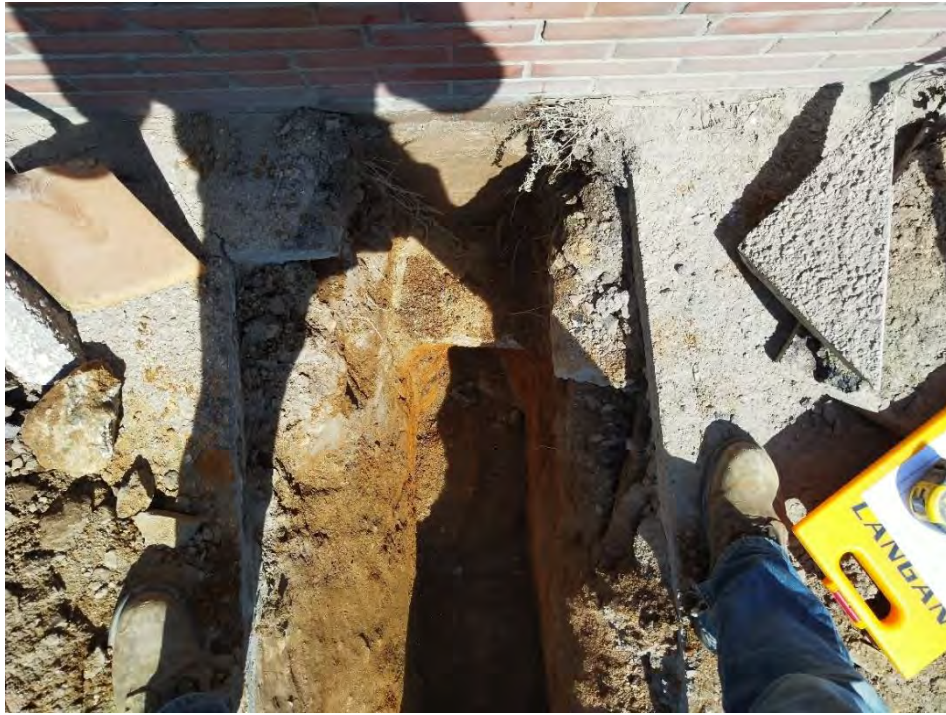
Test pit TP-2 was performed on the low side of the retaining wall at the point of the wall alignment where the most severe wall deflection was observed. The surface layer consisted of three inches of asphalt pavement and two inches of subbase stone. A layer of fill was encountered beneath the surficial layer extending to a depth of 1.75 feet and consisted of reddish brown medium to fine sand with varying amounts of silt, mica, slate, and brick. The fill was underlain by native decomposed mica schist rock consisting of brown, tan, orange-brown, reddish brown, black, and white fine sand with varying amounts of silt, gravel, and mica.

Photo 4: Top view of test pit on low side of wall

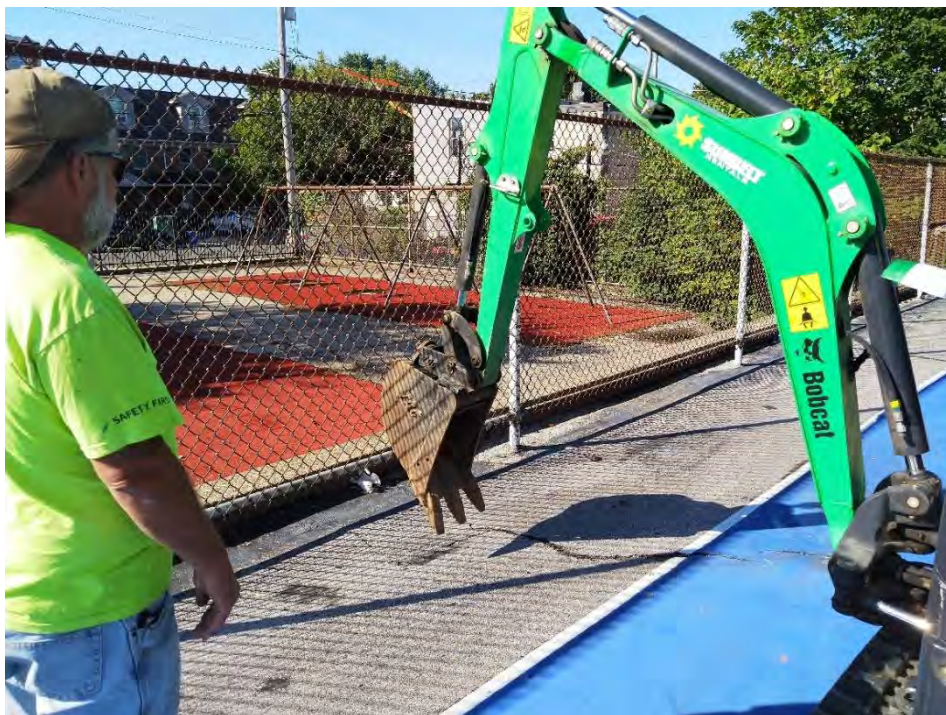
Test pit TP-1 was performed on the high side of the retaining wall near the eastern limit of observed wall deflection. The test pit was performed at the location of a large surface crack that is suspected to be the result of settlement. The test pit surface consisted of two inches of asphalt pavement and was immediately underlain by a concrete slab. The concrete slab could not be removed and the thickness of the slab could not be determined. Photographs 5 and 6 in Attachment B depict test pit TP-1.

Photo 5: First test pit on high side of wall intended to be excavated at crack in asphalt

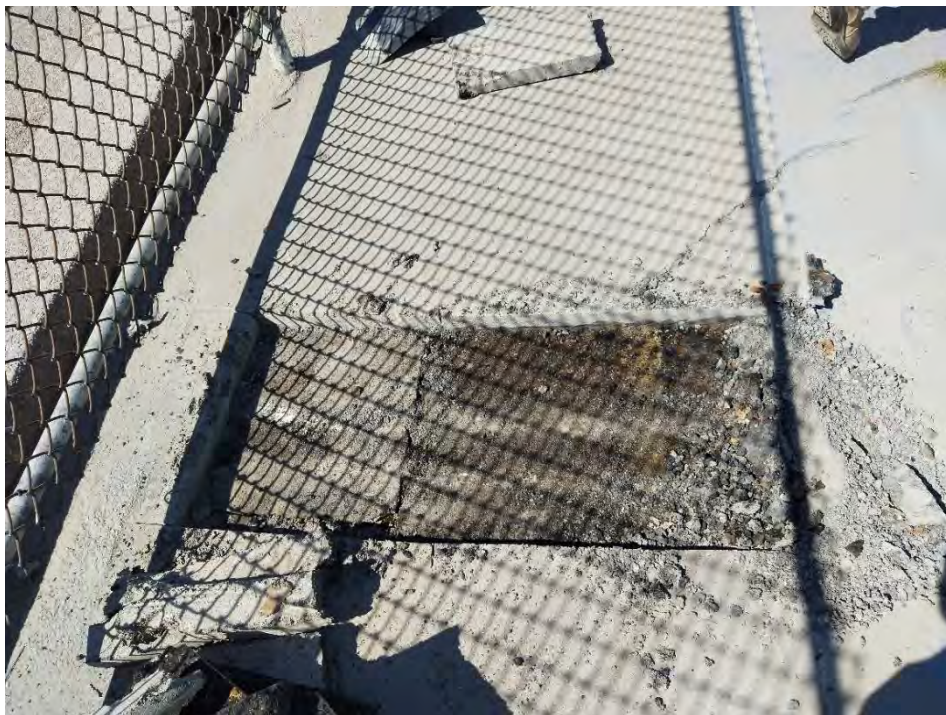
Photo 6: First test pit on high side of wall: 2 inches of asphalt underlain by concrete slab

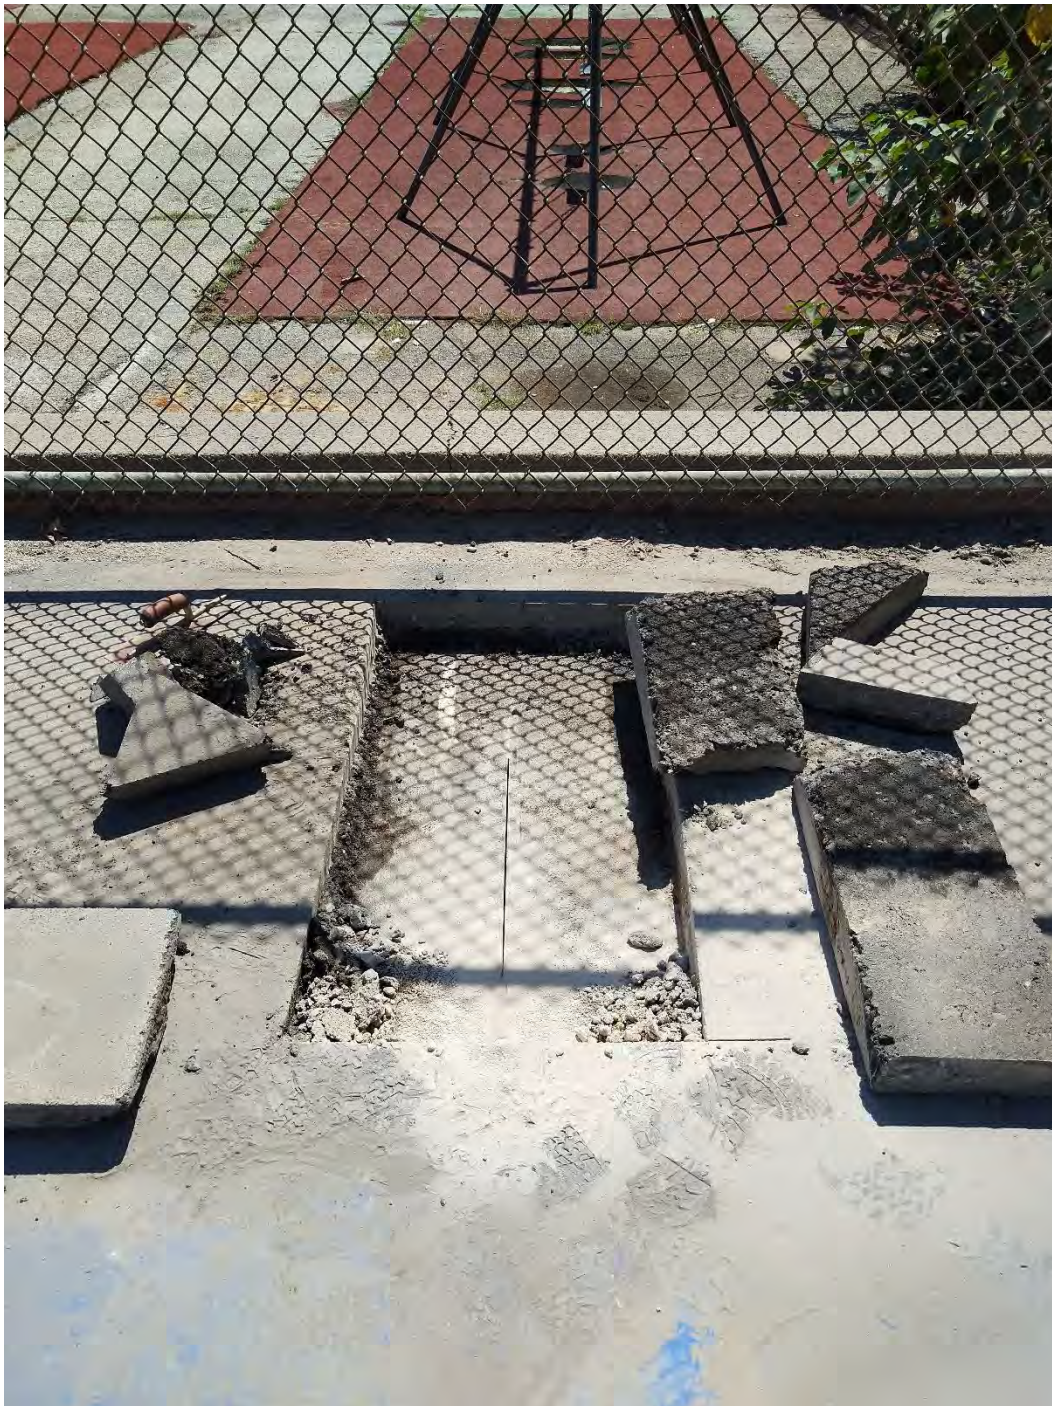
Test pit TP-3 was performed on the high side of the retaining wall on the west side of the wall alignment. The test pit was attempted at the location of a crack in the capstone on the wall. The test pit surface consisted of four inches of asphalt pavement and was immediately underlain by a concrete slab. The excavation contractor attempted to cut through the concrete slab with a demolition saw and discovered the concrete slab was at least 4.5 inches thick (full depth of the blade). The concrete slab could not be removed and the thickness of the slab could not be determined. Photograph 7 in Attachment B depicts test pit TP-3.

Photo 7: Second test pit on high side of wall: 4 inches of asphalt underlain by a concrete slab. Sawcut concrete slab, thickness unknown (at least 4 inches depth of cut)

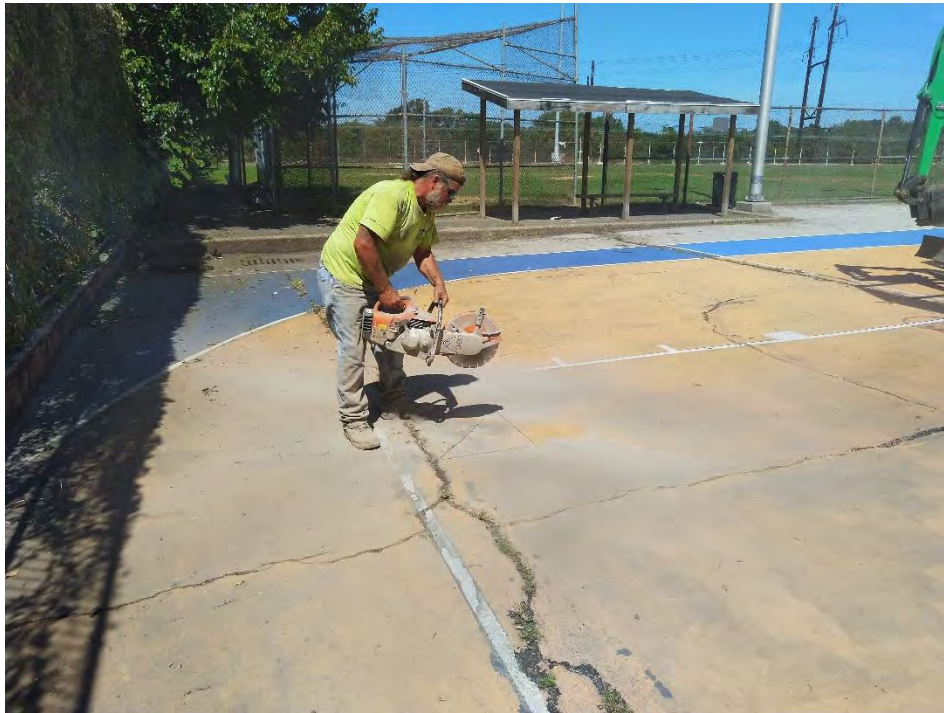
Test pit TP-4 was performed in near the center of the westernmost basketball court at the location of a large north-to-south crack in the pavement. The test pit surface consisted of three inches of asphalt pavement and was immediately underlain by a concrete slab. The excavation contractor attempted to cut through the concrete slab with a demolition saw and discovered the concrete slab was at least 4.5 inches thick (full depth of the blade). The concrete slab could not be removed and the thickness of the slab could not be determined. A thin flexible membrane was encountered between the asphalt and the concrete slab on the western portion of the test pit, beneath the alignment of the large north-to-south crack. Photographs 8 and 9 in Attachment B depict test pit TP-4.

Photo 8: Third test pit on high side of wall

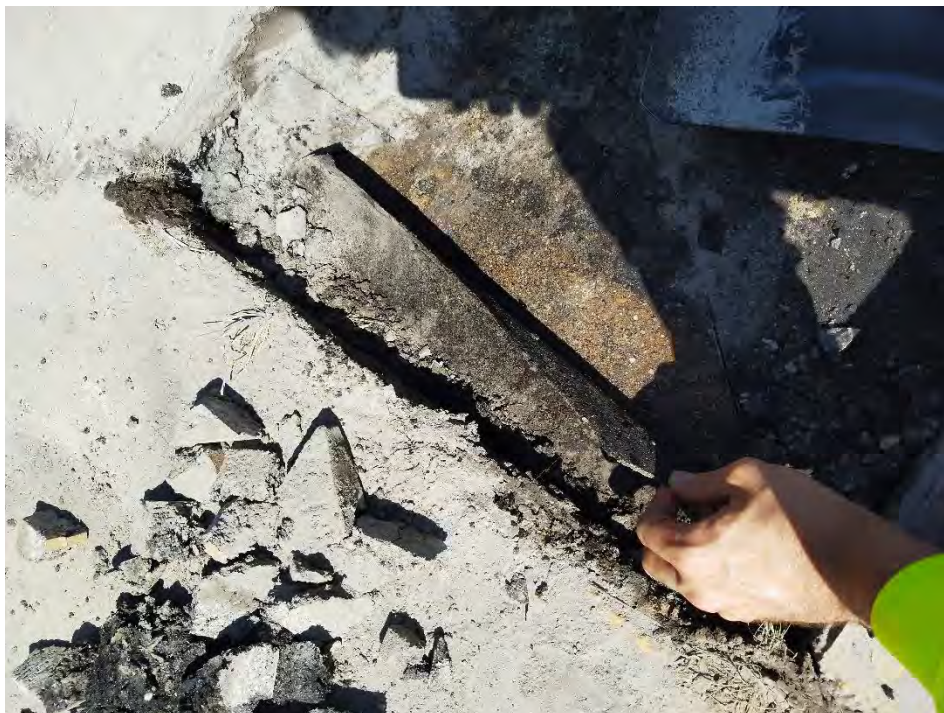
Photo 9: Rubber membrane sandwiched between asphalt (3 inches) and concrete, possible patch over preexisting crack in concrete (suspected location below crack shown in asphalt in previous photo)

We believe that repairing the damaged and cracked asphalt of the basketball courts at the back side of the wall is prudent to reduce the water infiltration in the backfill materials thereby also reducing the possibility of excess hydrostatic pressure against the backside of the wall. We recommend the use of a geosynthetic paving fabric such as Mirafi MPG100 glass filament reinforced paving composite for this purpose. This product is intended to be used as reinforcement of asphalt, repairing longitudinal cracks, and full-width repair of asphalt surfaces.
