Additional Probing and Wading Inspection Adjacent to Reviewing Stands – January 16, 2020

Reviewing Stands Along the Schuylkill River Philadelphia, PA

**RE: Additional probing and wading inspection adjacent to reviewing stands –
Renovation of the East Schuylkill River Wall at Reviewing Stands, Philadelphia, PA**

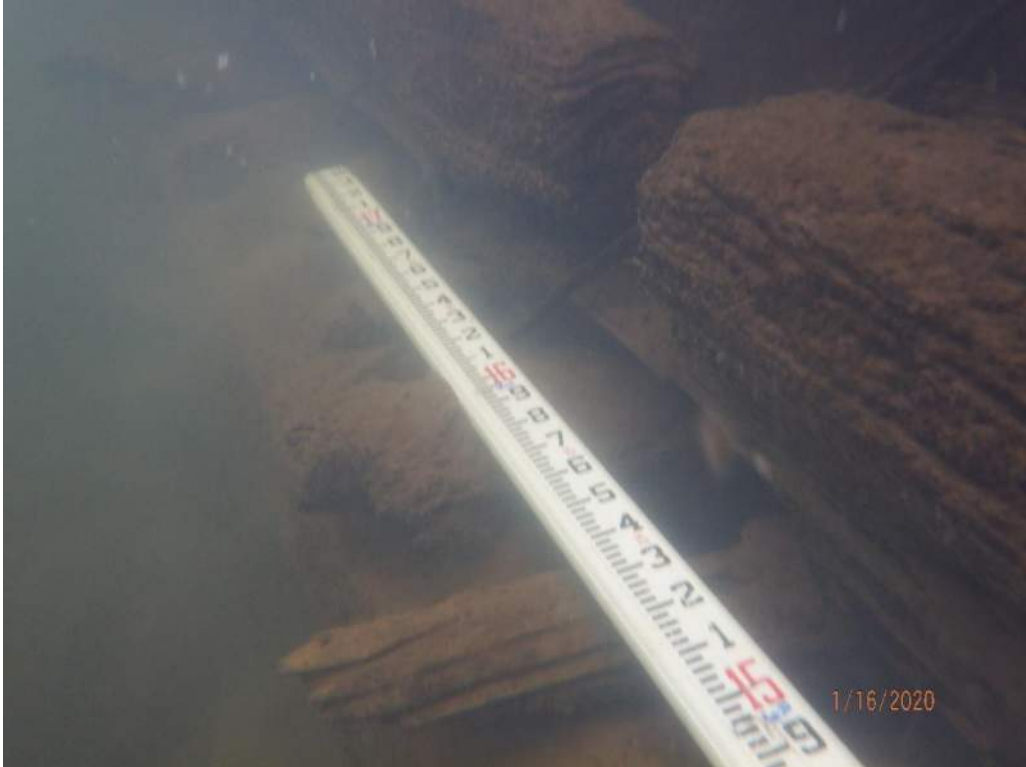
Photo 3: Typical view of the timber cribbing under the seawall.

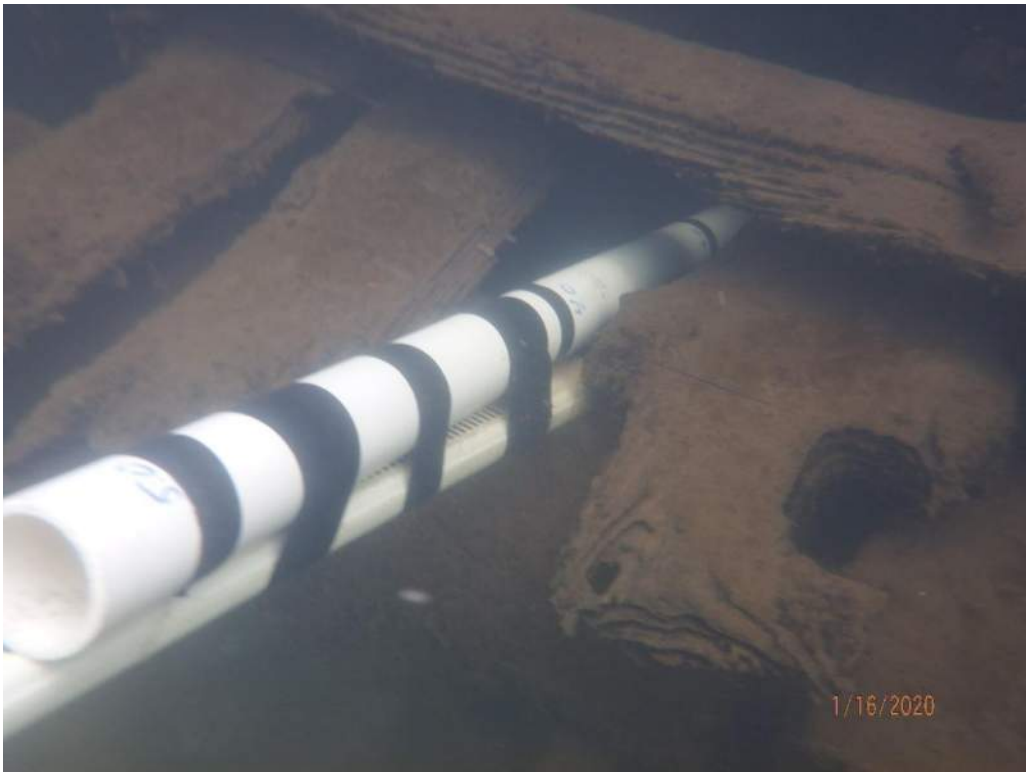
The inspection found that the previously noted areas of undermining have relatively stayed the same. There are locations that the undermining has reduced since the previous inspection. In the July 19, 2018 Inspection the undermining at Stations 0+75 to 1+75, 2+25 and 2+25 was called out up to 8-feet deep. At the time of our inspection our max undermining depth in these areas was 5-feet deep. Stations 10+50 to 12+00 had undermining noted in the July 19, 2018 probing inspection. At the time of our inspection no undermining was detected at these locations. During our inspection undermining was noted at Stations 15+00 to 15+50 and 16+00 where previously no undermining was noted. It should be noted that undermining depths/penetrations could be larger than what was recorded as the water depth in most locations were too deep for the inspector to go under the cribbing and probe horizontally under the seawall. The inspector had to probe at an angle between the timber cribbing to obtain the undermining depths/penetrations. *For additional details see attached Undermining Table in Appendix B.*

The channel along the seawall is comprised of rock and gravel at areas of no undermining. At locations of undermining the channel is mostly soft silty sand with probe rod penetrations up to 1.5-feet deep. There are isolated locations of riprap along the wall.

Photo 4: Area of undermining (Station 8+75 Shown)

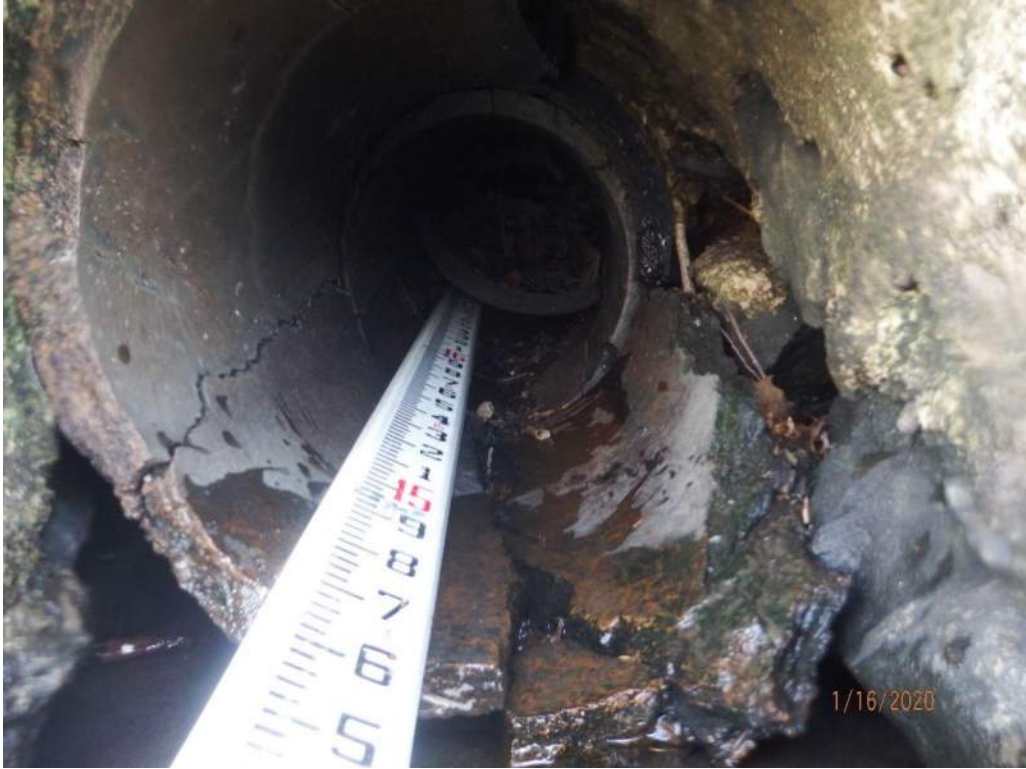
The seawall has weep holes (Approximately 10-inch diameter) periodically throughout. Weep holes were found at the following Stations: 0+48, 1+92, 3+80, 4+70, 7+15, 7+37, 9+37, 10+30, 12+10, 12+30, 15+55 and 15+75. The weep holes at Stations 0+48, 1+92, 9+37 and 10+30 are collapsed and clogged. The weep holes at Stations 7+37 and 15+55 have misaligned sections.

Photo 5: Collapsed weep hole at Sta. 0+48.

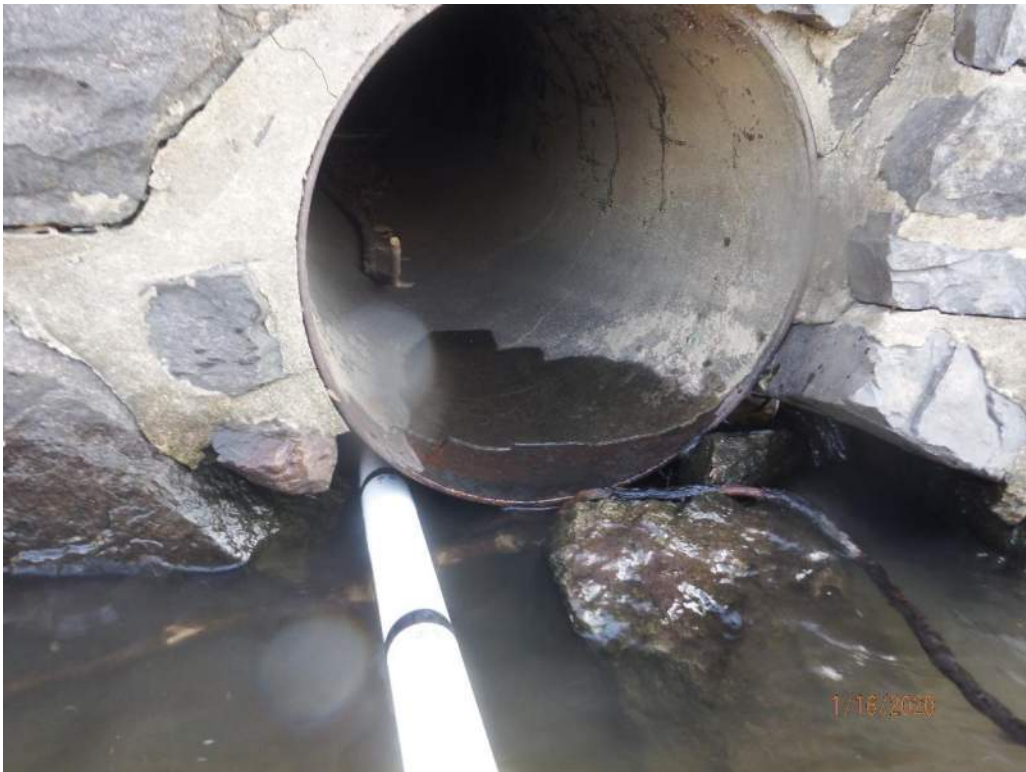
There are 18-inch diameter outlet pipes at Stations -5+80 and 3+51. The outlet pipe at Station -5+80 exhibits a 2.1-foot void under the pipe and at Station 3+51 the seawall exhibits a 1-foot void under the pipe.

Photo 6: 2.1-foot void under outlet pipe at Station -5+80

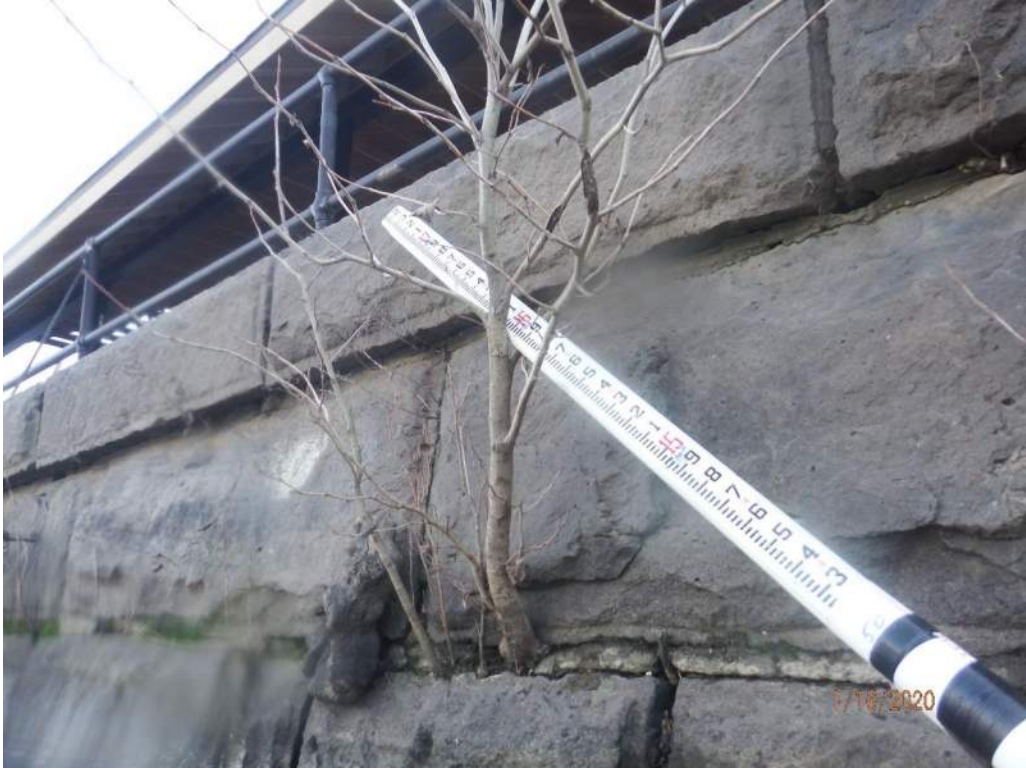
The seawall typically exhibits random small (less than 3-inch diameter) trees/vegetation growing out of it. A majority has been cut, but the roots still remain. The row of stones at the waterline typically exhibits 30% missing mortar.

Photo 7: Typical vegetation growing in seawall.

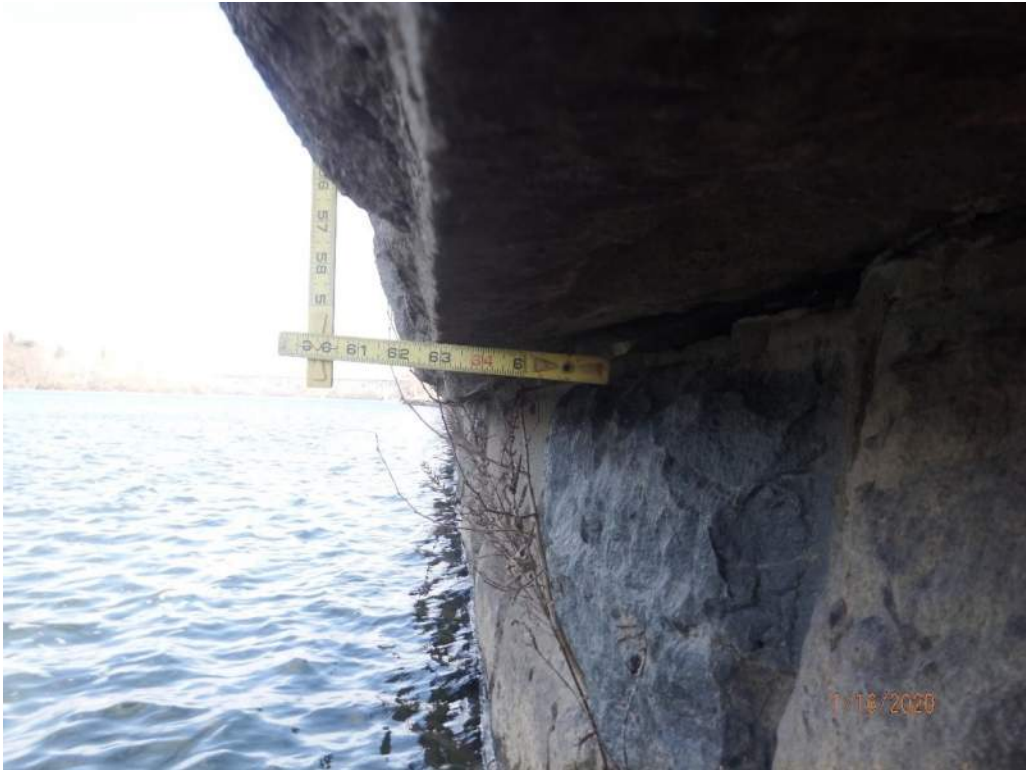
The top row of stones are overhanging from Stations 9+25 to 12+75 and have settled from Stations 9+25 to 10+75. The maximum overhang of the top row of stones is up to 1-foot. The maximum settlement at the time of inspection was 9.4 degrees from the horizontal, with the stones leaning towards the river. At Stations 11+25 to 11+40 timber shims have been installed between the first and second course of stone from the top.

Photo 8: Top row of stones overhanging. (Station 9+50 Shown)

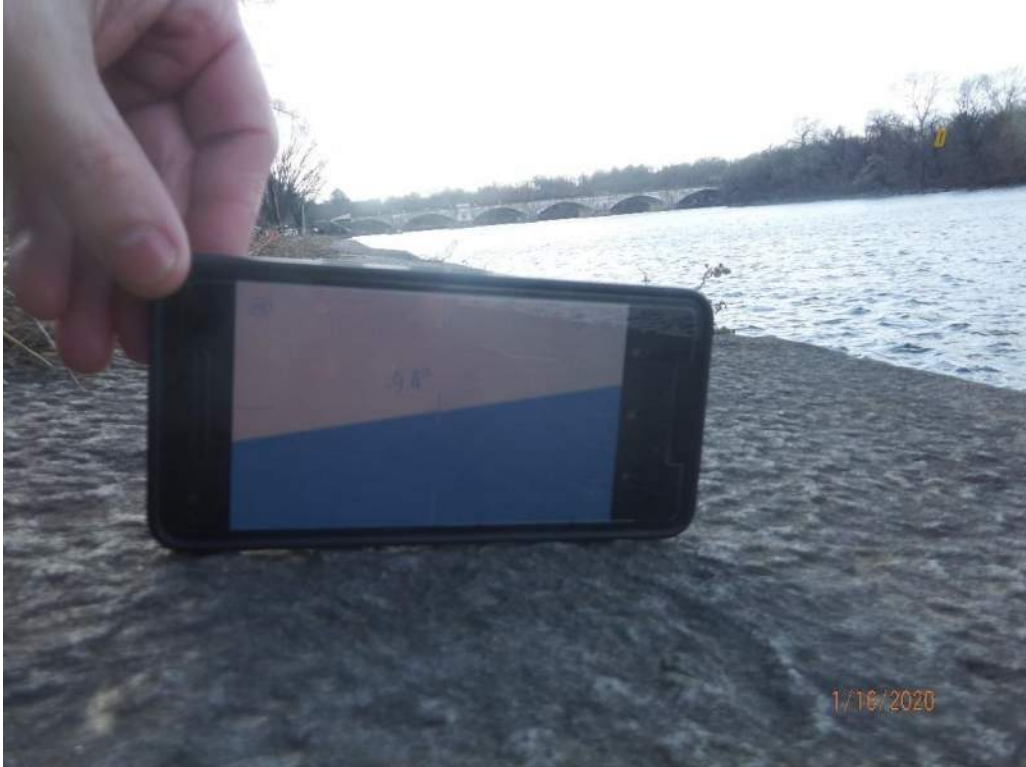
Photo 9: Top row of blocks settled up to 9.4 degrees towards the river

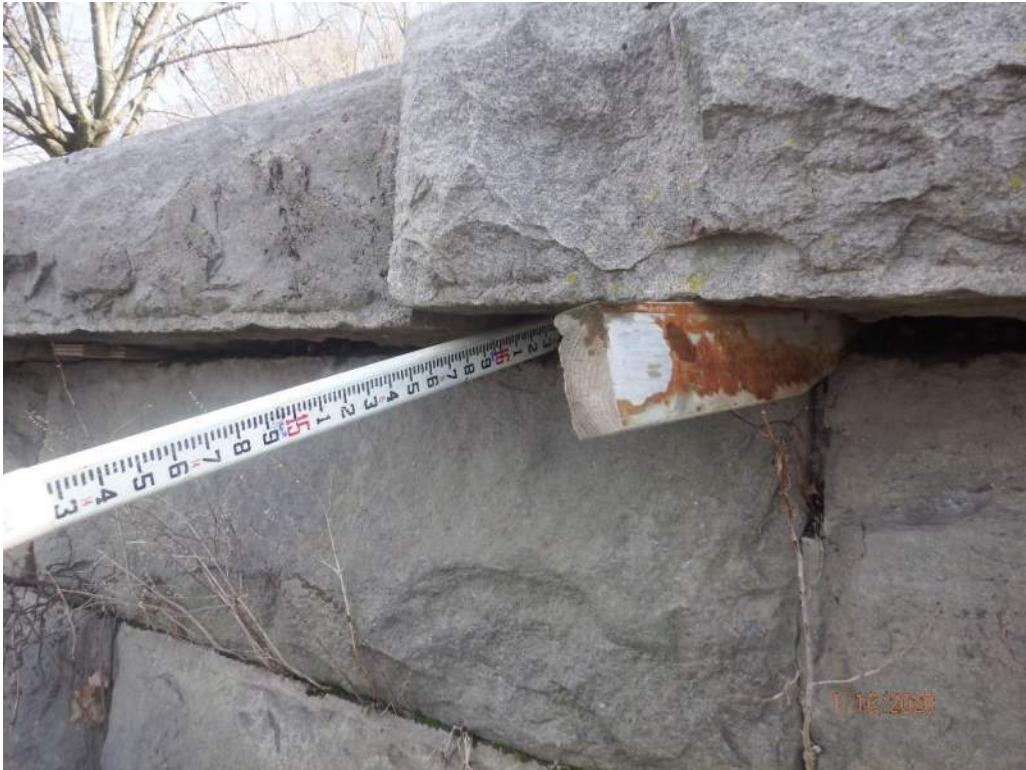
Photo 10: Timber shim installed between first and second course of stone

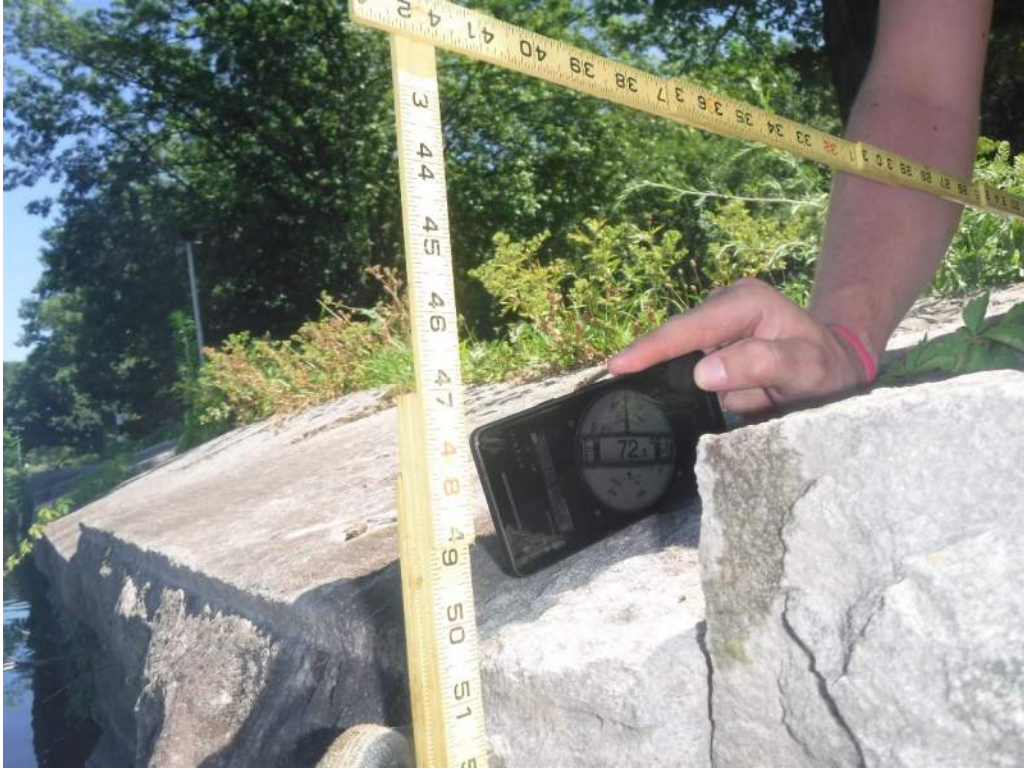
Photo 3: Rotation of top row of stone at Sta. 10+50.

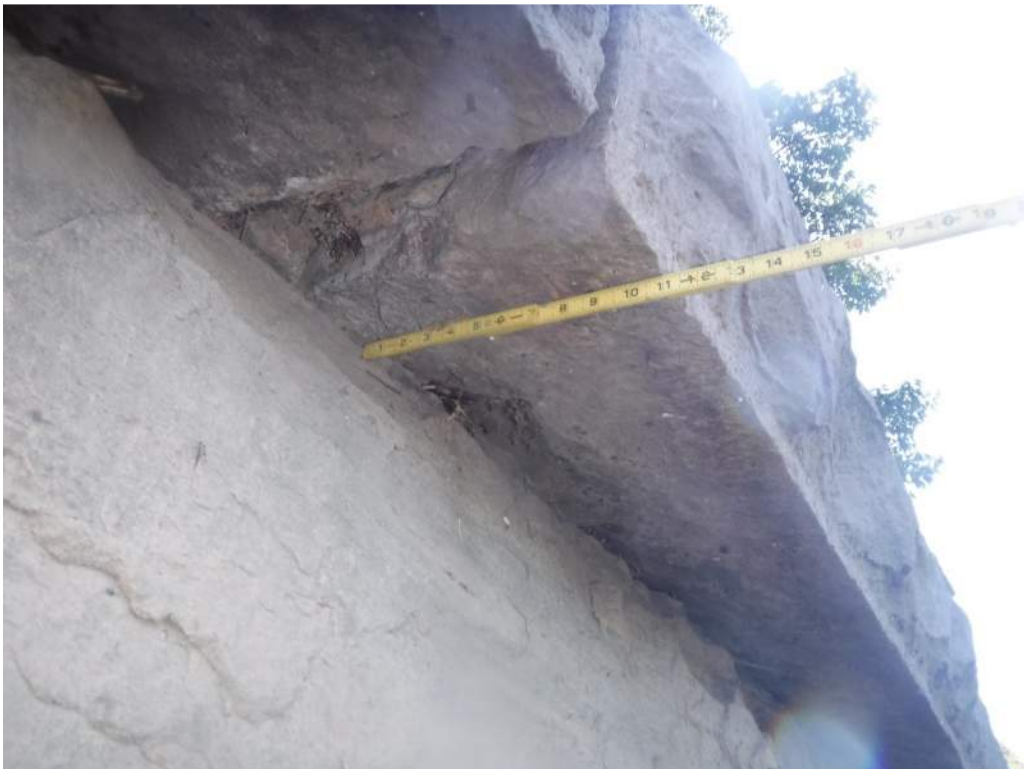
Photo 4: Overhang of top row of stone at Sta. 11+00.

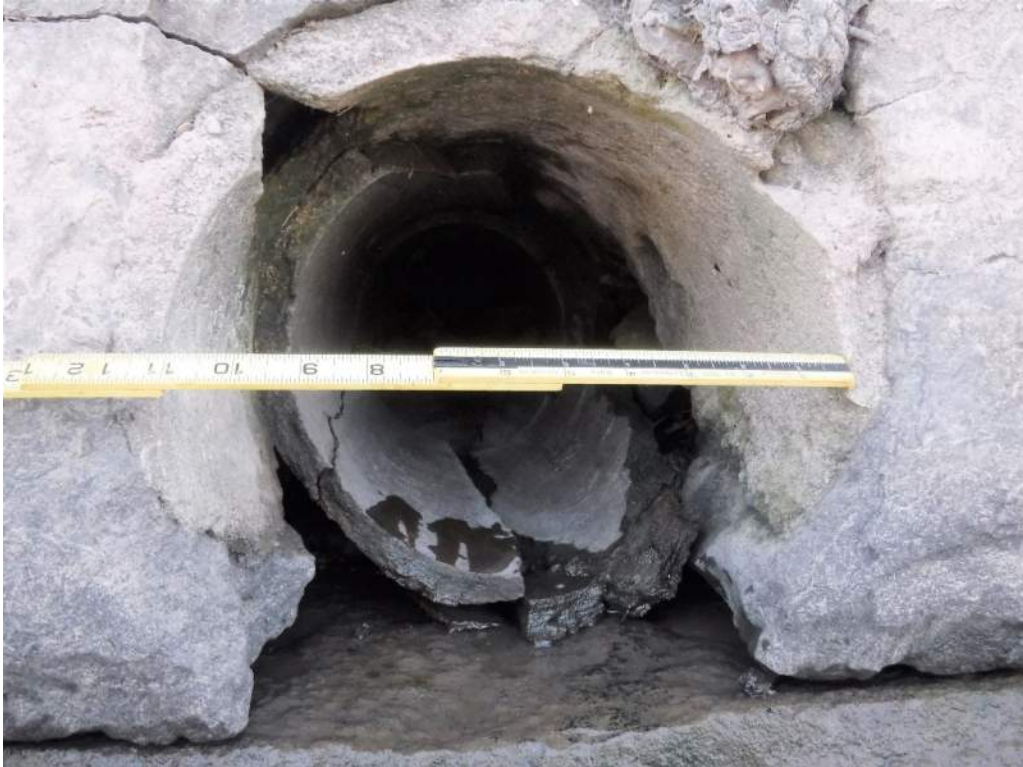
Photo 5: Collapsed outlet pipe at Sta. 0+60.

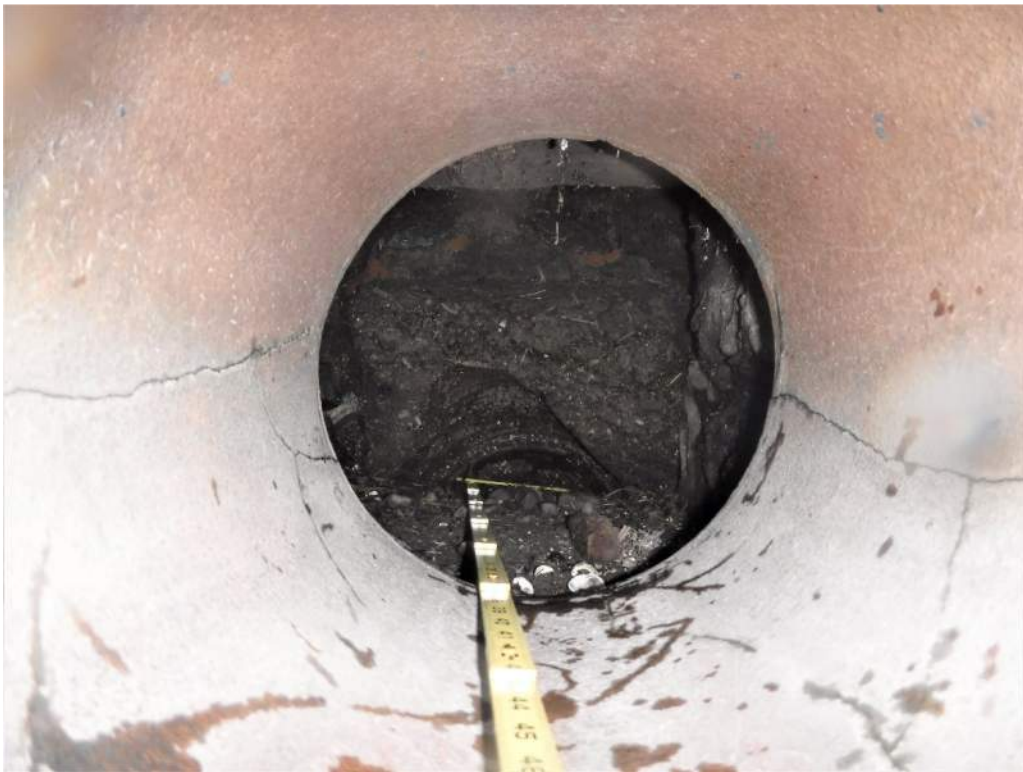
Photo 6: Collapsed and clogged outlet pipe at Sta. 11+10.
