STEPHEN
McLAUGHLIN
ROOFING
CONSULTANT

Reference: City of Philadelphia Project # 20-16-4919-99, Additional Services, Infrared Roof Survey at Simons Recreation Center, 7200 Woolston Avenue, Philadelphia, PA 19138

ROOF INFRA RED SURVEY

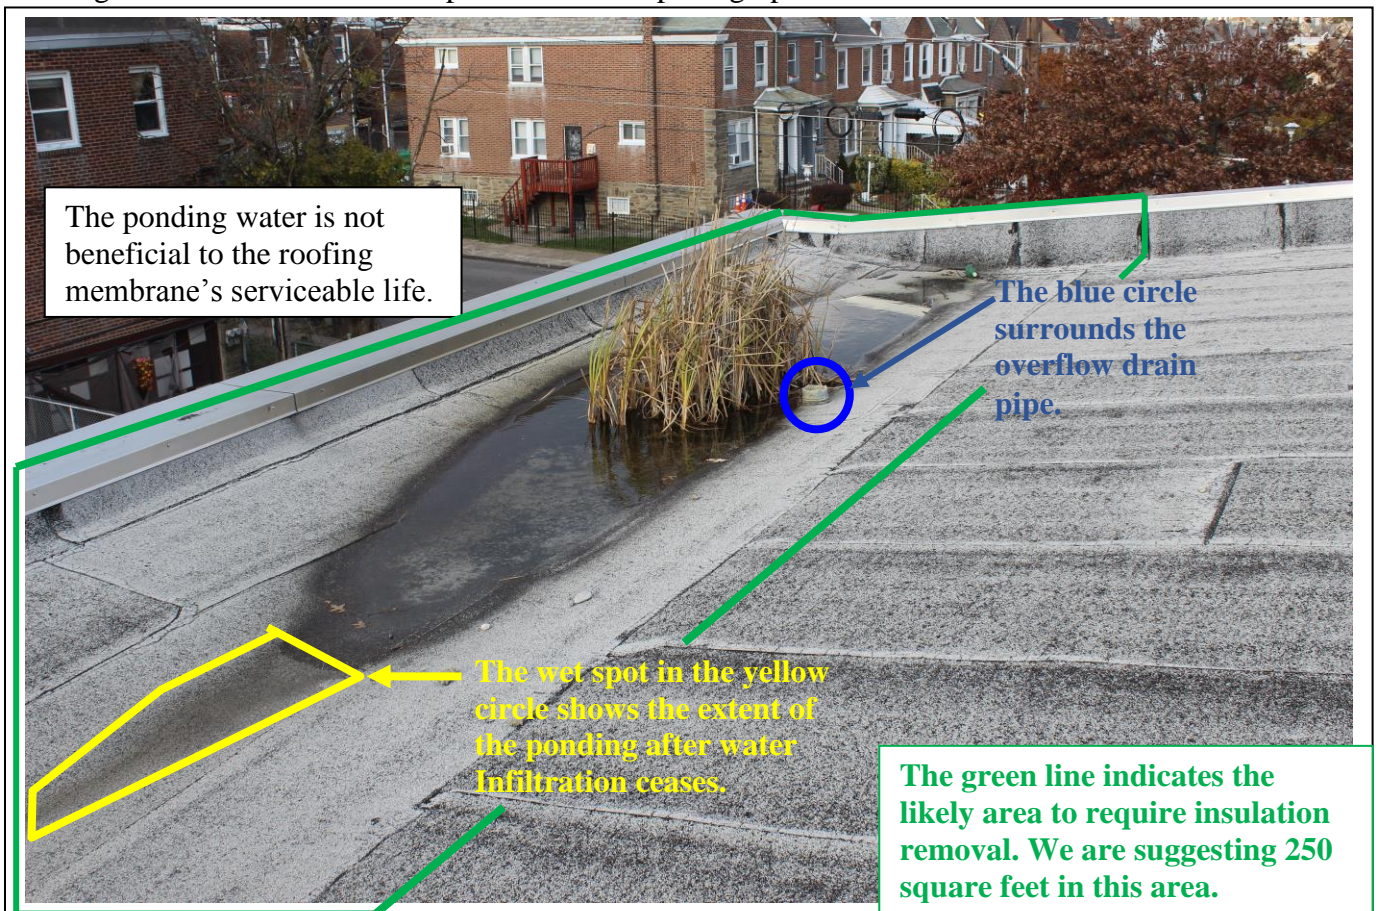
It should be noted that two of the 3 Gymnasium roofs are not accessible to the Recreation center staff or City employees without a minimum of a 28 foot ladder. There is no interior access to these roof areas to clean the drain strainers. The clogged drain and active water infiltration are a result of the inability of personnel to clean the roof drains bi-annually. We recommend that a roof access ladder and scuttle be provided to alleviate this condition. This will be included in the roof replacement project proposal form as an ADD Alternate bid.

We observed the interior conditions during previous site visits. We identified areas of roof deck in the Gymnasium that appear to have peeling paint. The north corner of this gym has been experiencing active water infiltration for years. The gym leak area identified is in the northernmost valley area of the roof. This area is experiencing severe ponding and vegetative growth. The roof drain has become completely clogged with organic debris. This area is represented in the photograph below.

Ponding and vegetative growth at roof drain on Roof Area “B”

There is an infra-red image sheet and a roof plan showing the anomalies attached. Included on the roof plan is the approximate location of the control joints and roof anomalies identified during the IR survey. Also identified are two roof drains that are clogged. The roof drains on the Gymnasium roof are not accessible by City personnel without 2 ladders. This always represents a safety concern. We recommend that a wall mounted, caged ladder and platform combination along with a ships ladder and roof scuttle should be included in this project to allow safe access to clean drain strainers and avoid future drain blockage. Regular biannual drain cleaning should be performed on all City roofs that are safe to access.

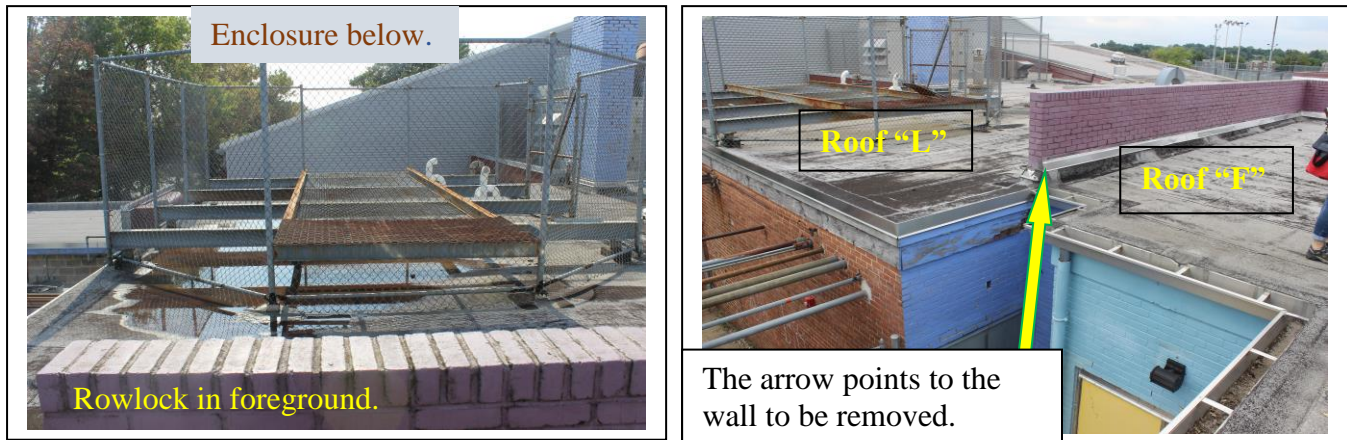
The parapet wall between roof area “F” & “L” was formally an exterior wall. A building addition added a roof to the exterior wall. The existing wall has a rowlock capping. On close observation, the mortar is deteriorated. The wall is now a common parapet wall. It is obsolete and in need of repair. Wood blocking and a metal coping system would be required, after completion of masonry repair work.

The cost of cutting reglets and patch pointing would offset the cost to remove the wall to a point 12 inches above the finished roof surface. We recommend the removal of this wall to 12” above the finished roof surface.

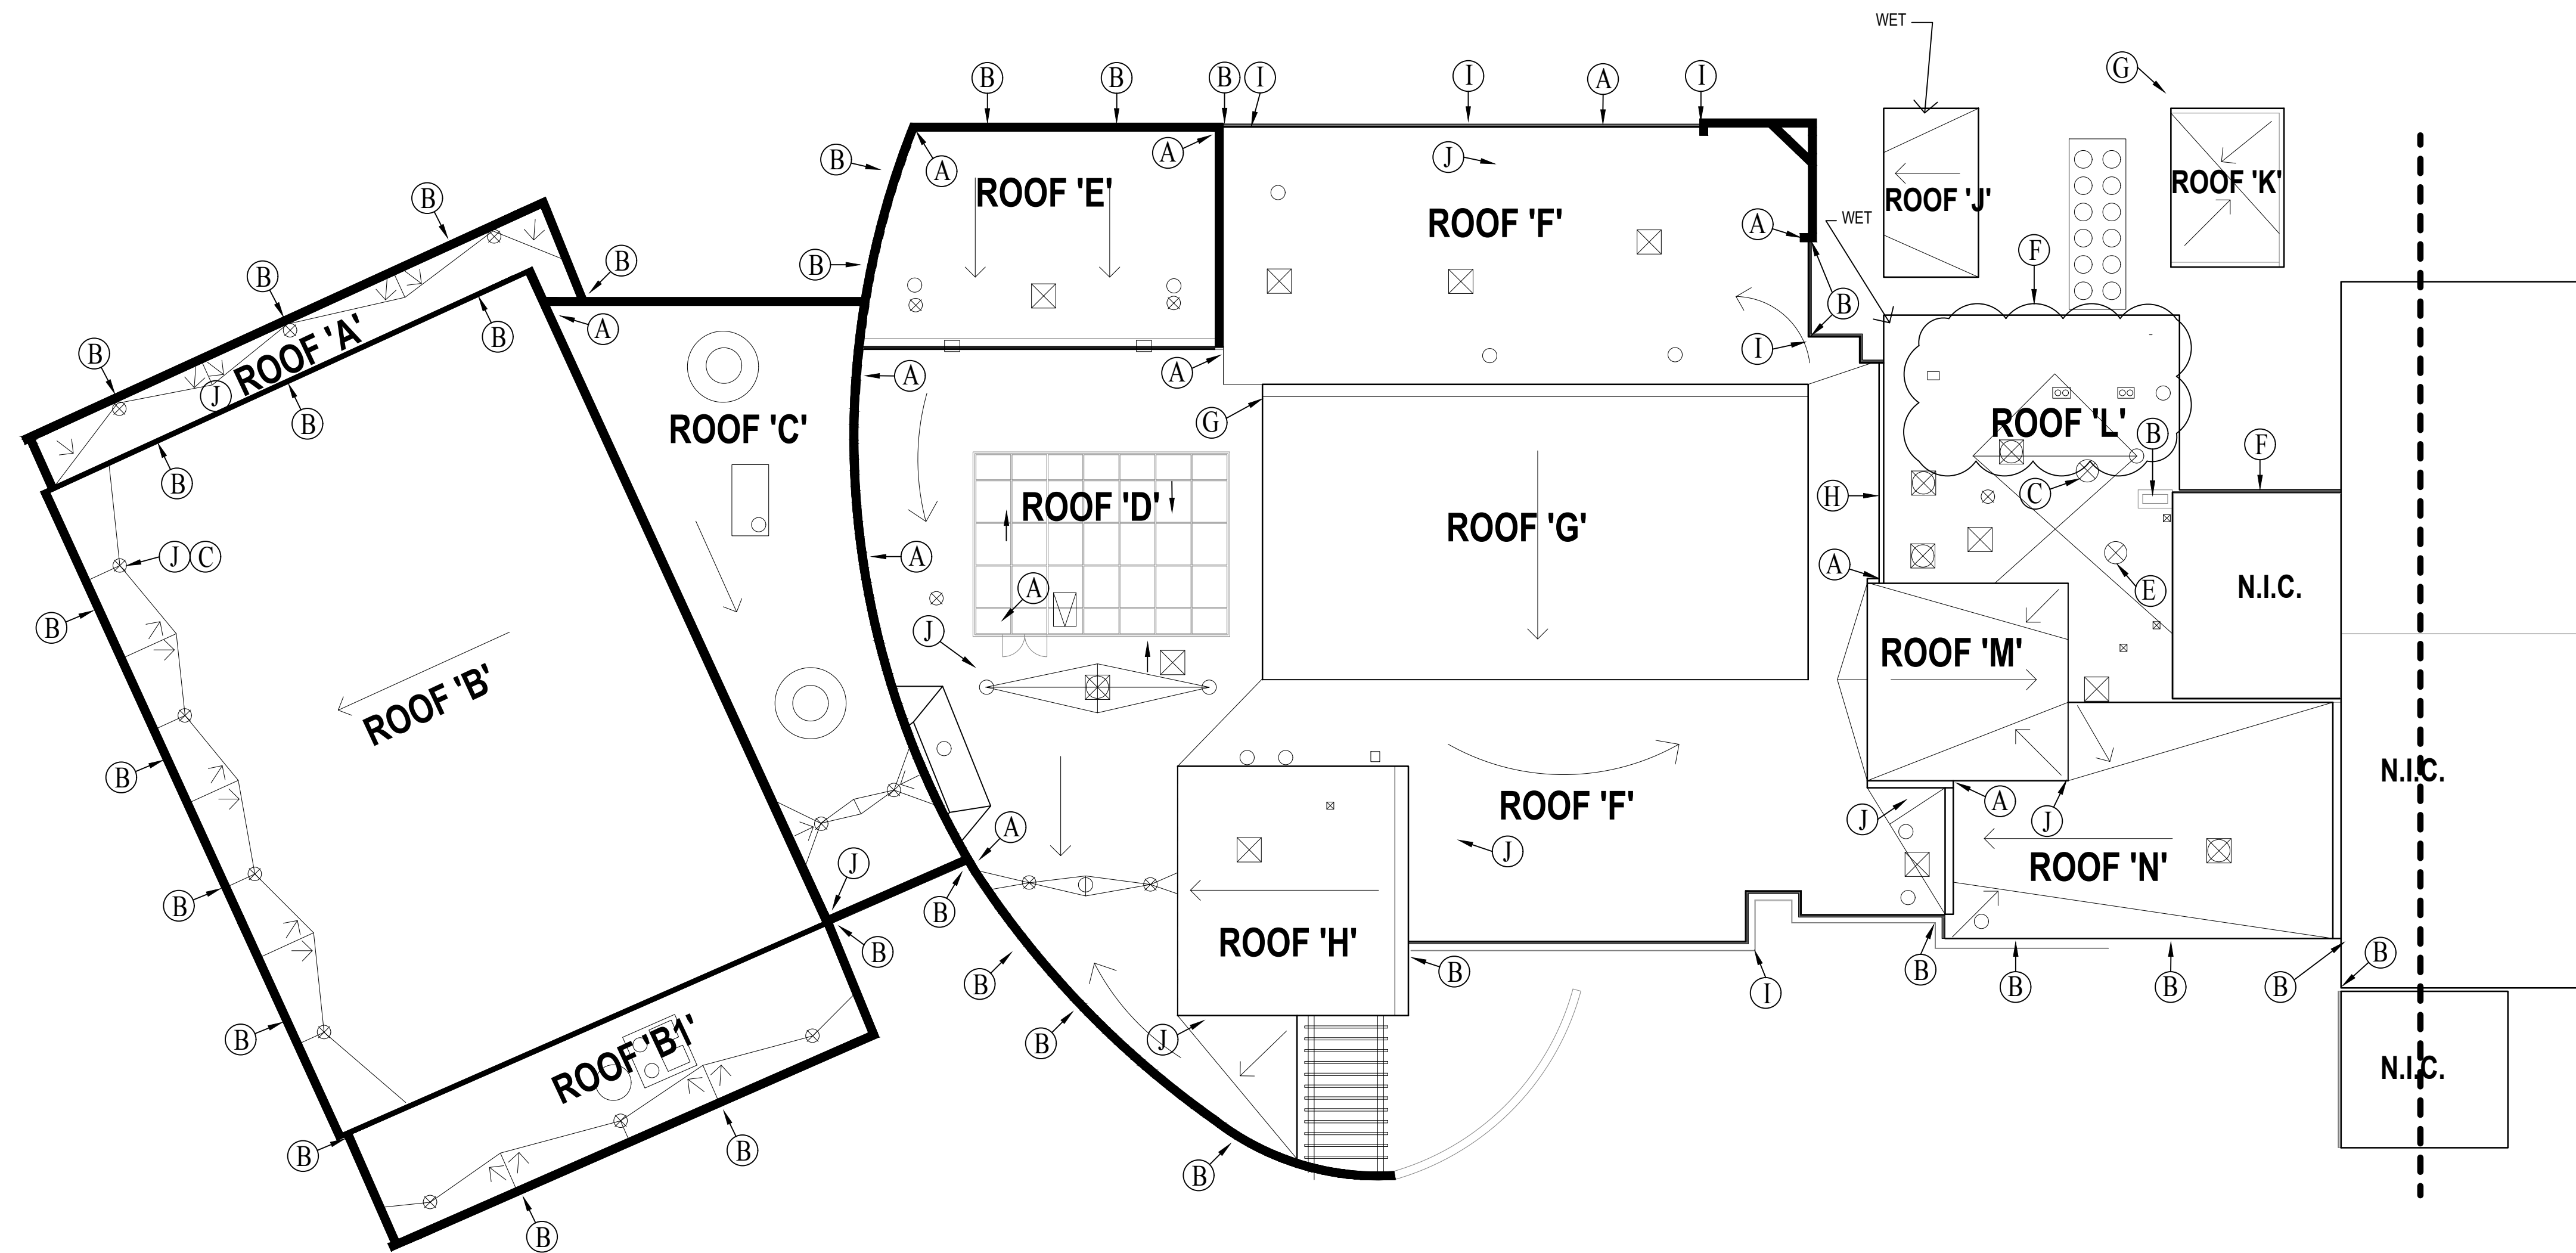
1 INFRA-RED SURVEY ROOF PLAN - GYM & CLASSROOMS
A1.60 1/16" = 1'-0"

Our survey findings indicate that the greater percentage of roof areas other than "J" & "L" are mostly free of moisture. Only roof areas "J" and "L" are saturated. It is accepted to assume that anything more than 25% of a roof being wet becomes too costly to specify removal and replacement of the wet areas only. This roof has less than 1% of its areas show to be wet, other than "J" & "L". All of the existing roofs have perlite insulation both on the metal deck and above the polyisocyanurate insulation, where present. Perlite insulation is one of the most accurate in terms of IR in determining wet areas.

In conclusion the benefits of a total roof removal far outweigh a decision to remove only the wet portions of roof areas, “J” & “L”. Removal of the roofing membrane on the balance of the roof areas, leaving the
