# Eastwick

## Hydrologic & Hydraulic Study Report

FEBRUARY 2022

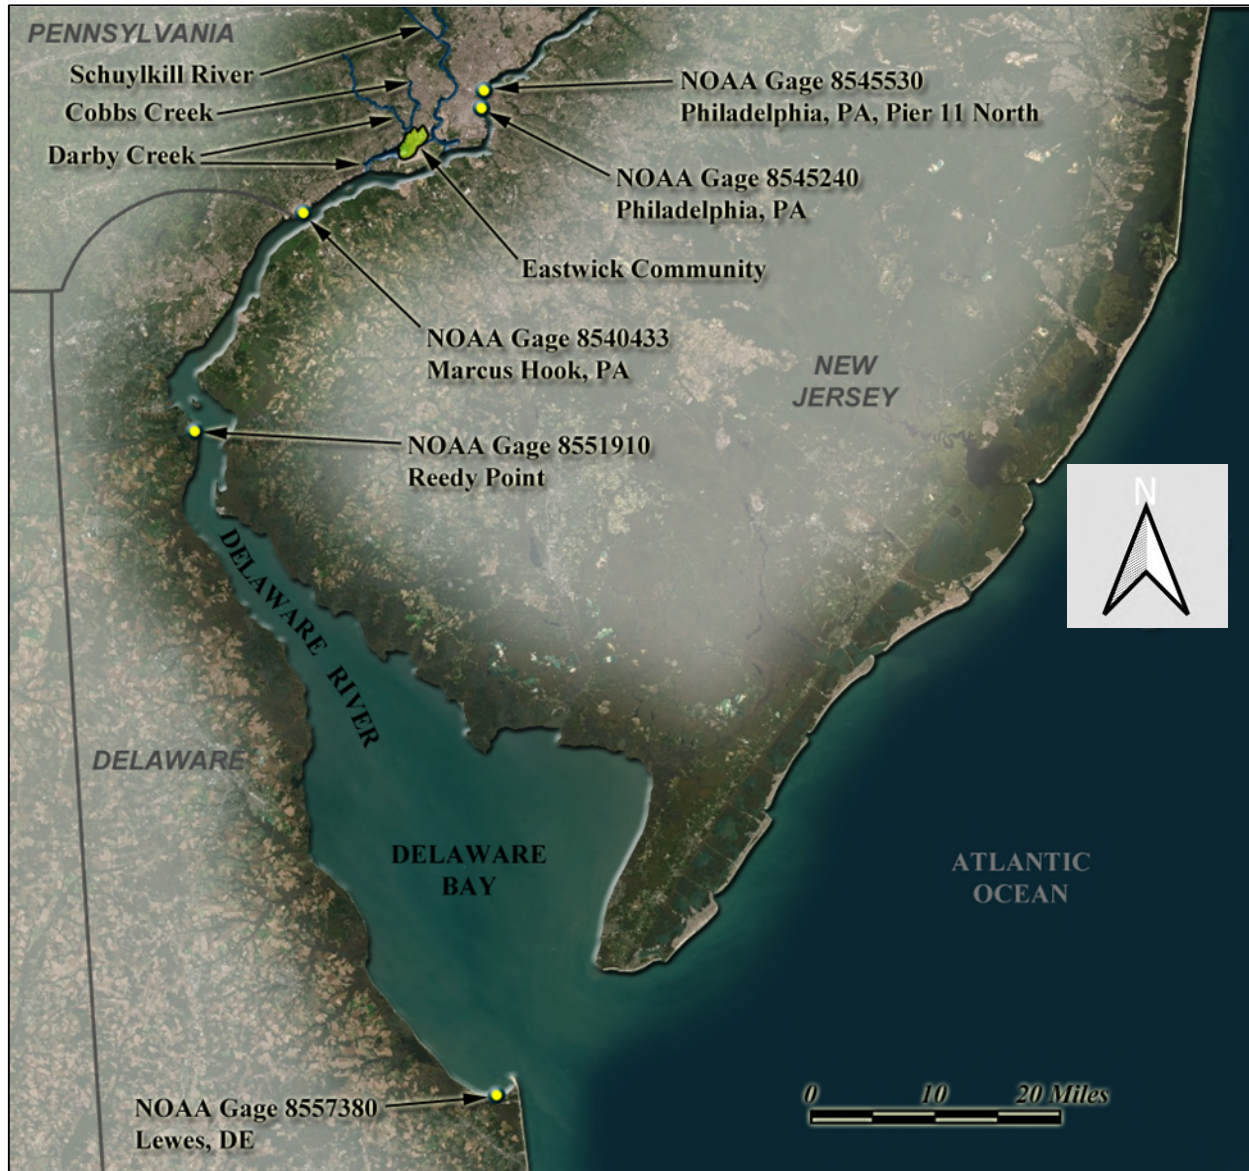
Except for a negligible tidal effect from the Chesapeake Bay through the Chesapeake and Delaware Canal, all tidal surge reaching the mouth of Darby Creek and the Schuylkill River is propagated from the Atlantic Ocean, through the Delaware Bay and Delaware River. Figure 4 shows Eastwick relative to the river, bay and ocean, and also shows several key tide gages maintained on the Delaware River by the National Oceanic and Atmospheric Administration (NOAA).

**Figure 4: Selected Delaware River and Bay Tide Gages**

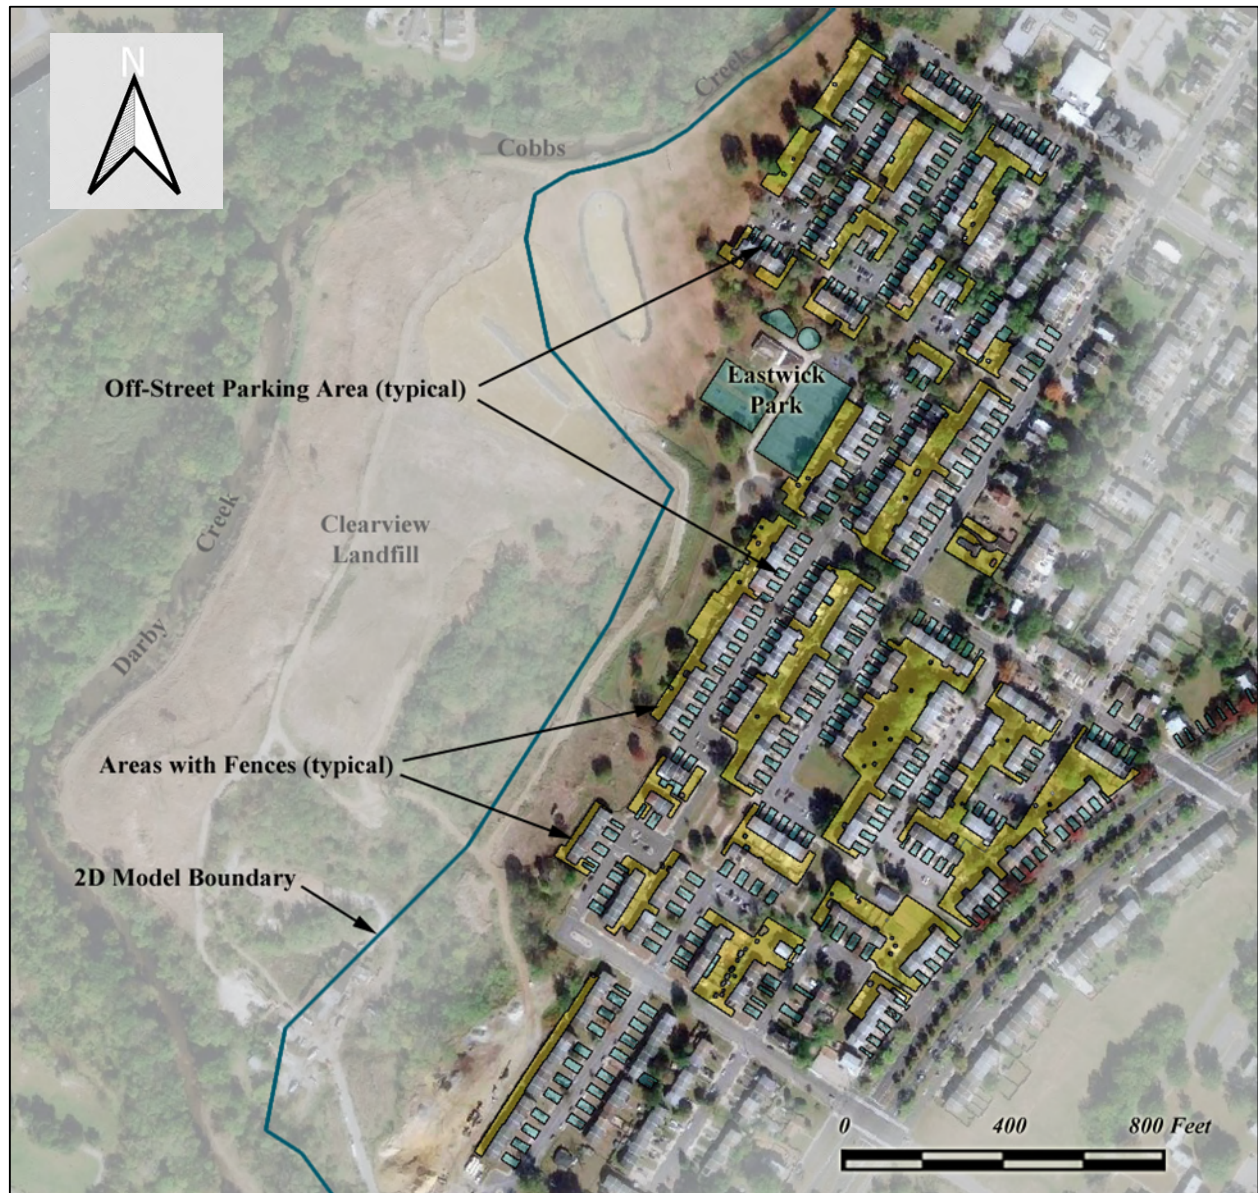
the aerial news footage indicated that a significant amount of debris may have accumulated in the fences, further increasing flow impedance. Areas with fences are shown in Figure 14 and a Manning's N roughness value of 1.0 was assigned in these areas rather than the mixed vegetation values initially assigned.

**Figure 14: Manning's N Adjustments in Terrestrial Overflow Area**

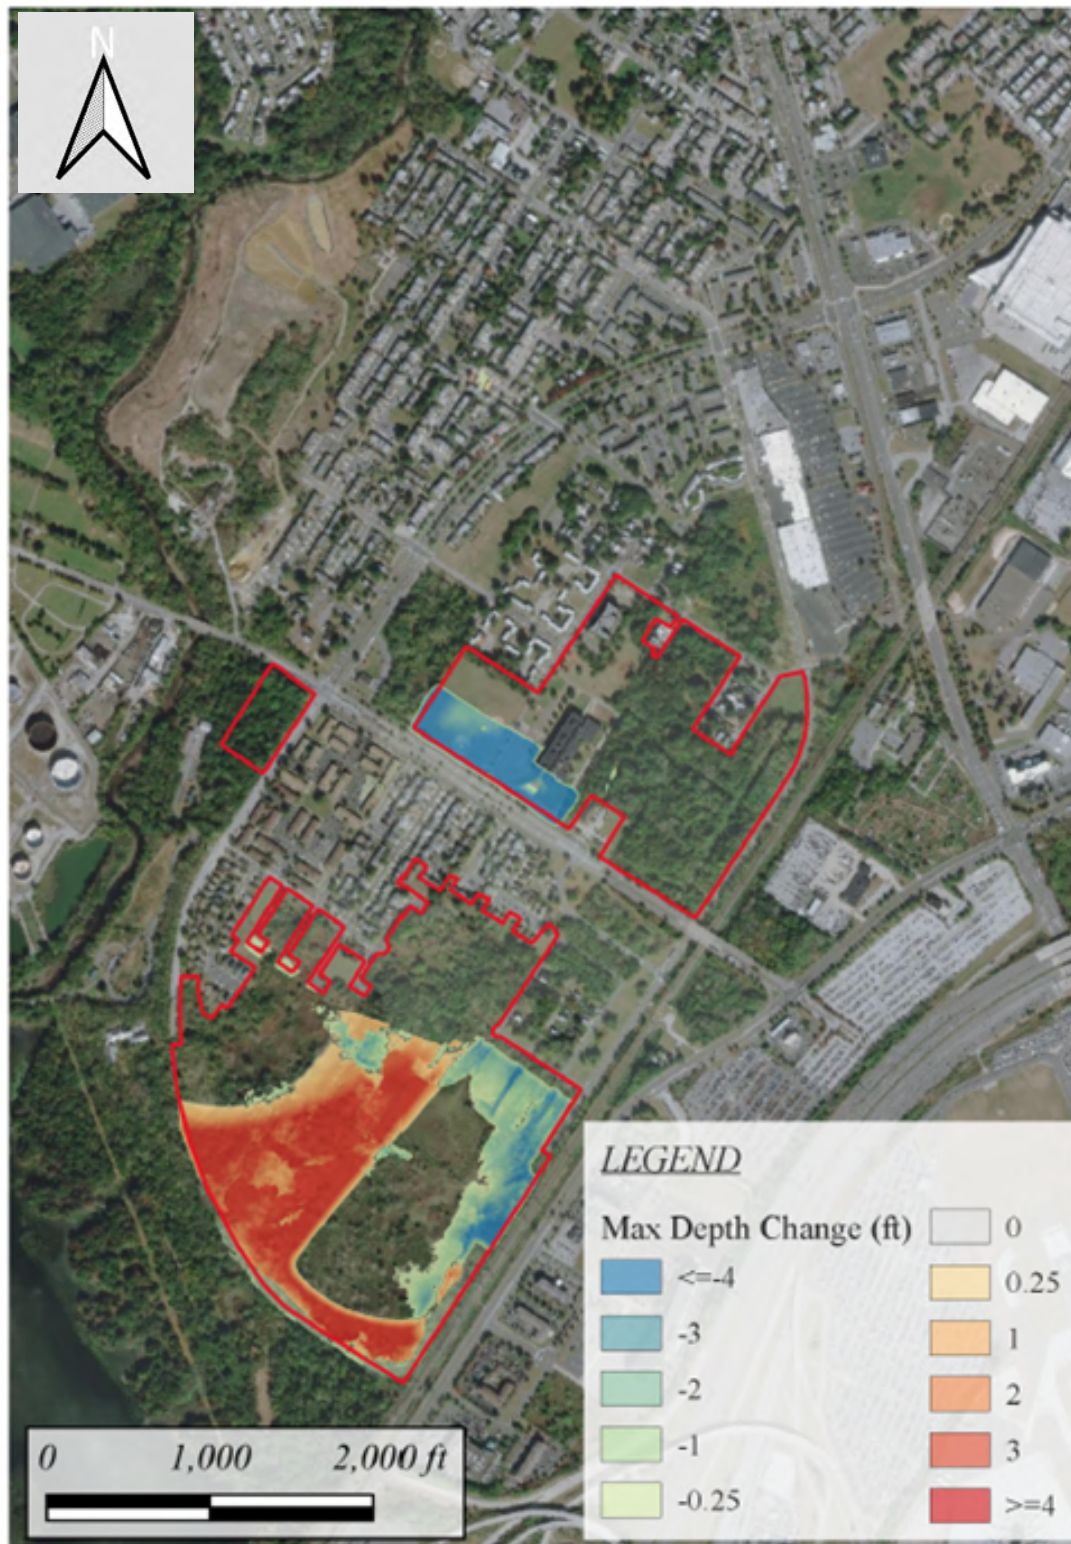
**Figure 26. Flooding Depth Change Between Existing Conditions and LEPLS Reuse Concepts for the 100-Year Terrestrial Event**

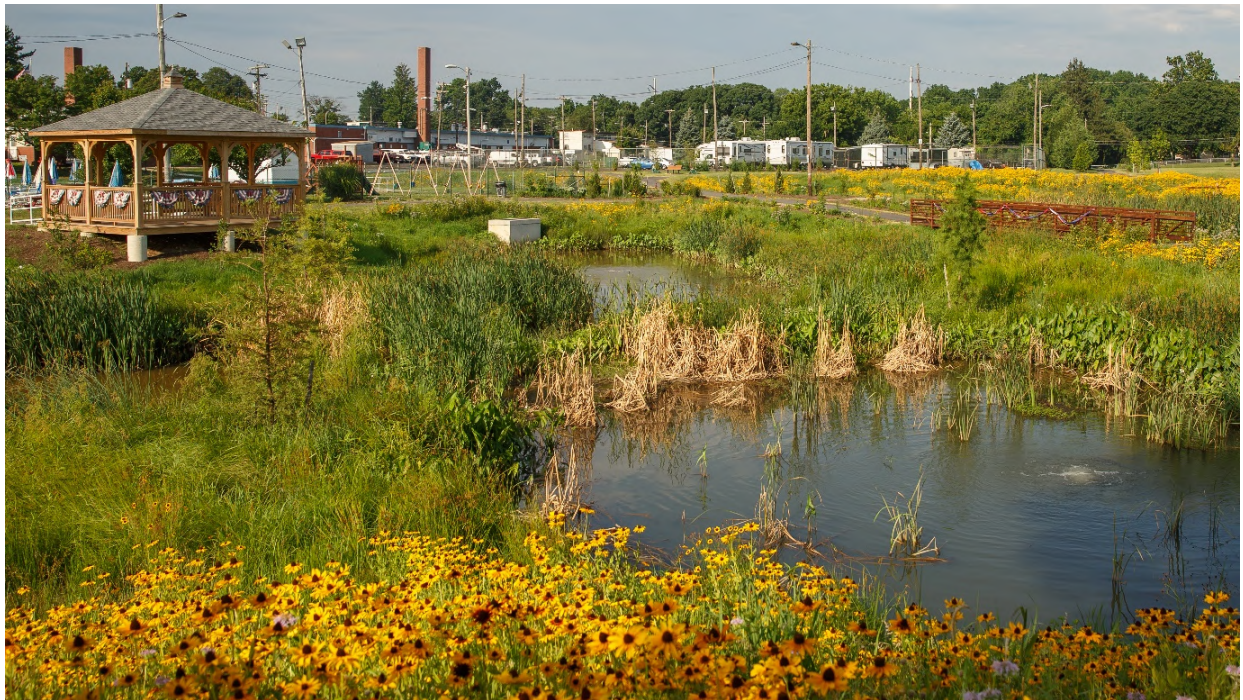
One unique and positive advantage of the vacant public land sites is the amount of available open green space and their proximity to the John Heinz National Wildlife Refuge. Future redevelopment efforts, particularly at Sites 1 and 3 due to their low elevations, could offer an opportunity for providing enhanced ecological restoration benefits to the surrounding Eastwick community. Enhanced ecological restoration at these Sites could be multifunctional: stormwater wetland systems that provide enhanced natural aesthetics, recreational benefits, wildlife habitats, stormwater treatment and storage during small intensity rain events, and flood mitigation storage during large flooding events. A representative example photo of an engineered stormwater wetland designed by AKRF elsewhere in Philadelphia is shown in Figure 29.

**Figure 29: Example Stormwater Wetland Project in Philadelphia**
