**Phase I Environmental Site Assessment  
Rebuild – Carousel House  
4300 Avenue of the Republic  
Philadelphia, PA 19104**

**March 16, 2022**

**Project No. 14378**

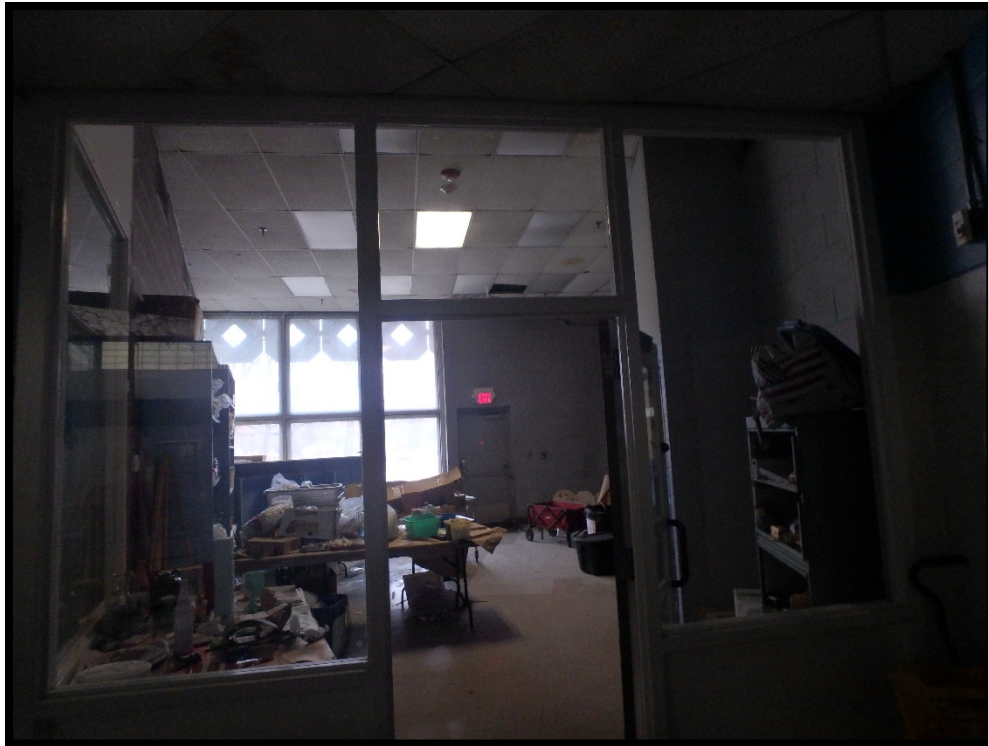
**The craft room** contains paints, including spray paint and art supplies. The room is also used for storage and contains a sink. Apparent water damage was observed (Photograph 9).

Photograph 9 – Craft room with paints, spray paints, ceramics and various craft items.

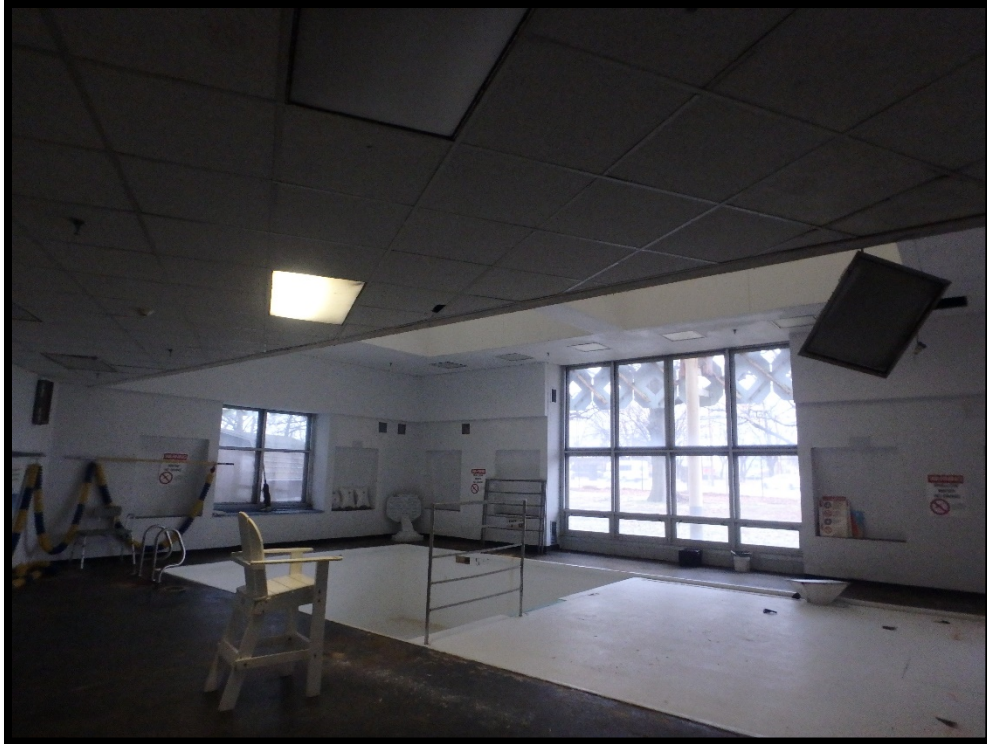
Photograph 11 – Pool area with an office, utility rooms, chemical storage and bathrooms.

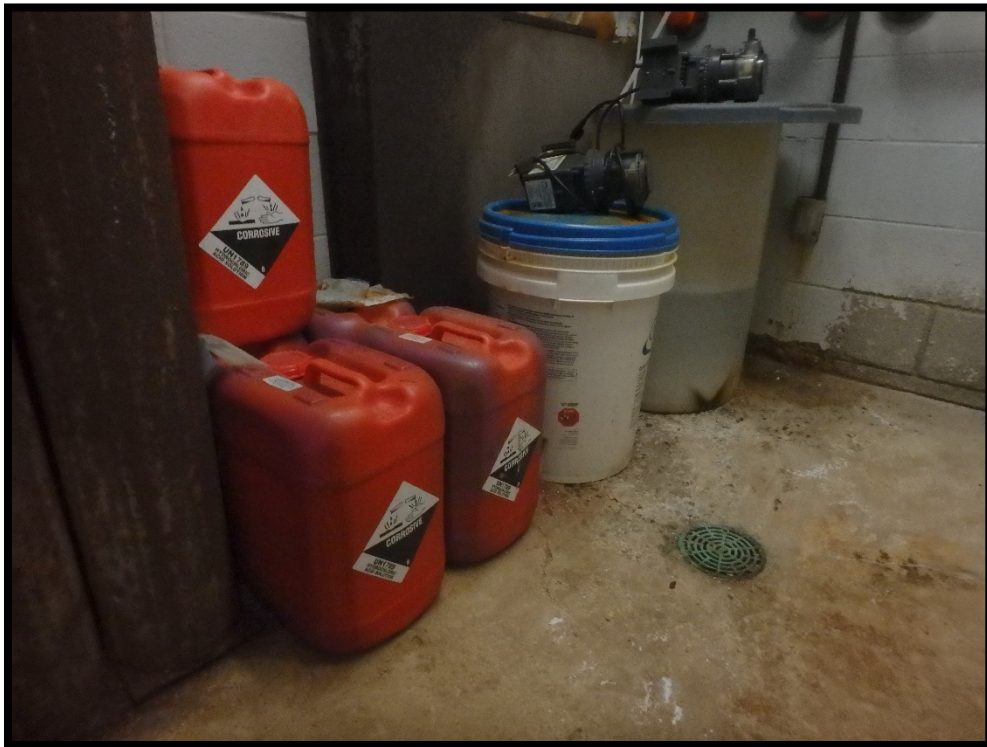
*Chemicals:* Chemicals for pool maintenance are present in the facility and include hydrochloric acid solution and calcium hypochlorite. The supply of these chemicals is approximately 50 gallons. Other chemicals include acrylic and oil-based paints, spray paint, cleaners, coolants and lubricants. The presence of small quantities of these materials is not considered a REC, but rather a *de minimis* condition.

Photograph 12 – Pool chemicals in room adjacent to utility room in pool area.

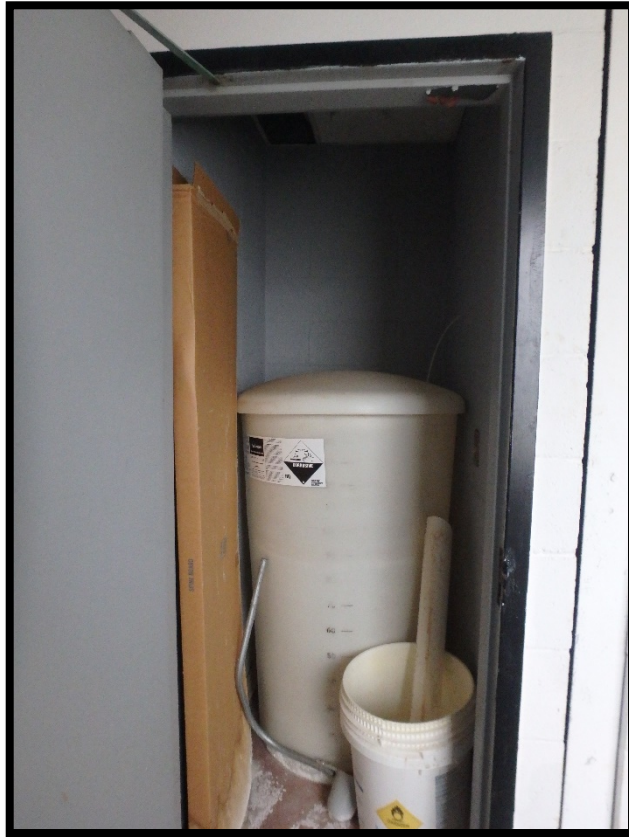
and sub-grade, the sub-grade areas have sump-pumps. Floor drains are present in the utility room. A 150-gallon tank of pool chemicals is present in a closet in a hallway in the pool area (Photograph 13). Public restrooms are also present in the pool area. Water damage to the was observed throughout the pool area.

Photograph 13 – Pool chemicals in storage closet in hallway in pool area.

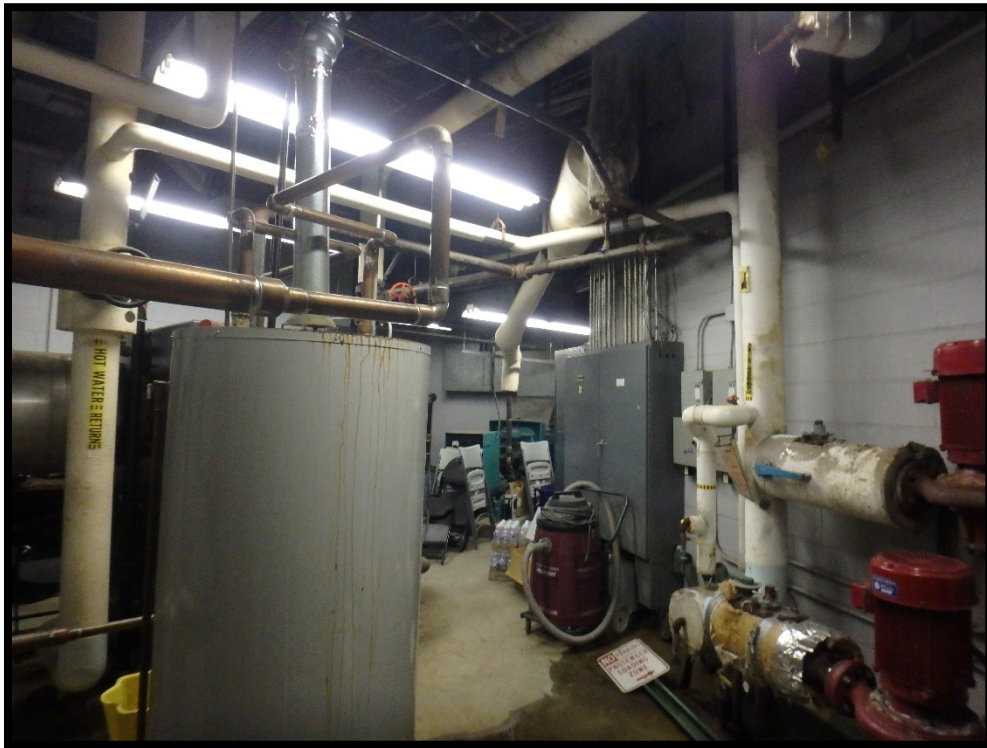
The Utility/mechanical room contains cleaning and maintenance supplies and mechanical equipment (Photograph 14). The utility area has a sink and floor drains. The mechanical room consists of boilers, HVAC equipment and storage, including chemicals, paints, lightbulbs and two refrigerators. Garden equipment and building maintenance equipment is also stored in this area and includes cleaners, chemicals, paints and lightbulbs and thermometers (Photograph 15). Standing water was observed on the floor of the mechanical room as well as and floor drains. No oily staining or other indication of a release was observed in connection with the floor drains or standing water.

Photograph 14 – Mechanical room with boilers, HVAC, transformers and control panels.

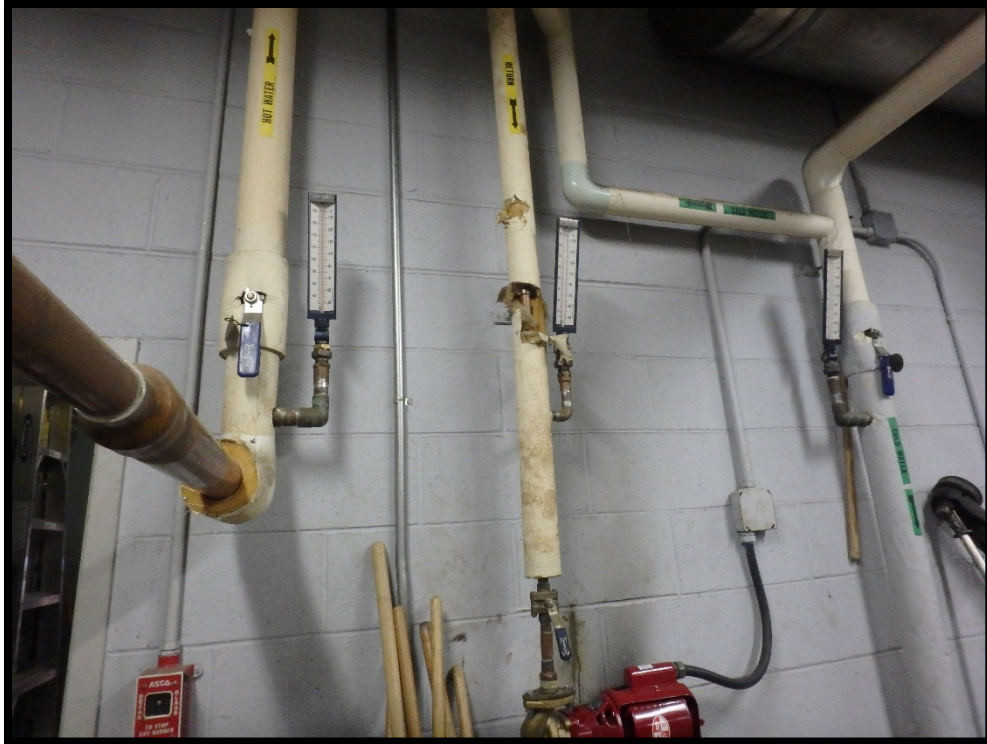
Photograph 15 – Thermometers monitoring pipes in mechanical room.

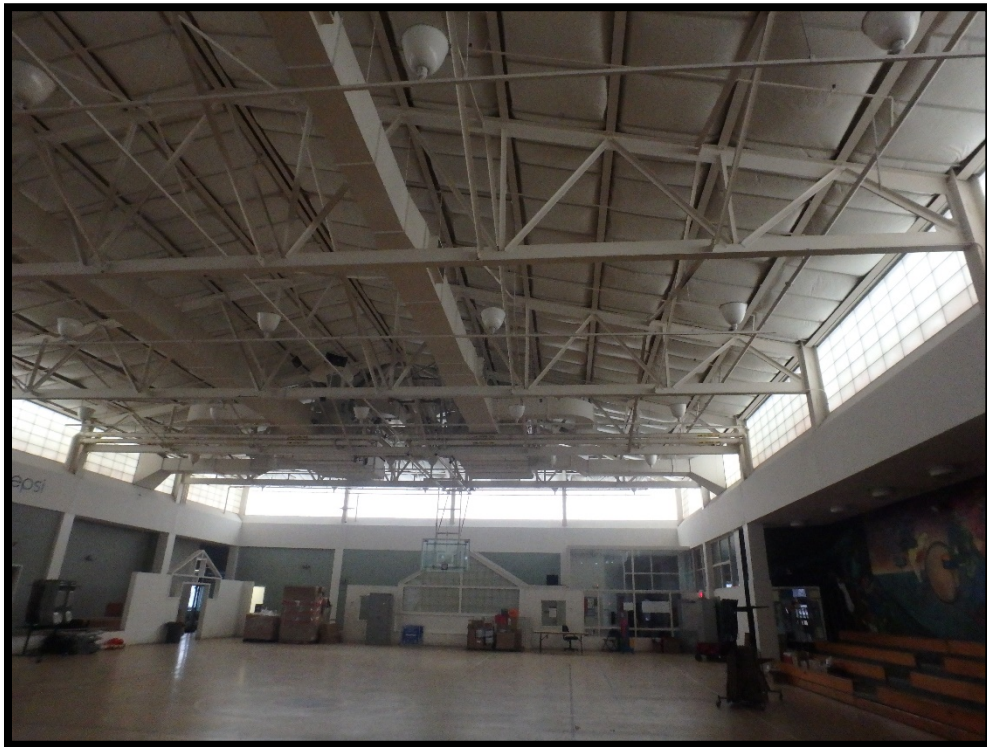
Photograph 16 – Gymnasium with bulk storage items, including food, books and cleaners.

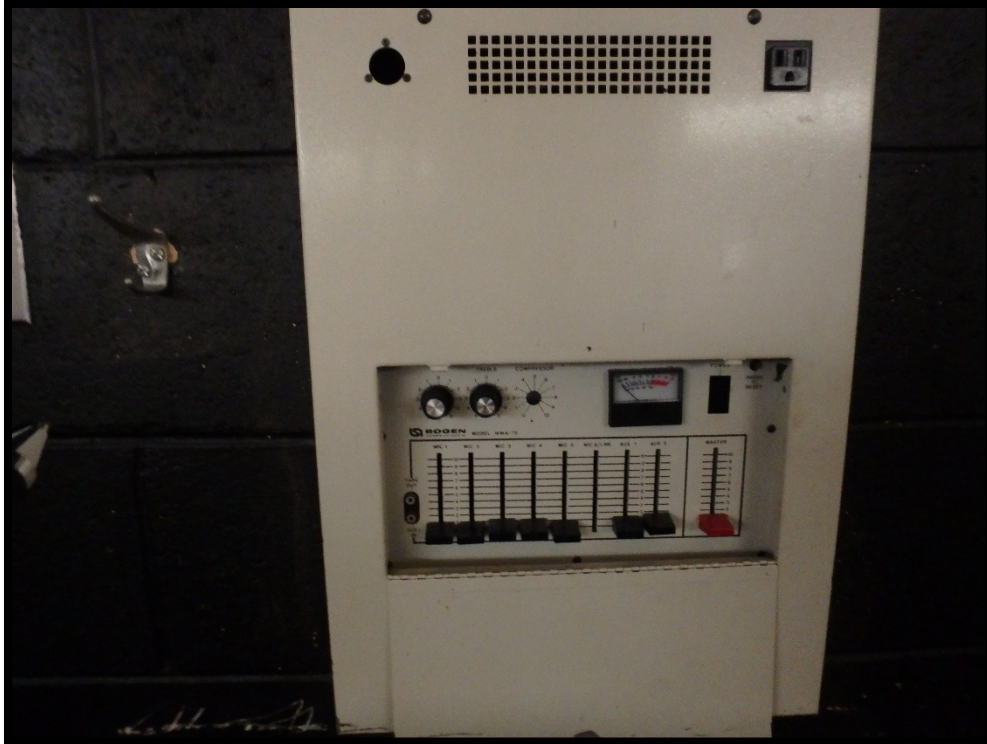
Photograph 17 – Control panel in gymnasium

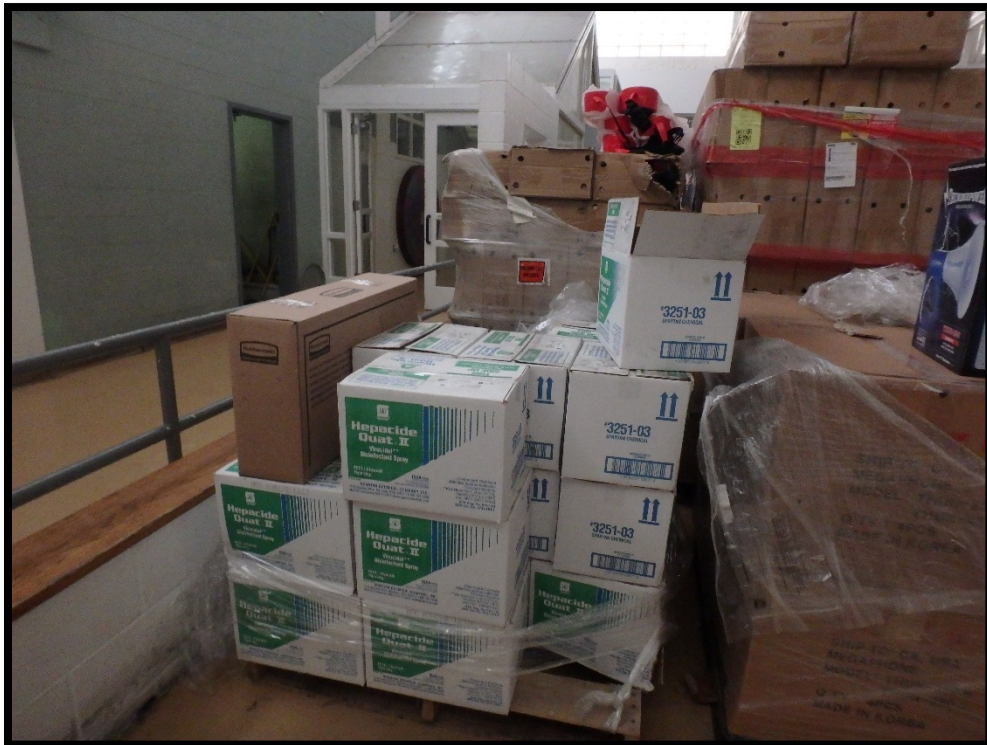
Photograph 18 – Bulk storage in gymnasium including cleaners and recreation equipment.

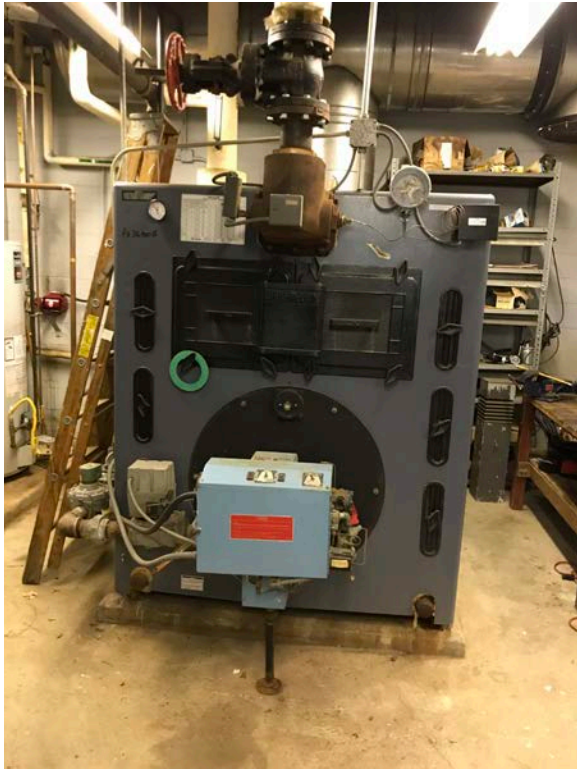
Weil-McLain 94 Series Sectional Boiler (internal materials assumed asbestos-containing)

Synertech recommends the removal of asbestos-containing materials prior to conducting renovations or demolition as per local and Federal regulations.

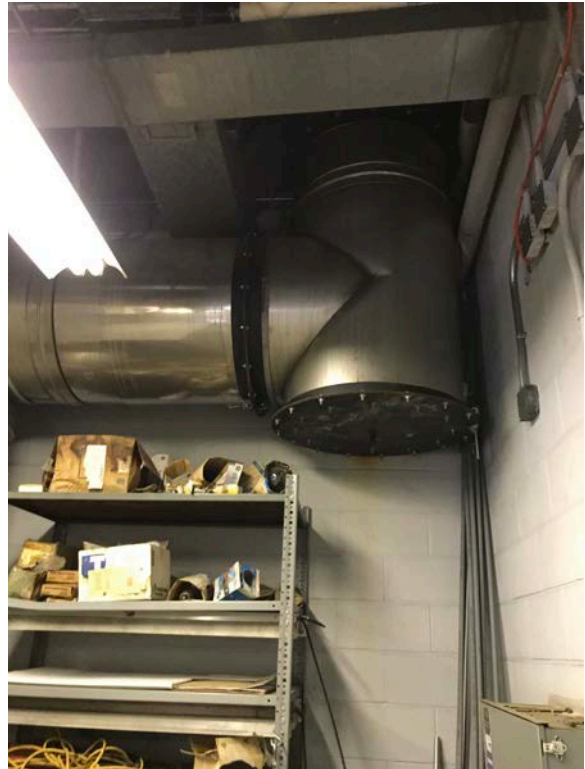
Boiler Breeching Gaskets (assumed present; assumed asbestos-containing)

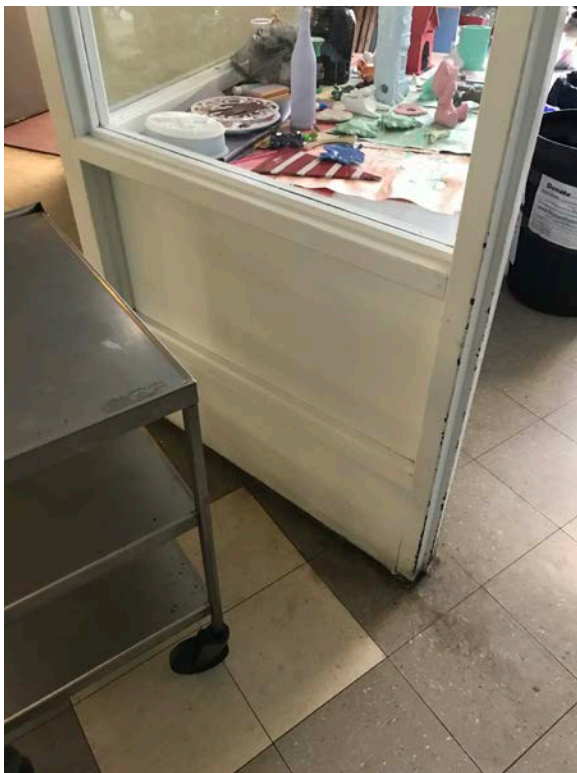
Insulation inside Metal Panel associated with Storefront Window at Entrance to Art Room (assumed present; assumed asbestos-containing)

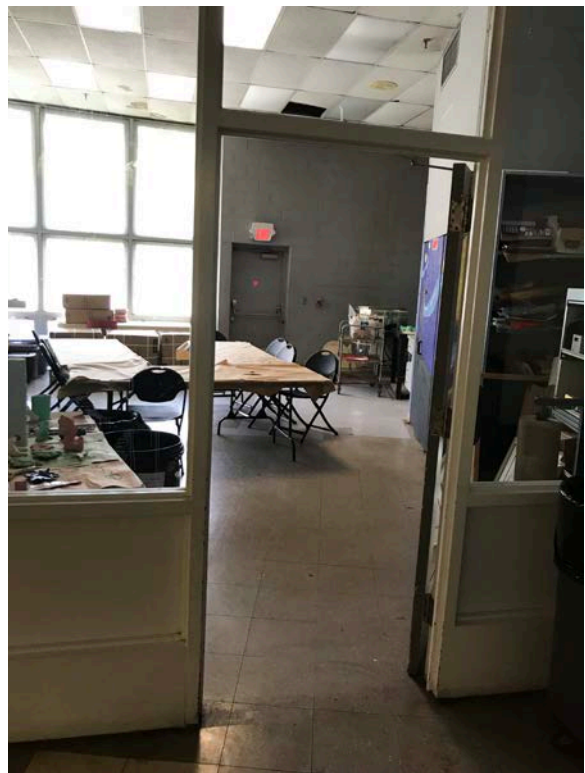
Insulation inside Wood and Metal Fire Doors throughout (assumed present; assumed asbestos-containing)
