Water Tower Recreation Center
209 E Hartwell Ln
Philadelphia, PA

Project Name
WATER TOWER REC STORM VPI

APPENDIX A - GPRS STORM WATER LINE INSPECTION REPORT

Inspection report

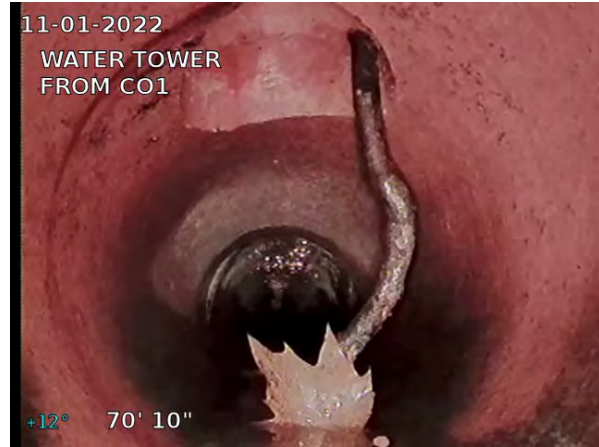
9, 00:02:47, 70.84ft
Obstruction Through Connection, 5% of cross sectional area at
12 o'clock / SMALL BRANCH WEDGED AT CLEANOUT

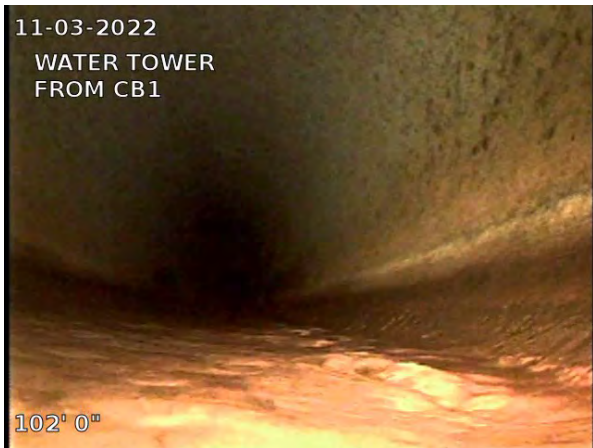
11-03-2022
 WATER TOWER
 FROM CB1
 102' 0"
 11, 00:03:52, 102.00ft
 Miscellaneous Survey Abandoned / CAMERA WOULD NOT
 PUSH FURTHER DUE TO FRICTION

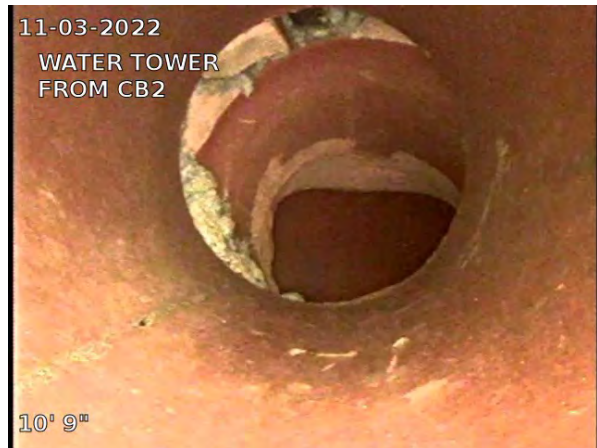
3, 00:00:24, 10.42ft
 Joint Separated Large, 1Inch, 1Inch / SEPERATION AT JOINT

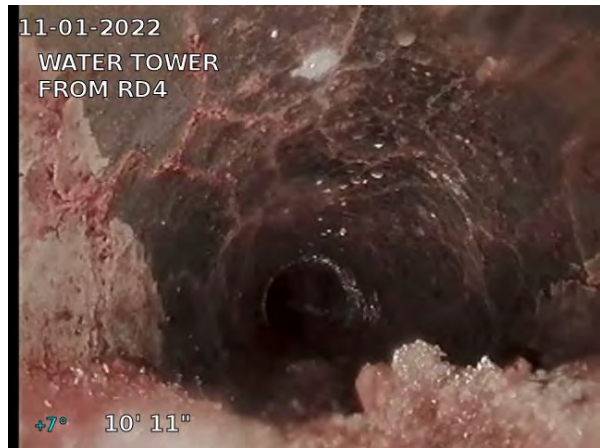
8, 00:00:50, 10.92ft
 Crack Multiple from 9 o'clock to 3 o'clock

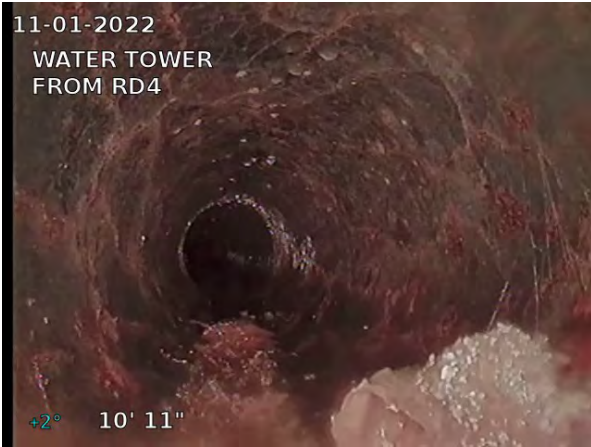
9.5	S01 DSF	Deposits Settled Fine, 25% of cross sectional area from 4 o'clock to 8 o'clock, within 8 inch, Start	00:00:40	7	
	10.9	CM	Crack Multiple from 9 o'clock to 3 o'clock	00:00:50	8, 9	S3

9, 00:00:50, 10.92ft
 Crack Multiple from 9 o'clock to 3 o'clock

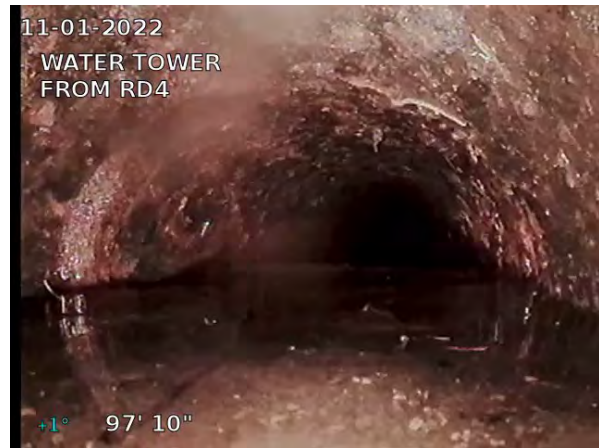
15, 00:03:50, 95.75ft
 Obstruction Other, 10% of cross sectional area at 6 o'clock / GOLF BALL

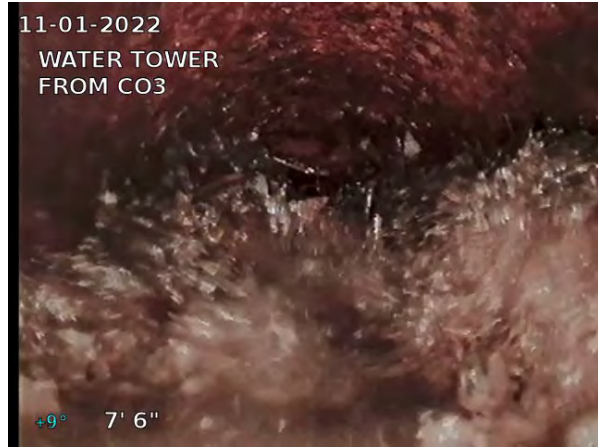
6, 00:01:01, 7.50ft
 Roots Medium Barrell from 3 o'clock to 9 o'clock, 50% of cross sectional area

7, 00:01:01, 7.50ft
 Obstruction Other, 100% of cross sectional area from 12 o'clock to 12 o'clock / BLOCKAGE - ROOTS, LEAVES, SEDIMENT, MISC DEBRIS

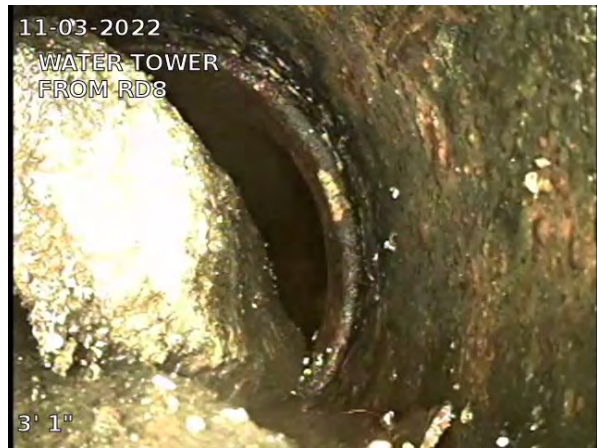
3, 00:00:10, 2.75ft
 Deposits Settled Other, 50% of cross sectional area from 3 o'clock to 9 o'clock / SEDIMENT AND STONE

4, 00:00:10, 2.75ft
 Deposits Settled Other, 50% of cross sectional area from 3 o'clock to 9 o'clock / SEDIMENT AND STONE

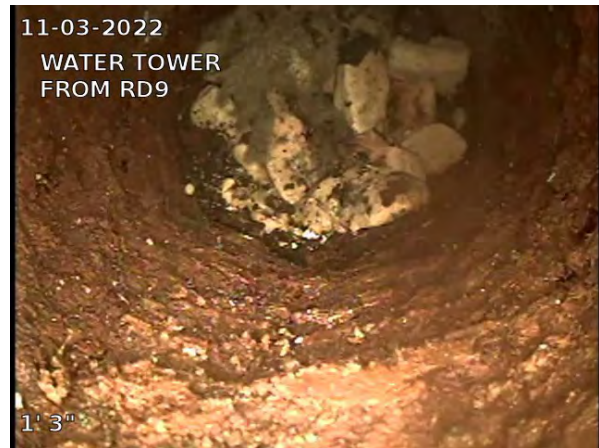
3, 00:00:34, 1.25ft
 Obstruction Rocks, 100% of cross sectional area from 12 o'clock to 12 o'clock / RISER FILLED WITH STONES

4, 00:00:35, 1.25ft
 Miscellaneous Survey Abandoned / RISER FILLED WITH STONES, CANNOT ENTER LINE

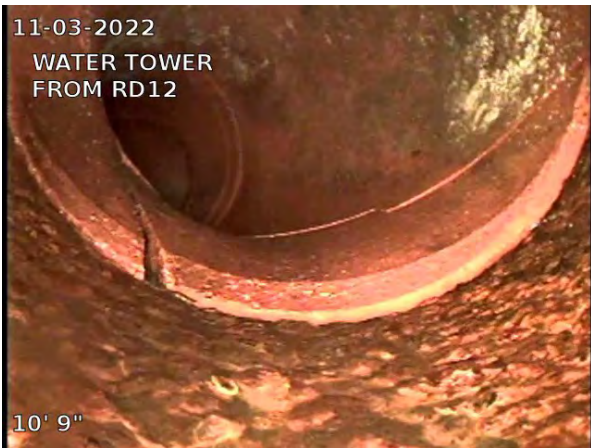
7, 00:00:34, 10.75ft
 Fracture Circumferential from 4 o'clock to 8 o'clock
