Germantown/Mount Airy Properties

Physical Conditions and Needs Assessment

Premises C

5429-43 Lena Street

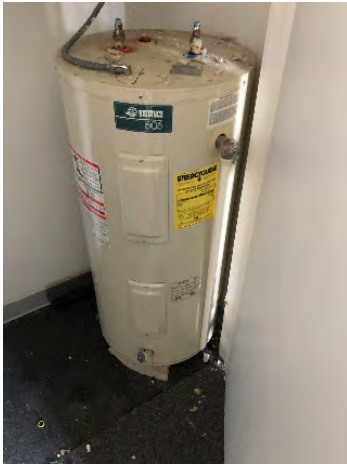
Main hot water heater in master bedroom.

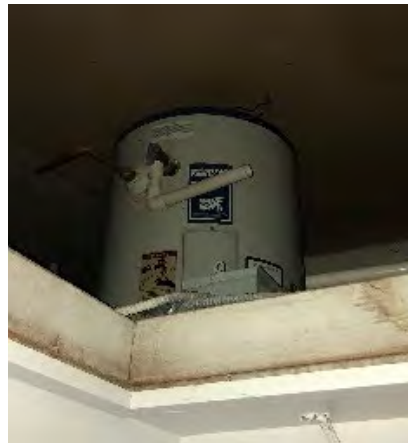
Small hot water heater in master closet ceiling.

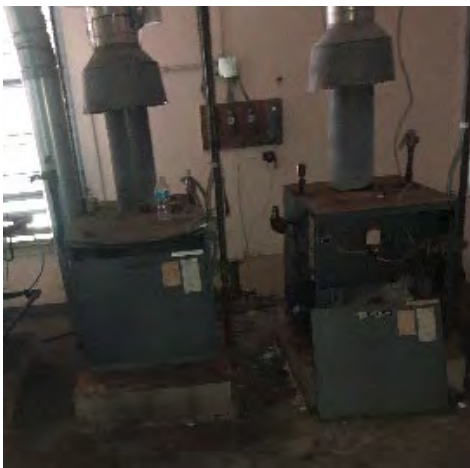
Boiler room furnaces (old).
