# Germantown/Mount Airy Properties

## Physical Conditions and Needs Assessment

### Premises V

**5417 Lena St**

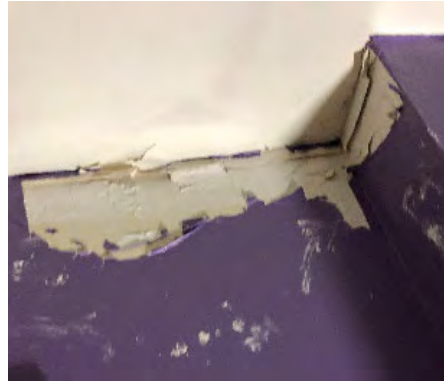
Master bedroom leak damage.

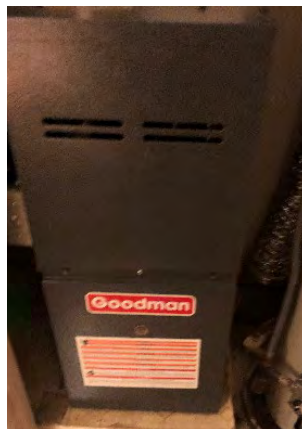
Gas fired furnace and hot water heater.

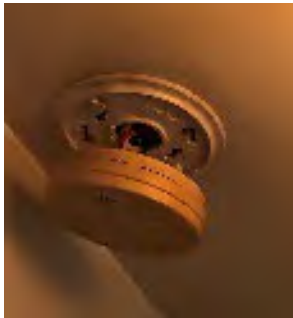
Hard wired fire alarm.

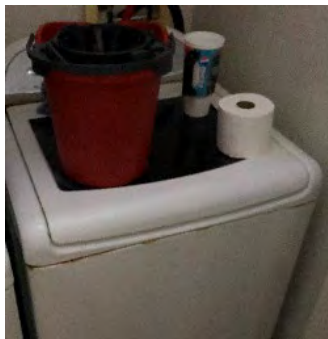
Brown mold or corrosion on washer.
