# Germantown/Mount Airy Properties

## Physical Conditions and Needs Assessment

### Premises Y

**5423-27 Lena Street**

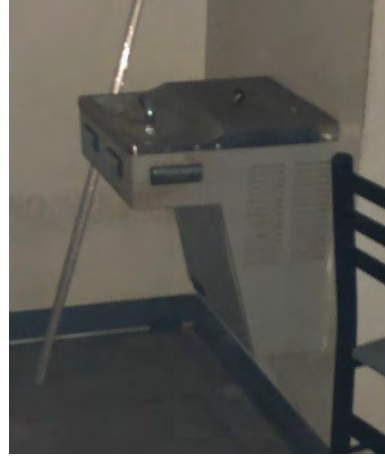
First floor water fountain in management office.

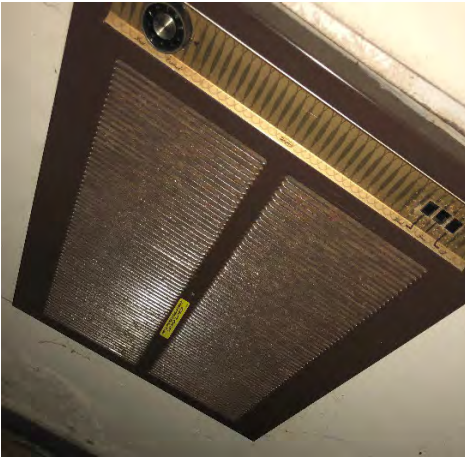
First floor corridor heater at main entrance.

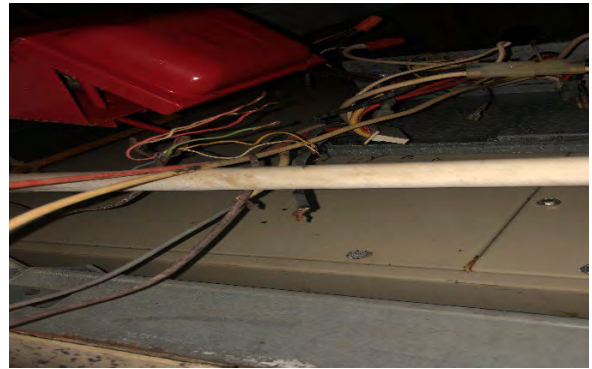
Unit 1a electric wiring next to indoor unit.

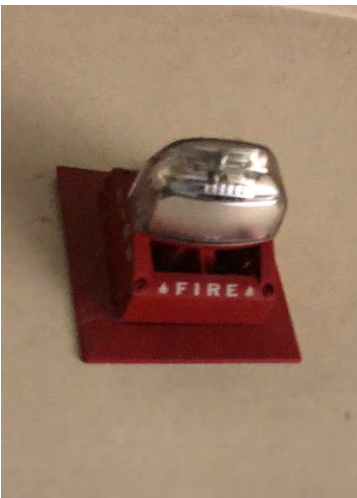
First floor fire alarm strobe.

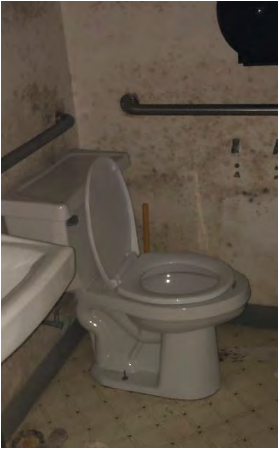
First floor public bathroom.

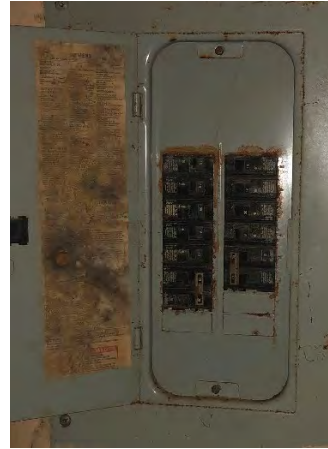
Unit 1a electric panel.

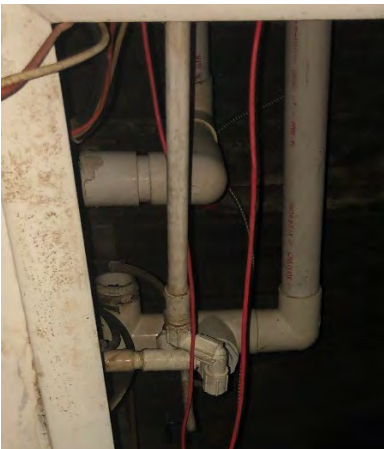
First floor management room pvc piping for indoor unit.

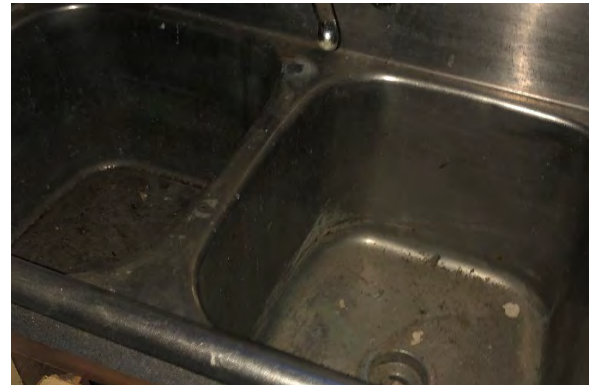
First floor management room sink/faucet.

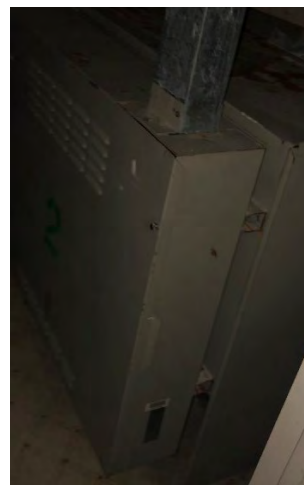
First floor elevator room.

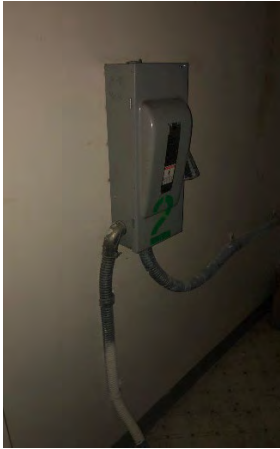
First floor elevator room panel.

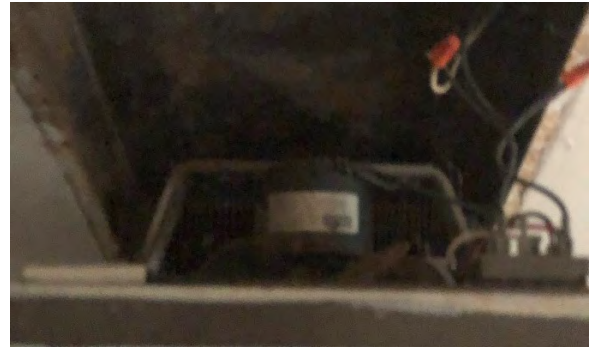
First floor corridor heater at main entrance.

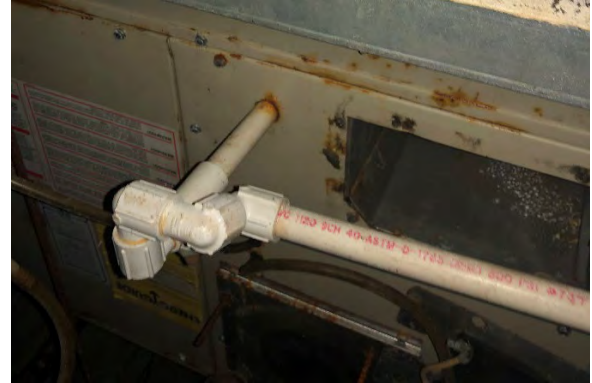
Unit 1a indoor gas unit.
