**Re:** Summary of Test Pit Exploration  
Miles Mack Playground  
Philadelphia, Pennsylvania  
LANGAN Project No.: 220104104

This memorandum presents the results of LANGAN's geotechnical engineering study for the existing retaining wall along the southern boundary of the basketball court at Miles Mack Playground in Philadelphia, Pennsylvania. The purpose of this study was to explore and evaluate the existing retaining wall in an effort to better understand the wall's construction and foundation, as well as to classify the wall's bearing and retained soils. This work was performed in accordance with LANGAN's ASR-2 dated 14 May 2019.

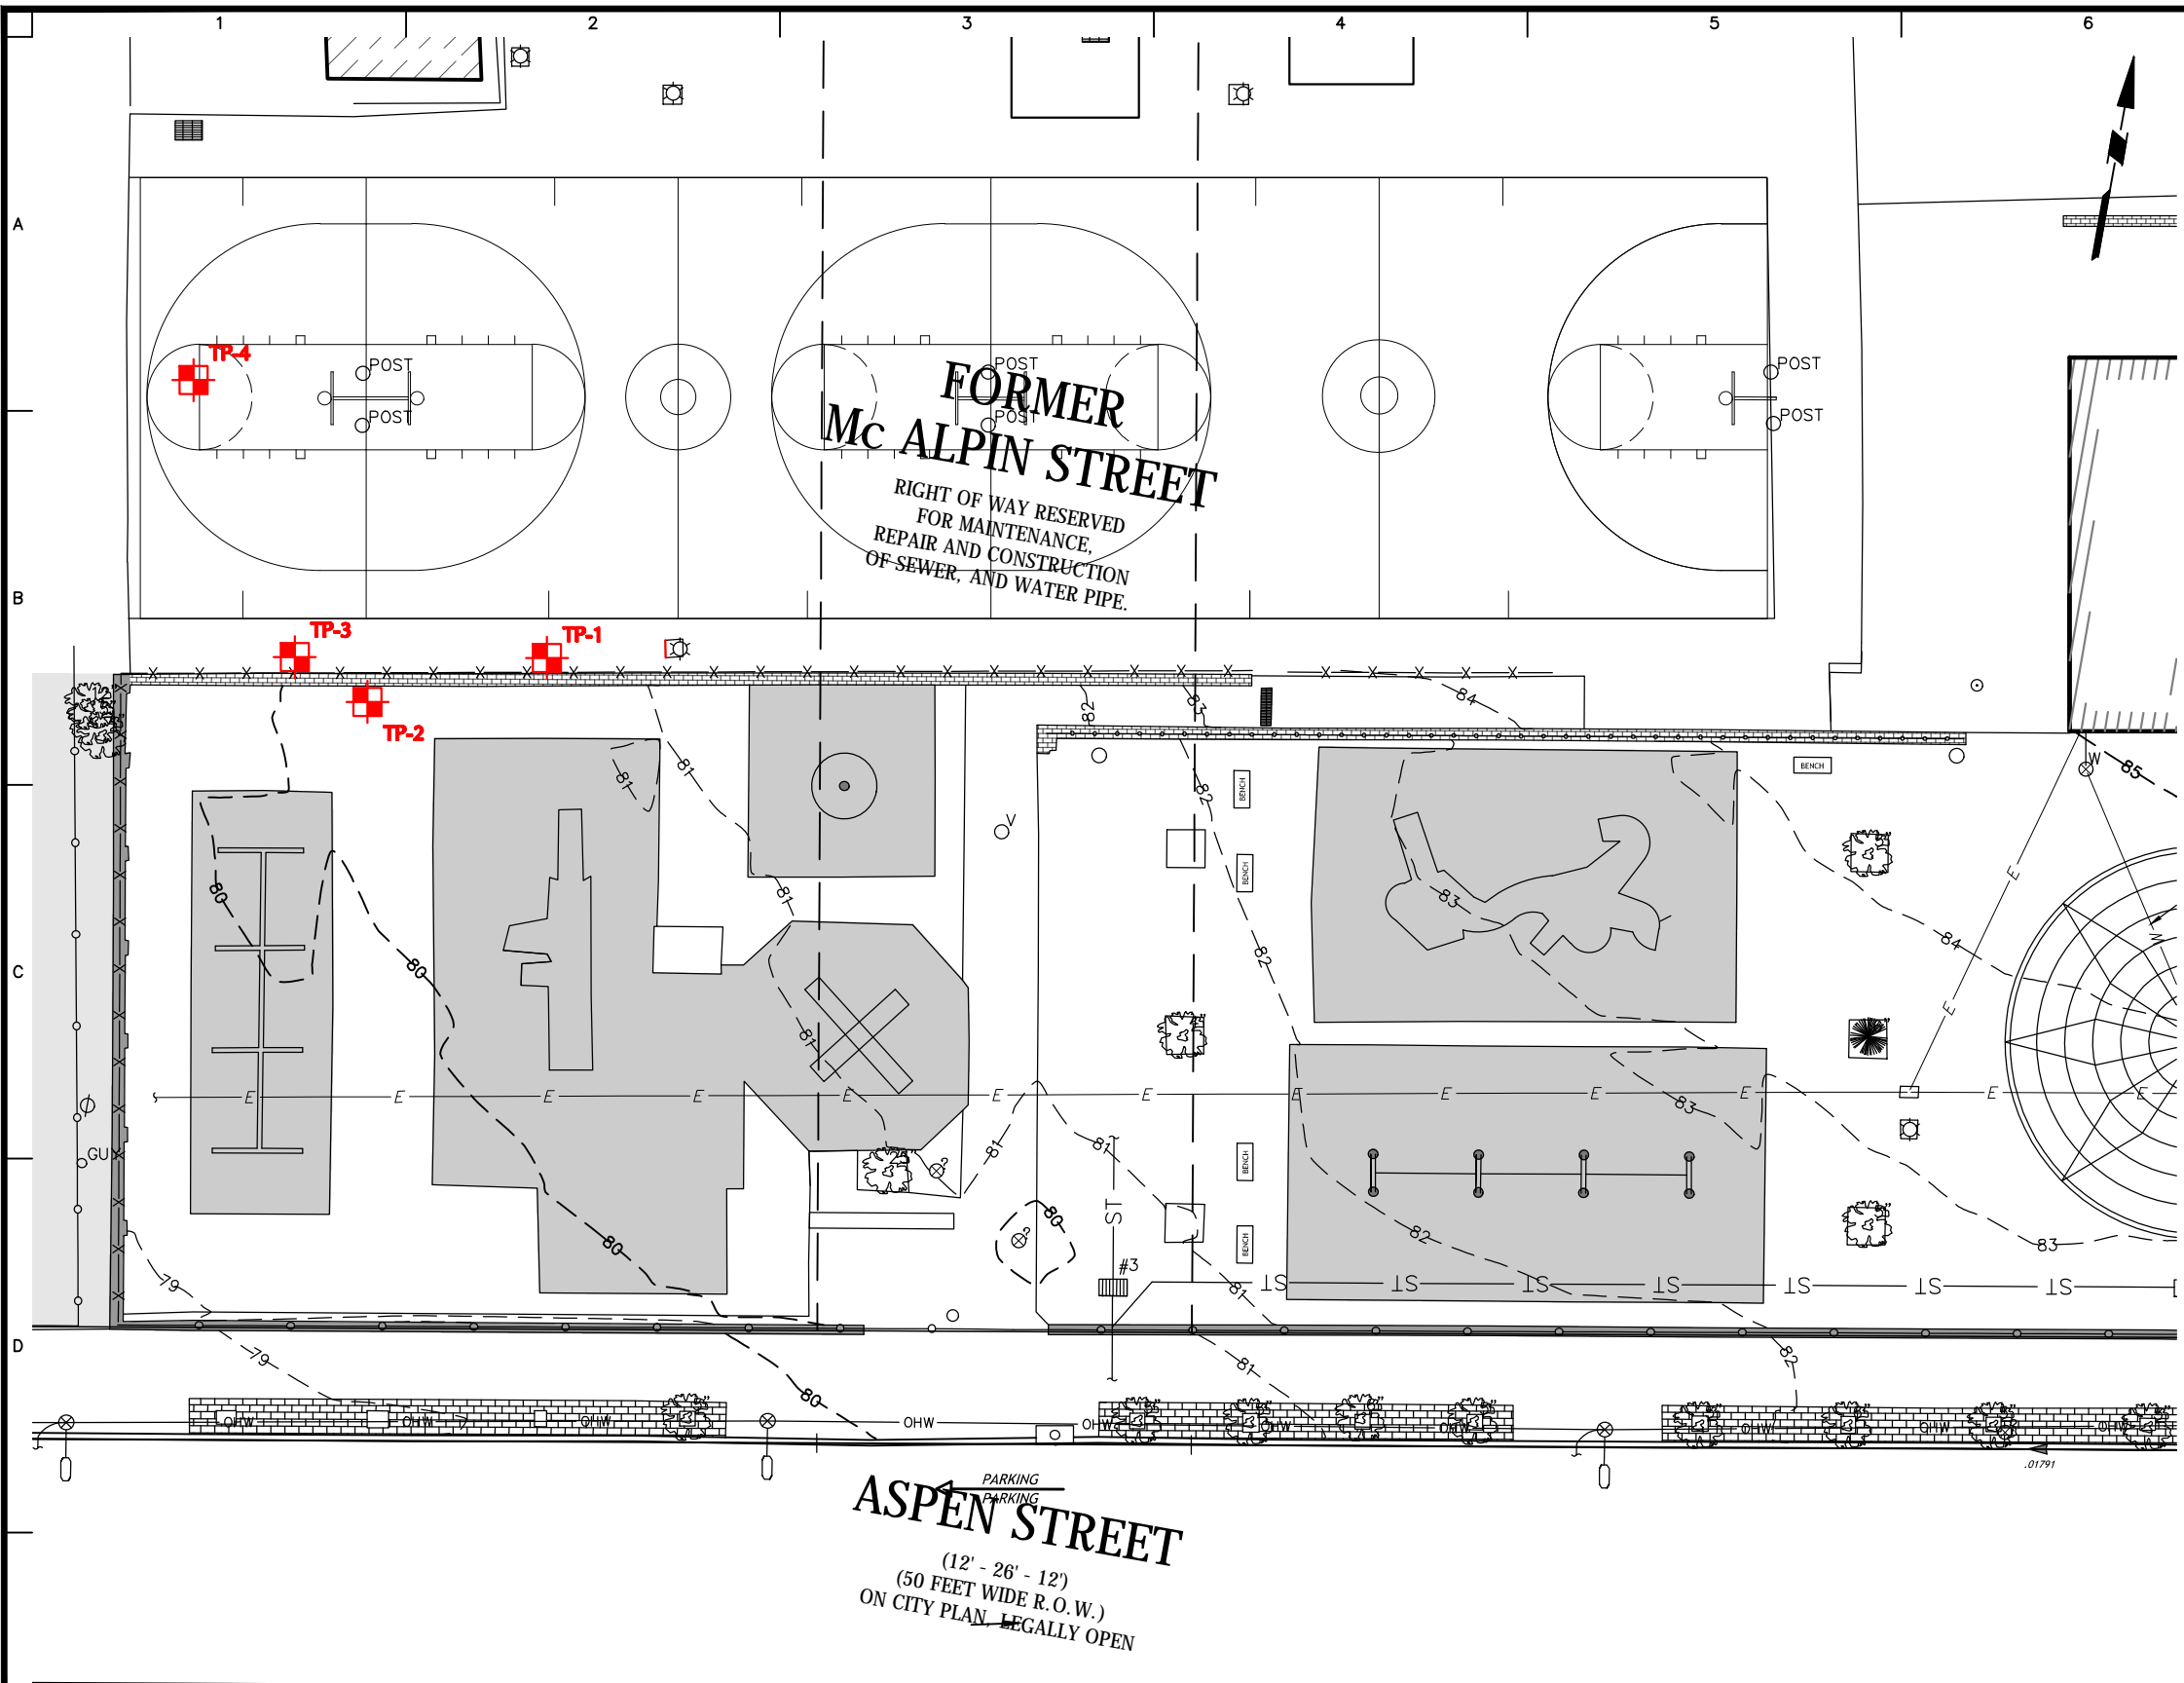
LANGAN attempted four test pits on 3 September 2019. Test pits TP-1 through TP-3 were located adjacent to the retaining wall, with two located at the top of the wall and one at the base of the wall. Test pit TP-4 was located on the west side of the basketball court playing surface. The test pits were completed by Uni-Tech with a Bobcat E-20 mini-excavator. All test pits were conducted under the full-time supervision of a LANGAN field engineer.

All but one test pit, TP-2, encountered a concrete slab immediately beneath the asphalt surface. The concrete slab at the three test pit locations could not be removed and were abandoned. At completion, test pit TP-2 was backfilled with excavated materials. All test pit surfaces were restored using cold-patch asphalt.
