STEPHEN
McLAUGHLIN
ROOFING
CONSULTANT

Reference: City of Philadelphia Project # 20-16-4919-99, Additional Services, Infrared Roof Survey at Simons Recreation Center, 7200 Woolston Avenue, Philadelphia, PA 19138

ROOF INFRA RED SURVEY

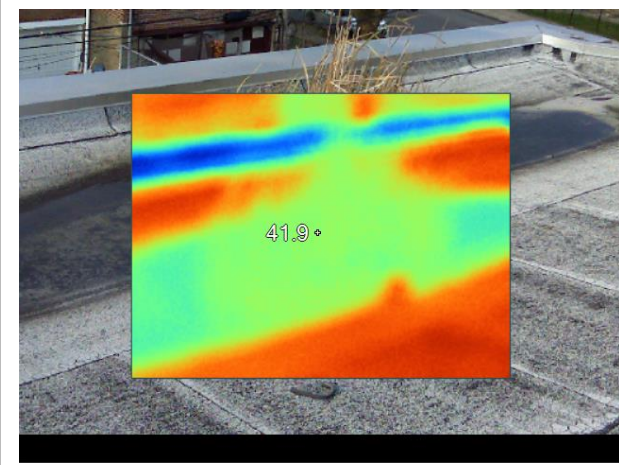
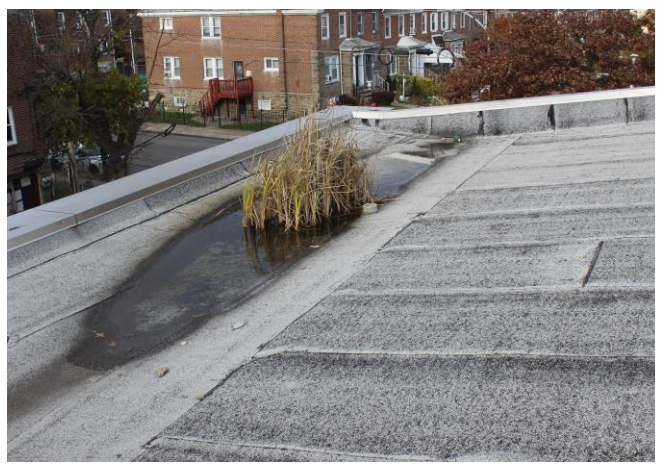
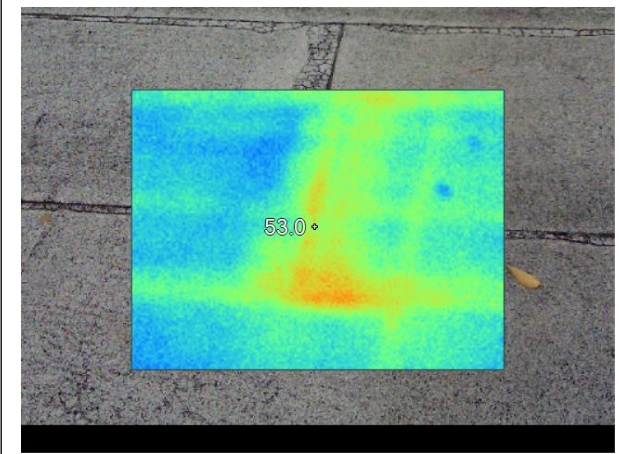
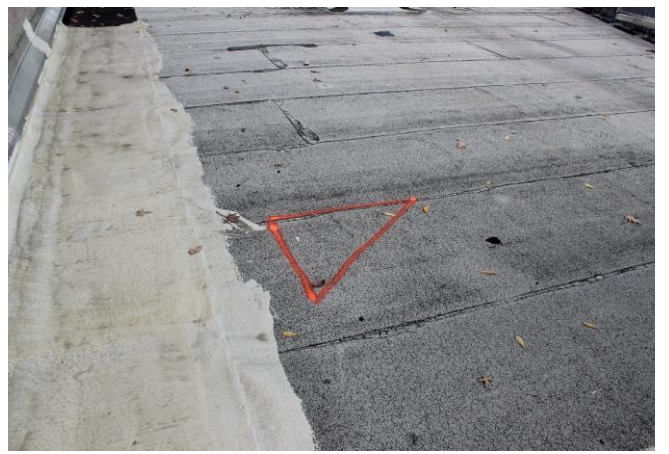
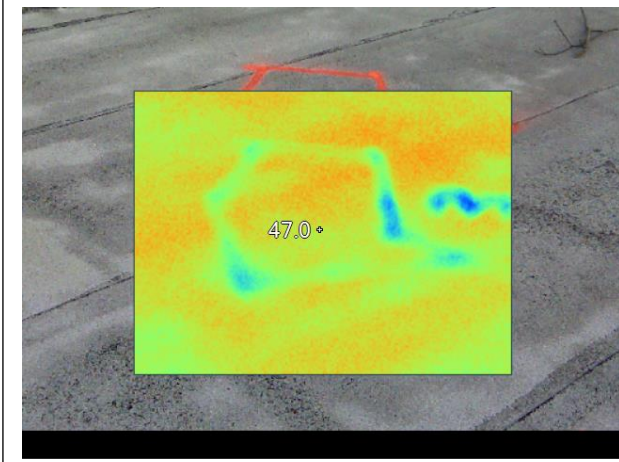
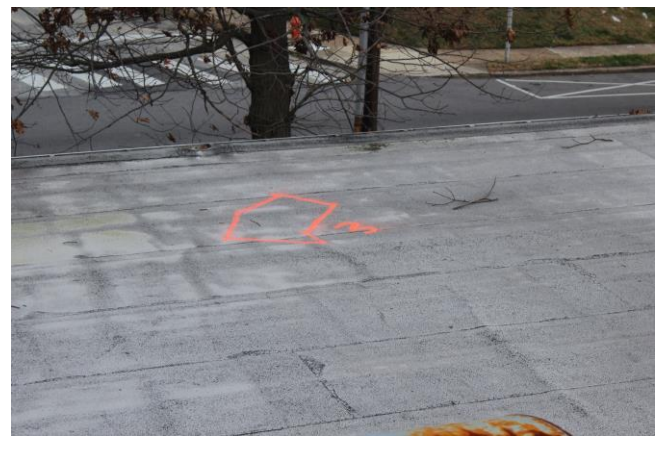
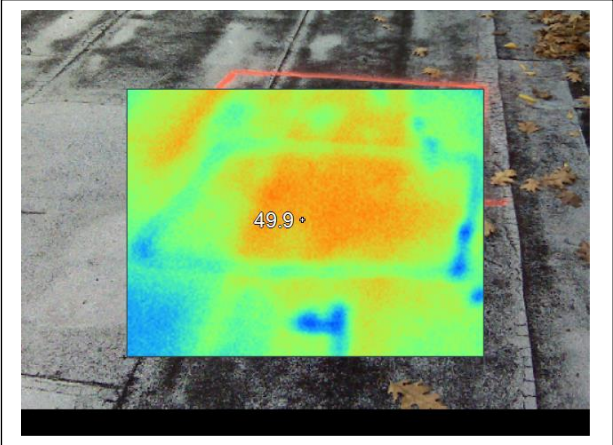
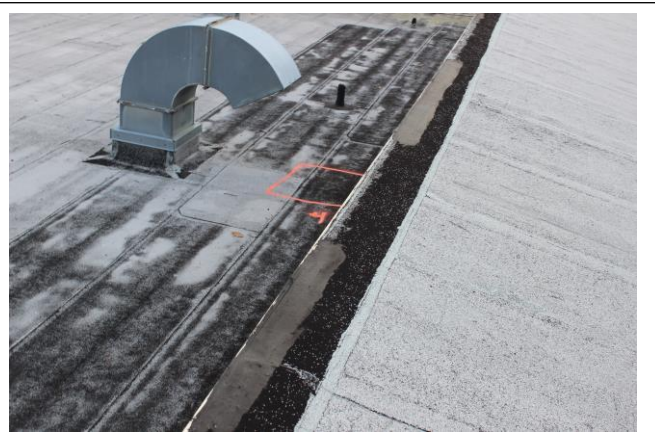
There is an infra-red image sheet and a roof plan showing the anomalies attached. Included on the roof plan is the approximate location of the control joints and roof anomalies identified during the IR survey. Also identified are two roof drains that are clogged. The roof drains on the Gymnasium roof are not accessible by City personnel without 2 ladders. This always represents a safety concern. We recommend that a wall mounted, caged ladder and platform combination along with a ships ladder and roof scuttle should be included in this project to allow safe access to clean drain strainers and avoid future drain blockage. Regular biannual drain cleaning should be performed on all City roofs that are safe to access.
