Germantown/Mount Airy Properties

Physical Conditions and Needs Assessment

Premises A

6526-34 Germantown Ave

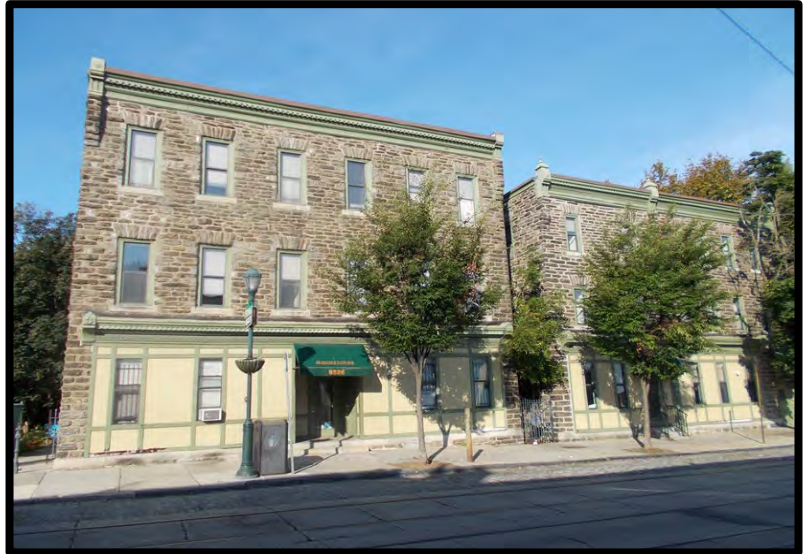
Photo No. 1

View of front facades of 6526 and 6534 Germantown Avenue as seen from Germantown Avenue looking west.

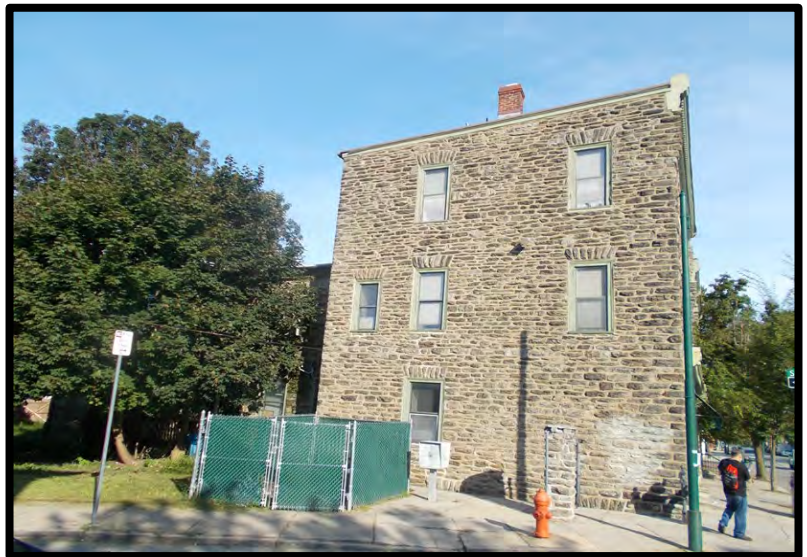
Photo No. 2

View of south elevation of 6526 Germantown Avenue.

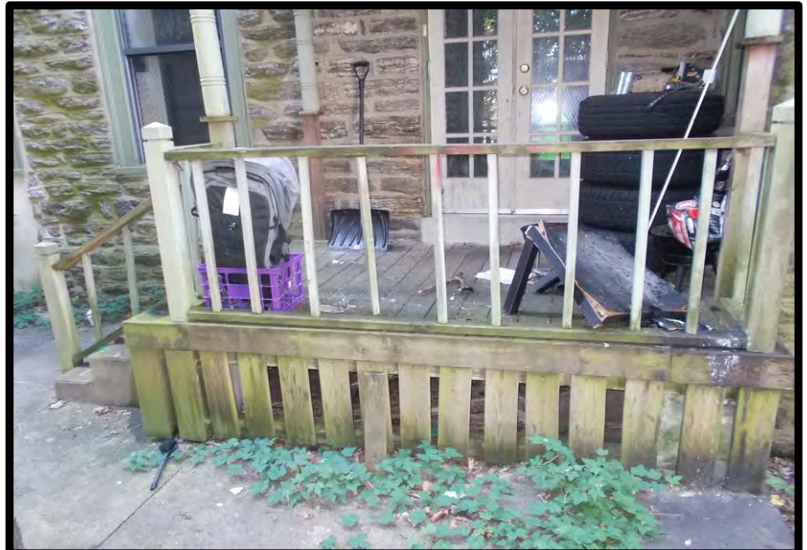
Photo No. 13

Detailed view of wood porch entry to unit along north
side of 6526 Germantown Avenue.

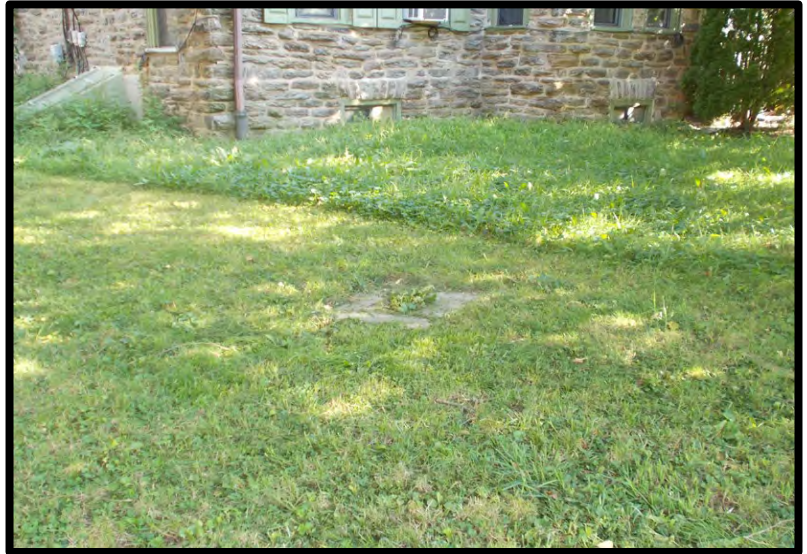
Photo No. 14

Depicts yard clean out located on the south side of property.

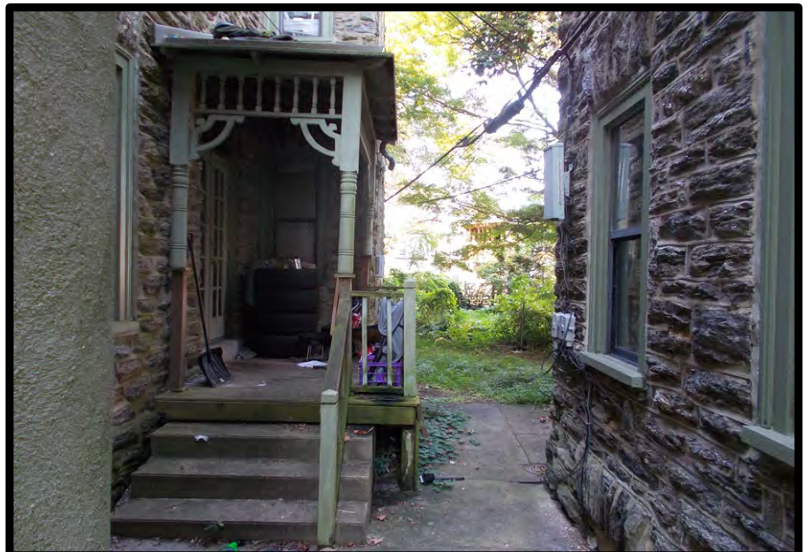
Photo No. 19

Depicts view of stairs and wood porch entry along
north side of 6526 Germantown Avenue.

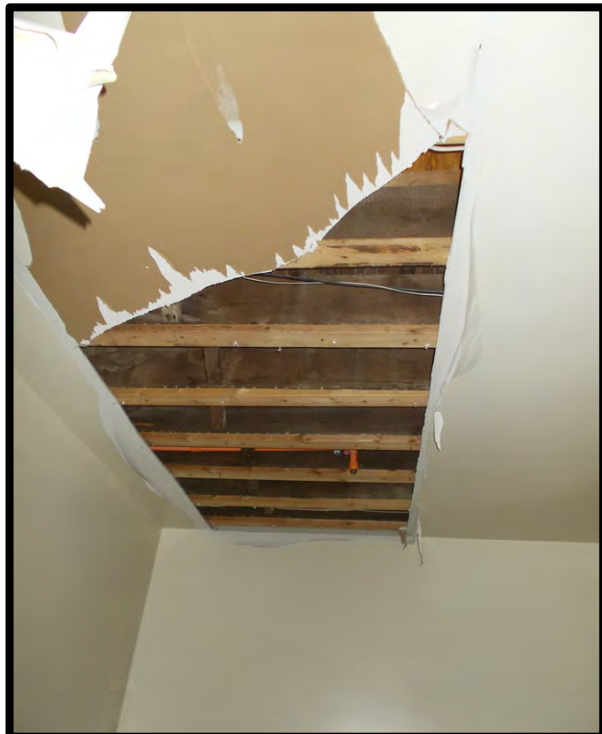
Photo No. 35

View of partially collapsed ceiling in rear bedroom.

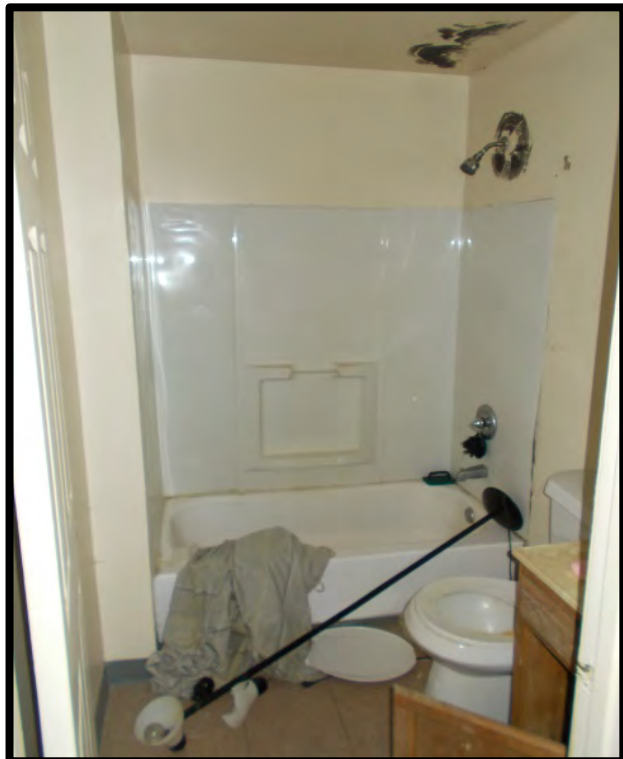
Photo No. 37

Overall view of bathroom within Unit 2.

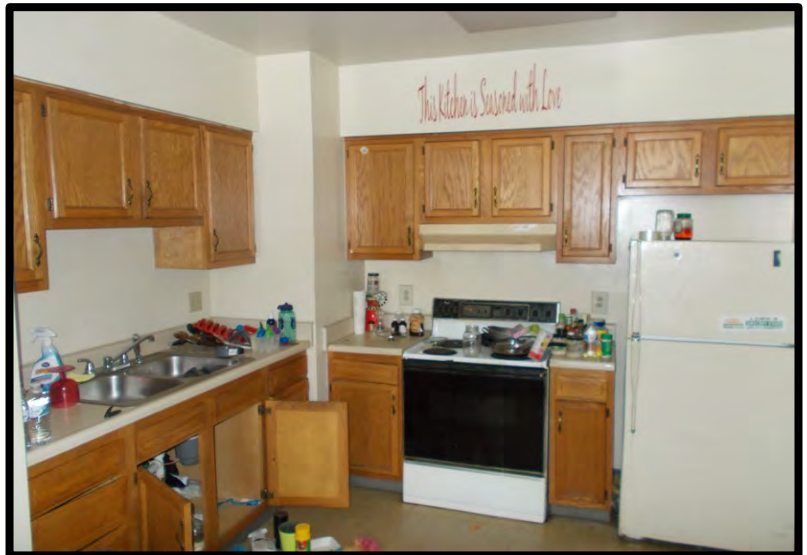
Photo No. 43

View of kitchen within Unit 6.

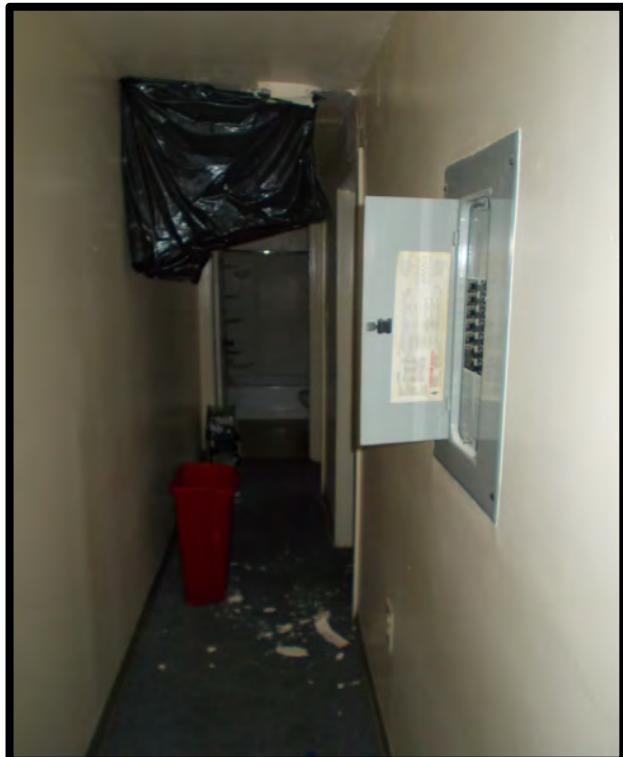
Photo No. 48

View looking at hallway leading to rear of building bedrooms and bathroom. Also visible in the photo is the apartment electrical panel.

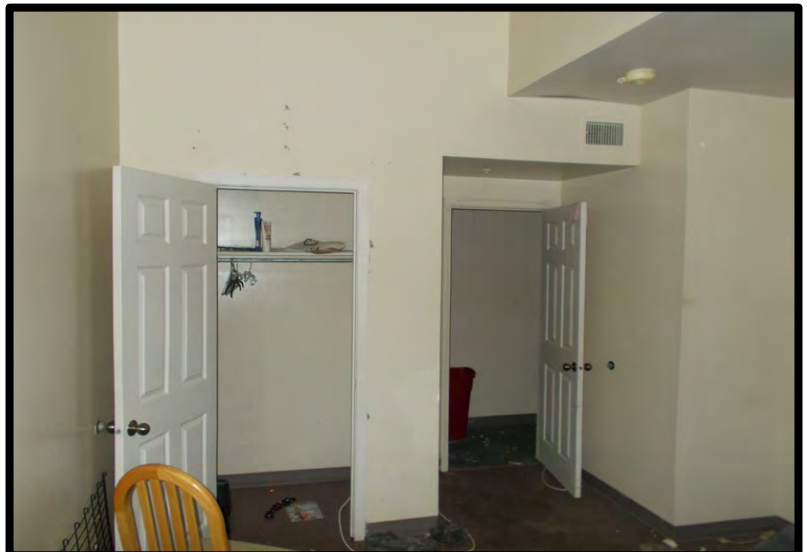
Photo No. 50

View of bedroom #1 closet and entry.

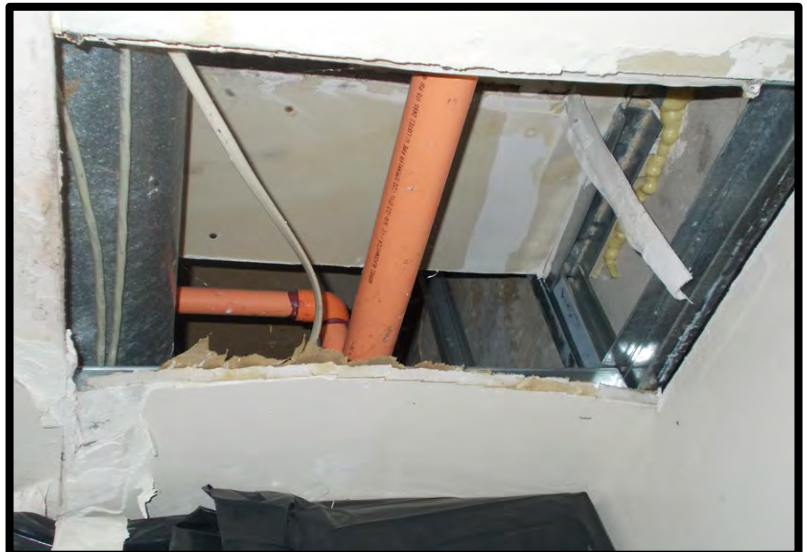
Photo No. 52

Close up view of sprinkler piping within ceiling inside Unit 6.

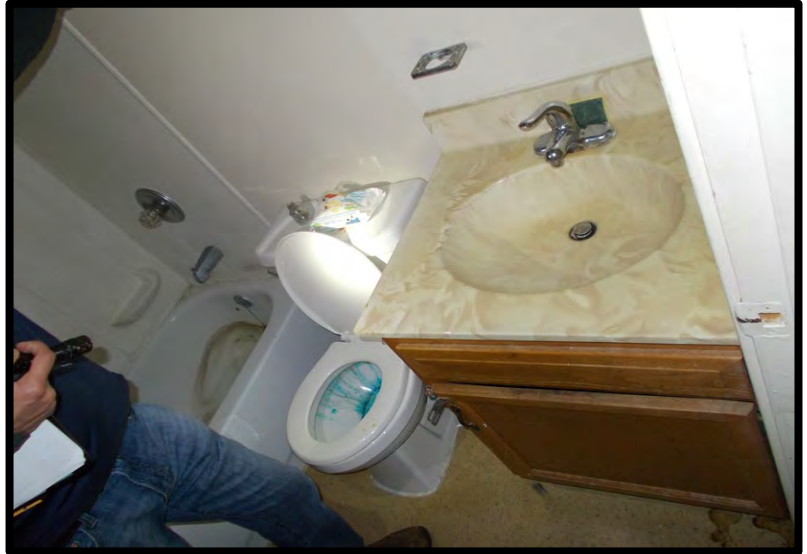
Photo No. 55

View of bathroom located at rear of building Unit #6.

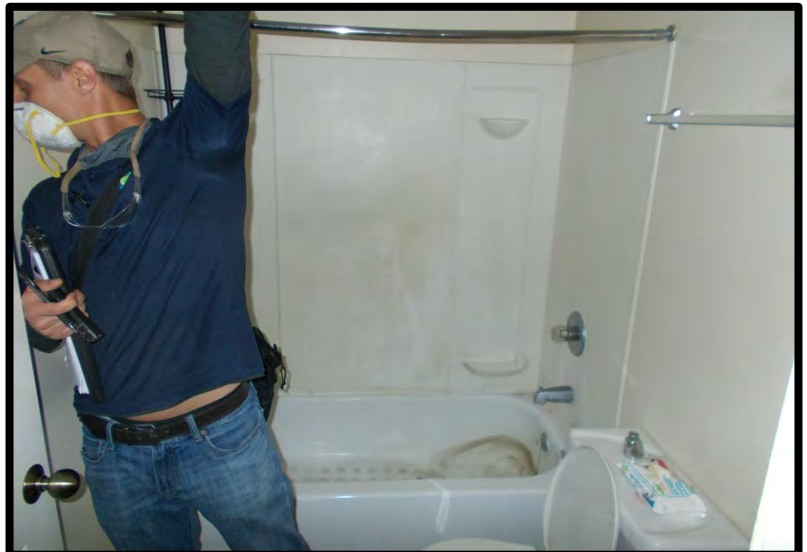
Photo No. 56

View of bathtub and fiberglass surround.

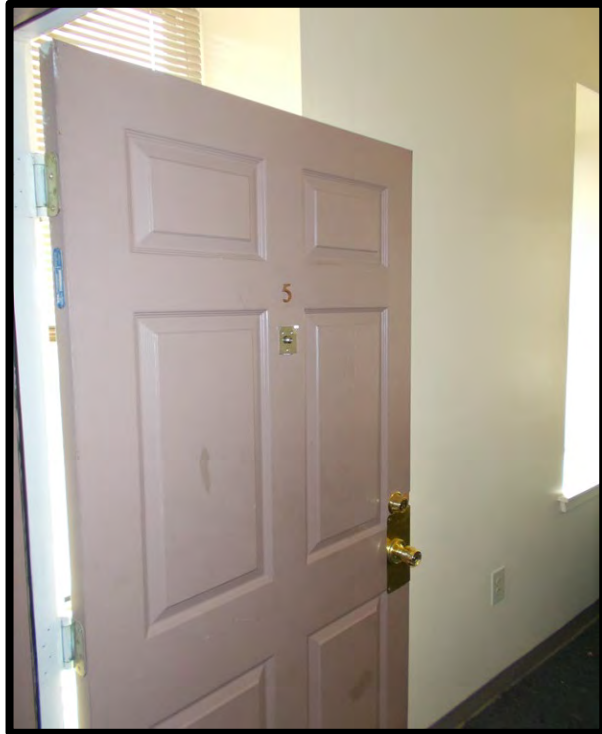
Photo No. 57

View of entry to Unit 5 at second floor.

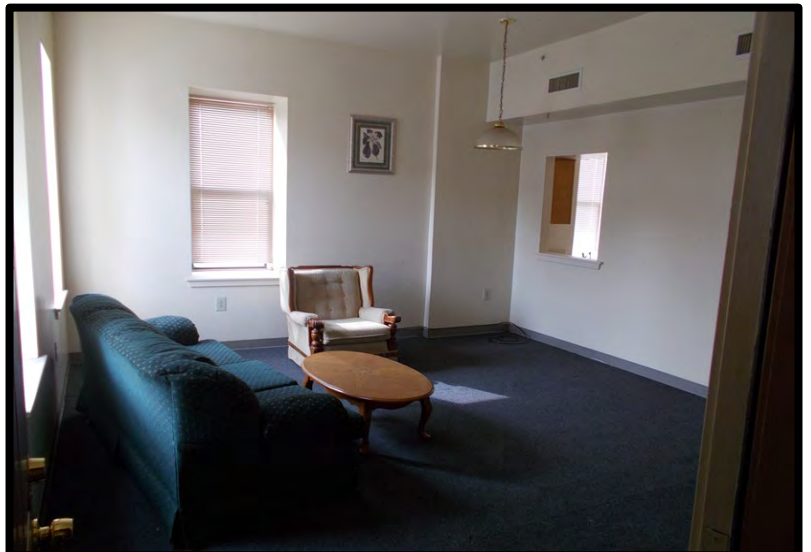
Photo No. 58

View of living room within Unit 5.

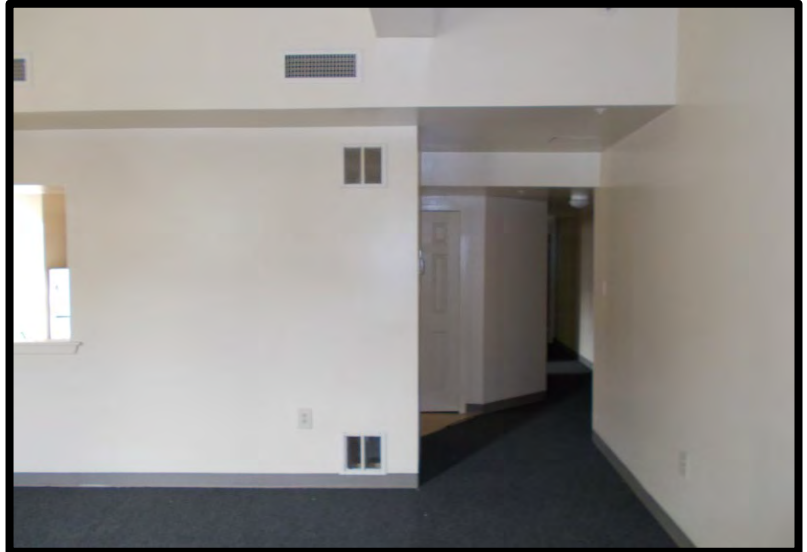
Photo No. 59

Panning right from previous photo. View looking
down towards kitchen and hallway.

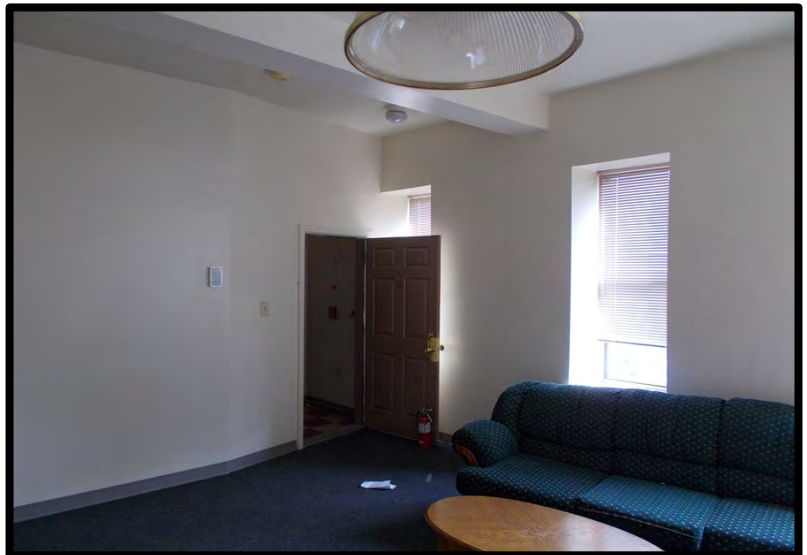
Photo No. 60

View of Unit 5 entry from living room.

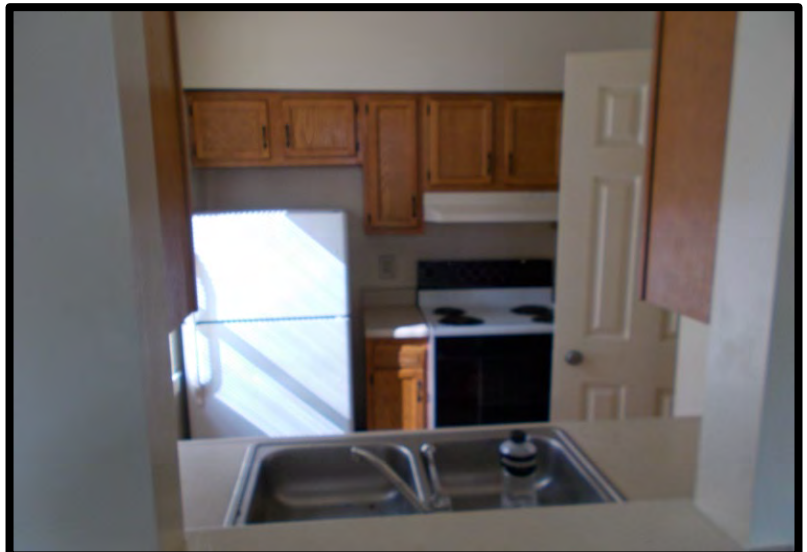
Photo No. 61

View inside kitchen as seen through pass-through in
living room.

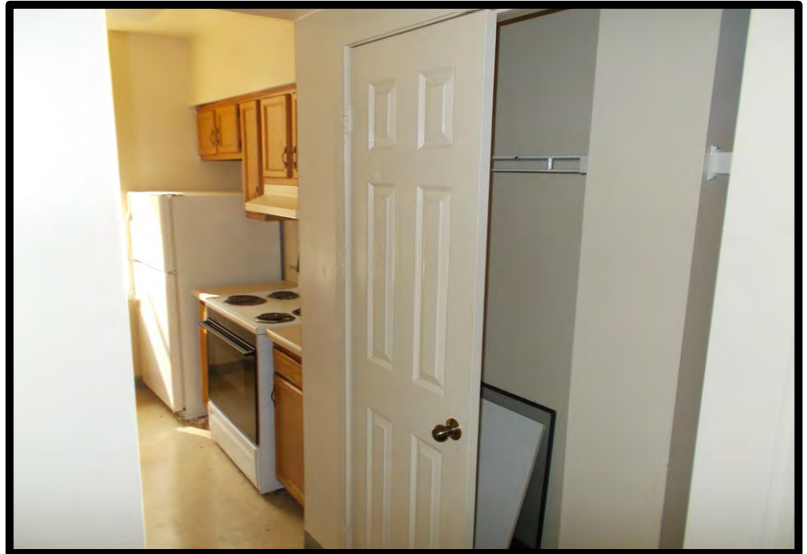
Photo No. 62

View of hall closet and kitchen.

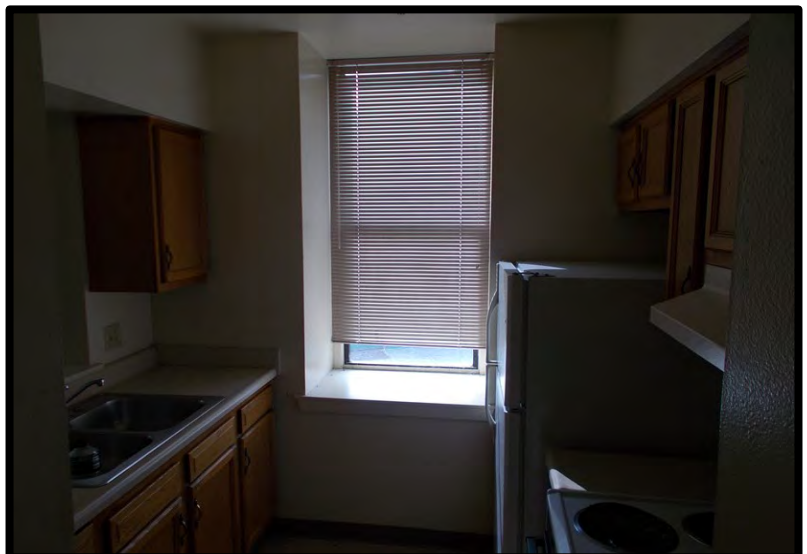
Photo No. 64

Additional view of kitchen.

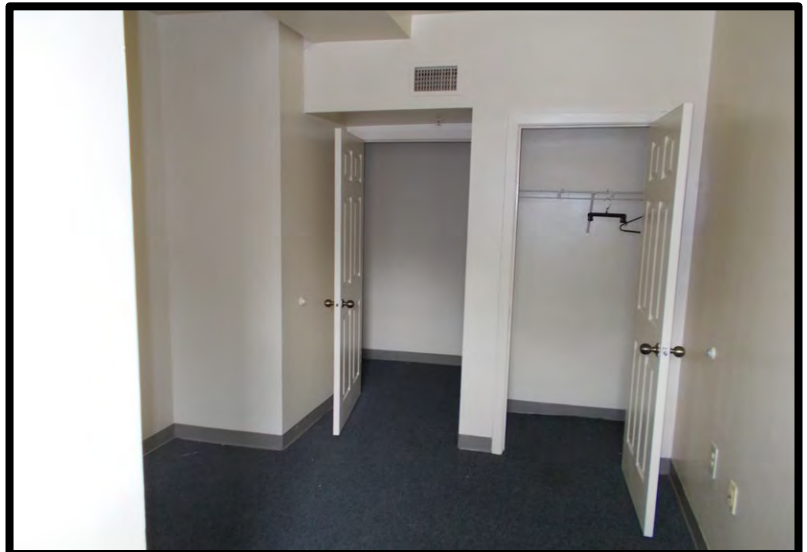
Photo No. 66

View of bedroom #1 closet and entry.

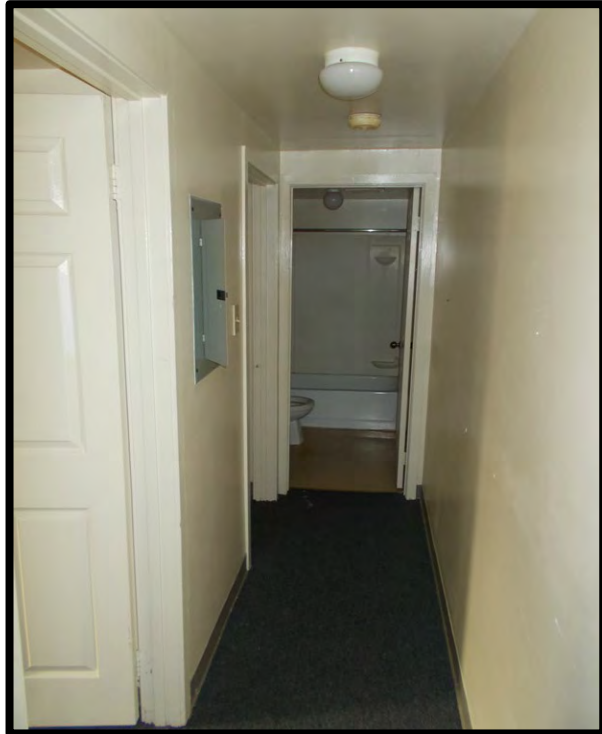
Photo No. 67

View looking towards rear of building at second
bedroom and bathroom.

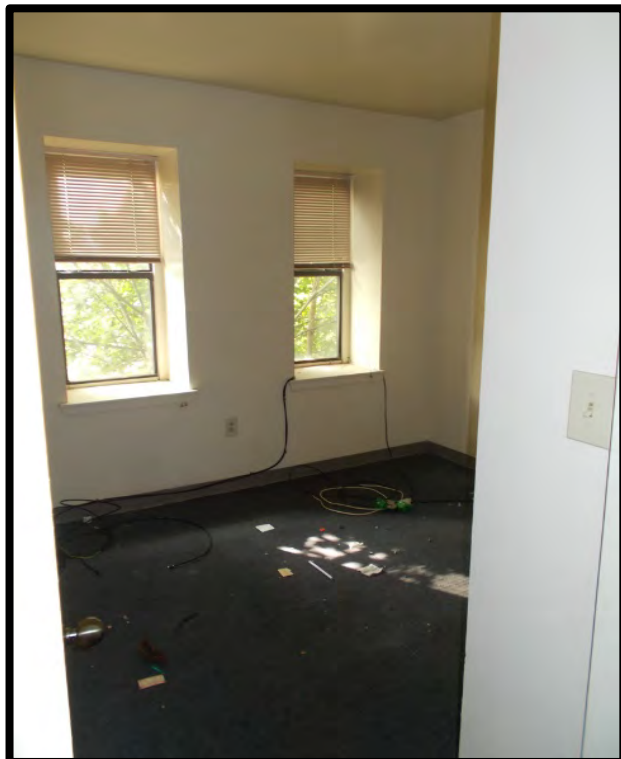
Photo No. 68

View of rear bedroom as seen from hallway.

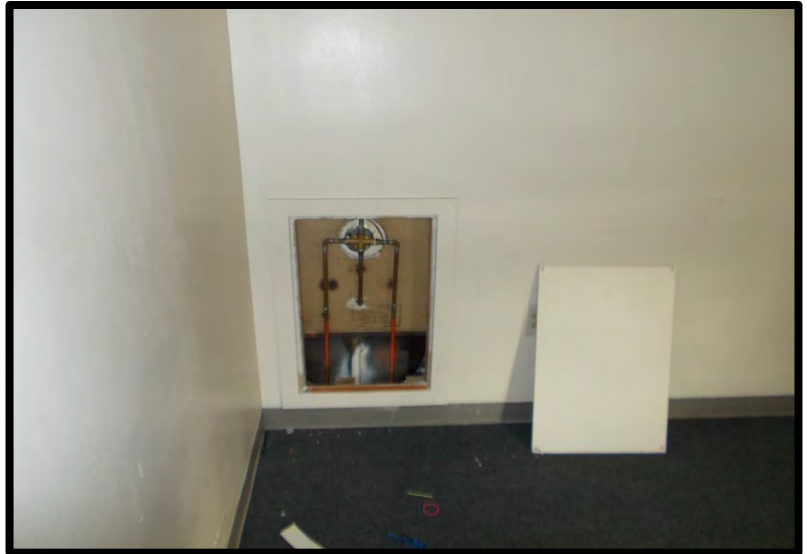
Photo No. 69

View of plumbing access hatch at rear bedroom
behind bathroom.

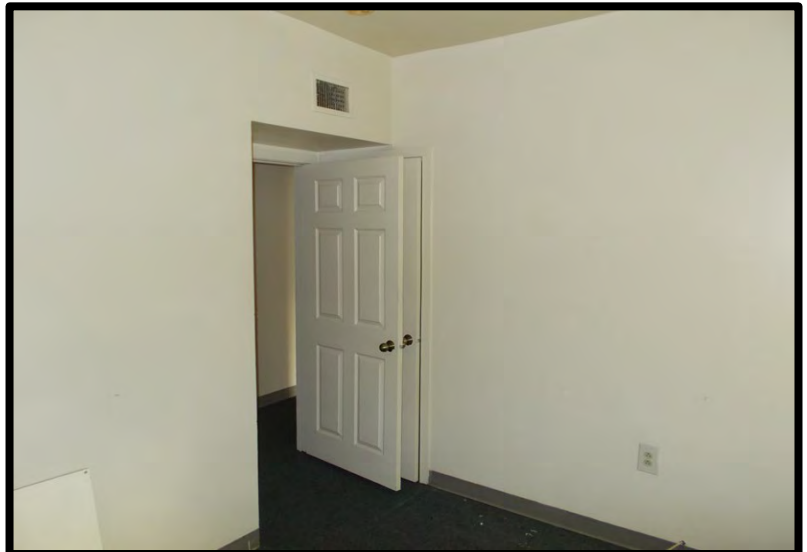
Photo No. 70

View of rear bedroom closet and entry.

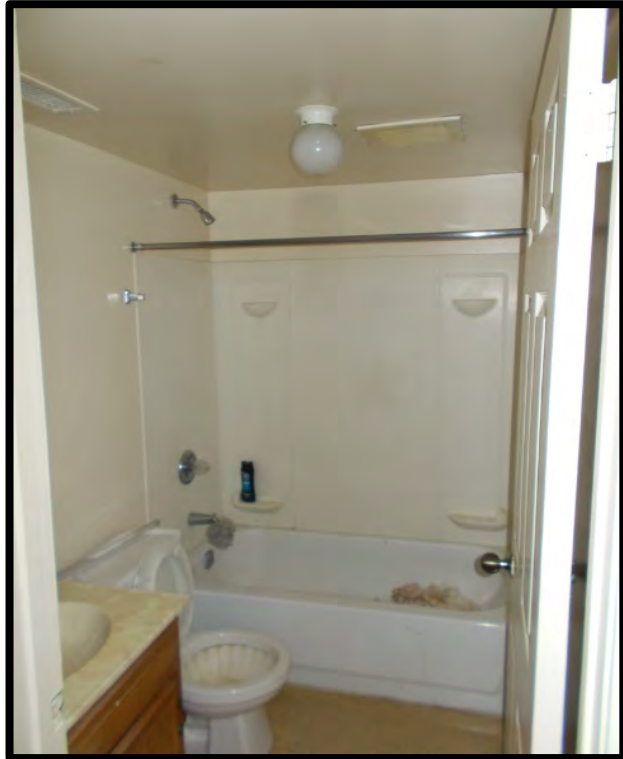
Photo No. 71

View of Unit 5 bathroom.

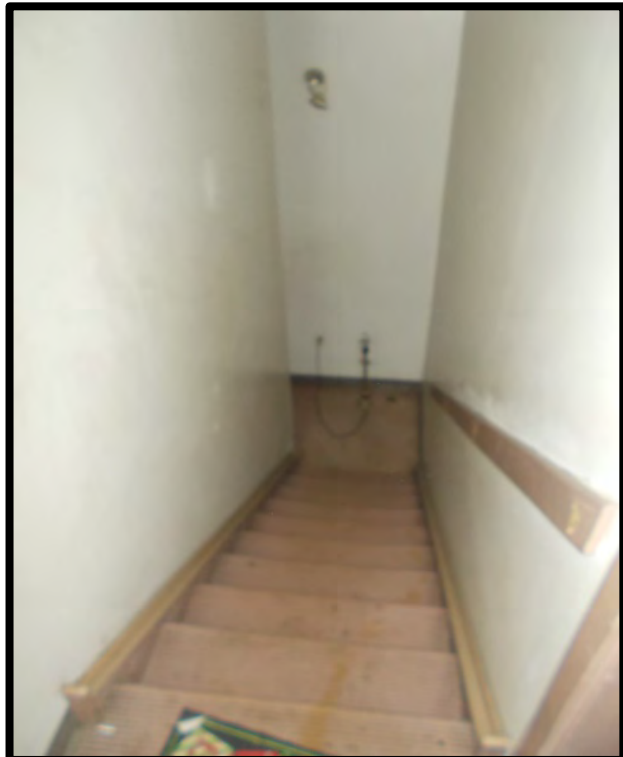
Photo No. 72

View of stairs leading down from third floor.

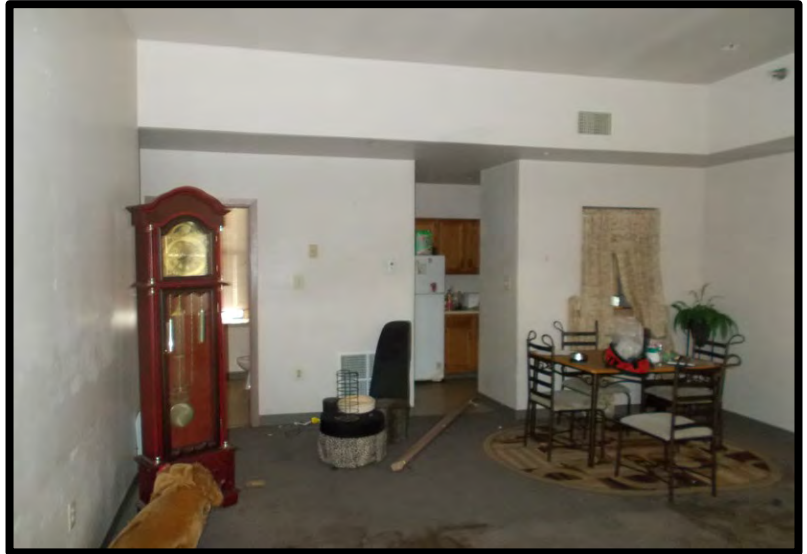
Photo No. 75

Panning left from previous photo. Additional view of living room with kitchen beyond.

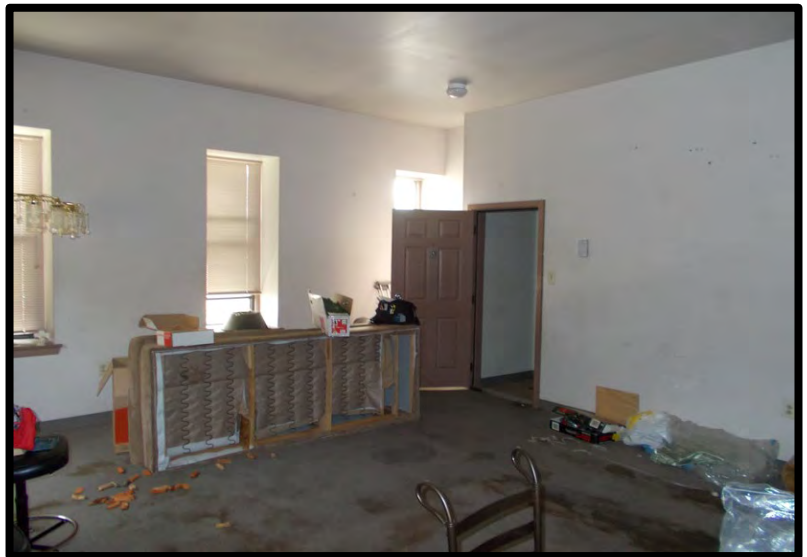
Photo No. 76

Panning 180 degrees from previous photo. View of Unit 7 entry.

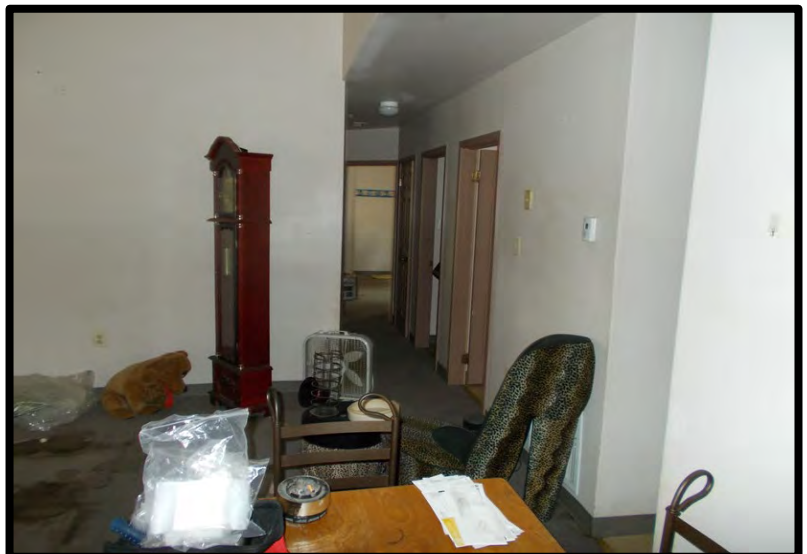
Photo No. 77

View looking south along hallway at bedrooms.

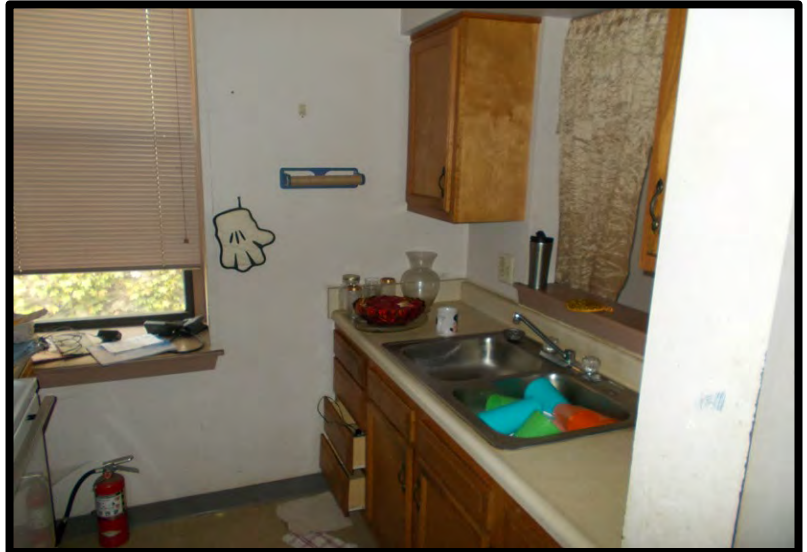
Photo No. 78

View of kitchen in Unit 7.

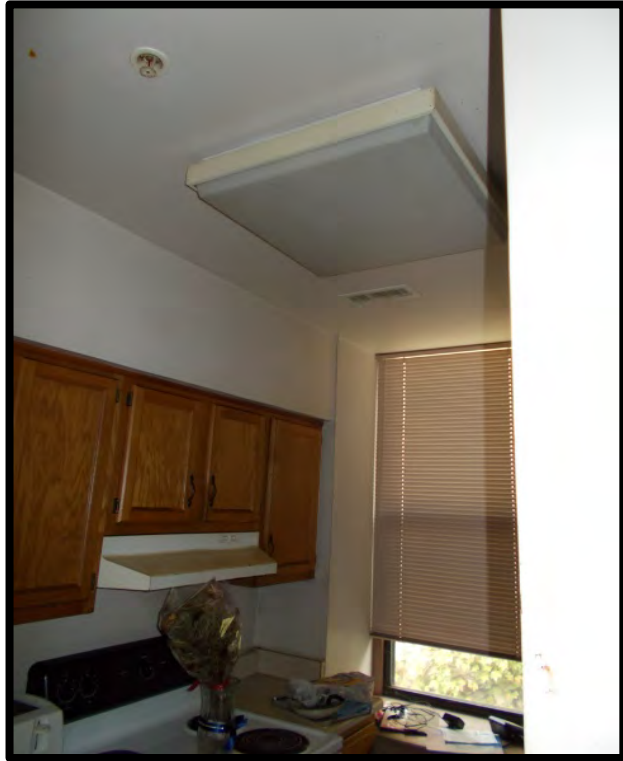
Photo No. 80

Panning up from previous photo indicating existing
lighting and sprinkler head.

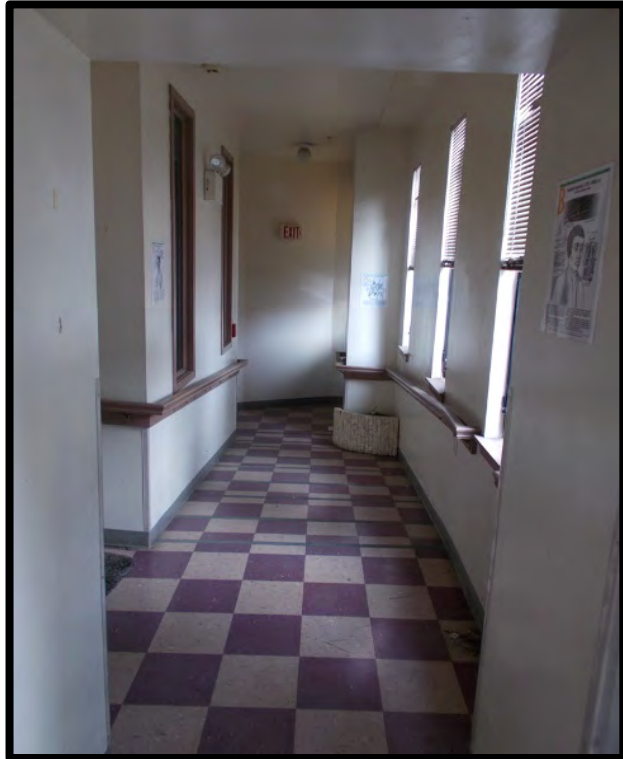
Photo No. 94

View of entry into first floor leasing office located at the north side of 6534 Germantown Avenue. As evident, a sloped hallway leads to a handicap access further down Germantown Avenue.

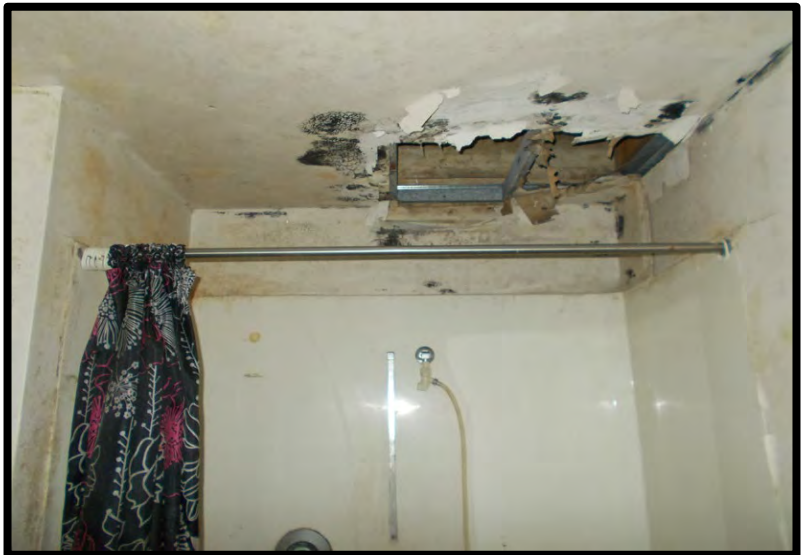
Photo No. 105

View of partially collapsed ceiling above shower.

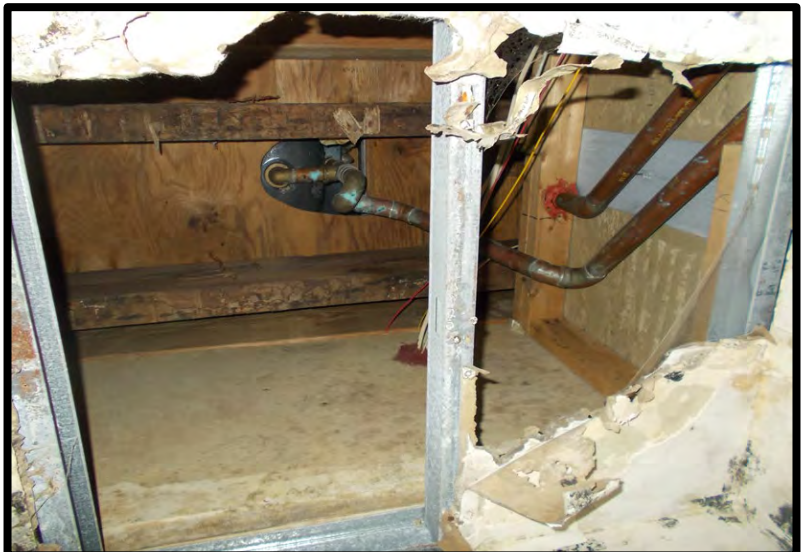
Photo No. 106

View through partially collapsed ceiling to bathroom above. This is the underside of Unit 2 above.

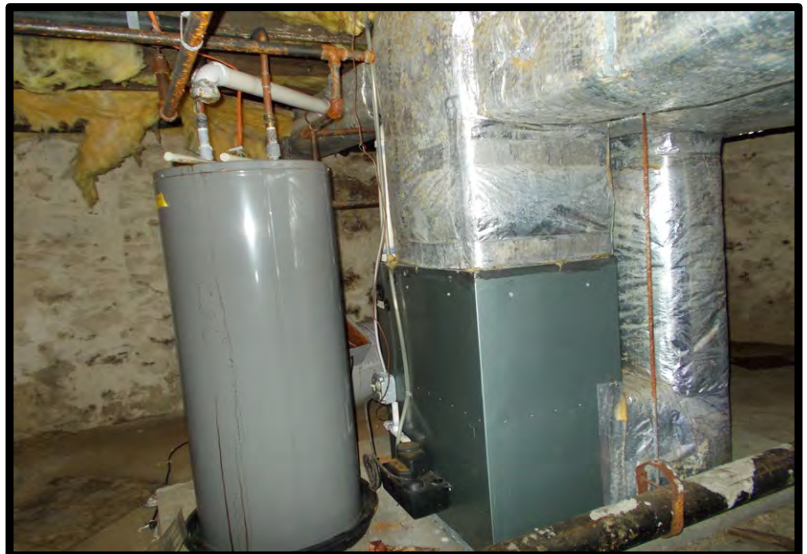
Photo No. 122

Additional mechanical equipment for separate unit
within 6534 Germantown Avenue.

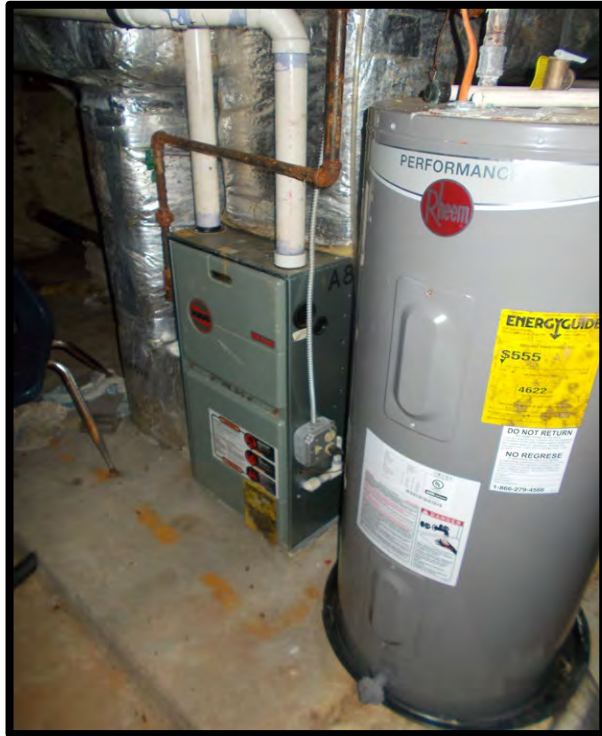
Photo No. 123

Additional photo of mechanical equipment.

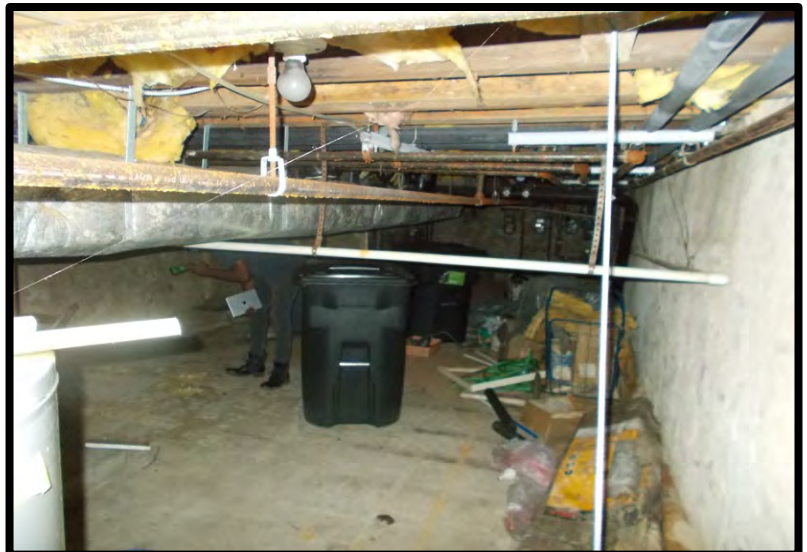
Photo No. 124

Depicts overall view of basement below 6534
Germantown Avenue.

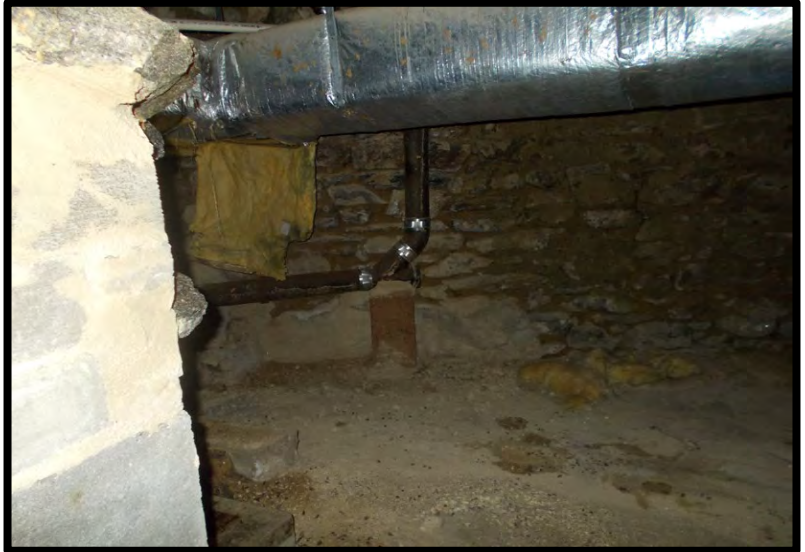
Photo No. 125

Depicts view of cast iron sanitary piping.

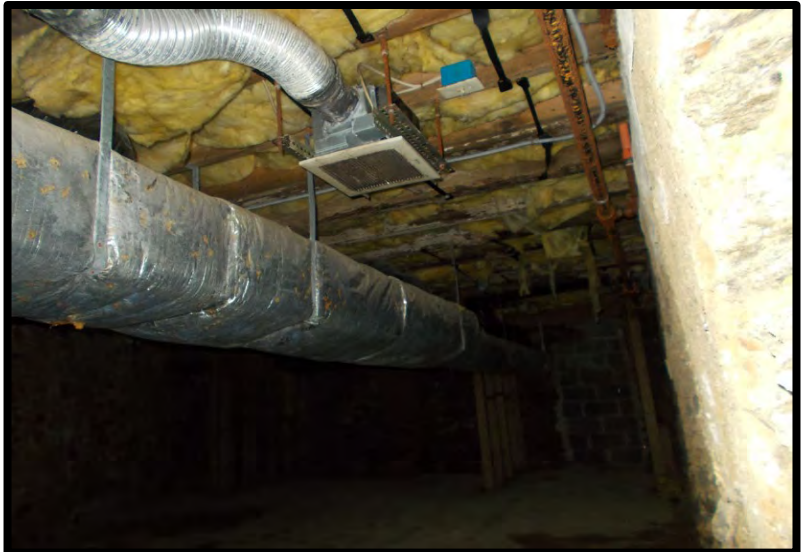
Photo No. 126

Depicts additional area in basement of 6534
Germantown Avenue.

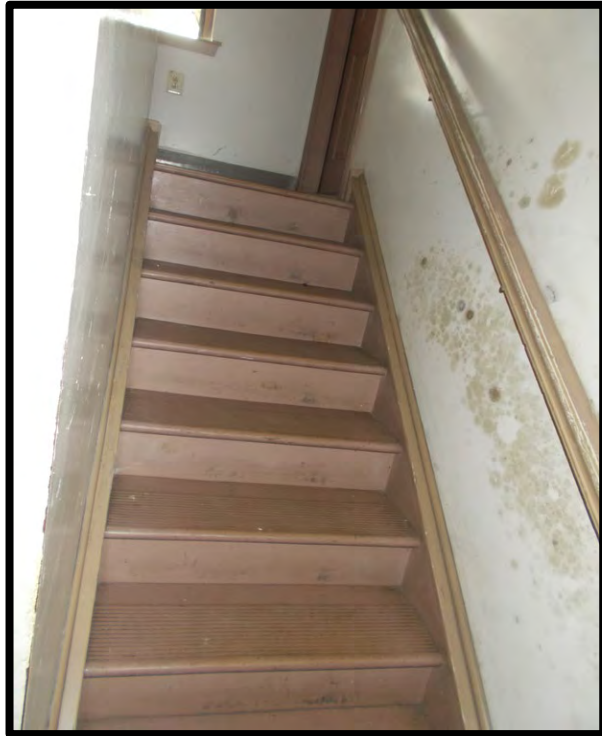
Photo No. 127

Depicts view of stairs leading to second floor of 6534
Germantown Avenue.

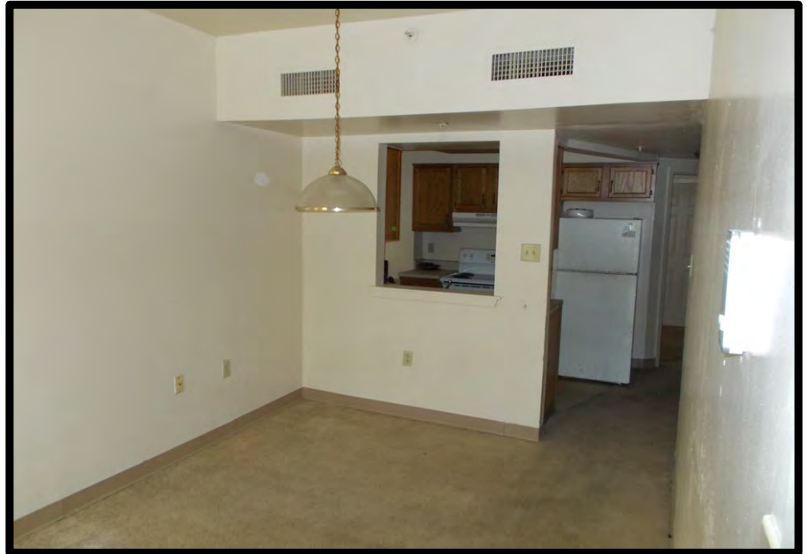
Photo No. 129

View of living room as seen from Unit 2 entry.

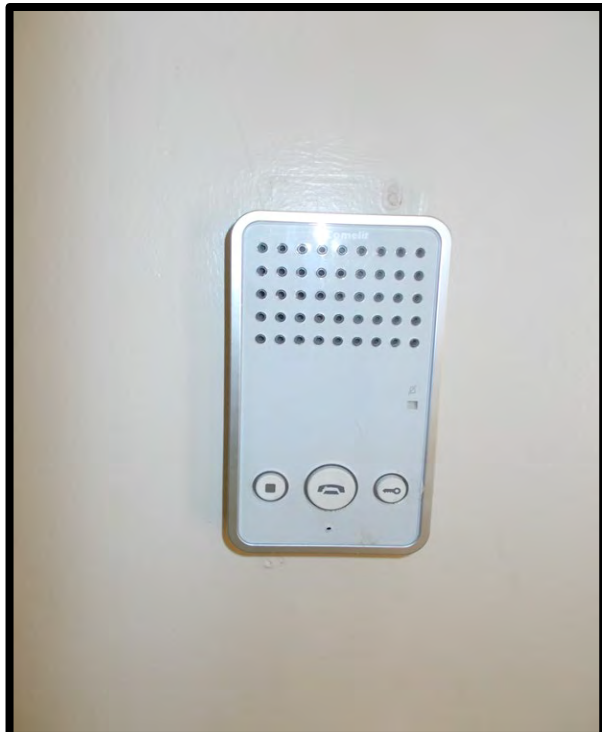
Photo No. 130

Detailed view of intercom system, typical for all units.

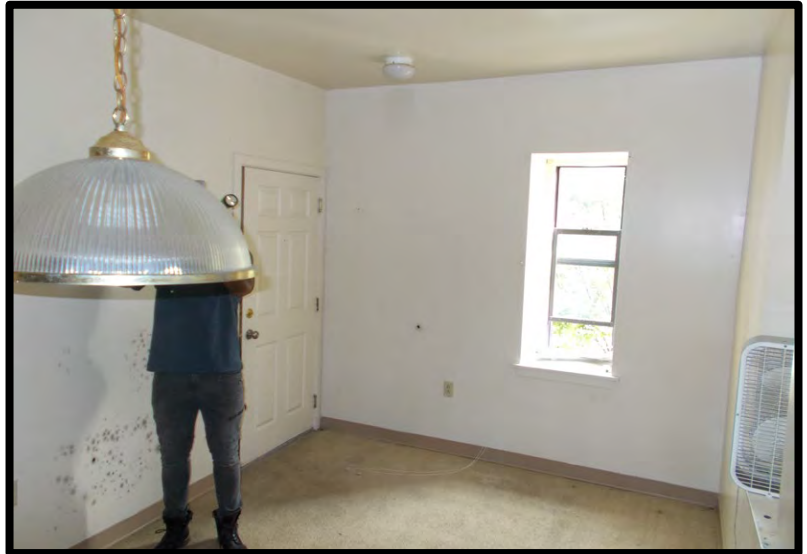
Photo No. 131

View of Unit 2 entry facing Germantown Avenue.

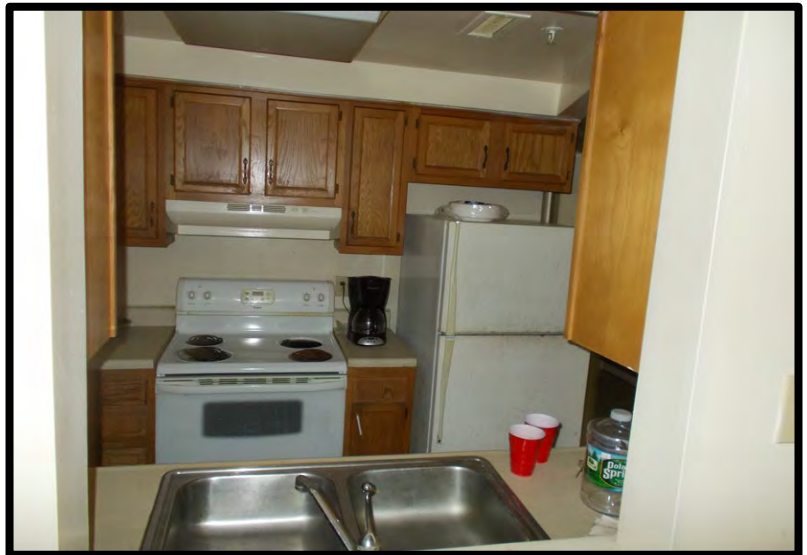
Photo No. 132

View inside kitchen through pass-through from living room of Unit 2.

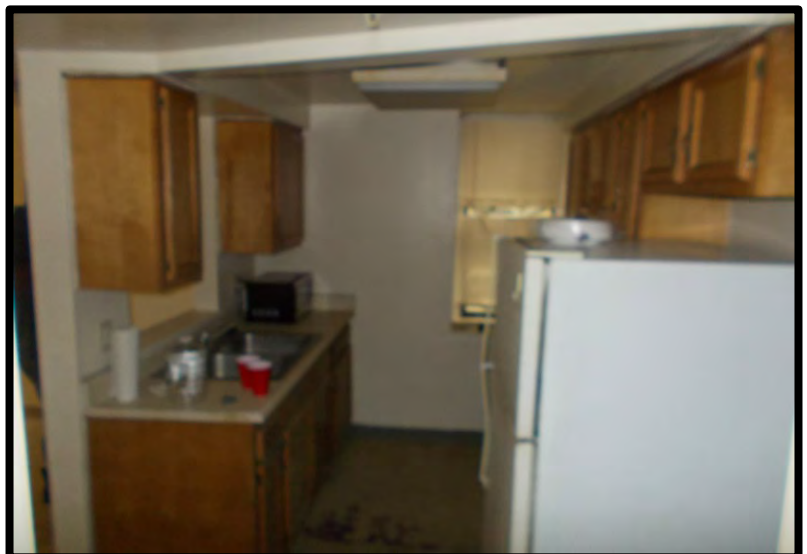
Photo No. 133

Additional view of kitchen from hallway.

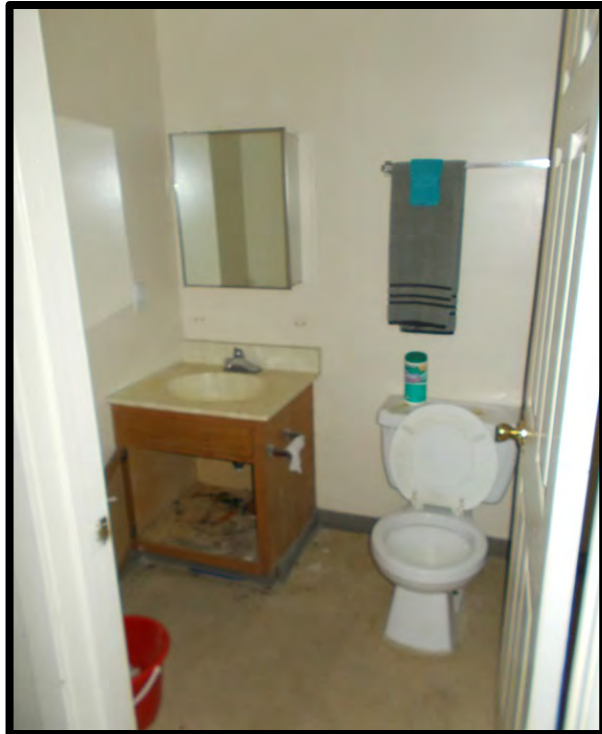
Photo No. 134

View of bathroom located opposite kitchen in Unit 2.

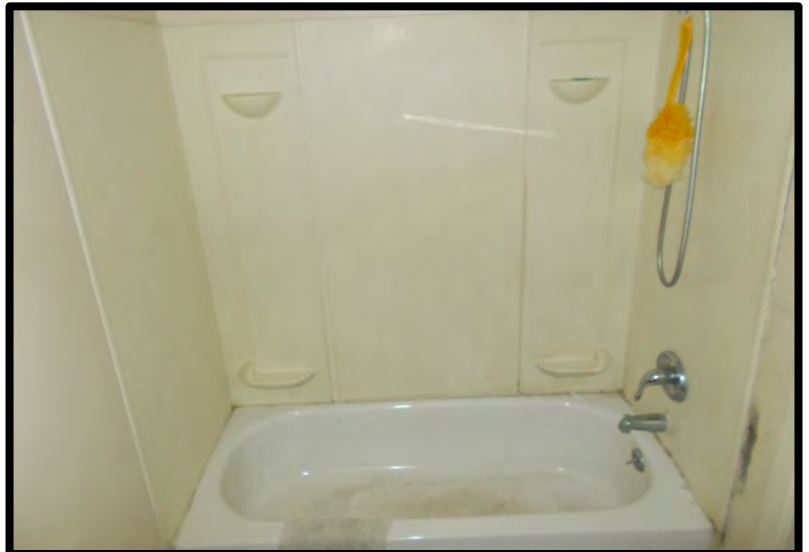
Photo No. 135

View of bathtub and fiberglass surround within bathroom.

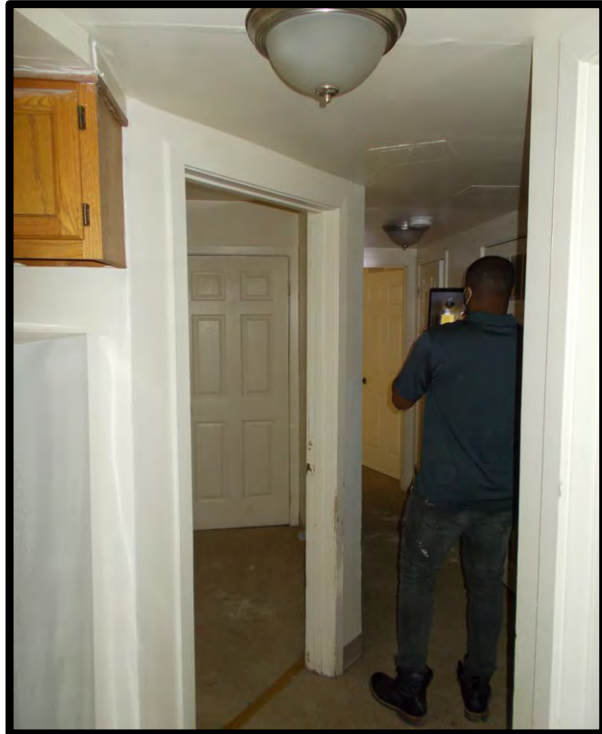
Photo No. 136

View of bedroom 1 entry from hallway/kitchen.
