Germantown/Mount Airy Properties

Physical Conditions and Needs Assessment

Premises A

6526-34 Germantown Ave

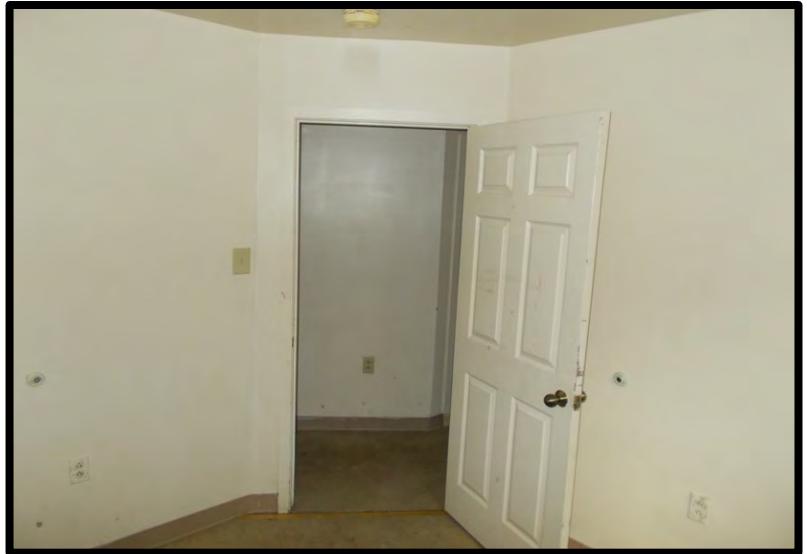
Photo No. 138

View of bedroom 1 entry.

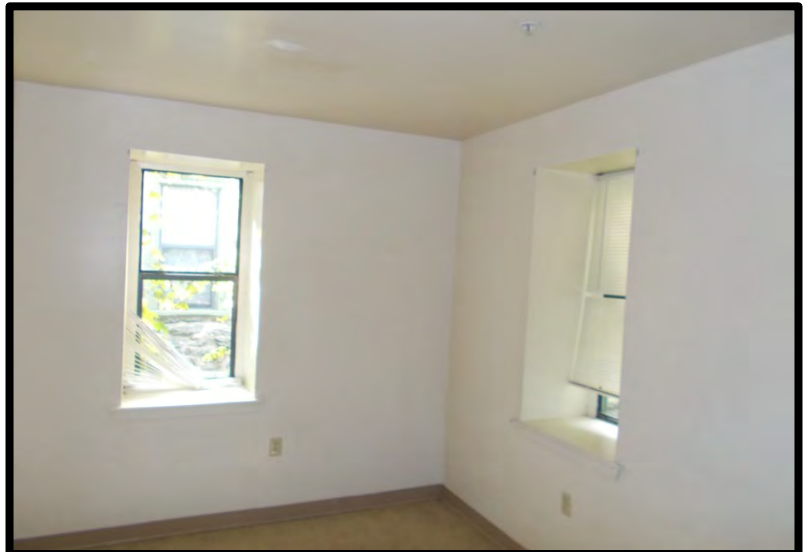
Photo No. 141

Interior view of bedroom 2.

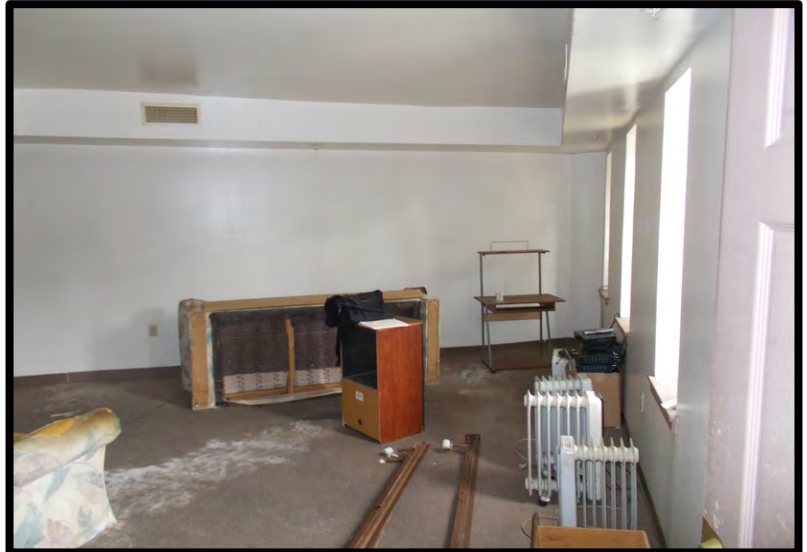
Photo No. 144

View of living room as seen from apartment entry Unit 3.

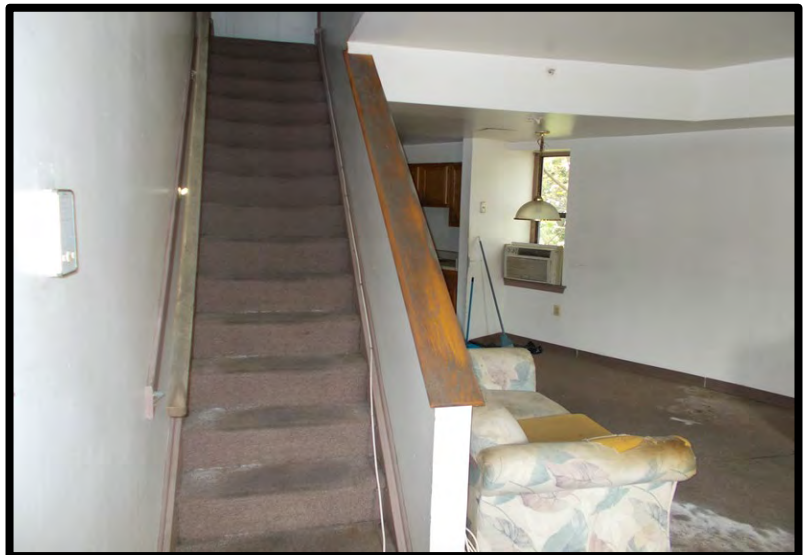
Photo No. 145

Panning left from previous photo. View of living room with kitchen beyond and stairs leading to second floor bedrooms in Unit 3 for 6534 Germantown Avenue.

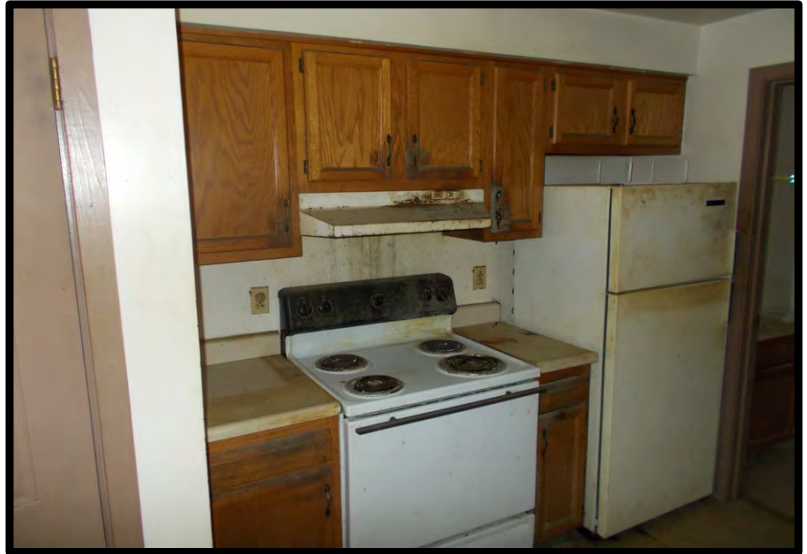
Photo No. 147

View of kitchen.

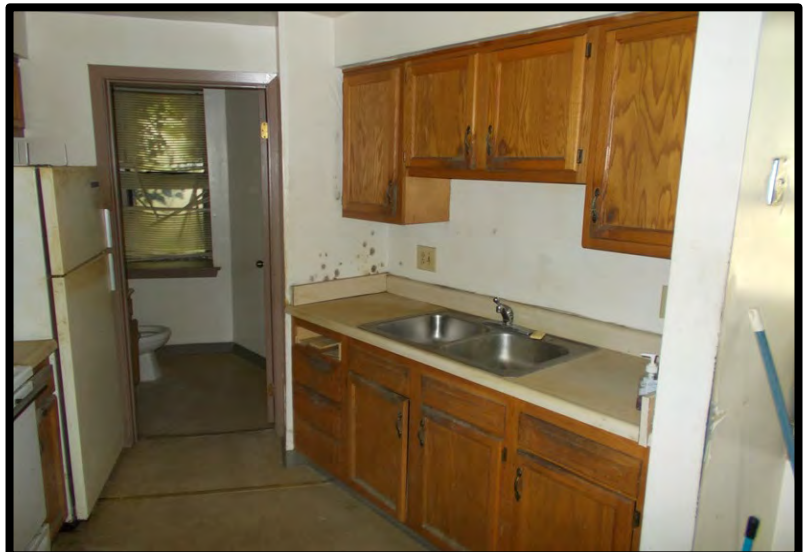
Photo No. 148

Panning right from previous photo. View of kitchen.

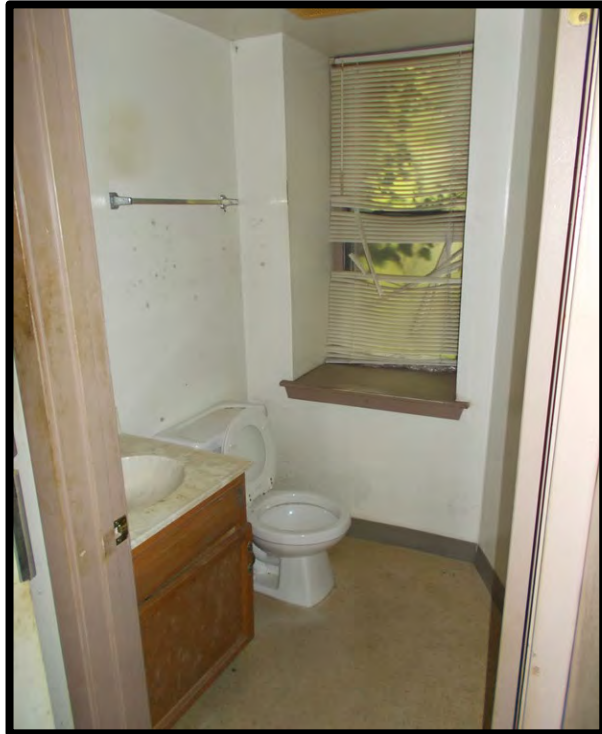
Photo No. 149

View of half bath located at rear of Unit 3 second floor
6534 Germantown Avenue.

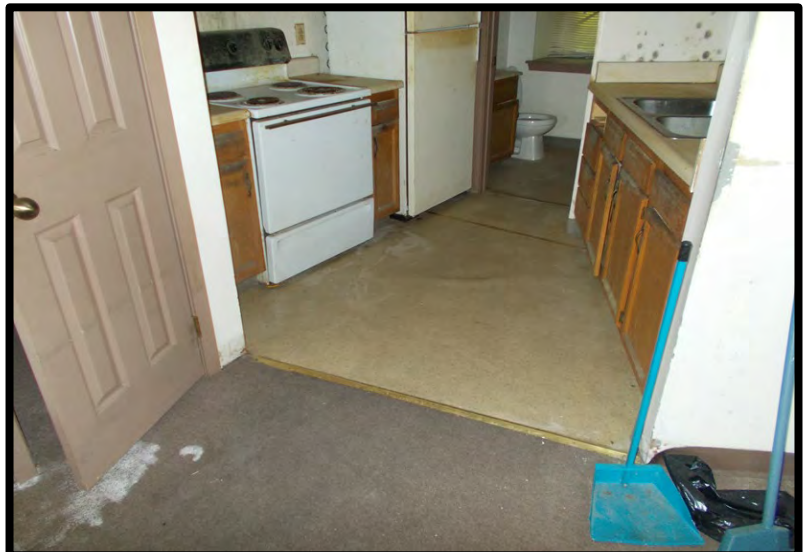
Photo No. 150

View of overall condition of kitchen flooring.

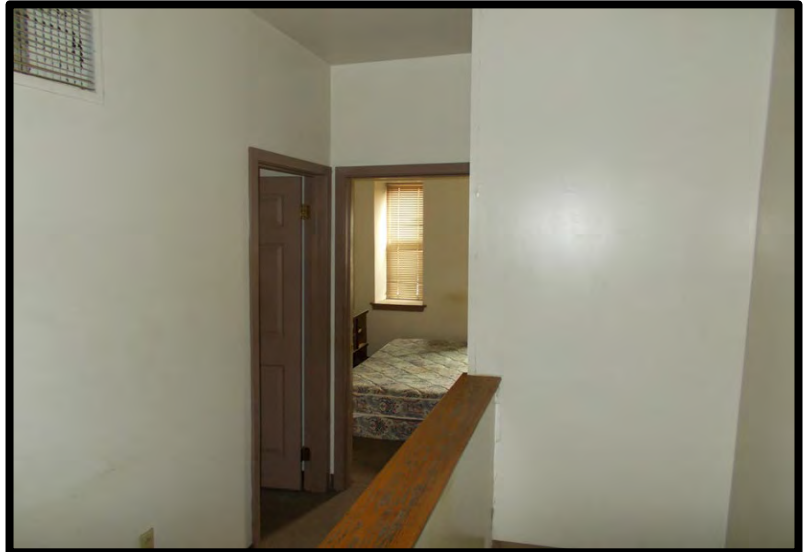
Photo No. 151

View looking towards Germantown Avenue from third floor stairs towards bedroom 1 straight ahead and bedroom 2 to the left.

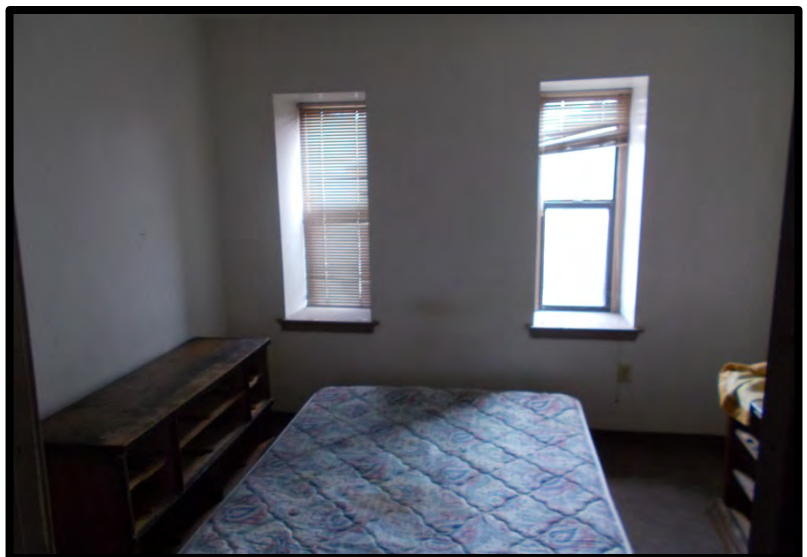
Photo No. 152

View of bedroom 1 interior facing Germantown Avenue.

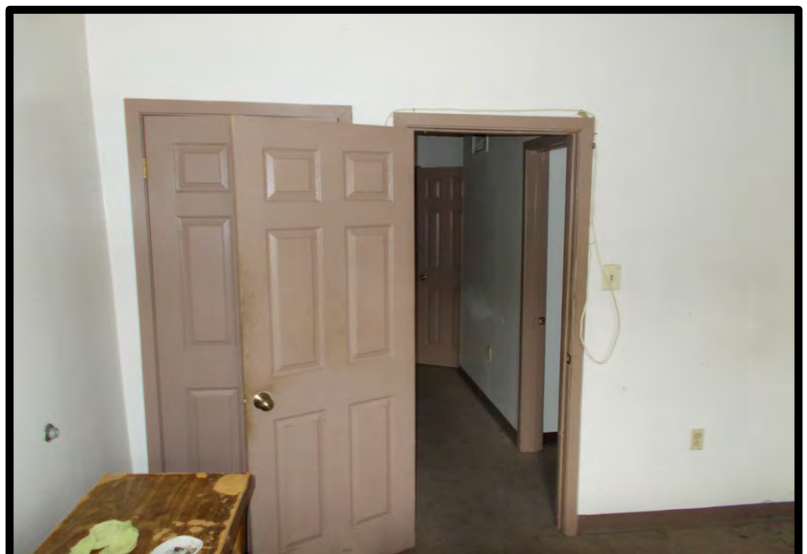
Photo No. 153

Panning 180 degrees from previous photo. View of bedroom 1 entry and closet.

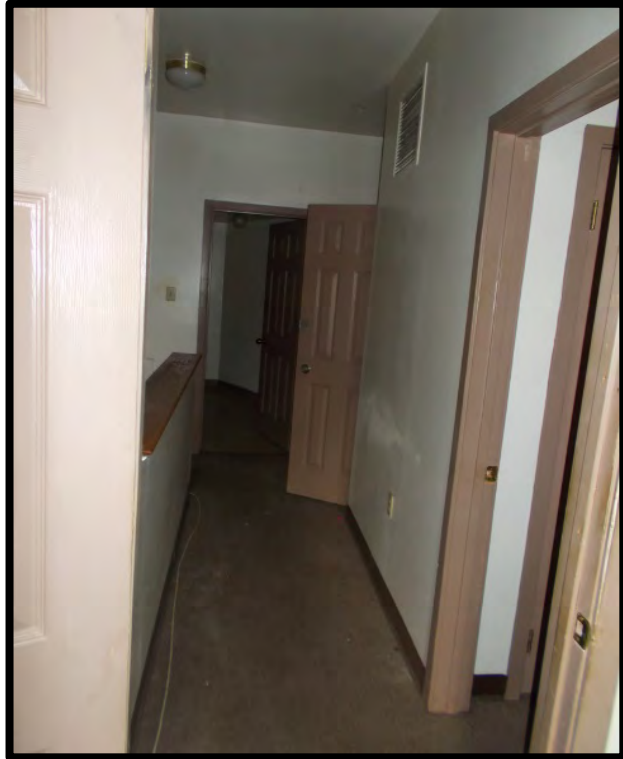
Photo No. 154

View looking west along hallway towards rear of
building from bedroom 1.

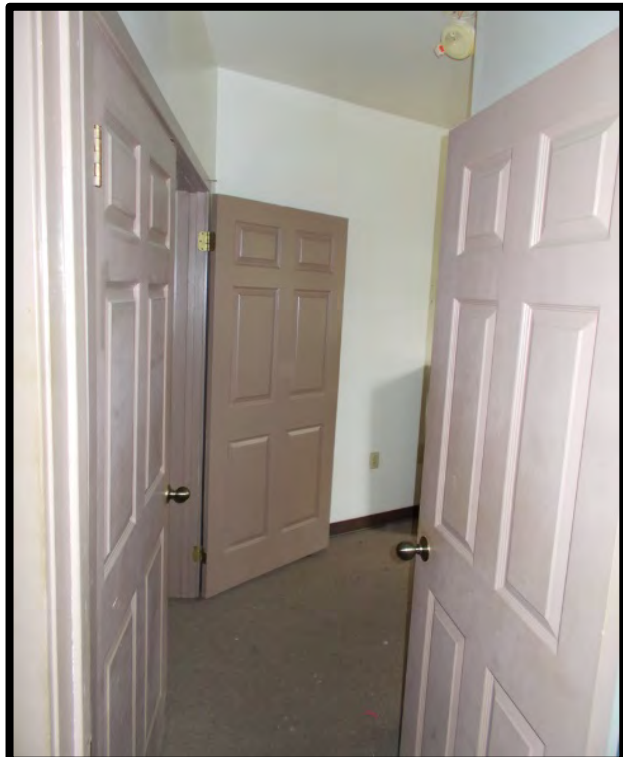
Photo No. 155

View looking into bedroom 2 from hallway.

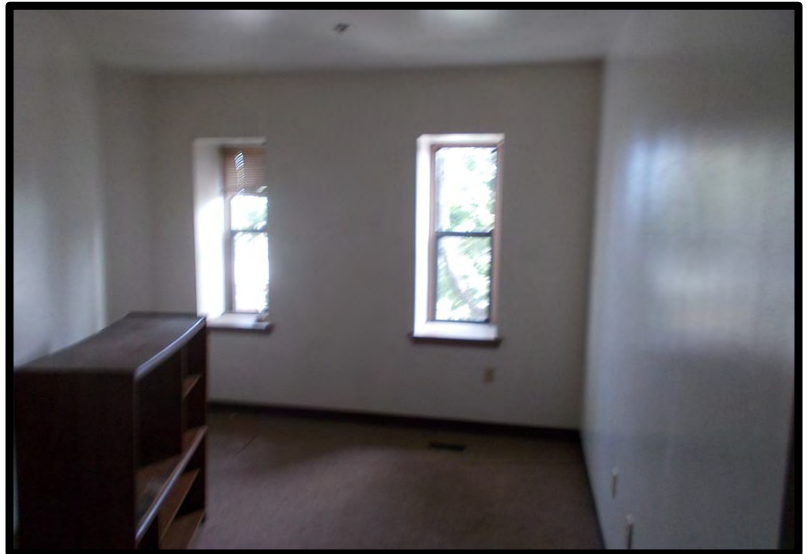
Photo No. 156

View of bedroom 2 facing Germantown Avenue.

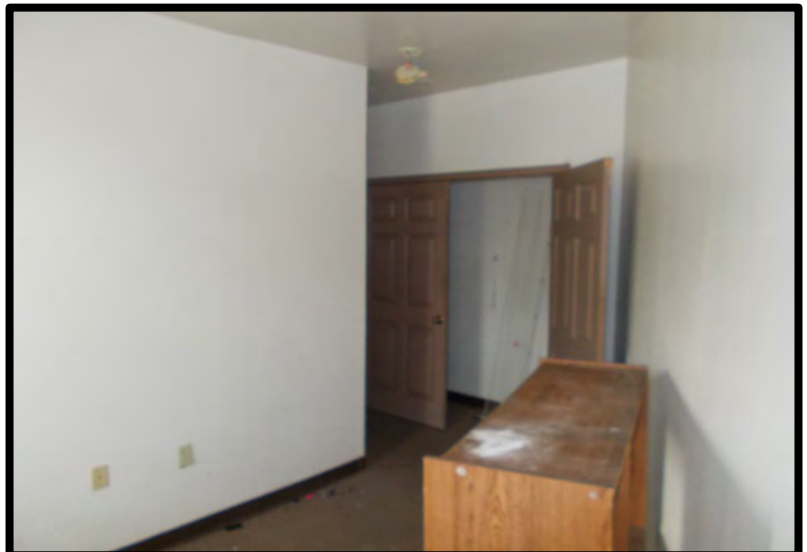
Photo No. 157

Panning 180 degrees from previous photo. View of
bedroom 2 entry and closet.

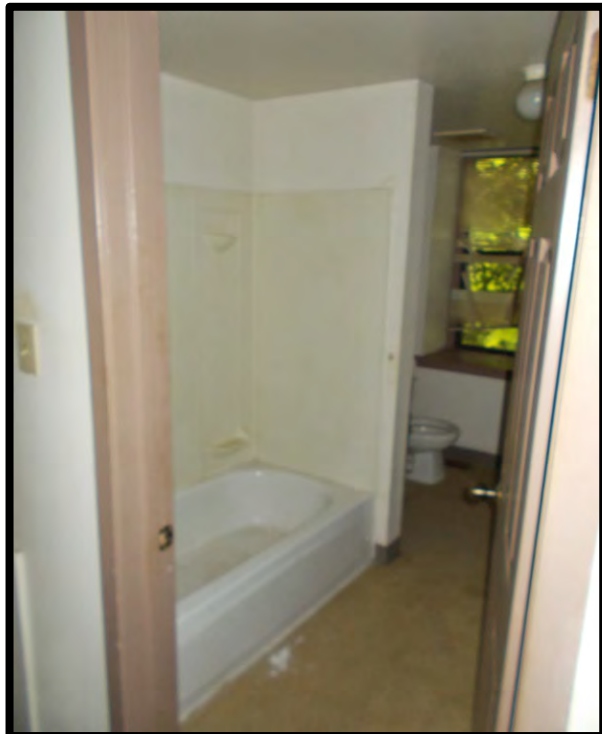
Photo No. 159

View of bathroom located at rear of Unit 3.

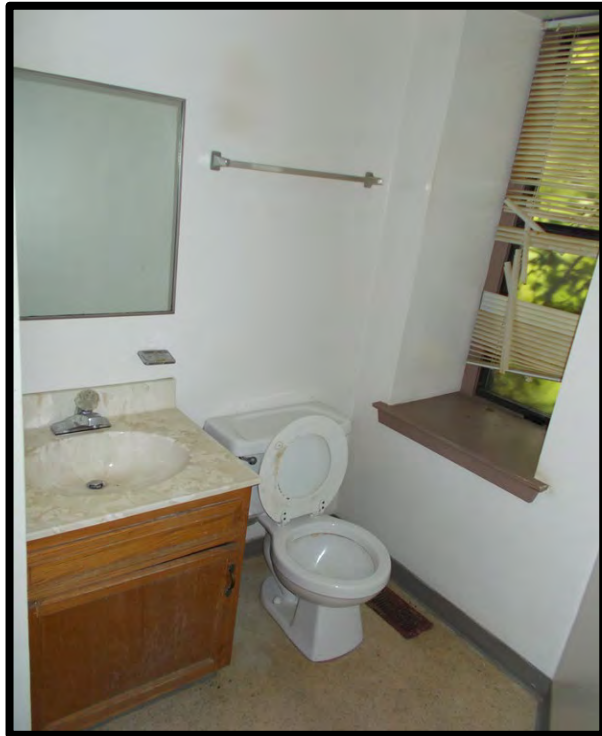
Photo No. 160

Detailed view of vanity and water closet.

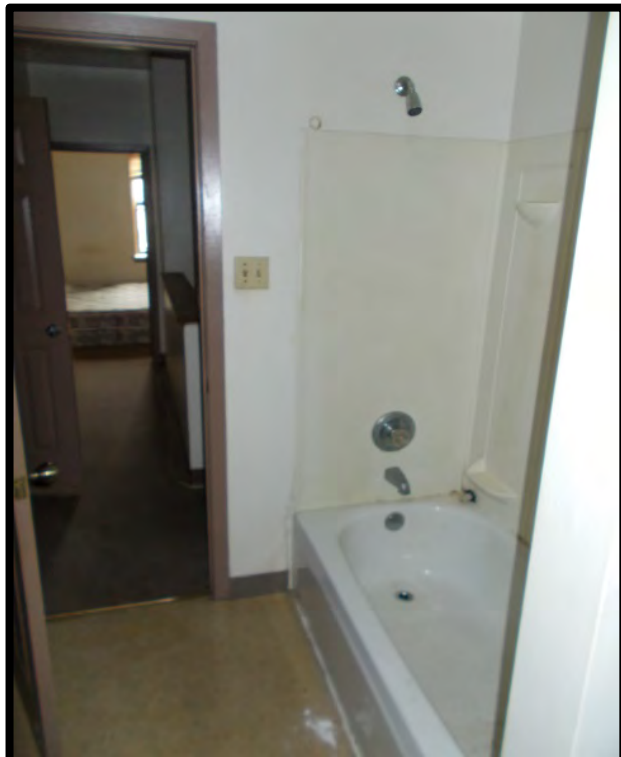
Photo No. 161

View of bathtub and fiberglass surround in Unit 3
6534 Germantown Avenue.

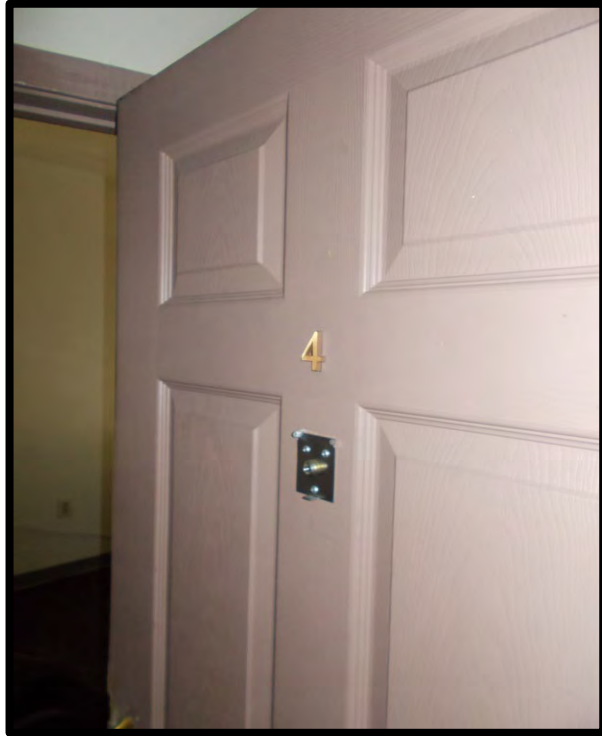
Photo No. 164

View of Unit 4 entry 6534 Germantown Avenue.

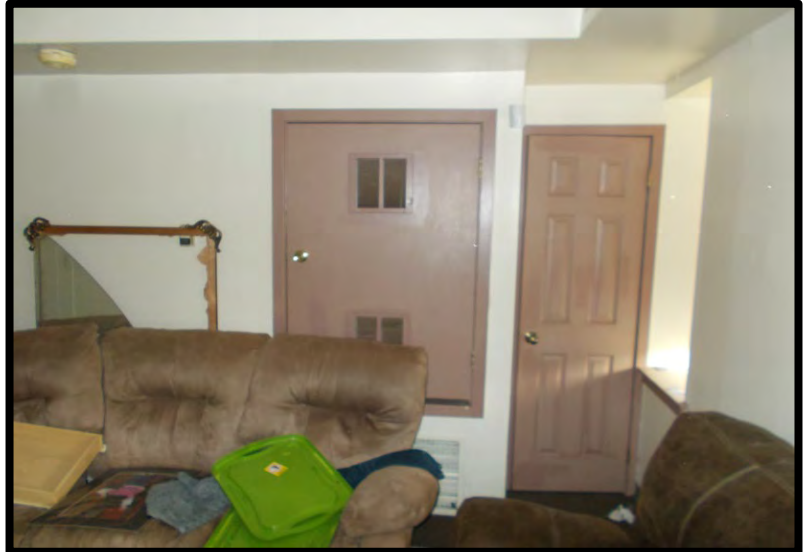
Photo No. 166

View of mechanical closet and storage closet located at the front of Unit 4. Germantown Avenue is to the right of photo.

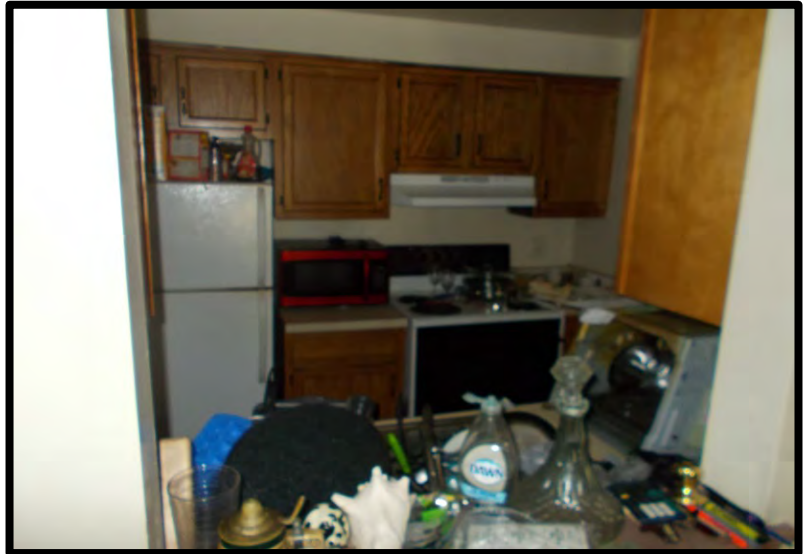
Photo No. 169

Detailed view of interior of kitchen.

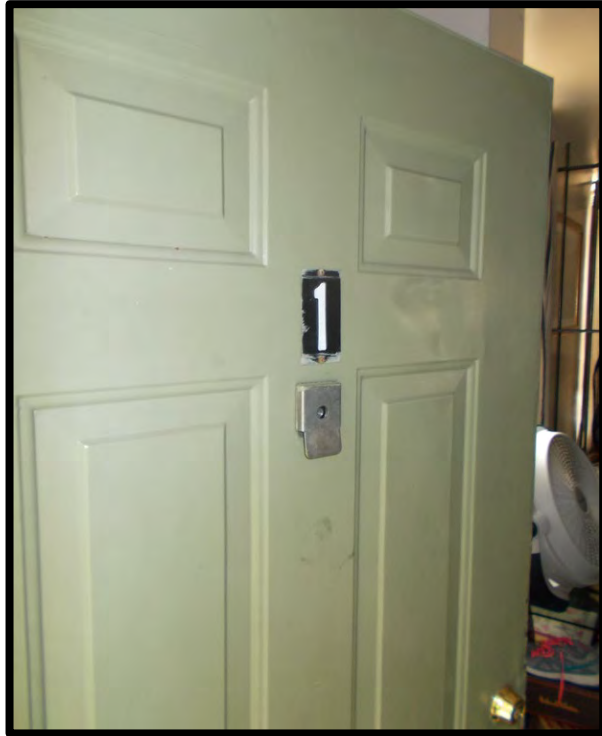
Photo No. 178

View of Unit 1 entry 6526 Germantown Avenue.

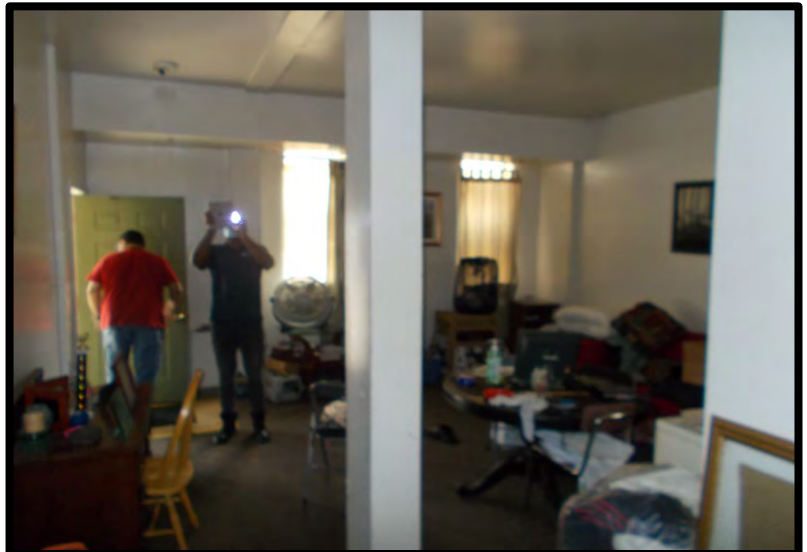
Photo No. 181

Overall view of living room with apartment entry.

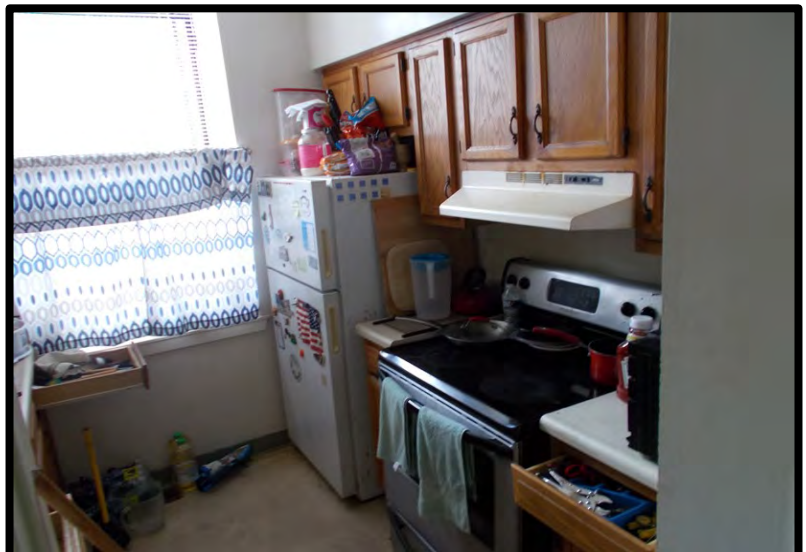
Photo No. 183

View of kitchen cabinets.

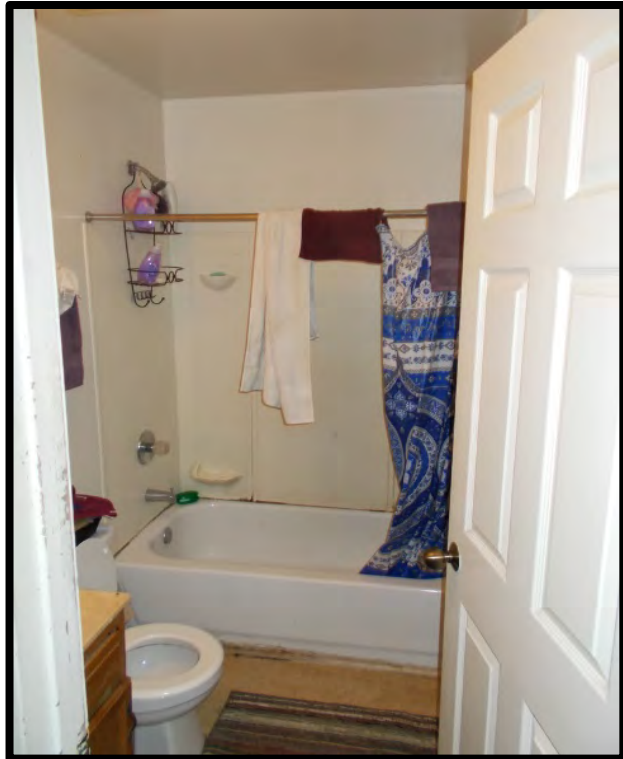
Photo No. 188

View of bathroom within Unit 1 6526 Germantown
Avenue as seen from hallway.

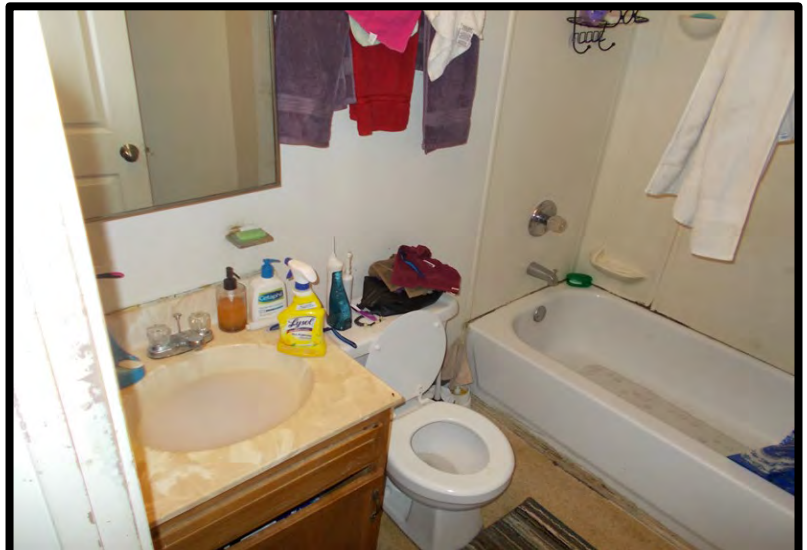
Photo No. 189

Detailed view of vanity, water closet and bathtub.

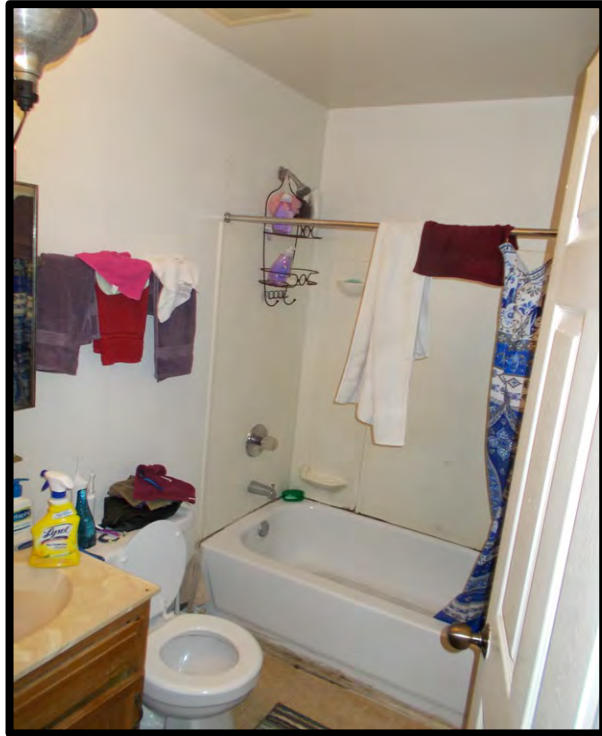
Photo No. 190

Additional view of bathroom.

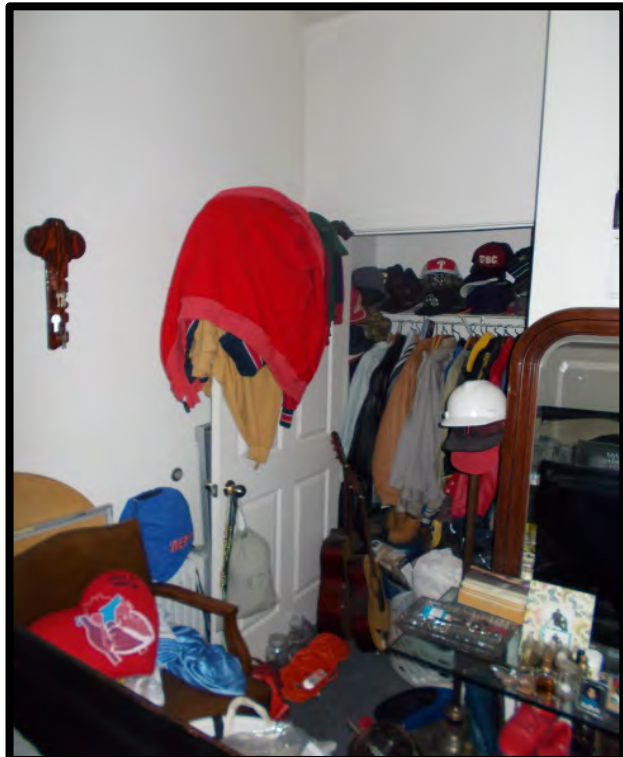
Photo No. 193

View of bedroom 1 closet.

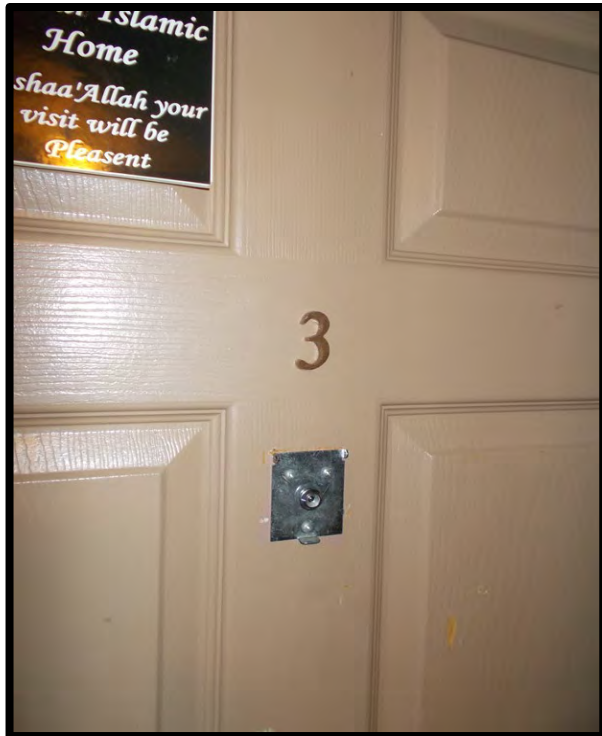
Photo No. 200

View of Unit 3 entry 6526 Germantown Avenue.

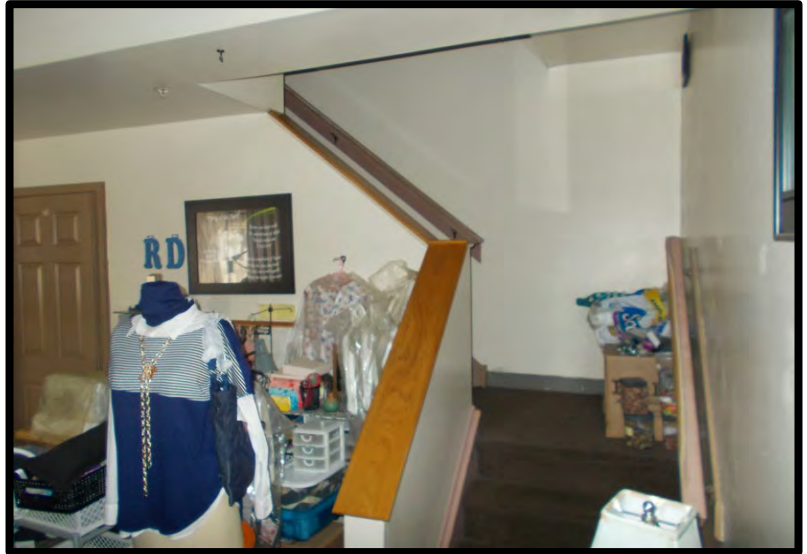
Photo No. 202

Panning right from previous photo. View of stairs
leading to second floor bedrooms Unit 3 6526
Germantown Avenue.

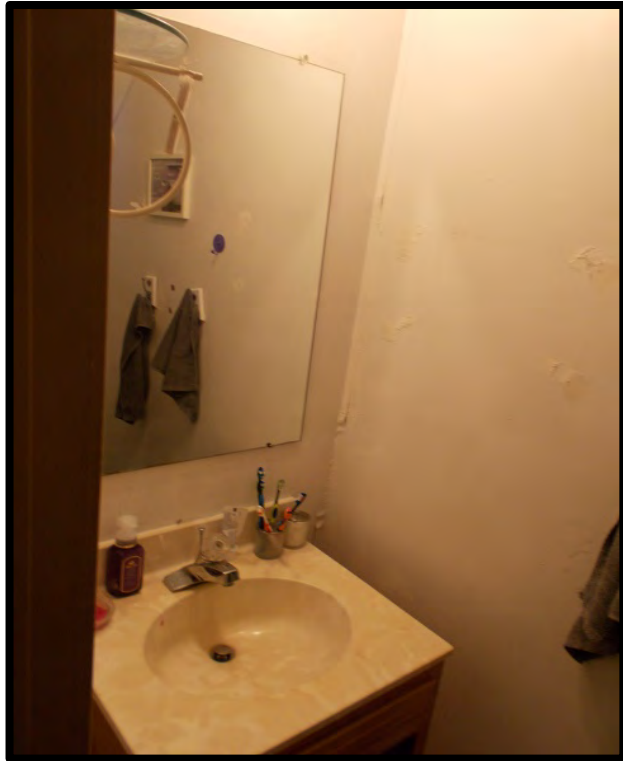
Photo No. 204

View of vanity for half bath located on the first floor of
Unit 3 below stairs.

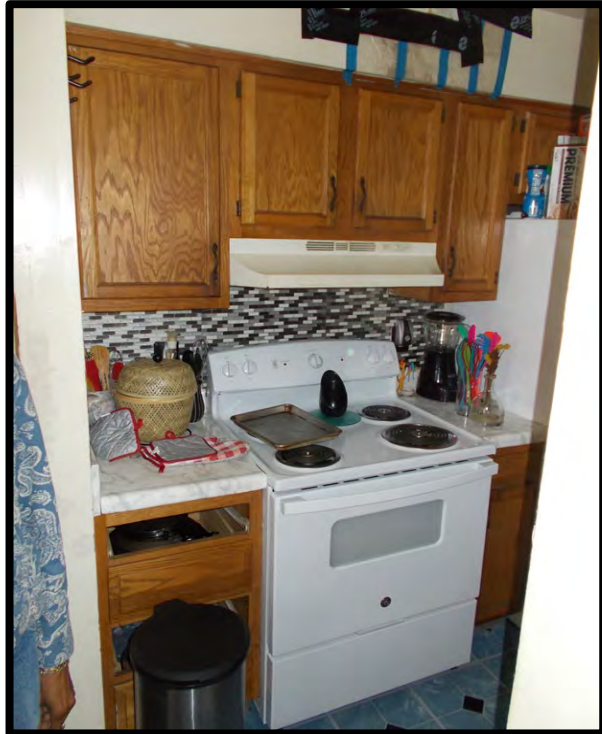
Photo No. 206

View of kitchen first floor.

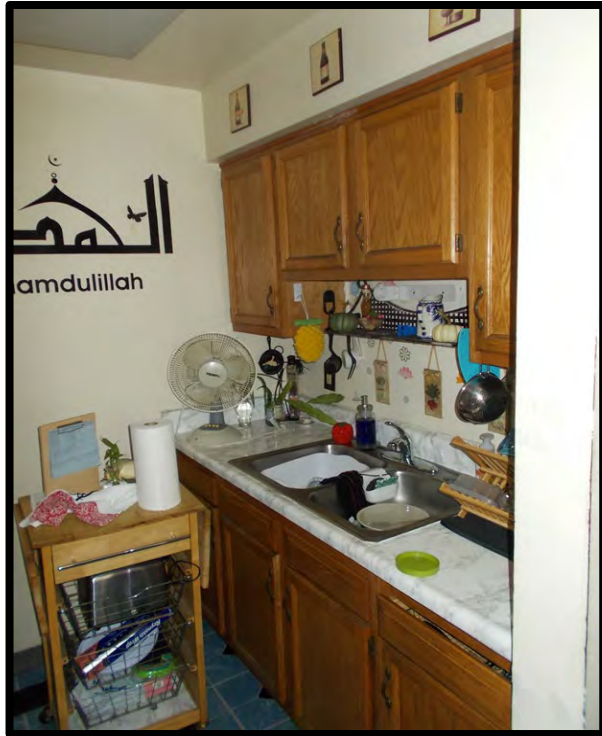
Photo No. 208

Panning right from previous photo. View of kitchen
cabinets and countertop.

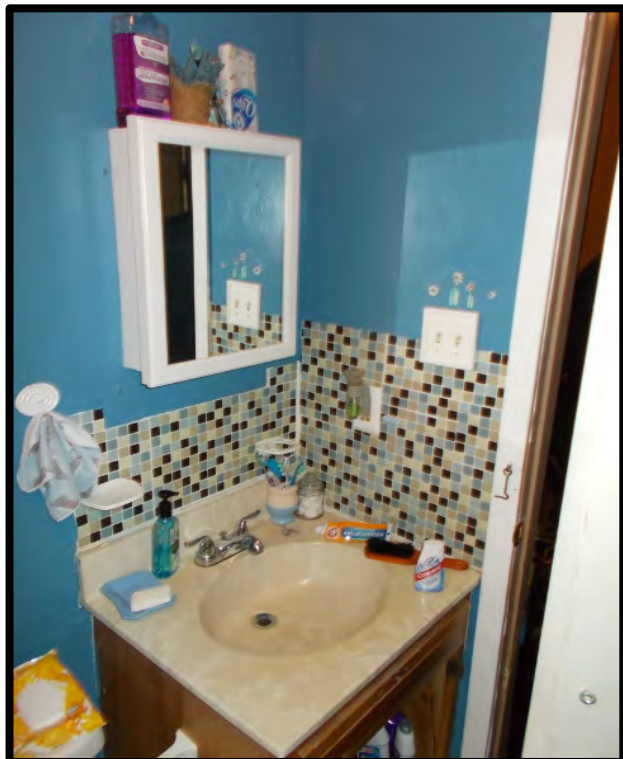
Photo No. 215

View of vanity in second floor bathroom Unit 3.

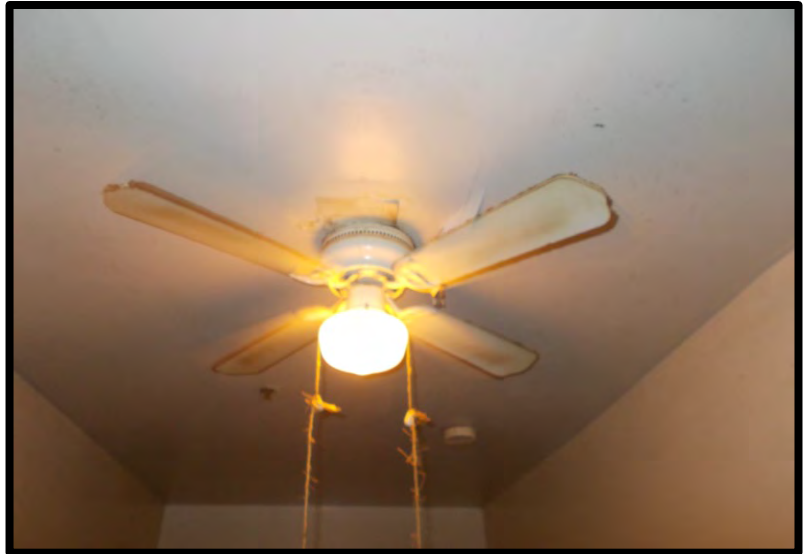
Photo No. 216

View of ceiling fan located in hallway of second floor
Unit 3.

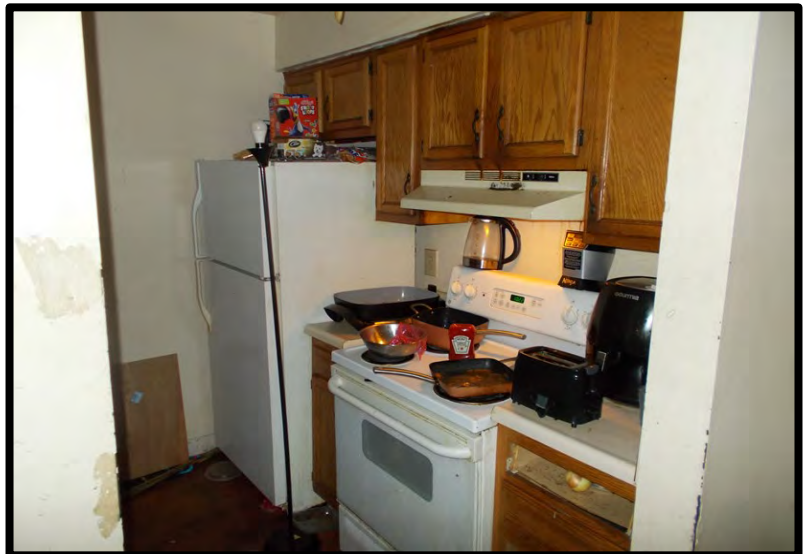
Photo No. 230

Panning down from previous photo. View of kitchen cabinets and countertop.

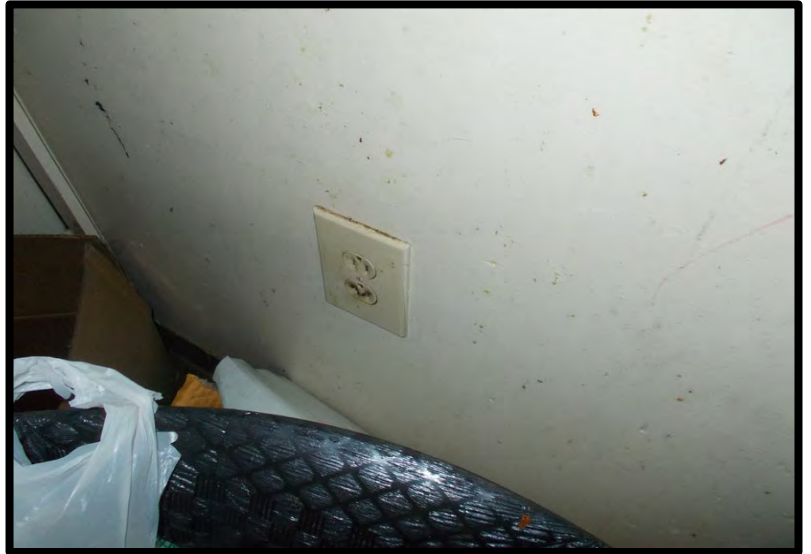
Photo No. 233

View of outlet that apparently short circuited in living
area.

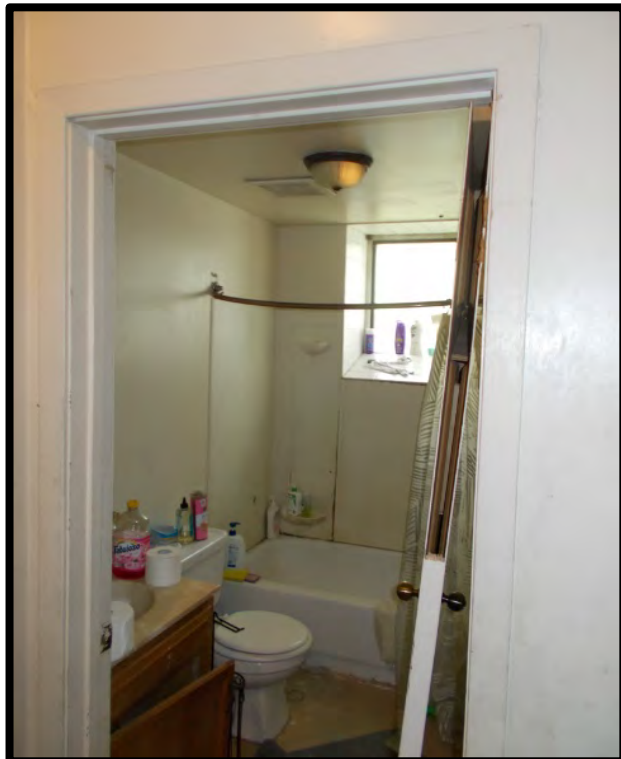
Photo No. 236

View of shared bathroom second floor Unit 4.

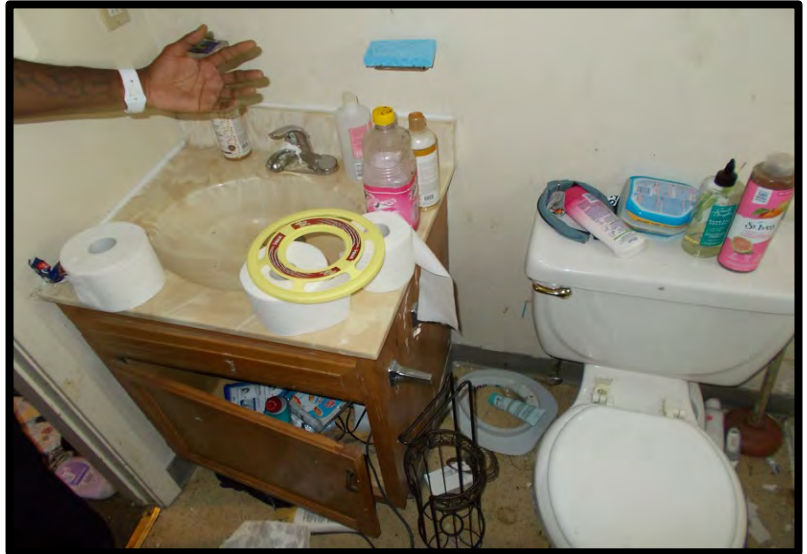
Photo No. 239

Depicts overall condition of water closet and vanity.

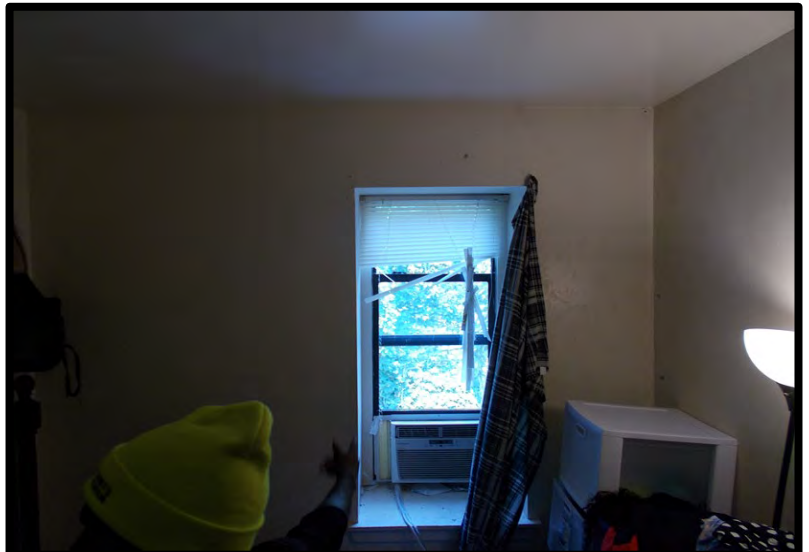
Photo No. 245

Depicts window exterior wall conditions at bedroom 2.

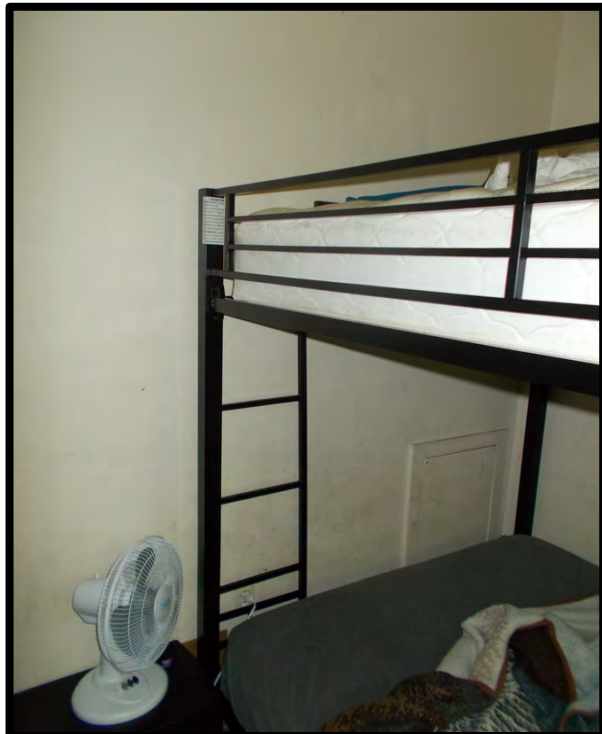
Photo No. 249

Depicts shared wall of bedroom 3 and bathroom
along with plumbing access panel.

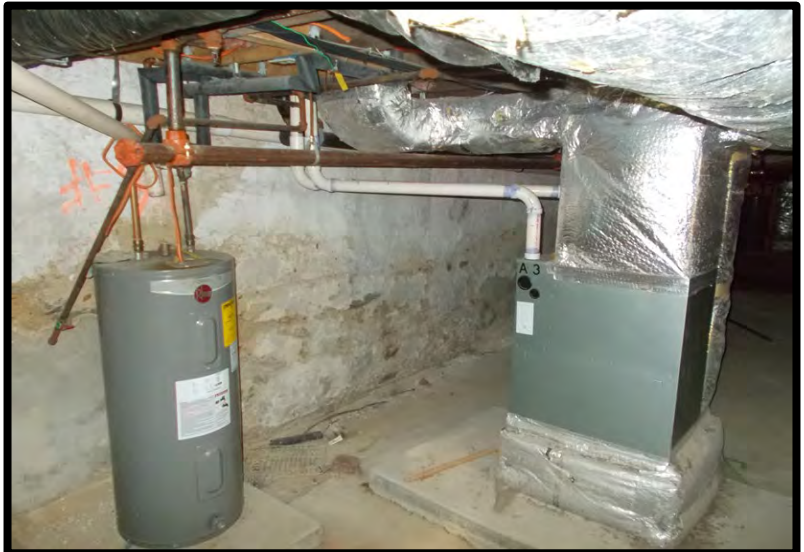
Photo No. 251

View of mechanical equipment for Unit 3.

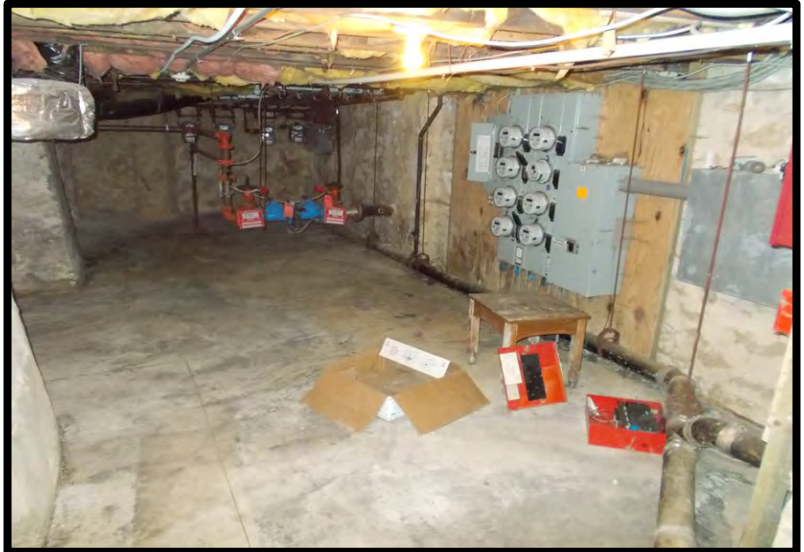
Photo No. 252

View of electric meter panels. Also visible in photo is
sprinkler main and gas meter.

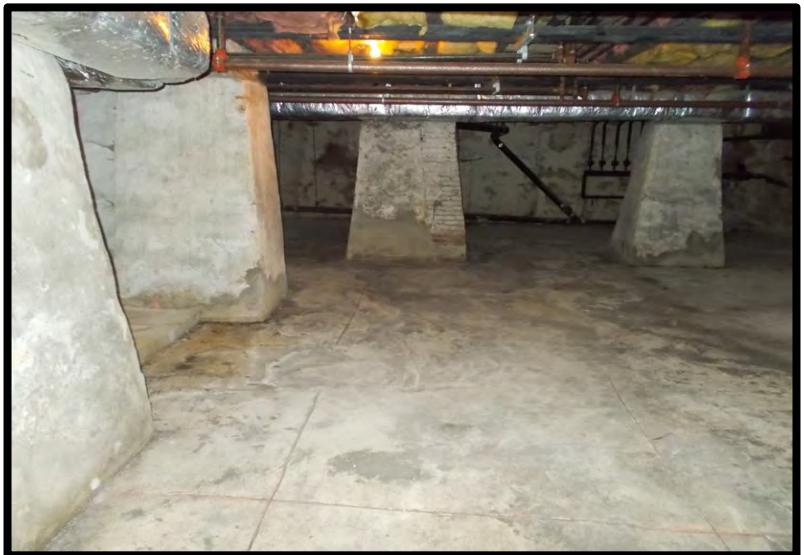
Photo No. 253

Overall interior view of 6526 Germantown Avenue
basement.

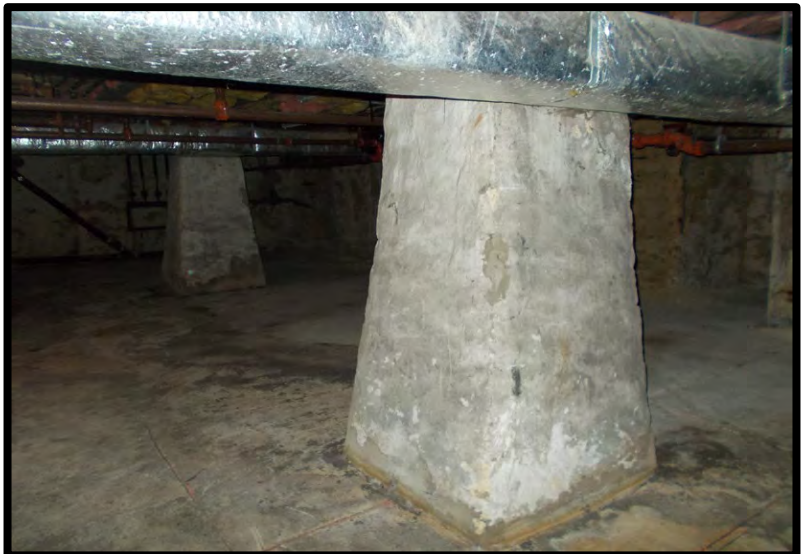
Photo No. 254

Panning right from previous photo.

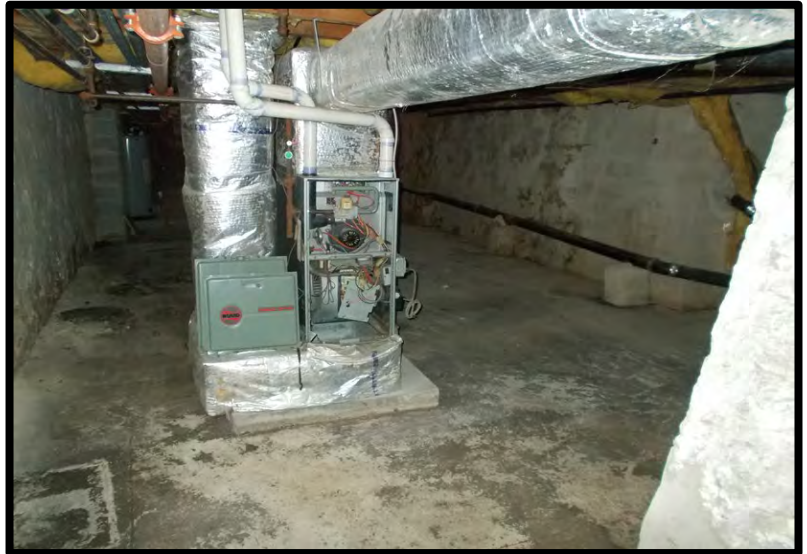
Photo No. 255

View of additional mechanical equipment.

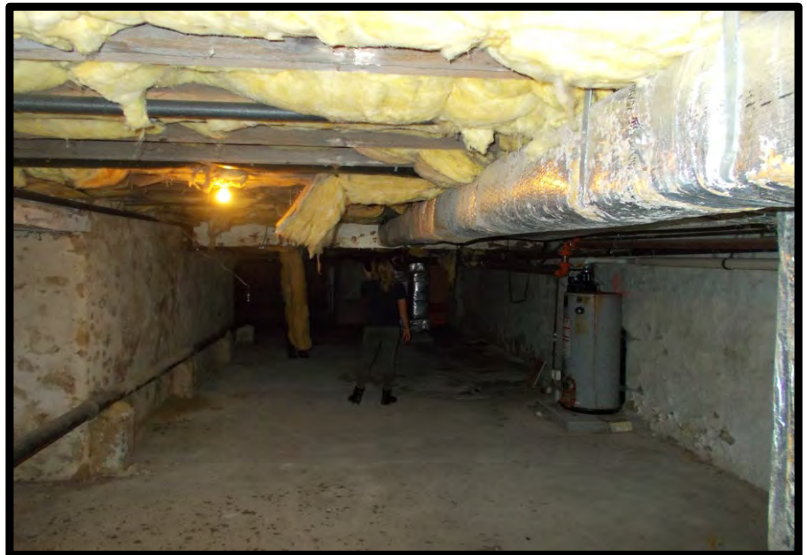
Photo No. 256

View of additional mechanical equipment in basement
of 6526 Germantown Avenue feeding apartments.

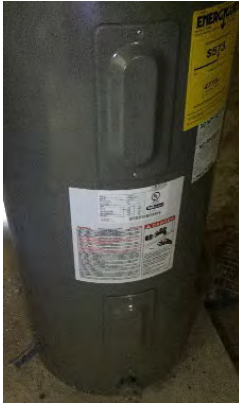
Gas hot water heater.

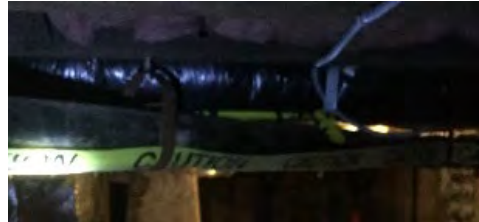
Sanitary piping with caution tape on it.

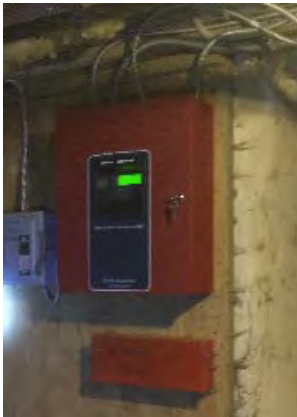
Fire panel.

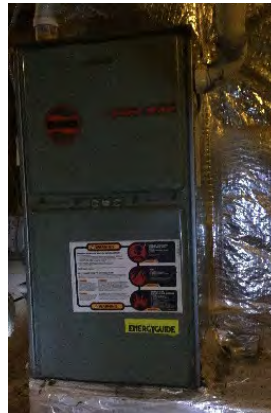
Gas fired furnace.

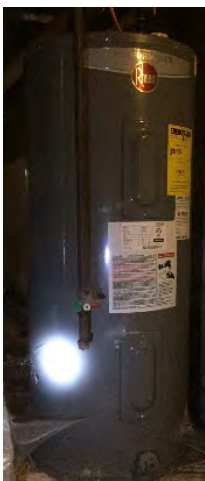
Hot water heater #2.

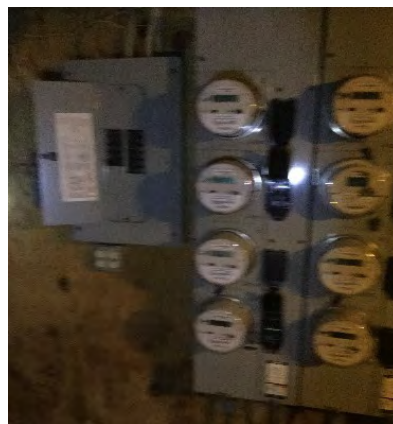
Electric meters and panel.

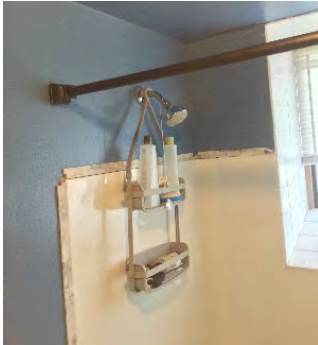
Bathroom shower.

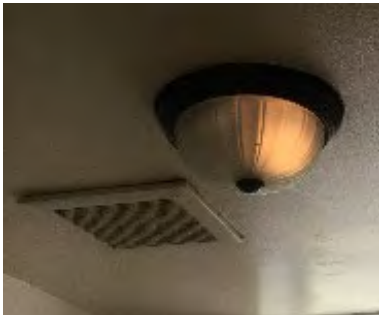
Bathroom light and exhaust fan.

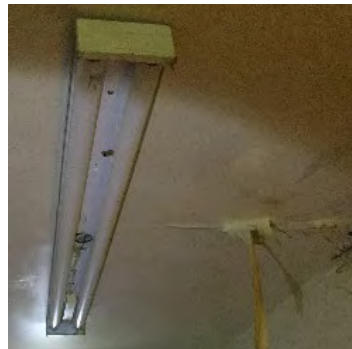
Kitchen light with water damage to ceiling.
