Germantown/Mount Airy Properties

Physical Conditions and Needs Assessment

Premises A

6526-34 Germantown Ave

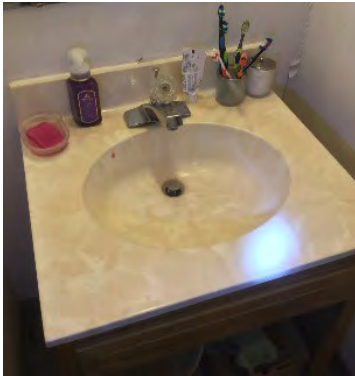
Bathroom sink in good condition.

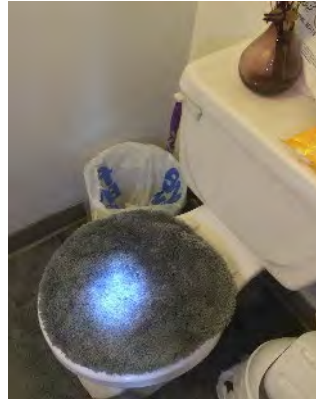
Bathroom toilet working and in good condition.

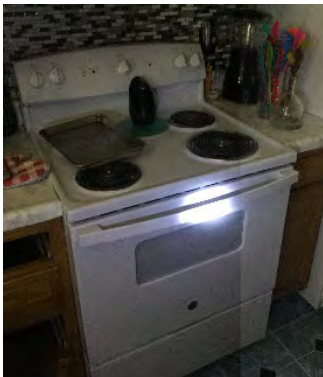
Electric stove.

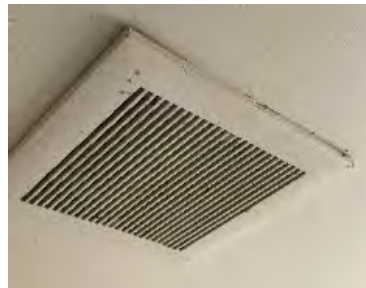
Bathroom exhaust fan working and in good condition.
