Germantown/Mount Airy Properties

Physical Conditions and Needs Assessment

Premises C

5429-43 Lena Street

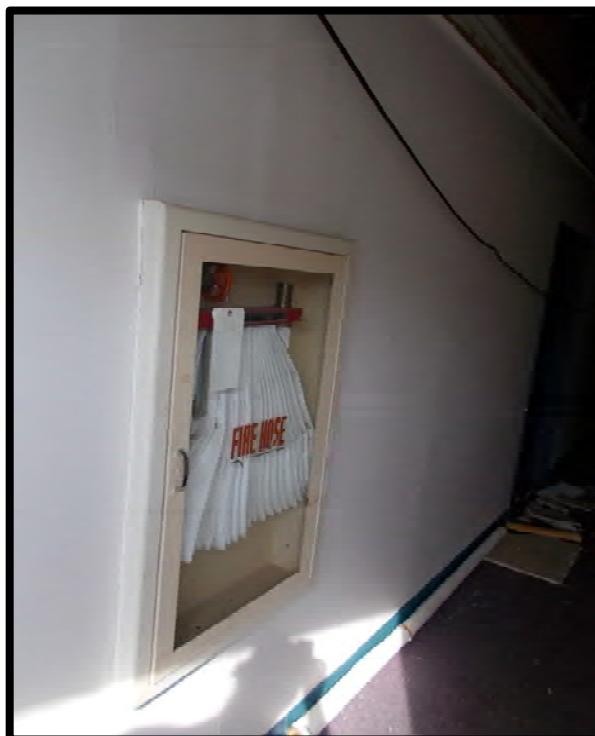
Photo No. 2

View of fire hose cabinet installed at south end of 4th FI corridor.

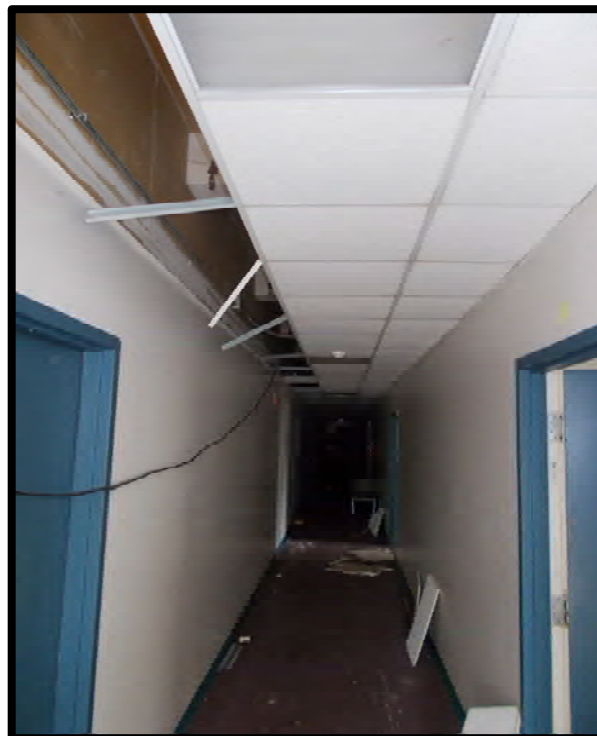
Photo No. 3

Typical view of corridor. Note copper supply water lines have been removed from above ceiling.

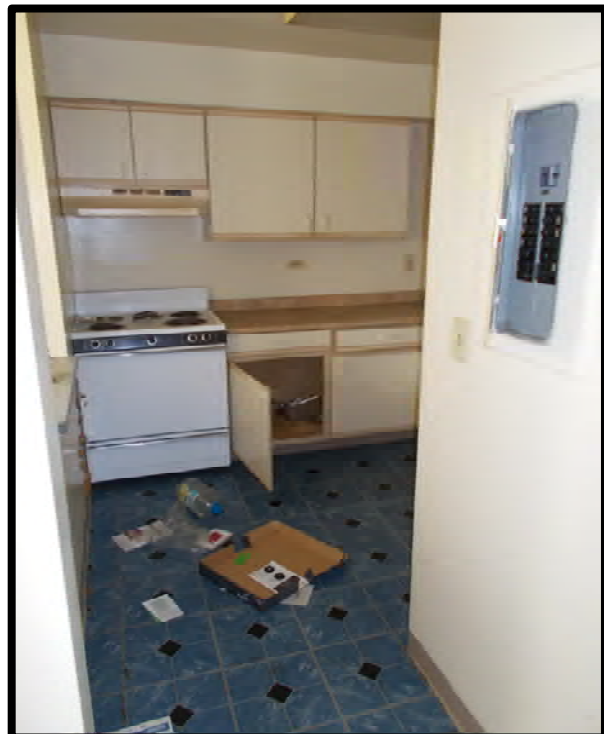
Photo No. 6

View of typical kitchen in apartments, with tenant electrical panel on right.

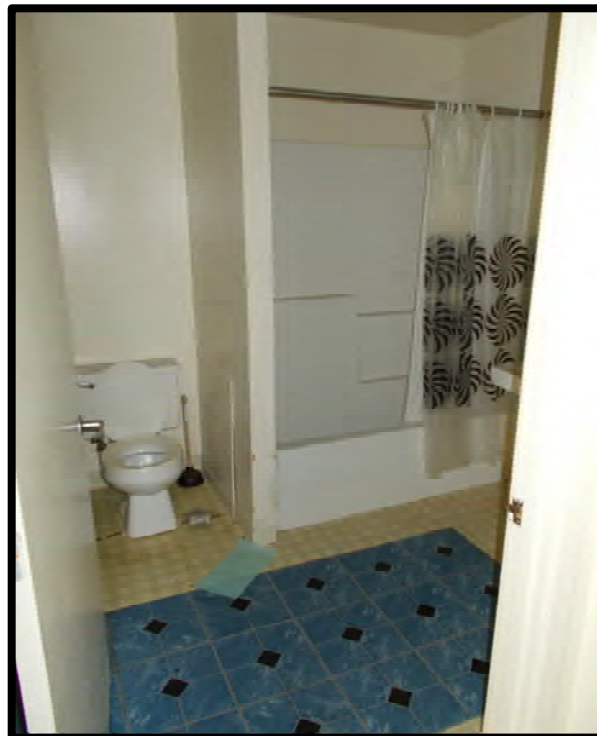
Photo No. 9

View of typical apartment bathroom.

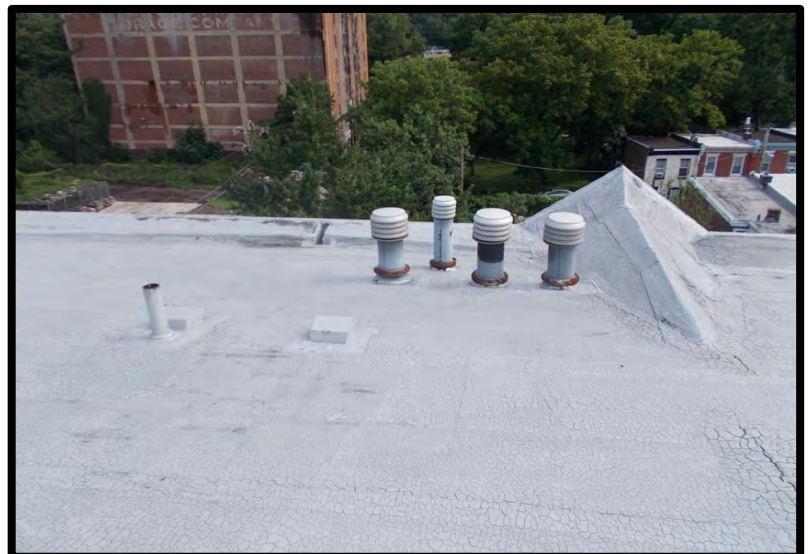
Photo No. 15

View of boiler flues above roof level.

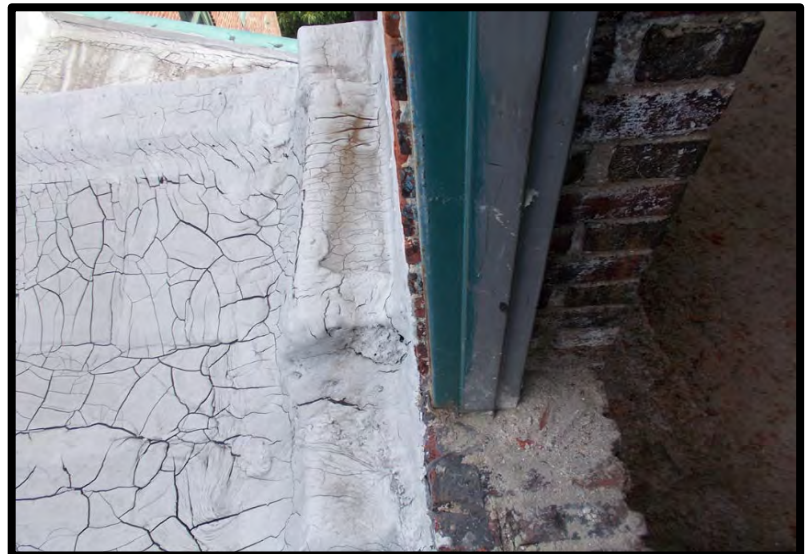
Photo No. 21

View of roof coating and connection at stair tower.

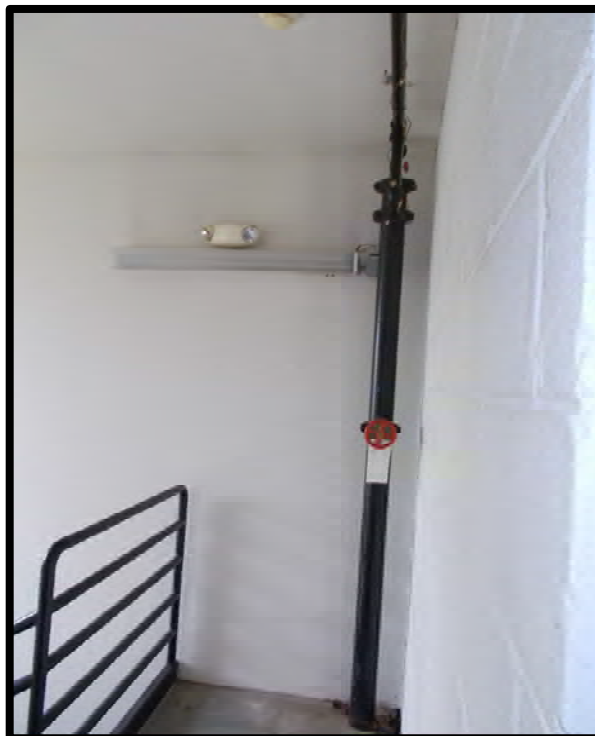
Photo No. 36

View of standpipe riser in north stair tower, 4th Fl.

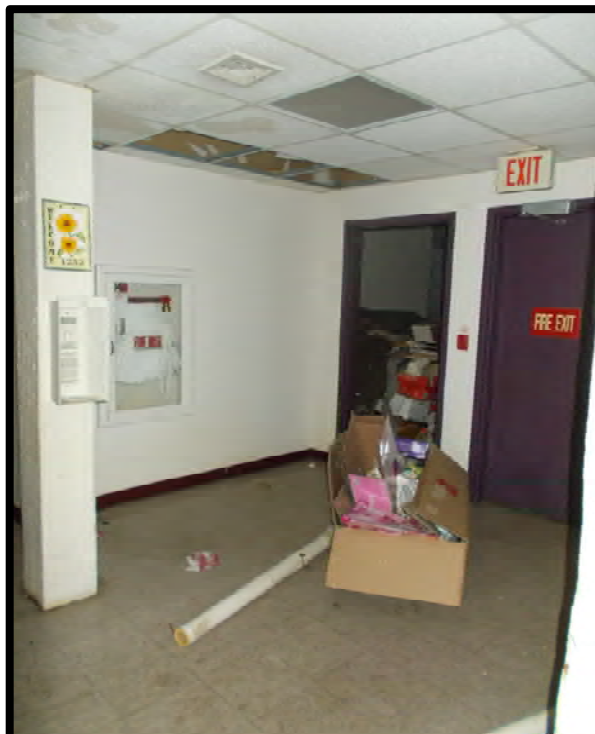
Photo No. 39

View of 3rd Fl north stair tower entry and fire hose cabinet.

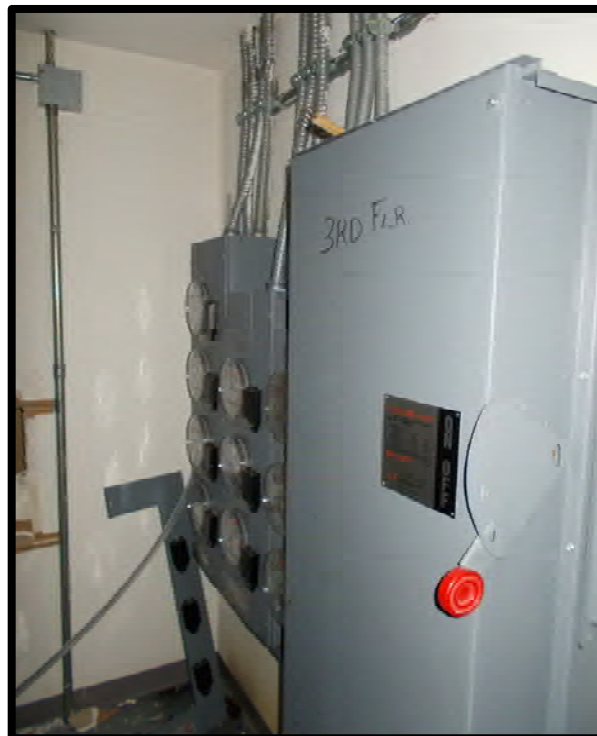
Photo No. 43

View of 3rd Fl mechanical room.

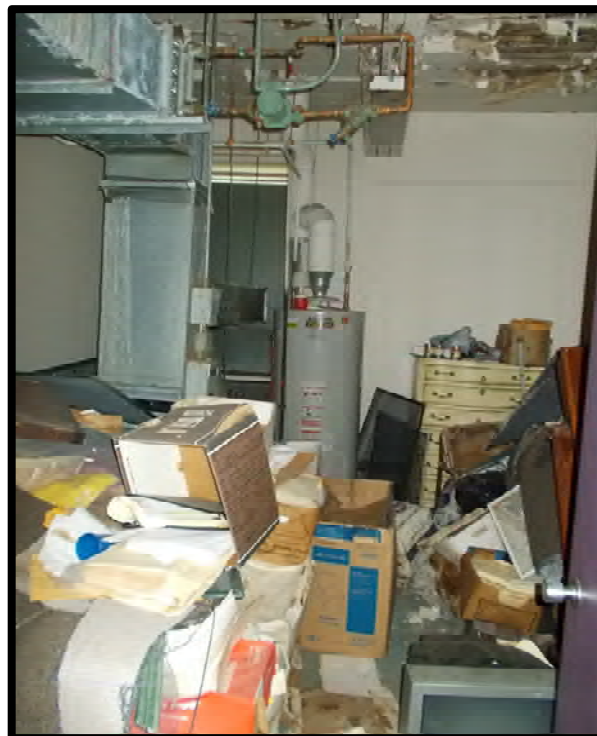
Photo No. 44

Panning right from previous photo.

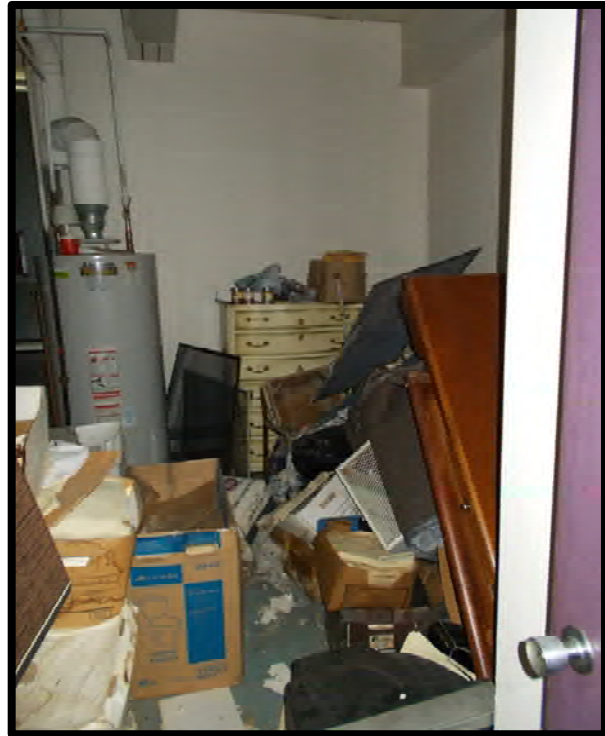
Photo No. 45

Additional view of mechanical equipment.

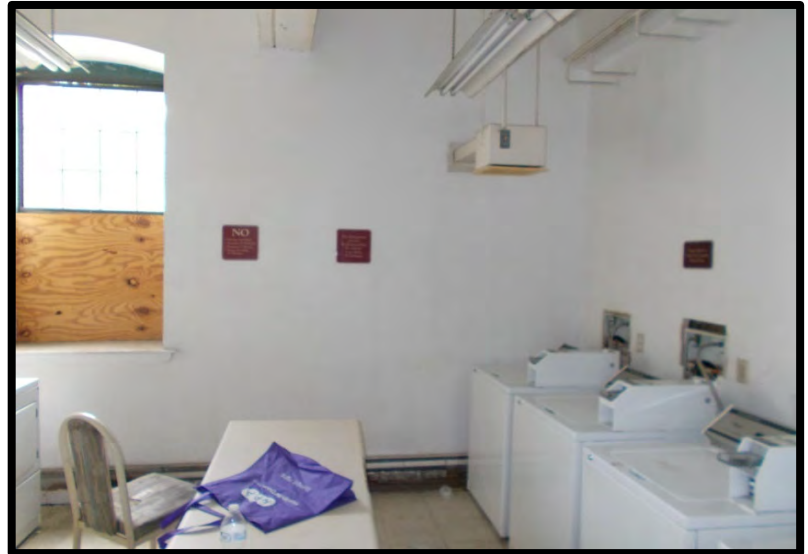
Photo No. 57

View of coin operated dryer units.

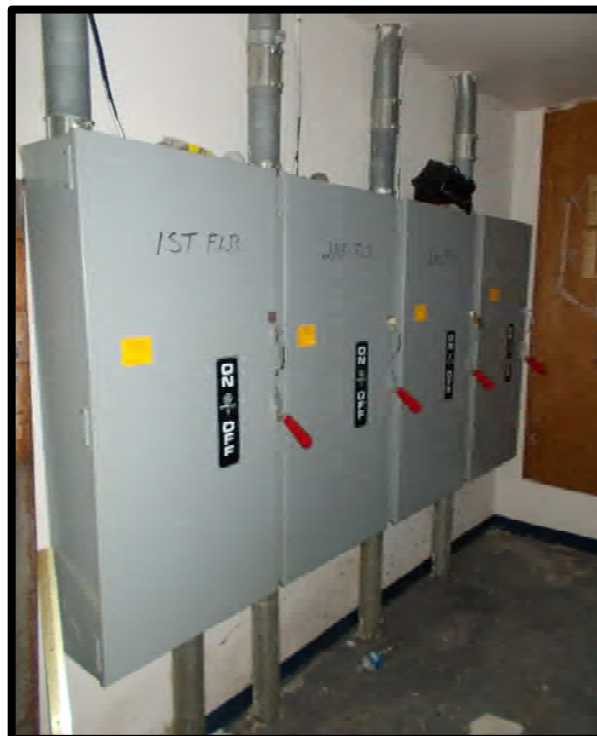
Photo No. 66

Panning right from photo #64 at electric raceway.

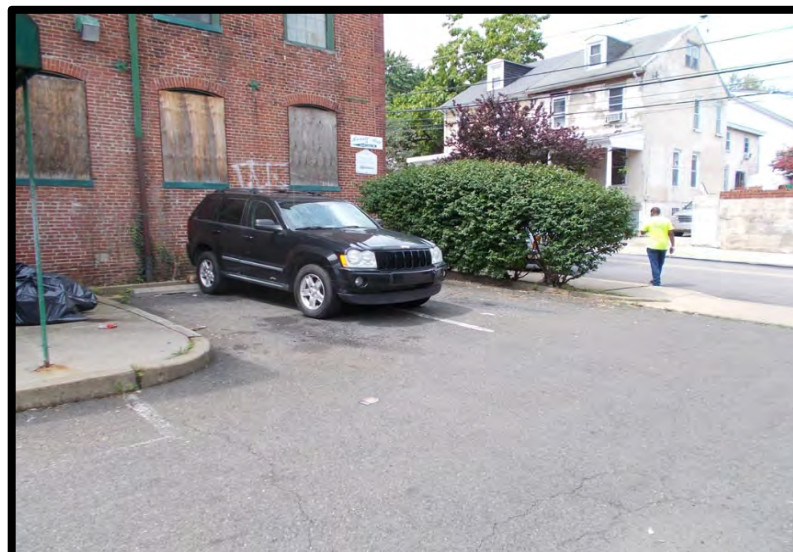
Photo No. 81

View looking south at parking lot.

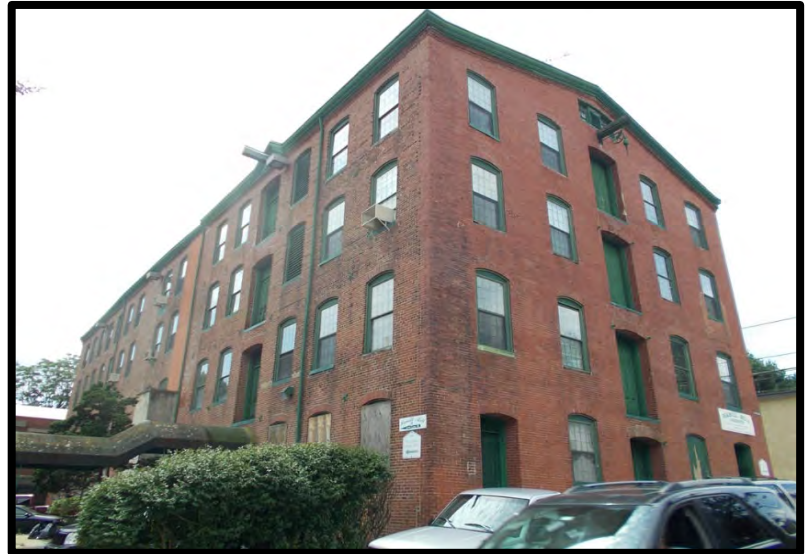
Photo No. 85

View of northwest corner of building.

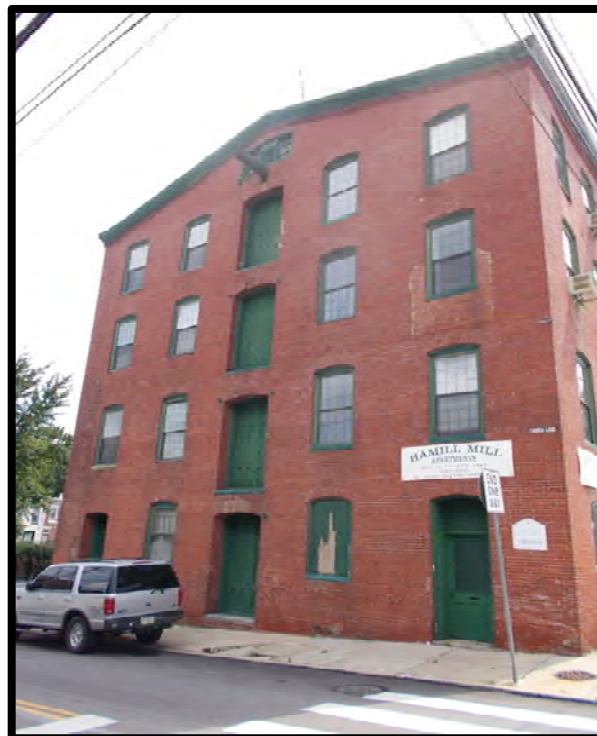
Photo No. 86

Overall view of north façade.

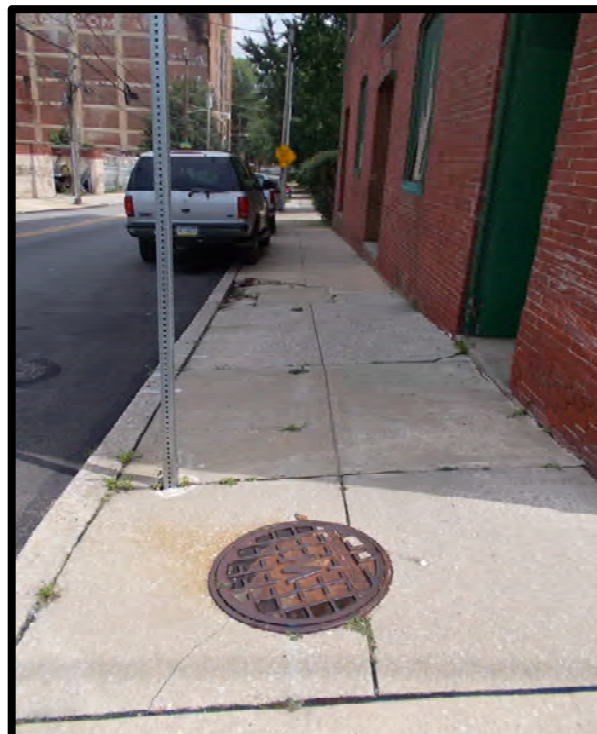
Photo No. 87

View of sidewalk along north portion of property.

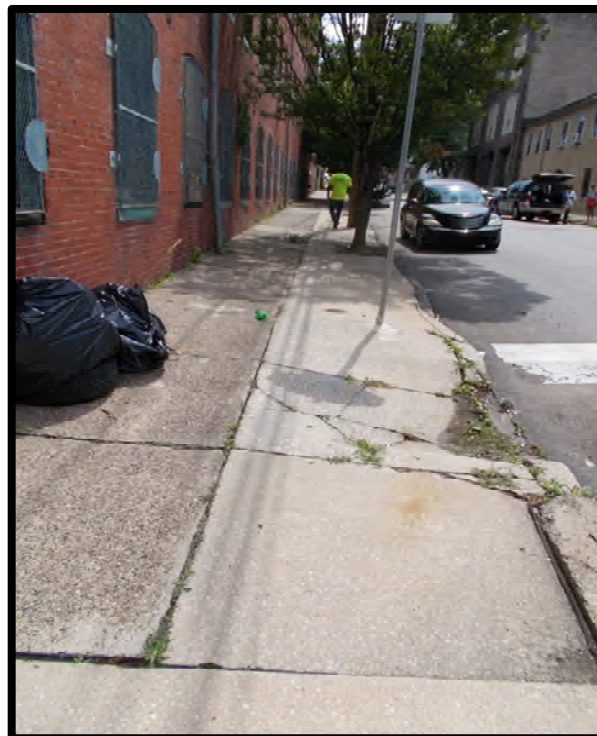
Photo No. 88

View of northwest portion of sidewalk along west side of property. Corner of Lena St. and Church Ln.

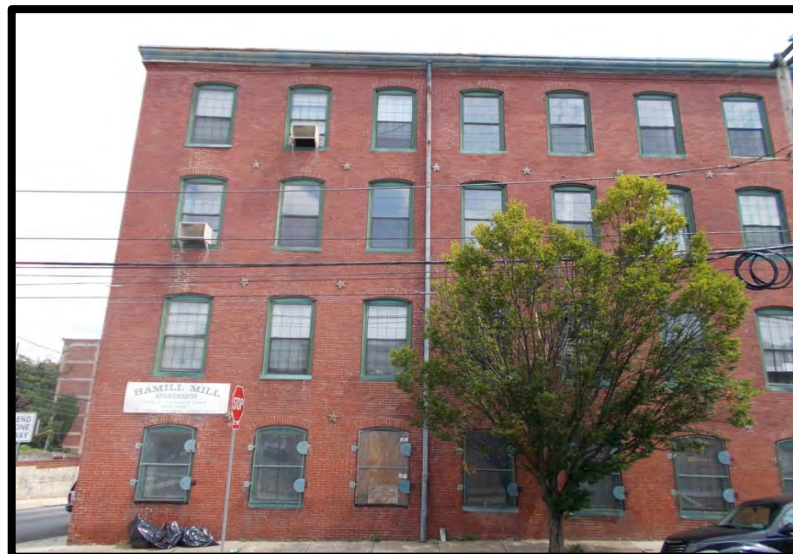
Photo No. 89

View of north portion of west façade,

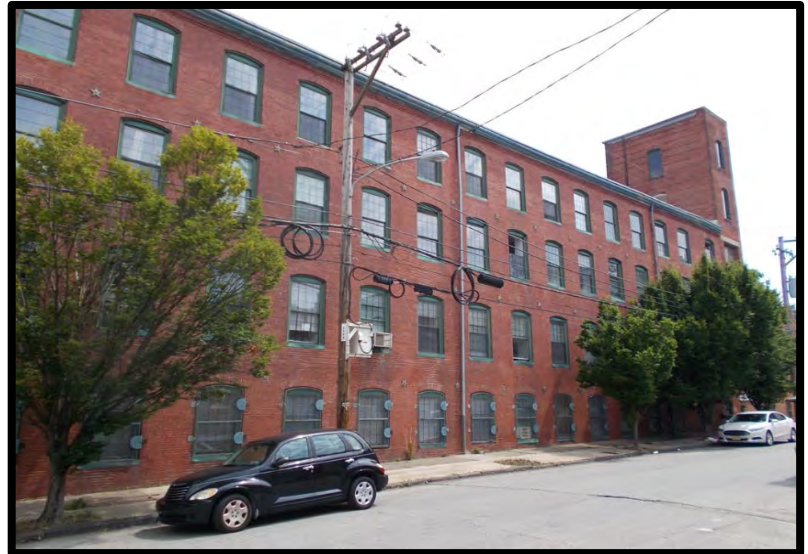
Photo No. 90

Panning right from previous photo. View of southern portion of west façade.

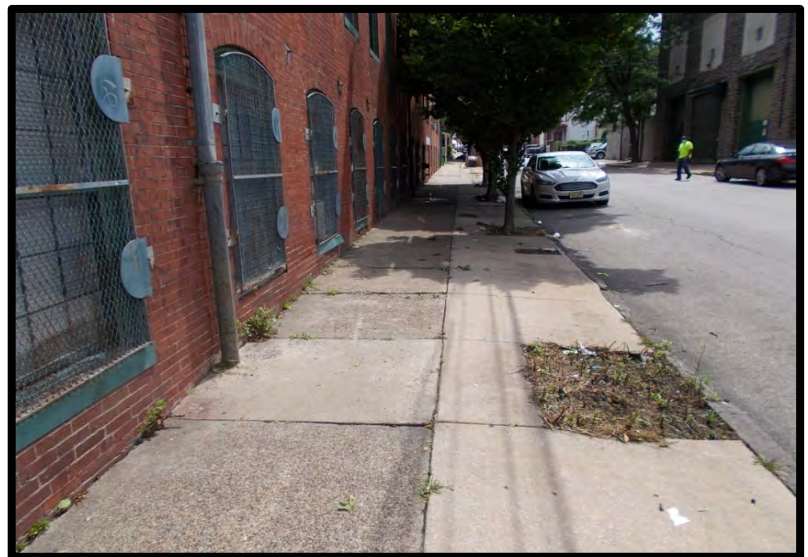
Photo No. 91

Additional view of sidewalk along west side of building (Lena St) looking south.

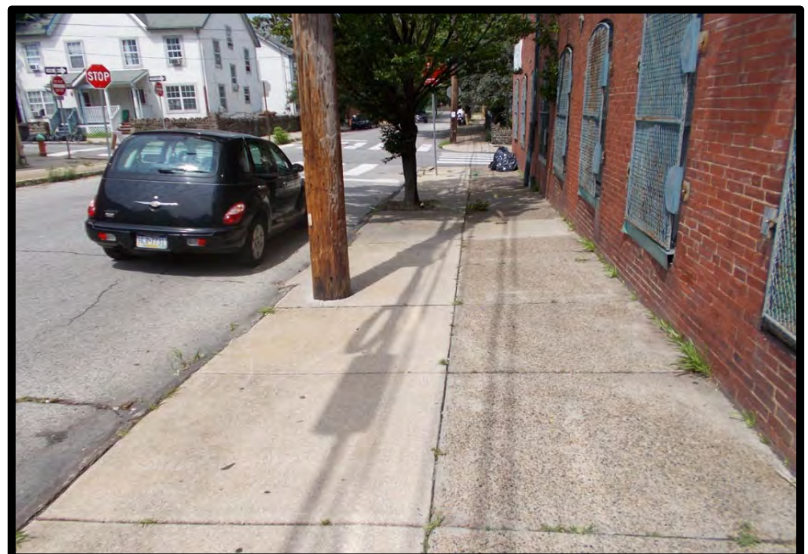
Photo No. 92

View of side walk along Lena St looking north.

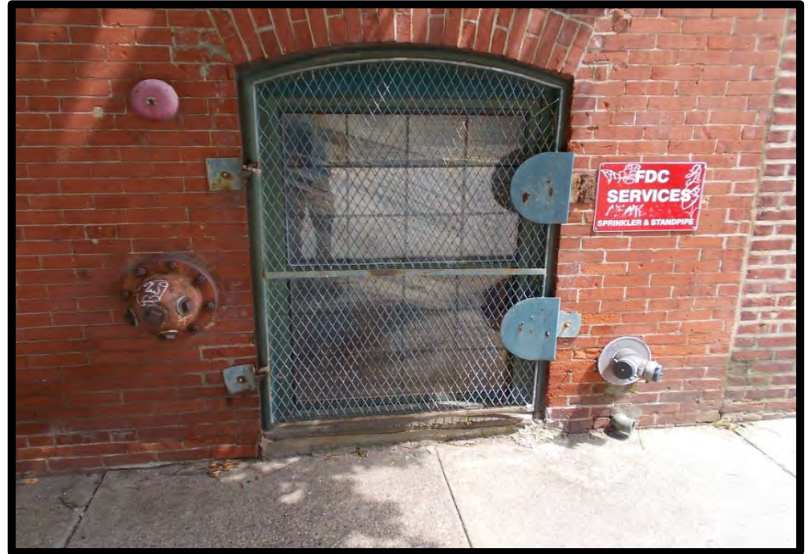
Photo No. 93

View of Fire Department connections along west façade.

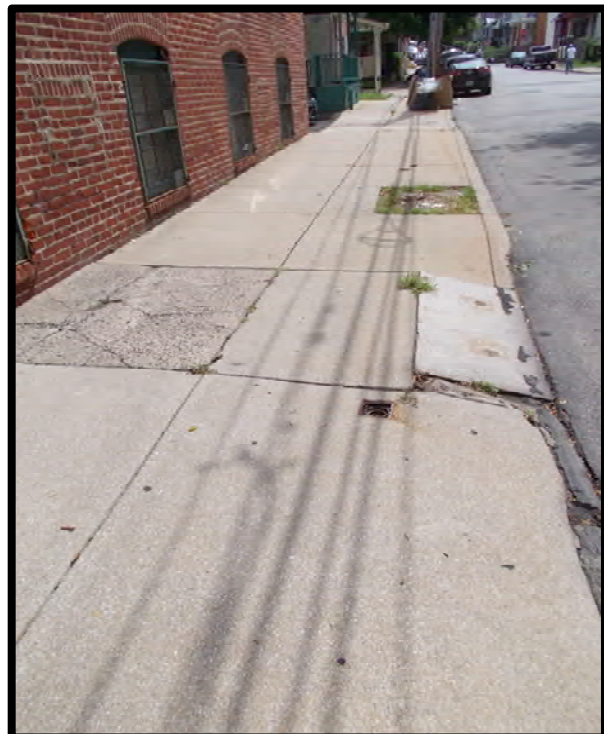
Photo No. 94

Additional view of sidewalks along the west side of building. South end of property along Lena St.

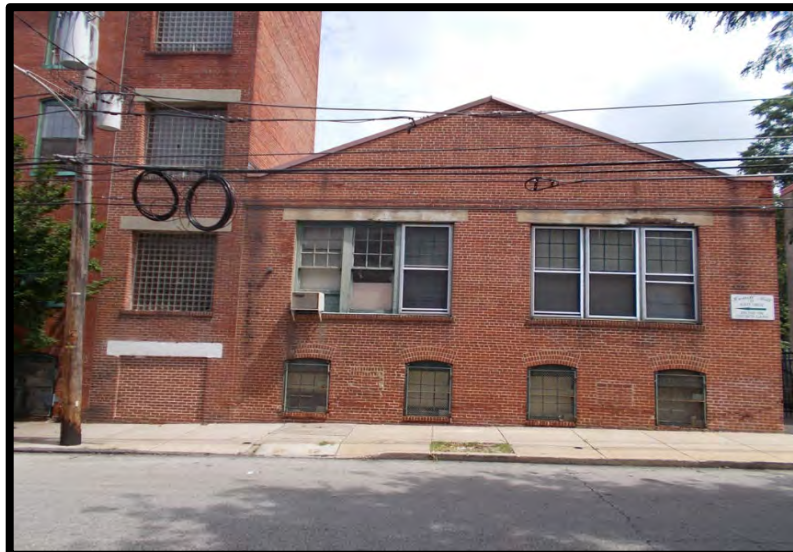
Photo No. 95

View of the west façade of south stair tower and
Premises Y (5423 Lena St.)

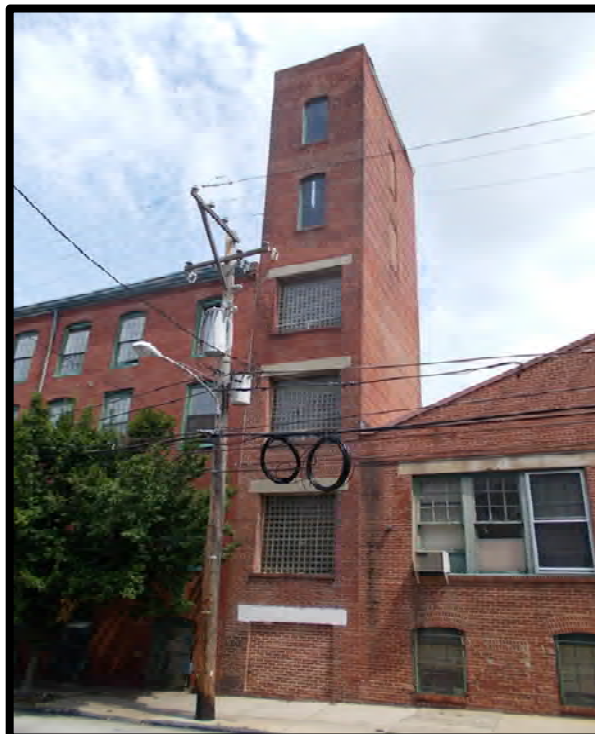
Photo No. 96

Ditto previous photo

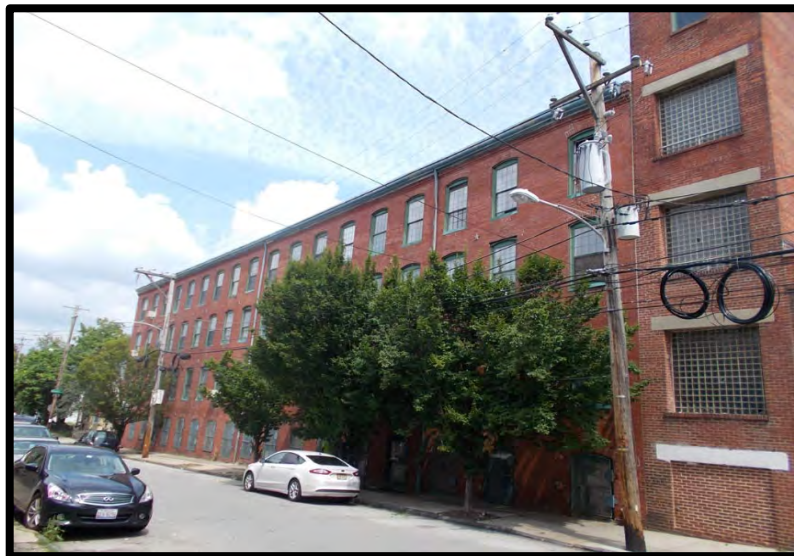
Photo No. 97

Overall view of west façade,

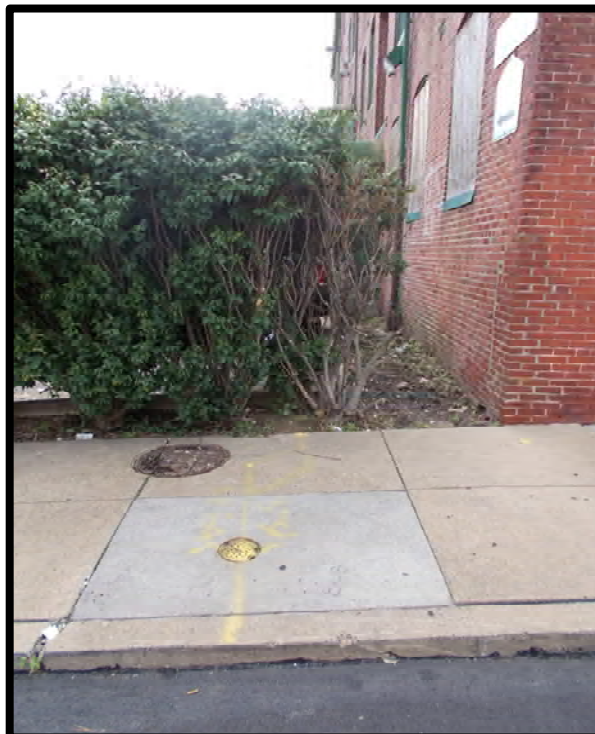
Photo No. 98

View of incoming gas service along north sidewalk.

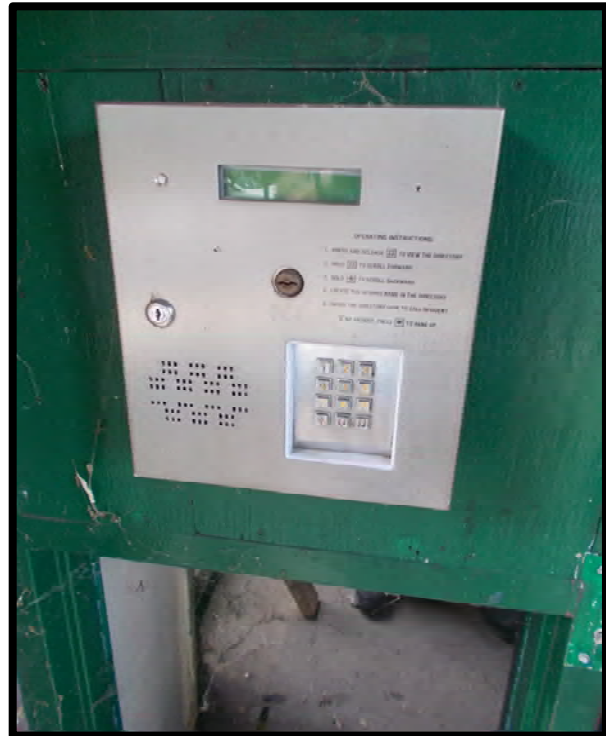
Photo No. 101

View of postal point of contact pad at building entry.

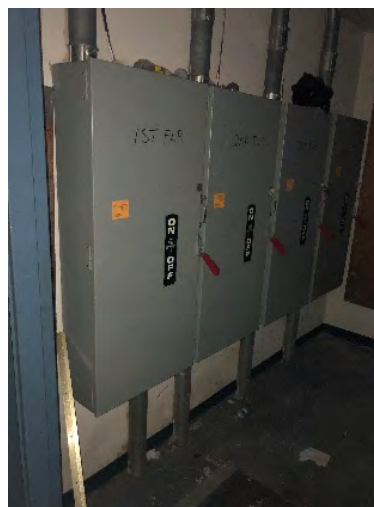
Electric room.
