Germantown/Mount Airy Properties

Physical Conditions and Needs Assessment

Premises D
60-74 Collom St
Philadelphia, PA 19144

March 2021

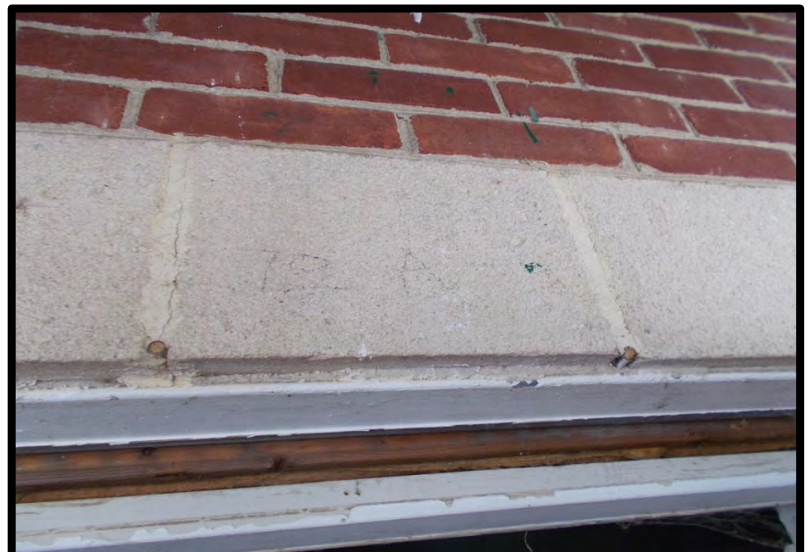
Photo No. 104

View of typical weep joints at head of entry door. Weeps are clogged.

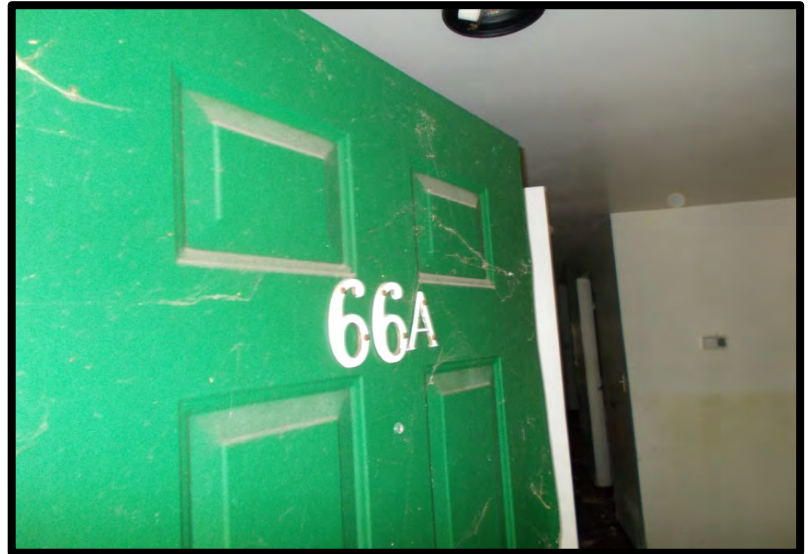
Photo No. 105

Unit 66A.

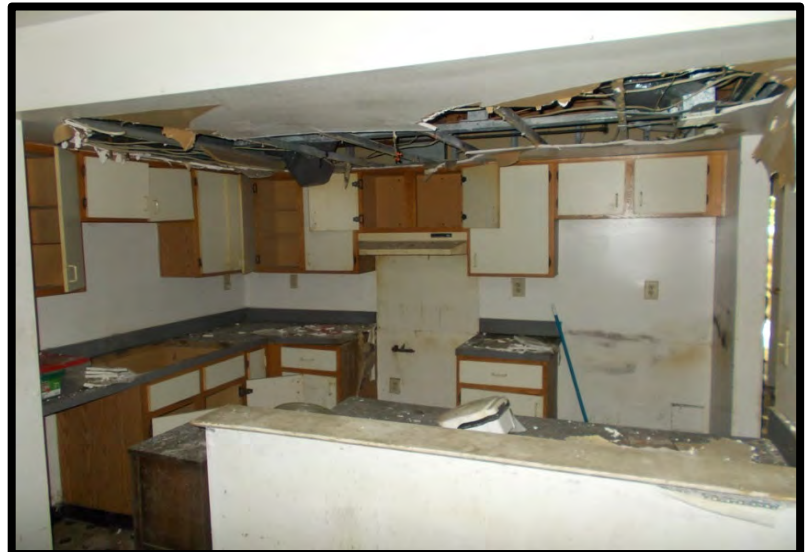
Photo No. 106

View of kitchen from dining room.

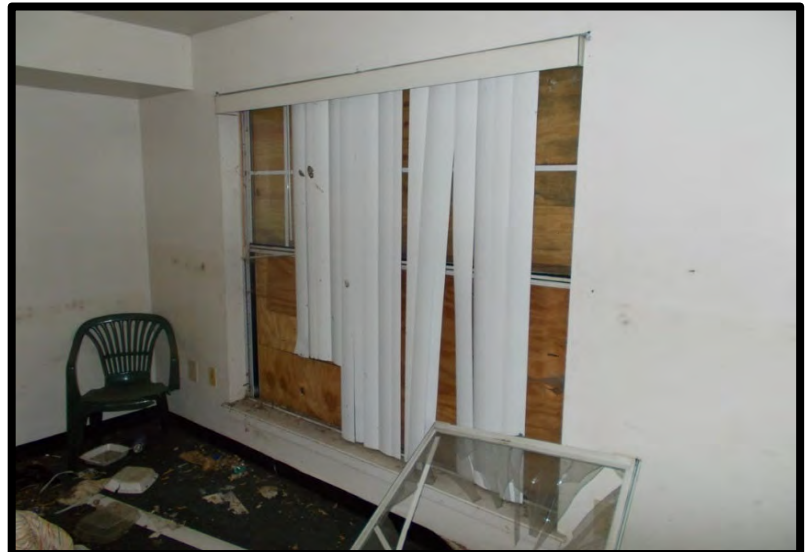
Photo No. 108

View of front windows at living room.

It is recommended to replace all exterior windows for uniformity and increased energy efficiency.

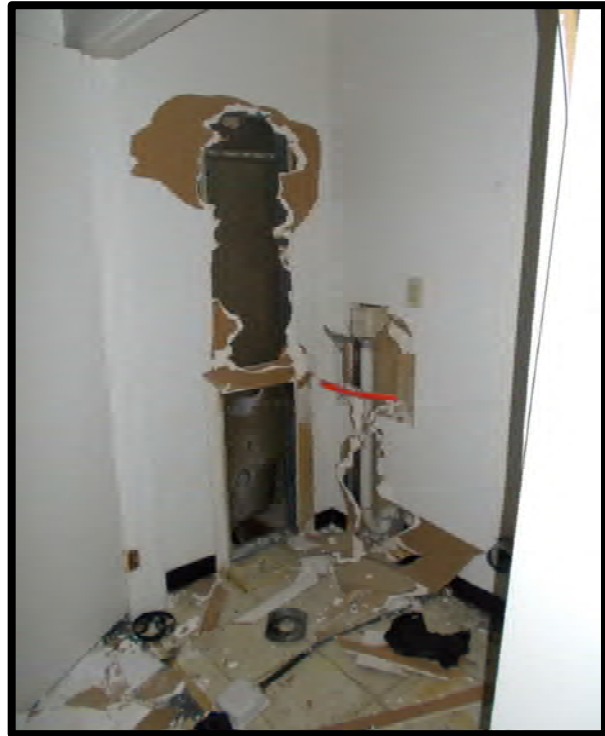
Photo No. 109

View of washer/dryer closet at second floor.

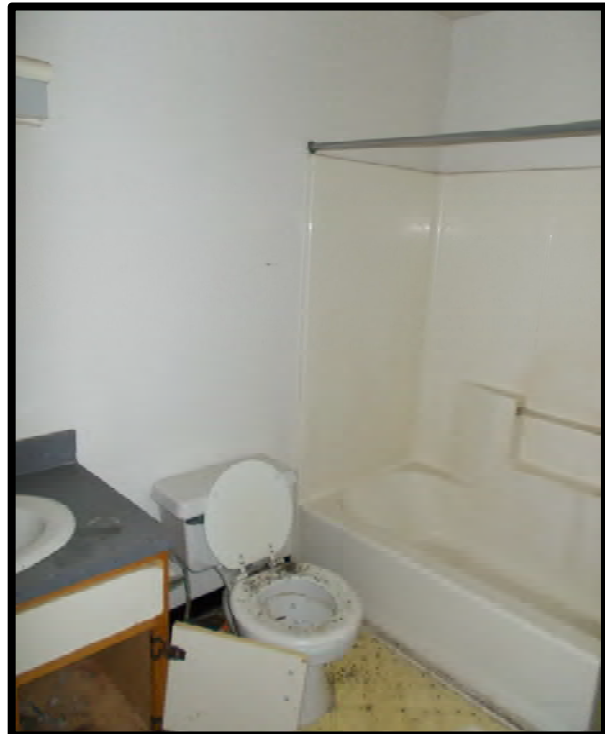
Photo No. 110

View of bathroom at second floor.

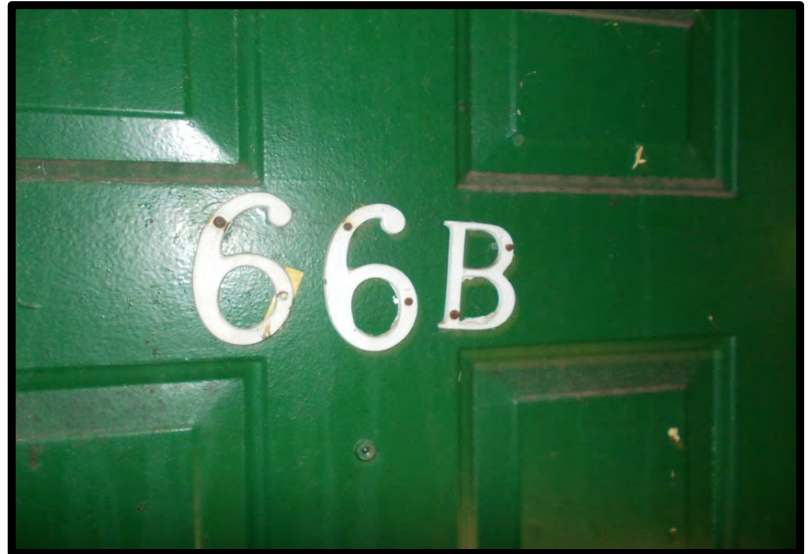
Photo No. 113

Unit 66B.

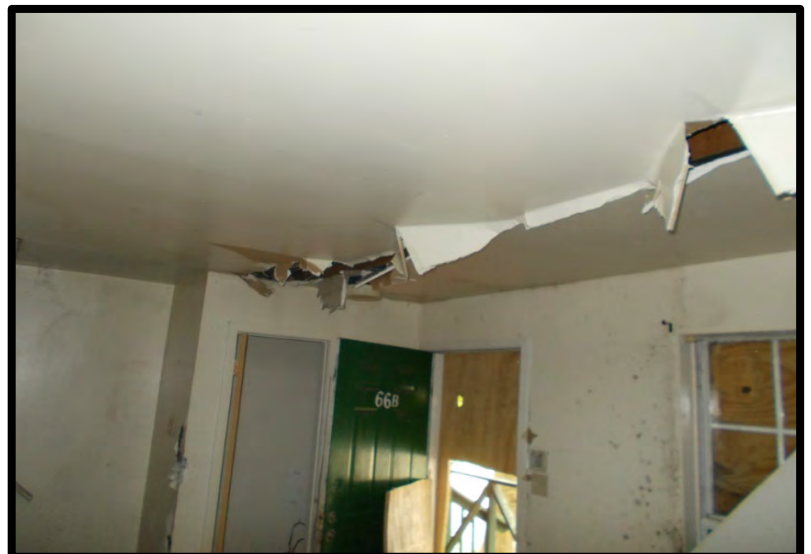
Photo No. 115

View of ceiling damage in living room at entry.

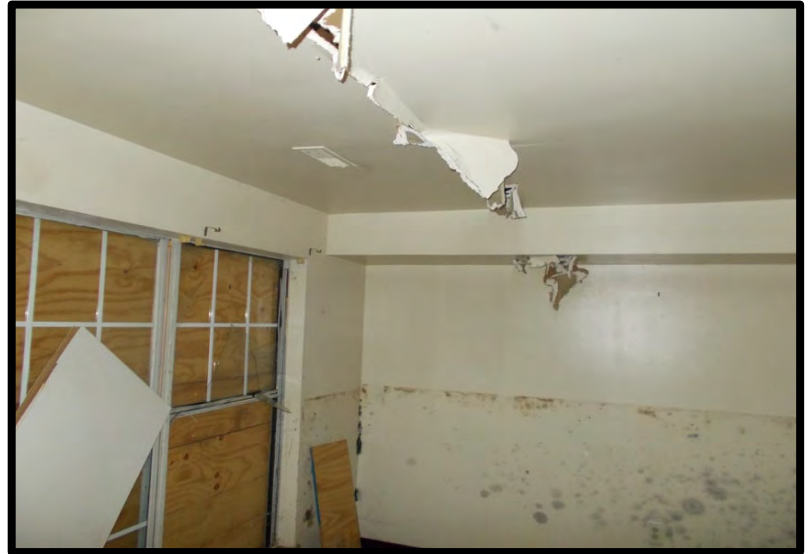
Photo No. 116

Panning right from previous photo. Additional view of living room.

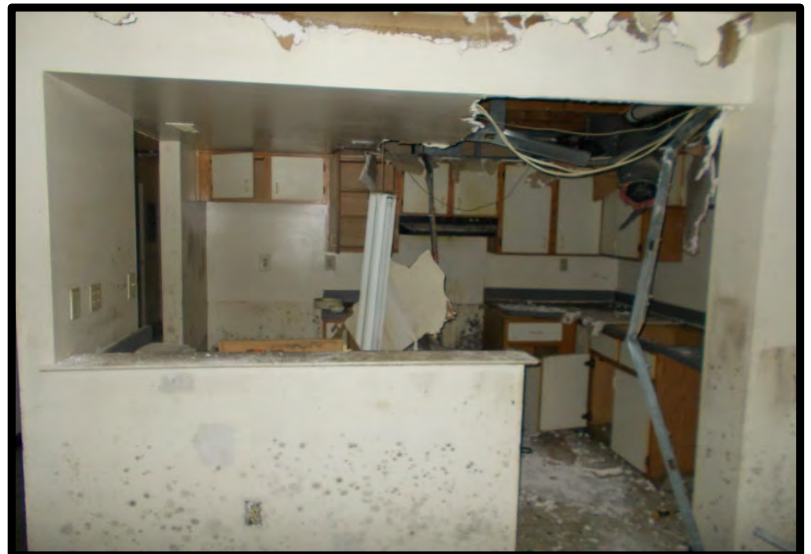
Photo No. 117

View of kitchen from dining room.

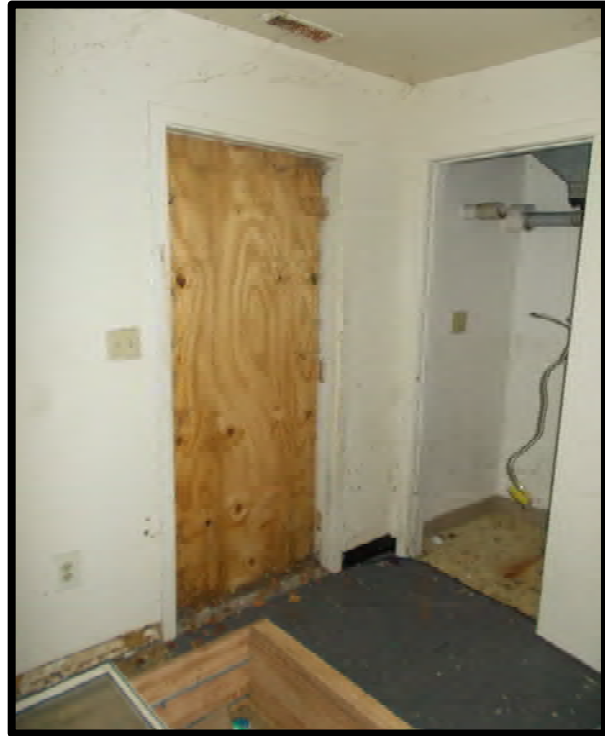
Photo No. 118

View of rear door to yard and mechanical closet on right.

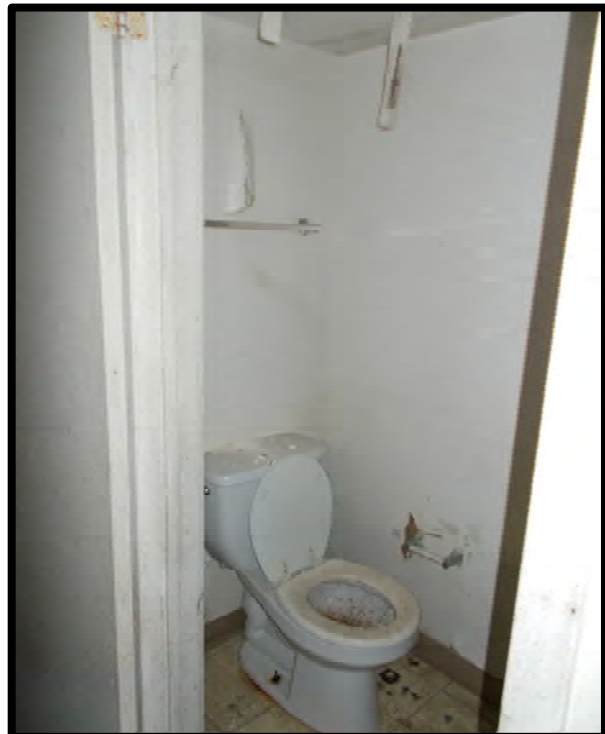
Photo No. 119

View of water closet at half bath on first floor.

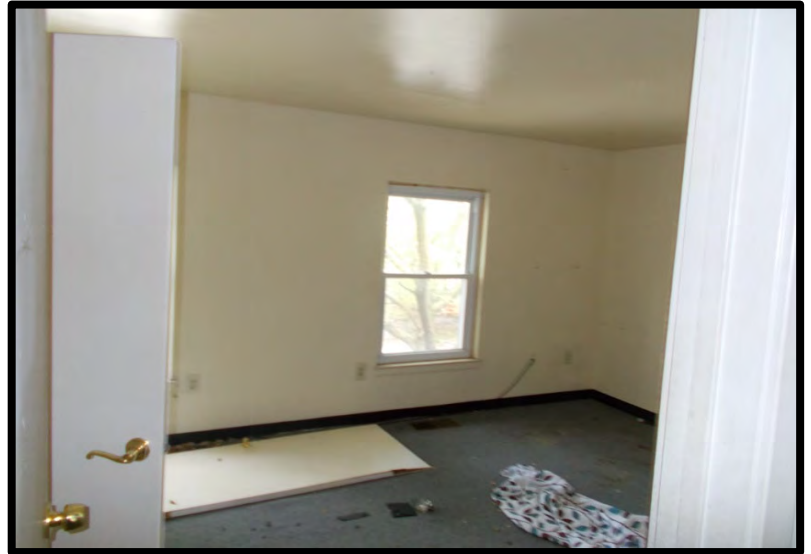
Photo No. 120

View of master bedroom.

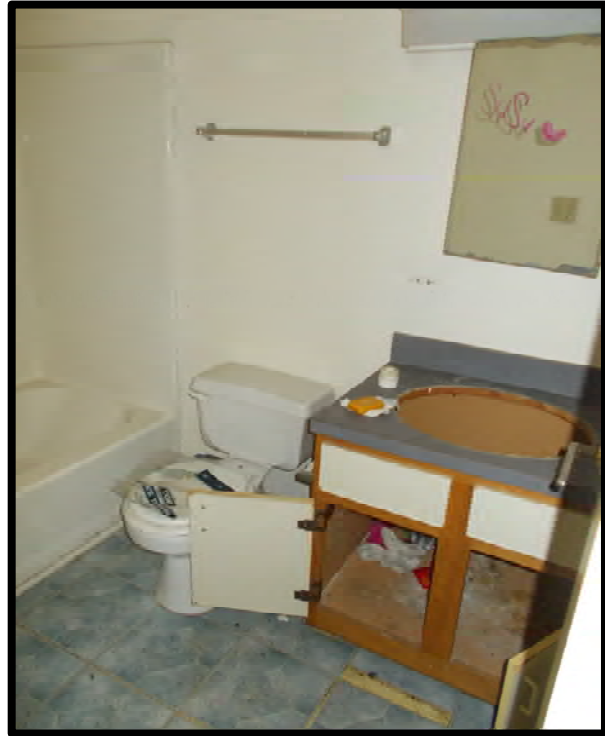
Photo No. 122

View of bathroom on second floor.

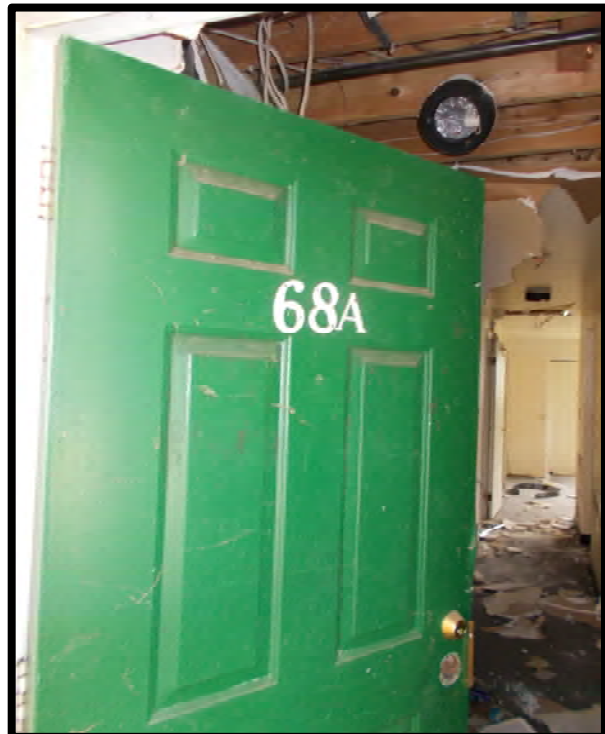
Photo No. 123

Unit 68A.

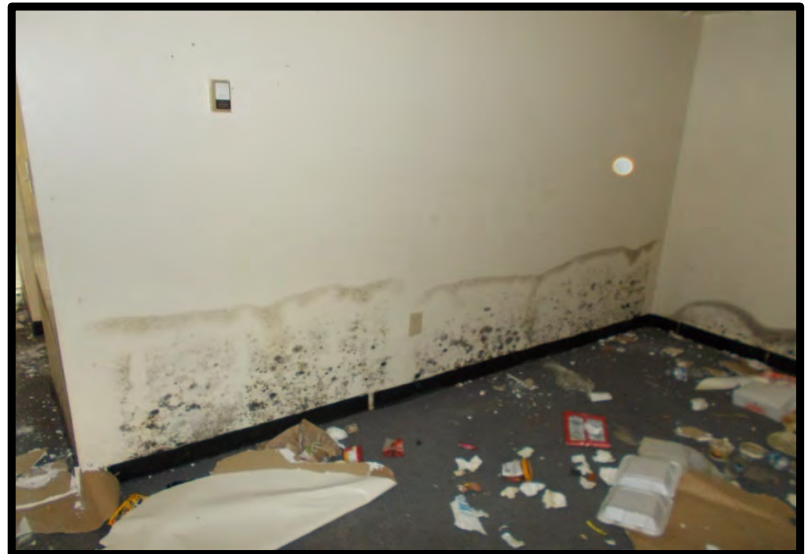
Photo No. 124

View of living room. Wall is back of kitchen.

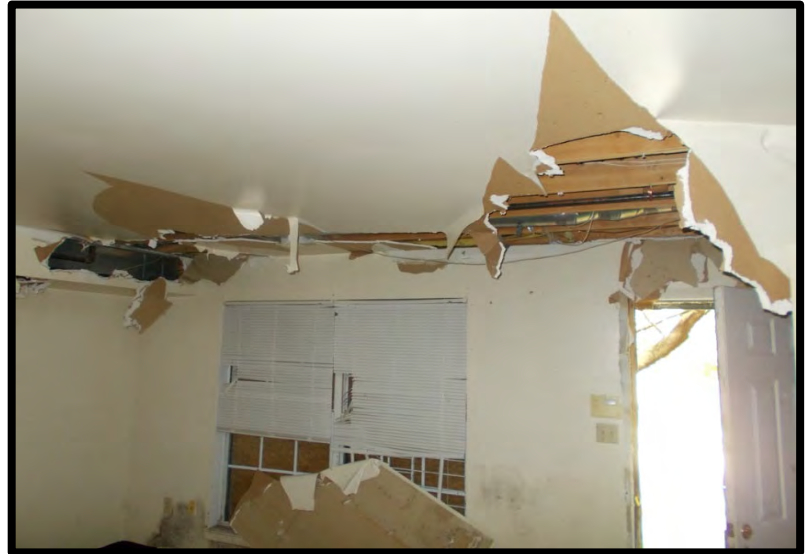
Photo No. 126

View of living room and unit entry.

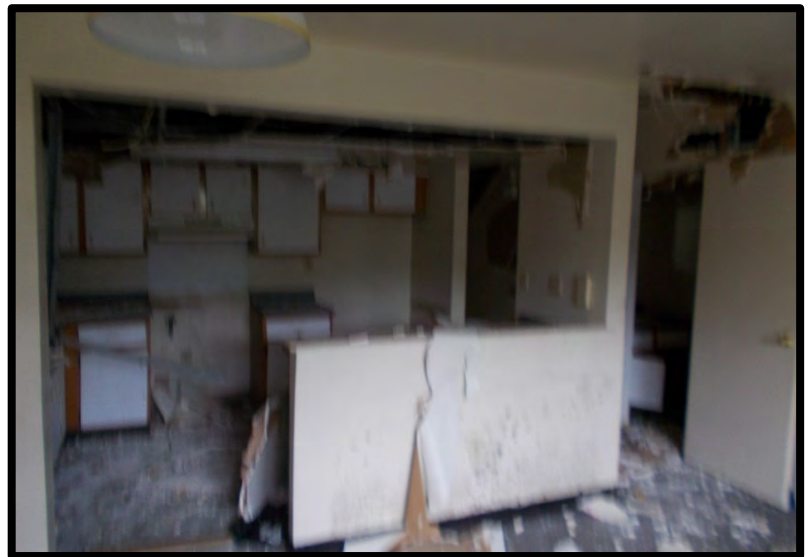
Photo No. 127

View of kitchen from dining room.

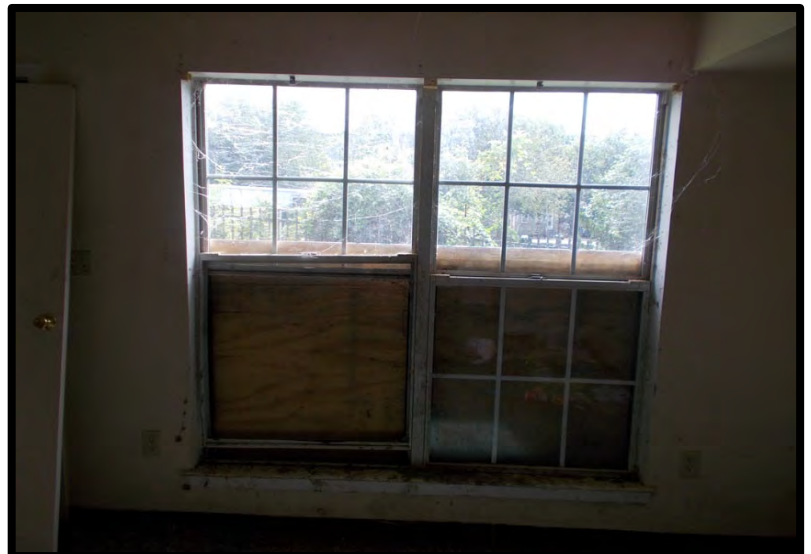
Photo No. 128

View of dining room windows looking into rear yard.

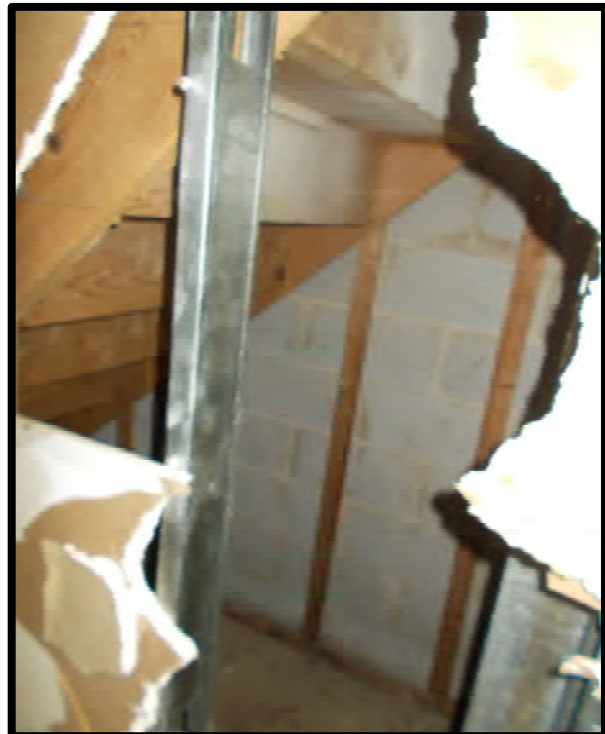
Photo No. 130

View of underside of stair to second floor.

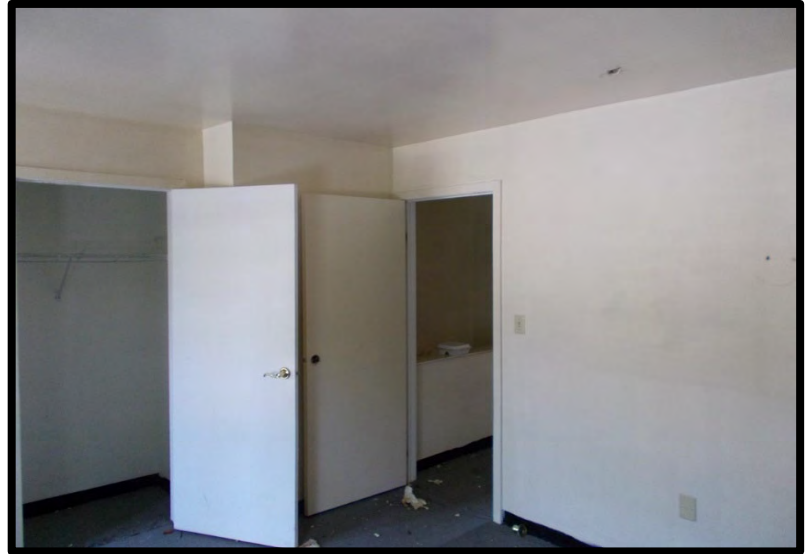
Photo No. 131

View of master bedroom closets and entry.

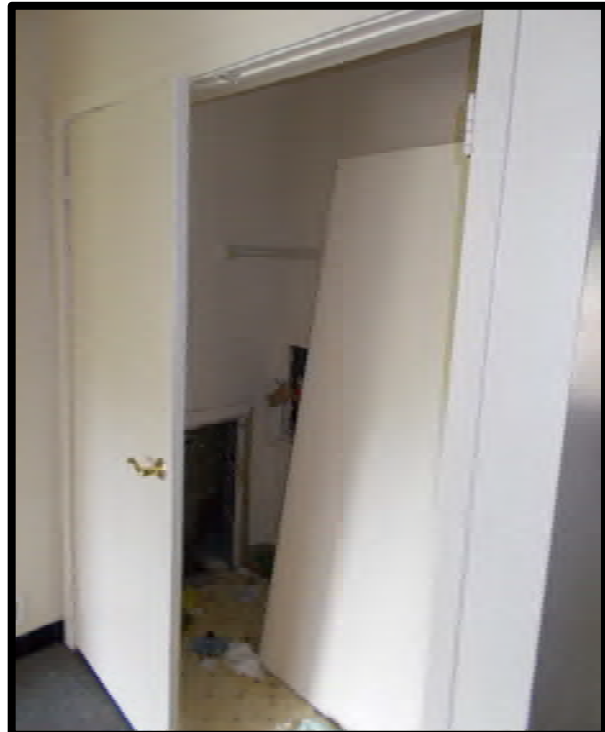
Photo No. 132

View of washer/dryer closet on second floor.

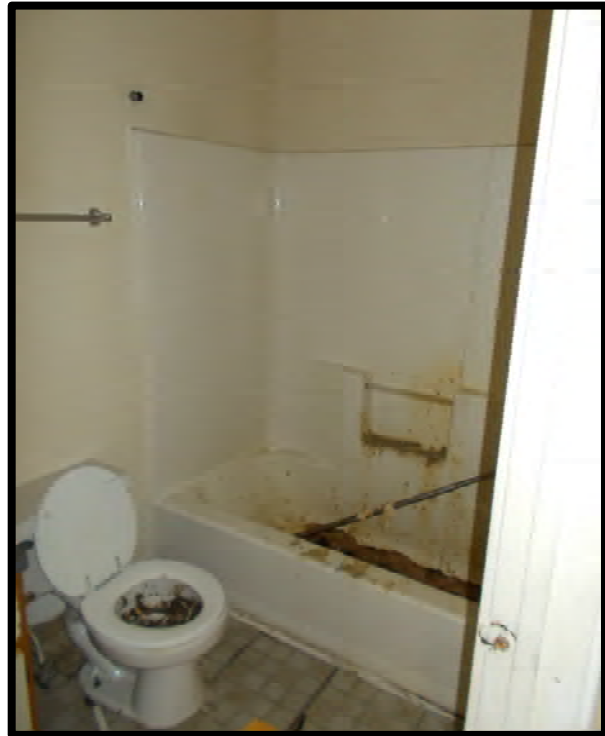
Photo No. 133

View of shower and water closet at second floor
bathroom.

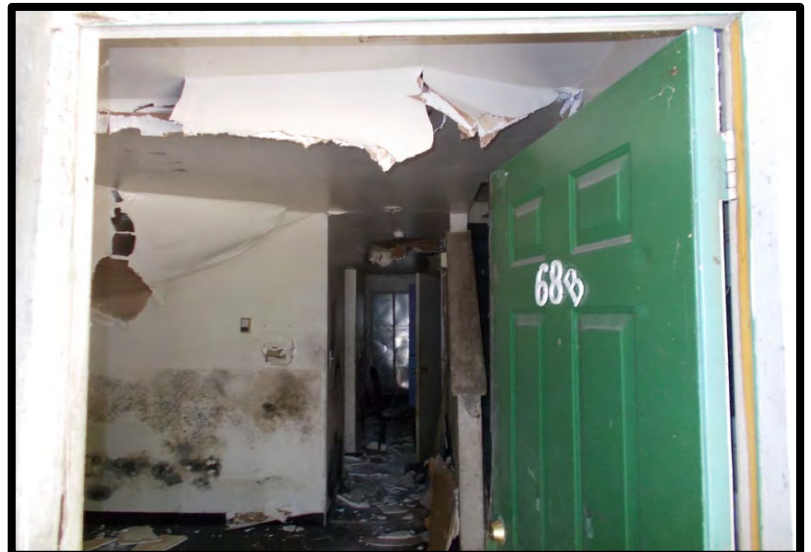
Photo No. 134

Unit 68B.

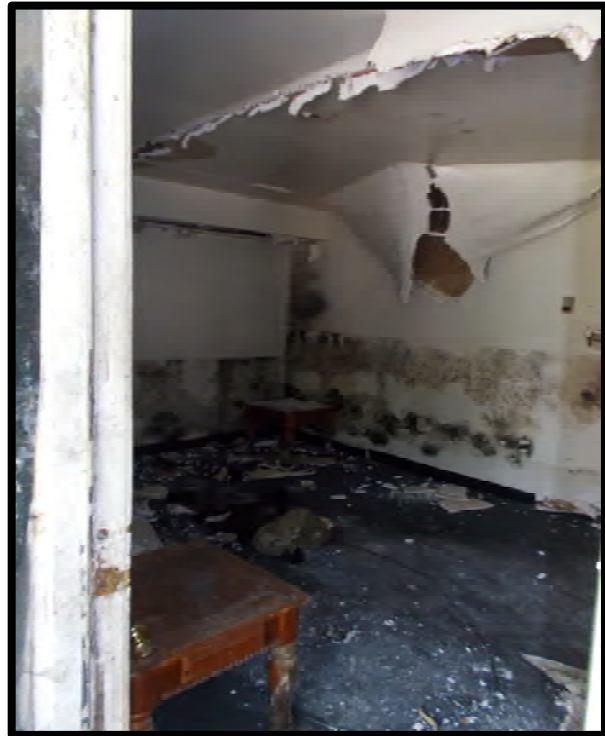
Photo No. 135

View of living room from entry.

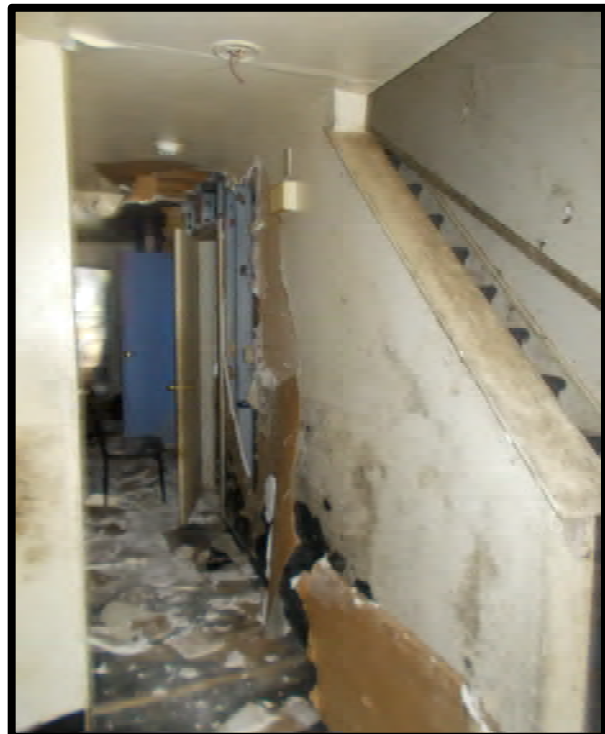
Photo No. 136

View of stairs to second floor and hallway leading to kitchen and dining room.

Each unit had an interior wood stair from the first to second floor. The stair structure in all units was sound. New carpeting for the stair should be provided. The entry porch and stairs are generally in poor condition throughout the complex. Stairs from grade and porch decking should be replaced throughout.

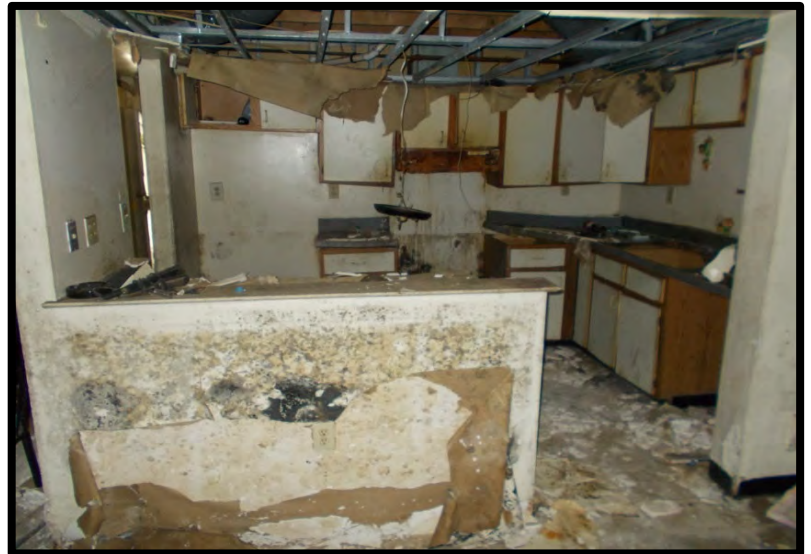
Photo No. 137

View of kitchen from dining room.

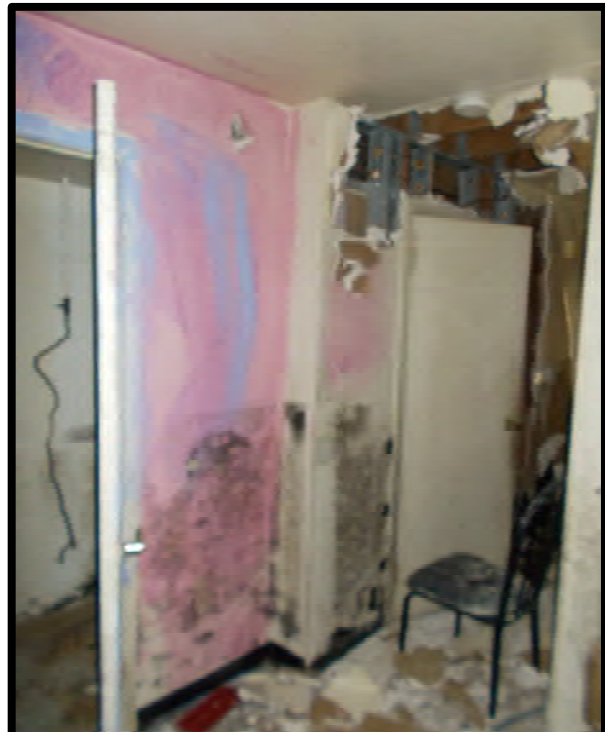
Photo No. 138

View of half bath and dining room closet.

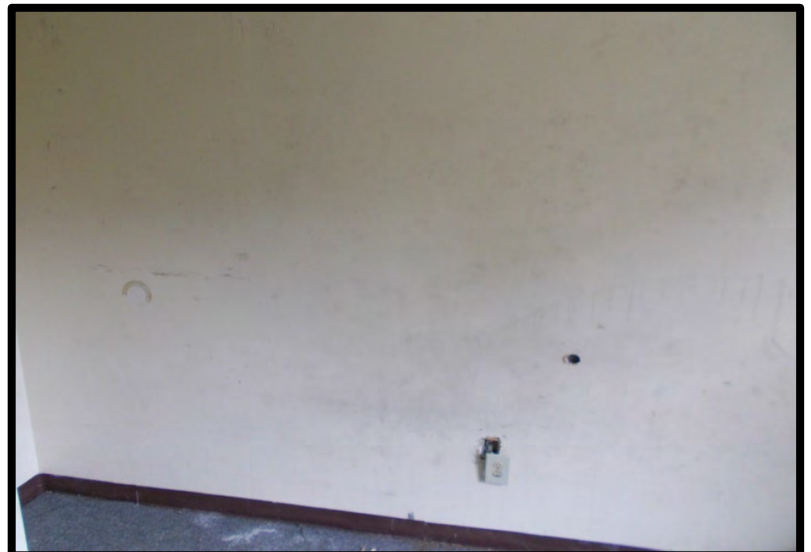
Photo No. 140

View of bedroom interior.

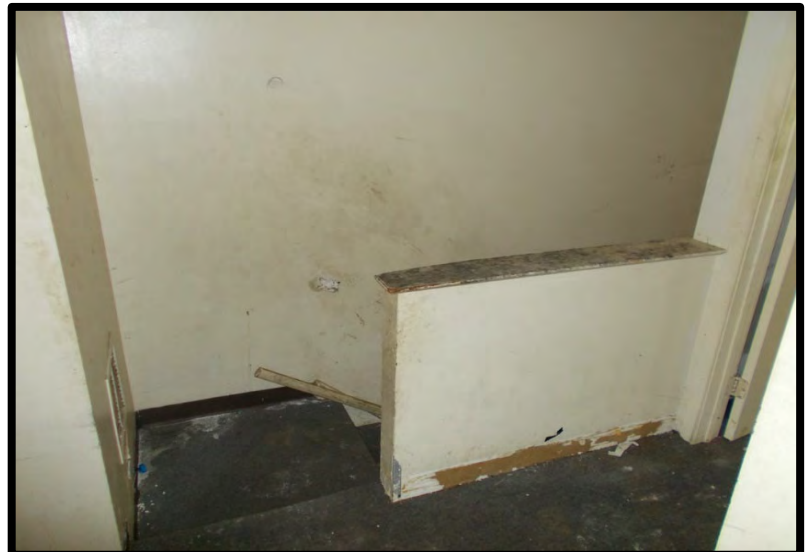
Photo No. 142

View of stair and broken handrail at second floor.

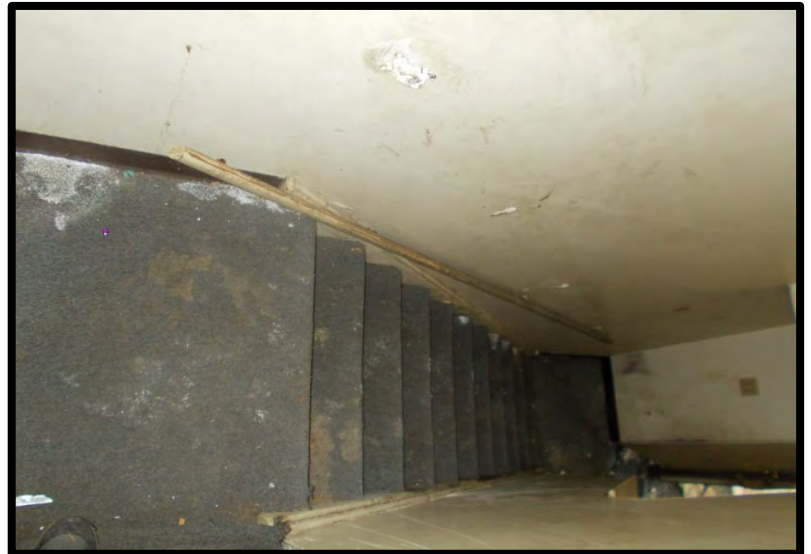
Photo No. 143

View looking down stair to first floor.

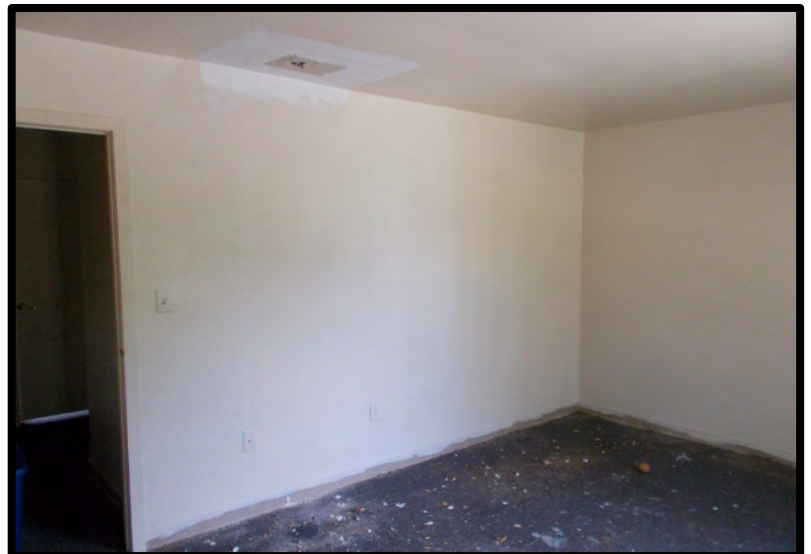
Photo No. 148

View of master bedroom with previously repaired hole in ceiling.

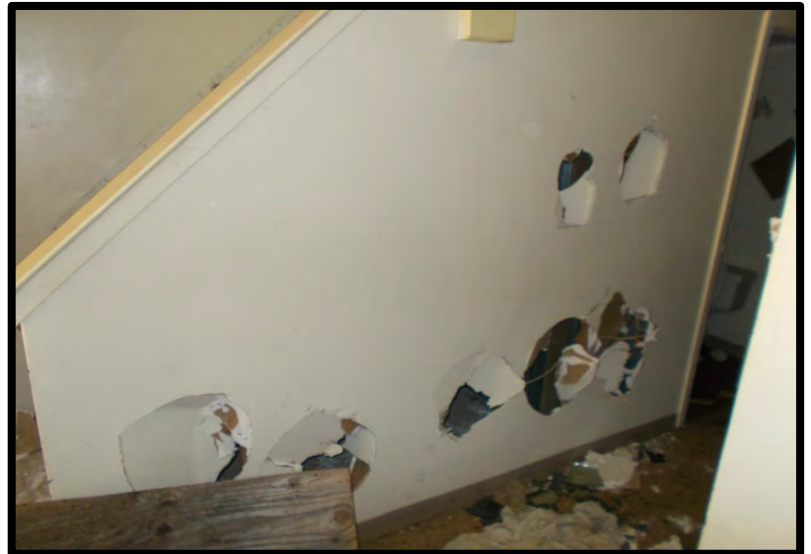
Photo No. 197

View of damaged gypsum wallboard at stair to second floor.

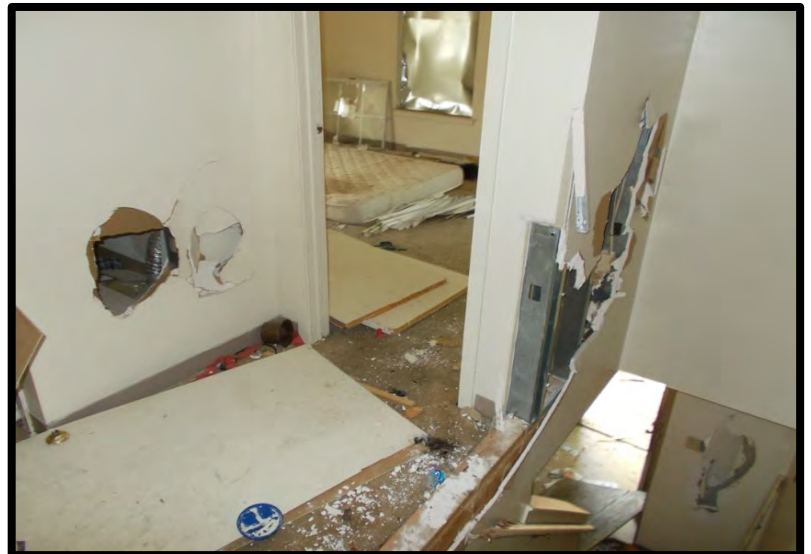
Photo No. 200

| Division | Capital Expense Category | Description / Comments | Condition | Action | EUL (yr) | Effective Age (yr) | RUL (yr) | Quantity | Unit of Measure | Unit Cost | Total Cost | Critical Repairs | Year 1 12 Month | Year 2 | Year 3 |
|---|---|---|---|---|---|---|---|---|---|---|---|---|---|---|---|
| | Unit 74B | Half wall at stair removed; fall hazard | Poor | Repair | 35 | 20 | 15 | 10 | LF | \$8.00 | \$800 | | | | |

View into master bedroom. Note the wall separating the stair has been removed.

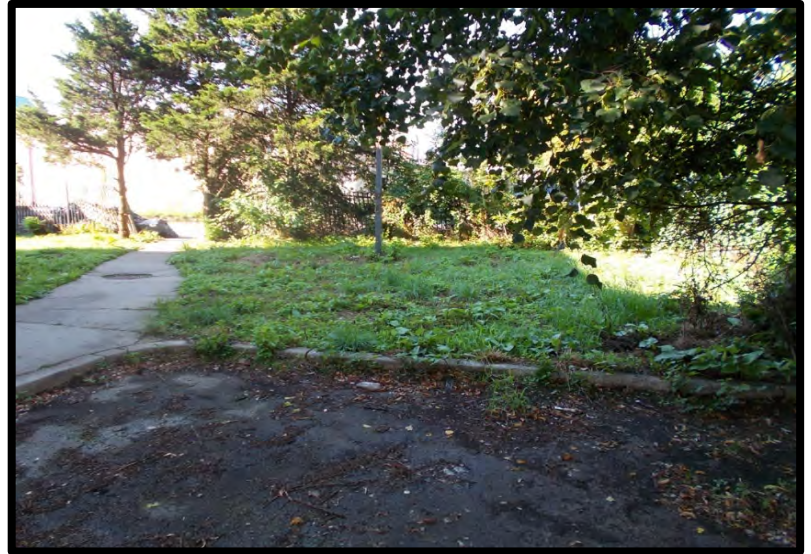
Photo No. 23

View of southern property line and walkway.

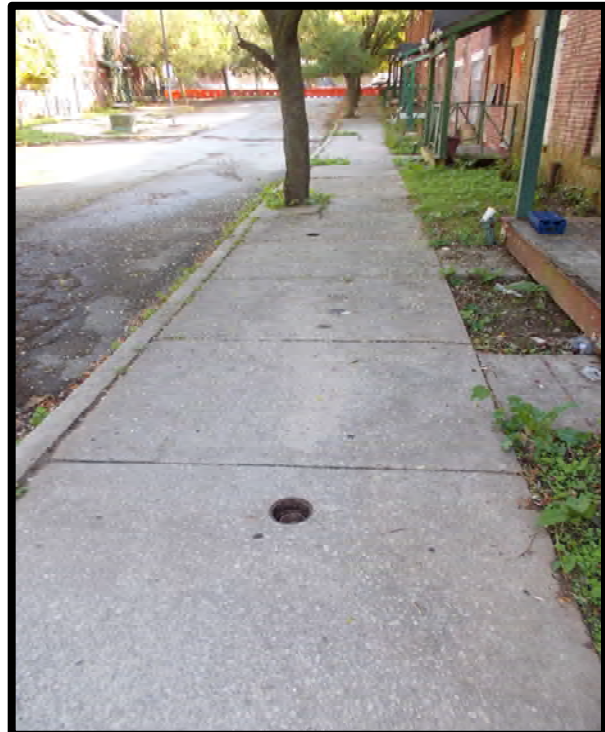
Photo No. 24

View of sidewalk, looking north along east side of
court yard.

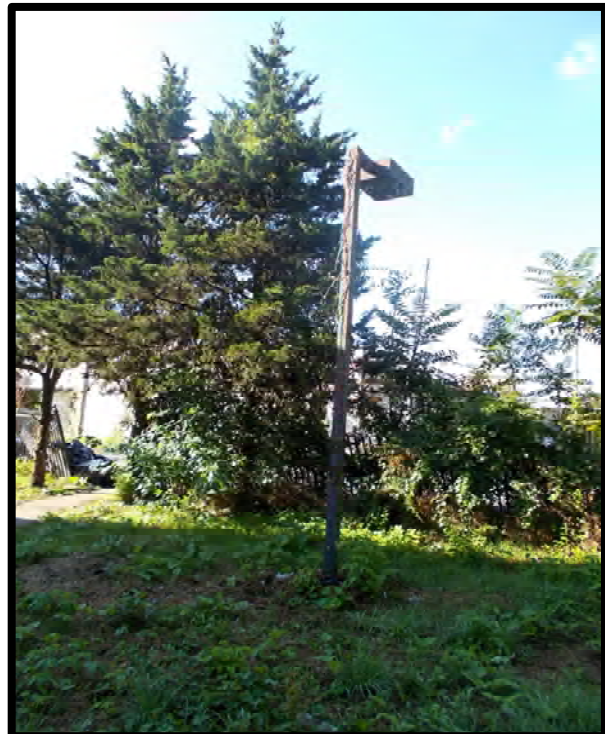
Photo No. 26

View of site lighting located on the south side of the
property.

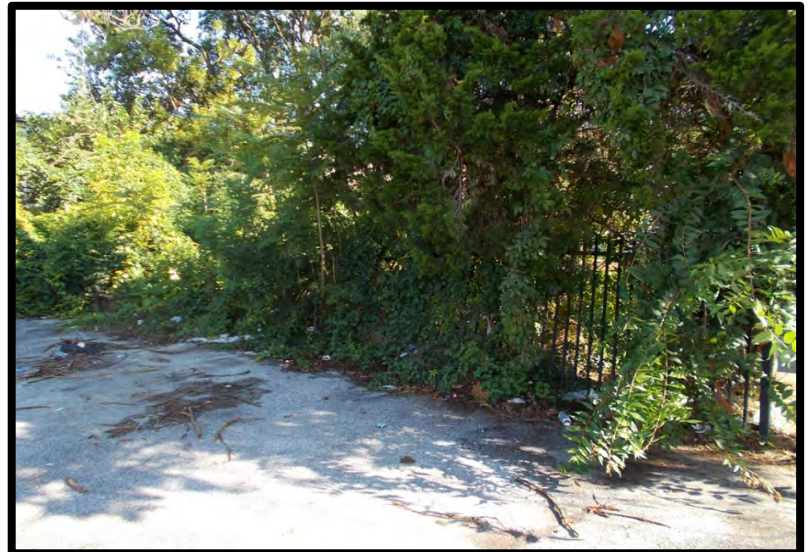
Photo No. 28

View of fencing along south side of property.

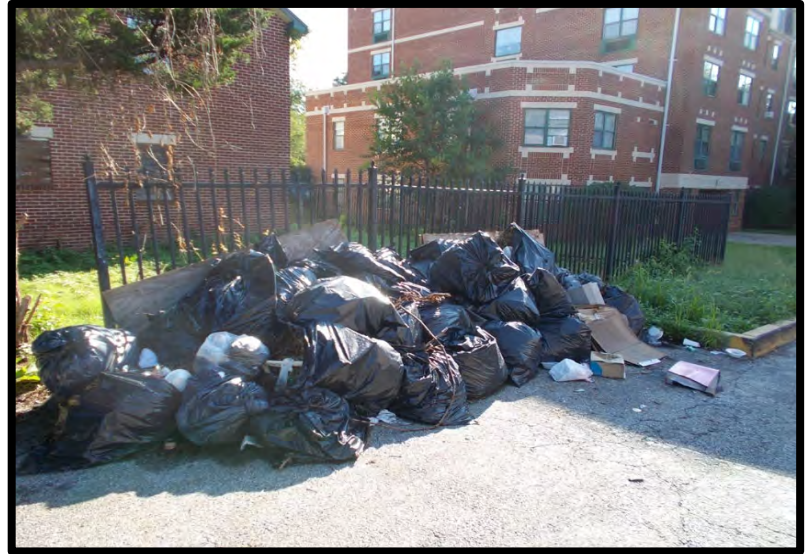
Photo No. 29

View of garbage piled against fencing south of unit
74B.

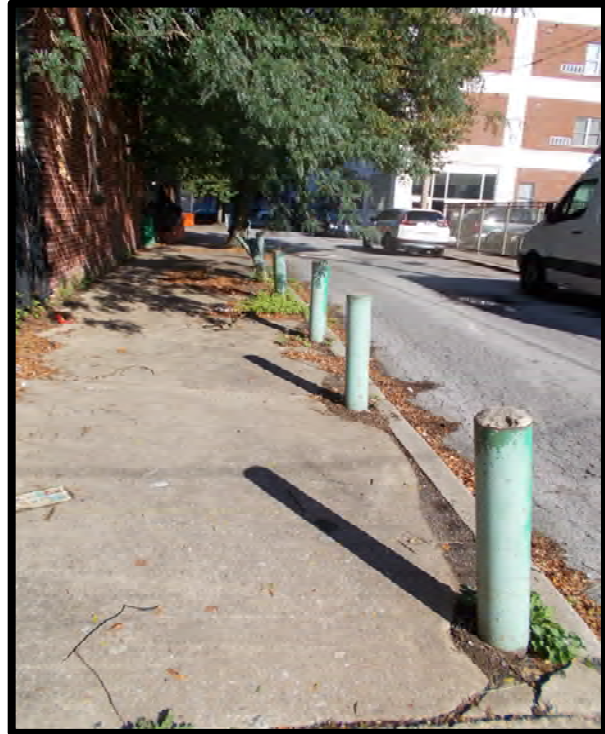
Photo No. 33

View looking west along Lena St. at sidewalk
condition.

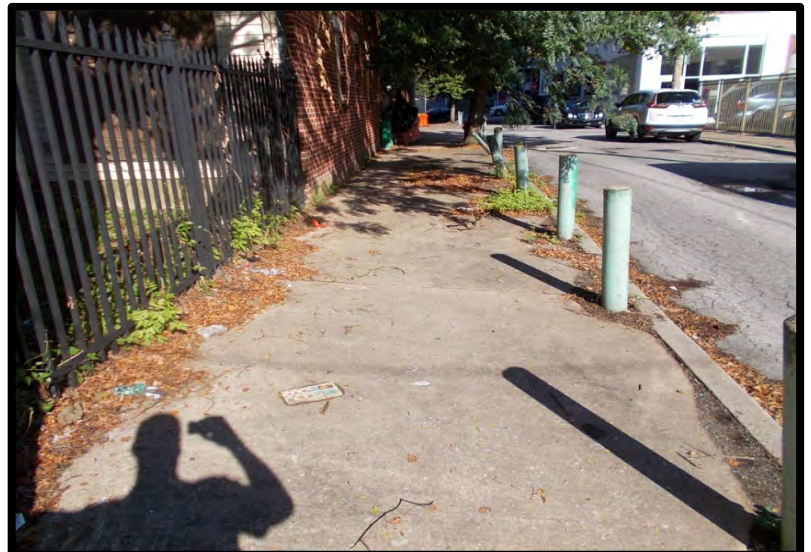
Photo No. 34

Ditto previous photo.

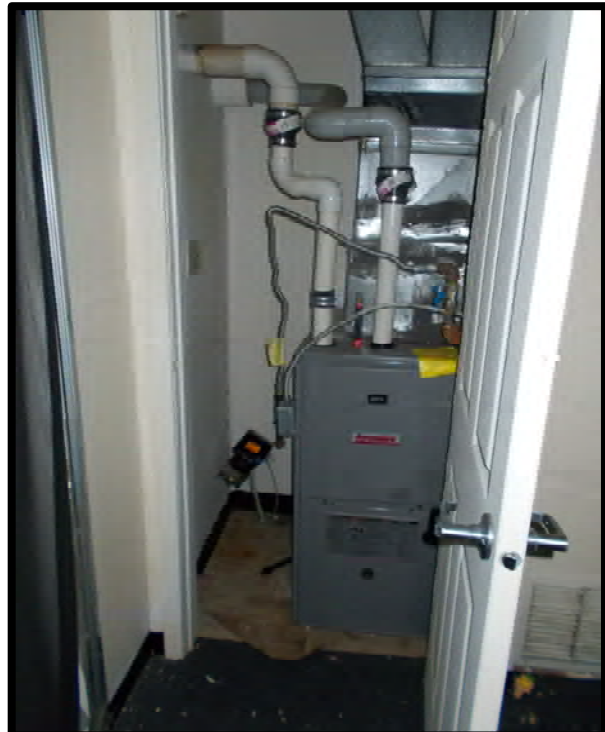
Photo No. 46

Depicts view of typical furnace installation.

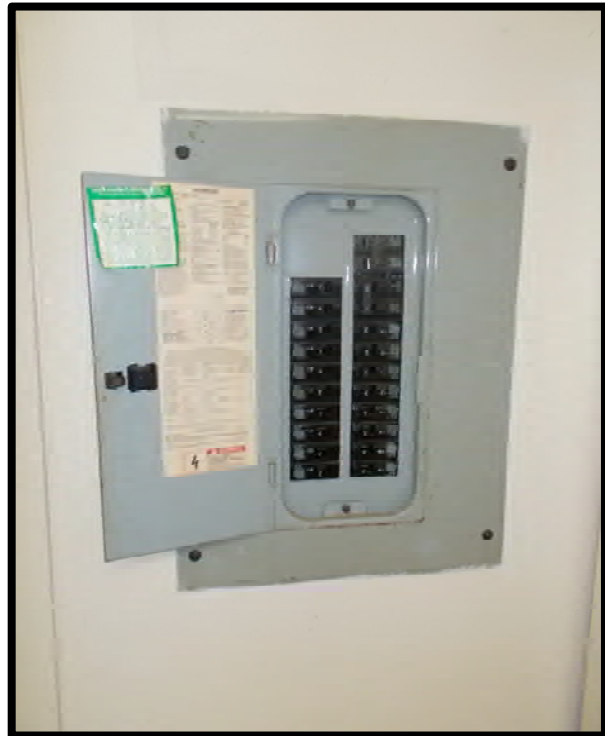
Photo No. 64

View of apartment electrical panel.

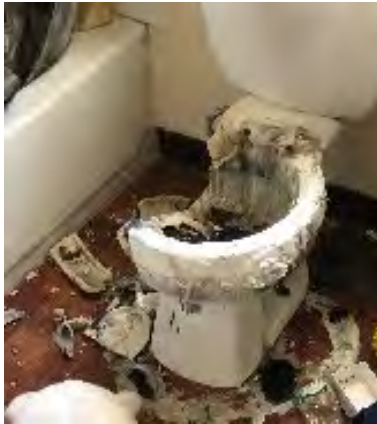
Toilet seat in Unit 60.

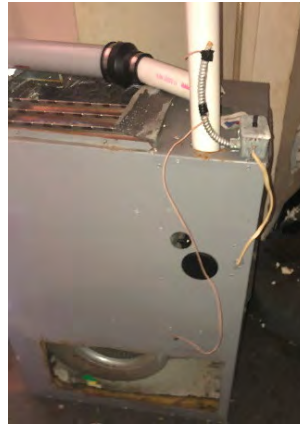
Gas furnace disassembled and misplaced.

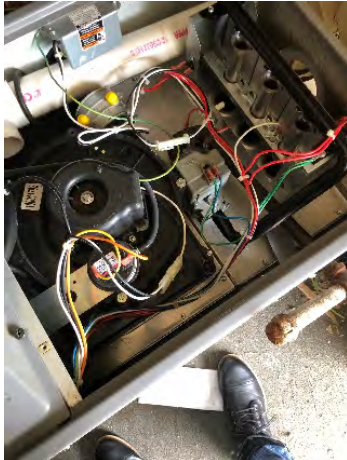
Another gas furnace disassembled and misplaced.
