Germantown/Mount Airy Properties

Physical Conditions and Needs Assessment

Premises P

83 E. Church Lane

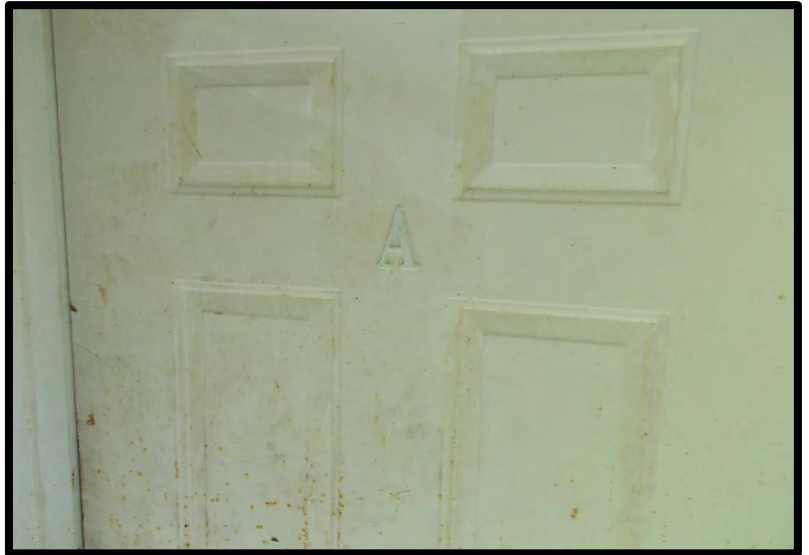
Photo No. 3

Panning right from previous photo. Entry to Unit A.

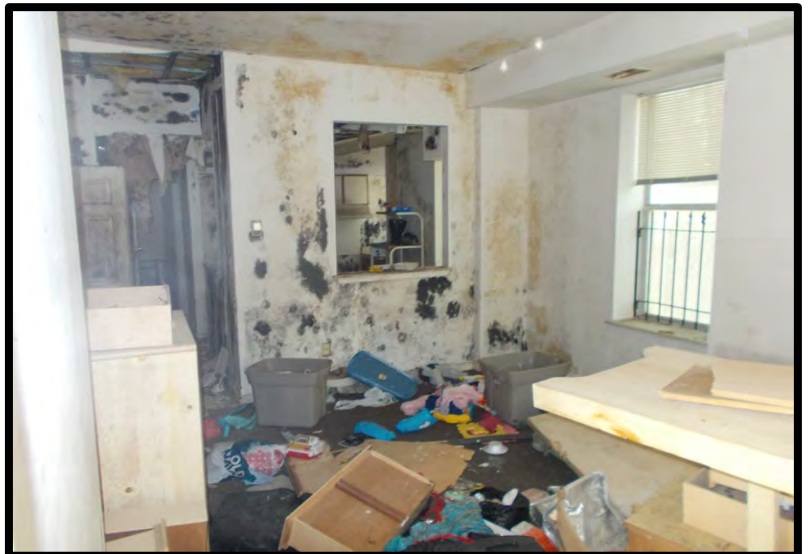
Photo No. 4

Overall view of living room area for Unit A. This photo also looks towards the rear of the dwelling unit and kitchen.

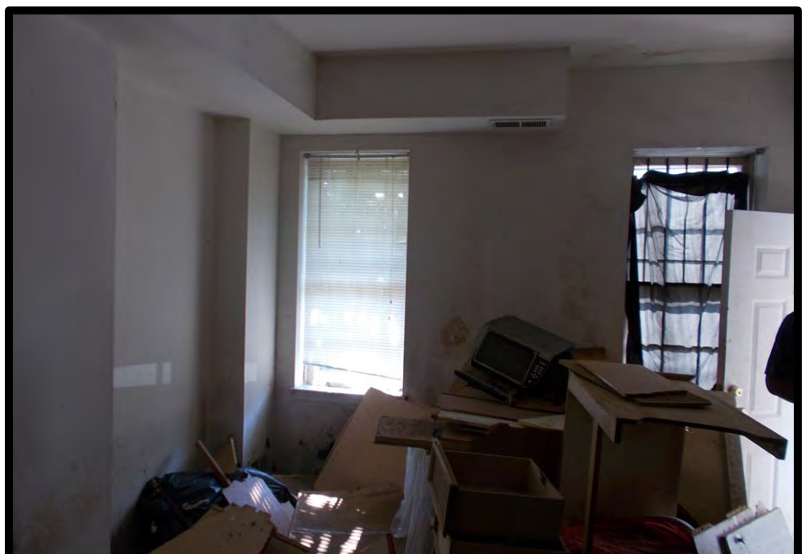
Photo No. 5

View looking at front of Unit A living room with apartment entry on the right.

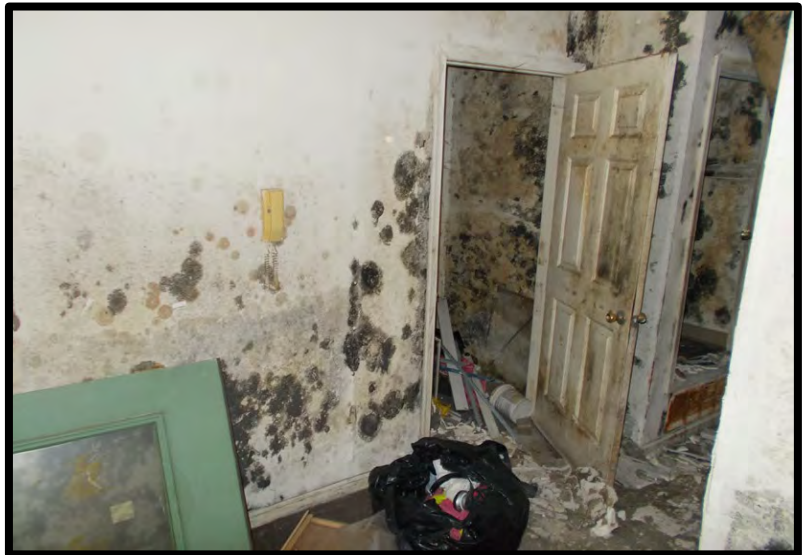
Photo No. 6

Depicts view of hall closet and mechanical room
within first floor Unit A.

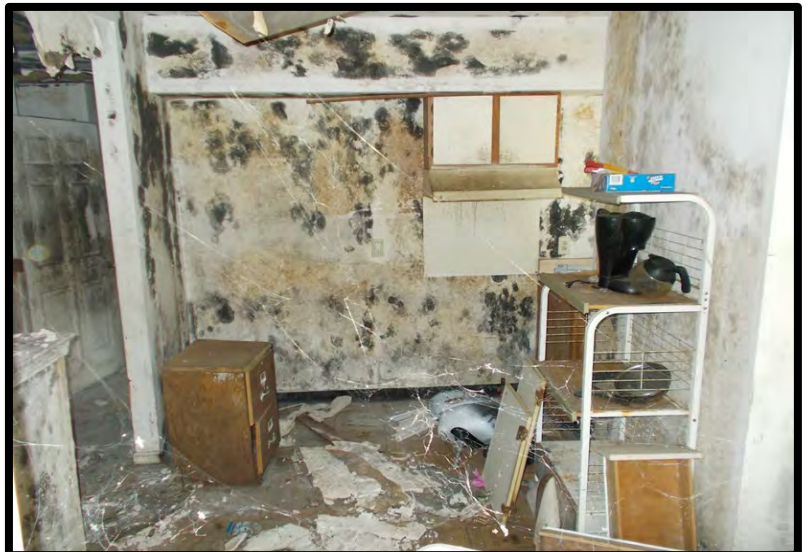
Photo No. 7

Interior view of kitchen area.

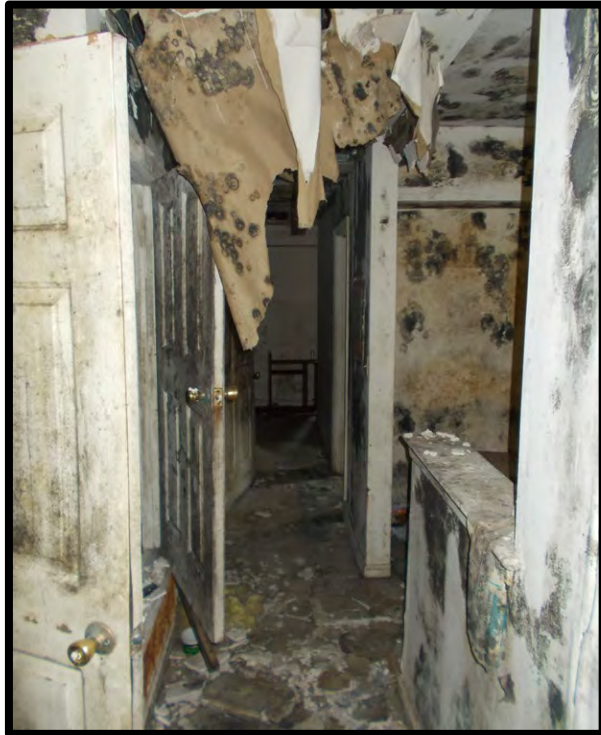
Photo No. 8

View of hallway leading towards rear bedrooms at
first floor Unit A.

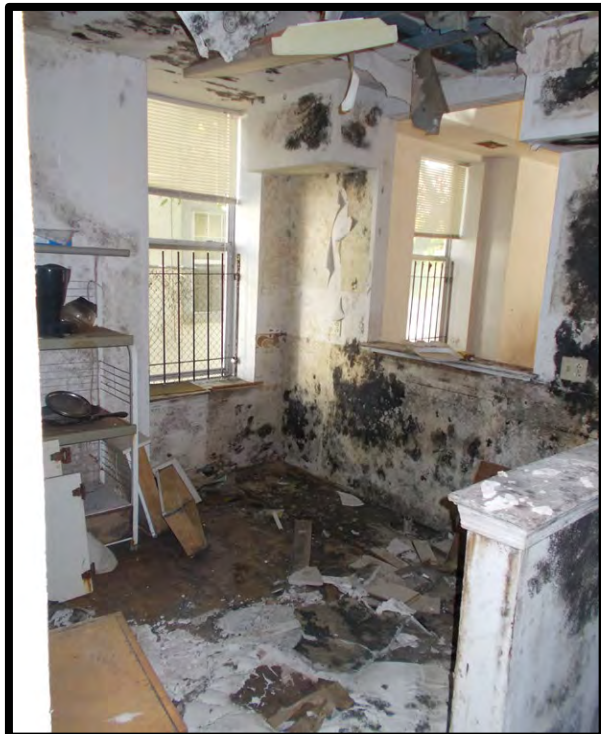
Photo No. 9

Interior view looking at kitchen from hallway. Pass-
through is to the living room area.

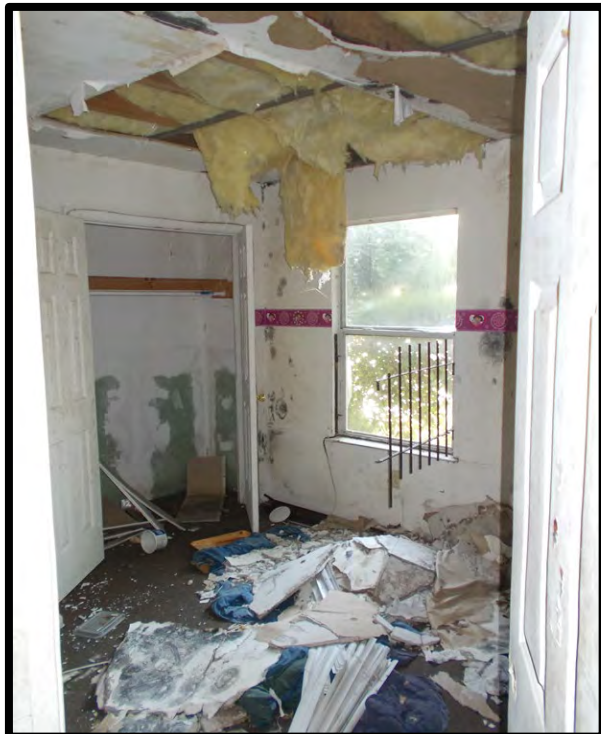
Photo No. 11

View of bedroom #1 located behind the kitchen. View
is from hallway.

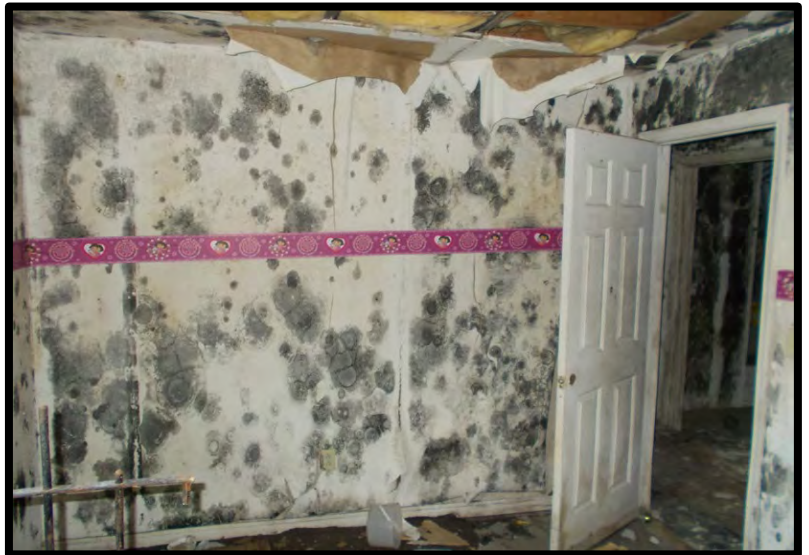
Photo No. 12

Additional view of bedroom #1 looking towards
bedroom entry and hallway.

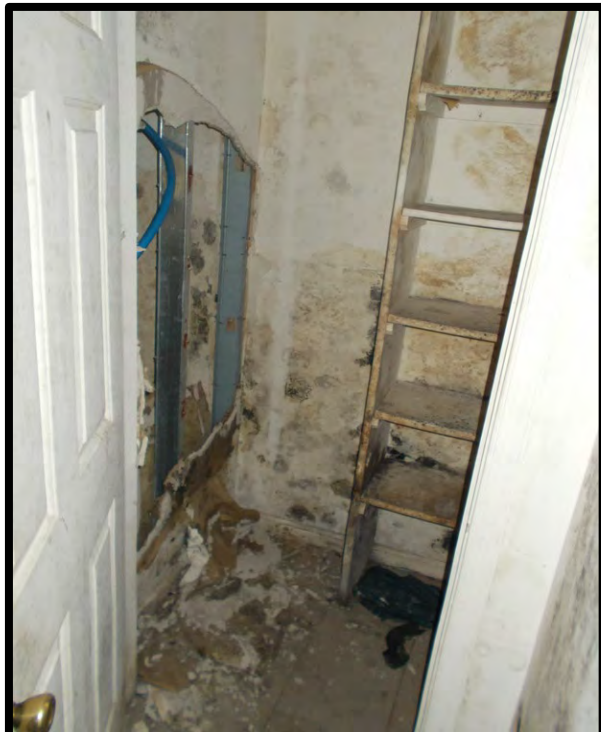
Photo No. 13

Depicts view of hall closet.

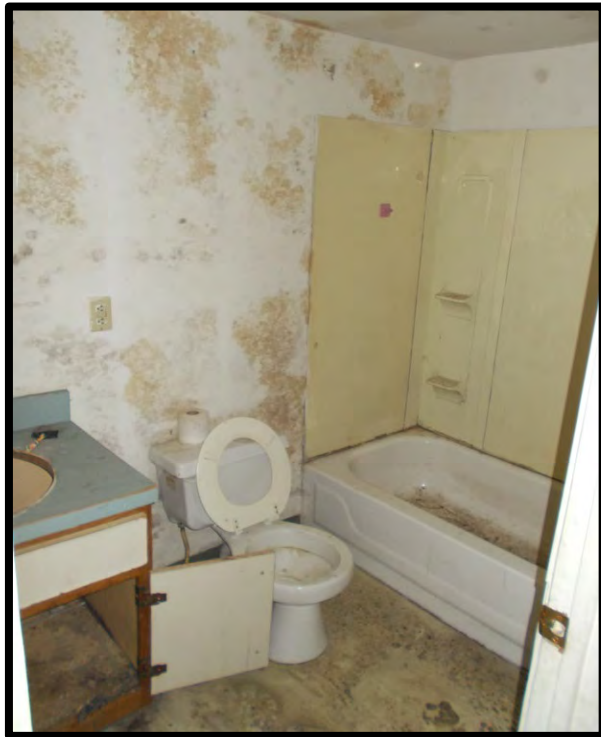
Photo No. 14

Interior view of first floor bathroom.

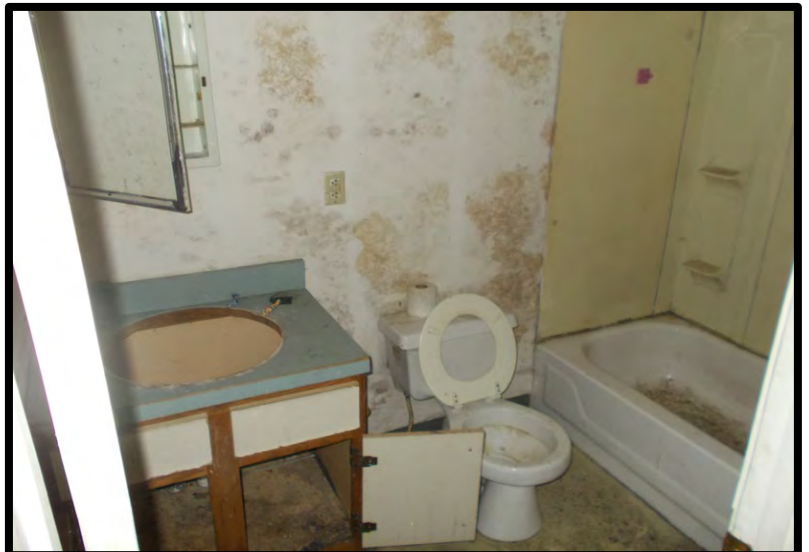
Photo No. 15

Additional view of first floor bathroom vanity, water closet and bathtub.

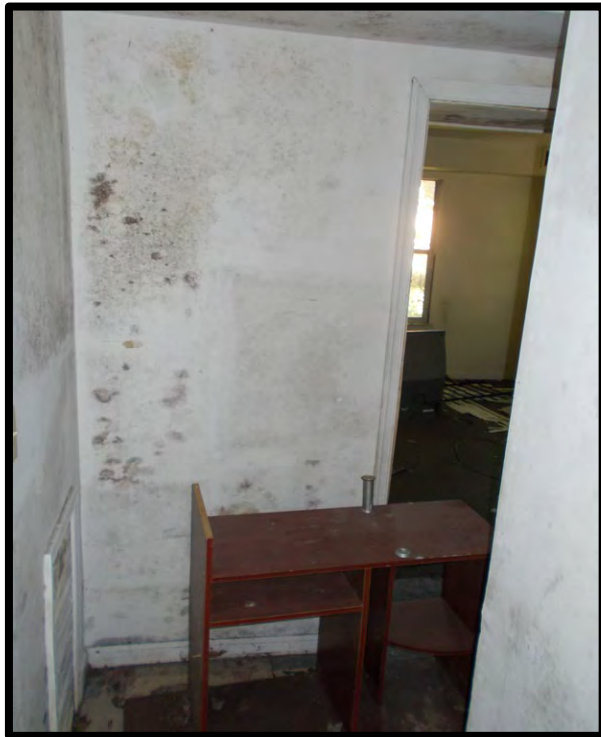
Photo No. 16

View of hallway at the end of the first floor for Unit A
with entry to rear bedroom.

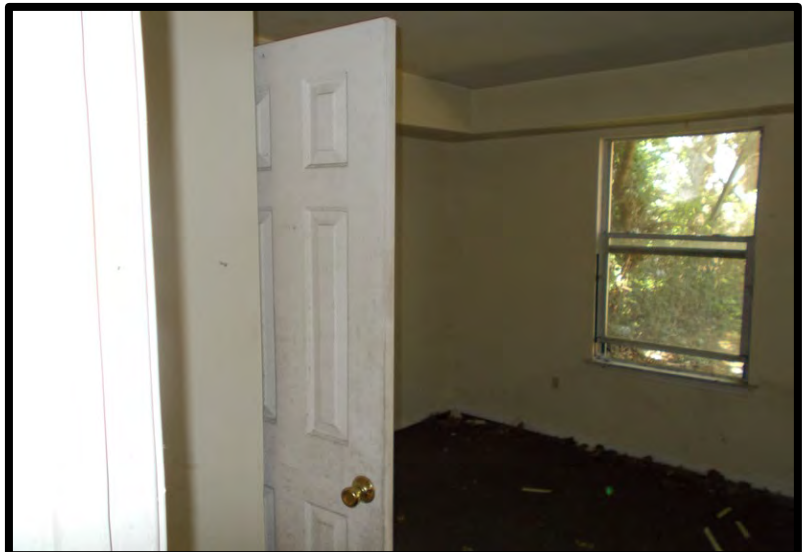
Photo No. 17

View inside bedroom #2 from hallway and bedroom
closet on left.

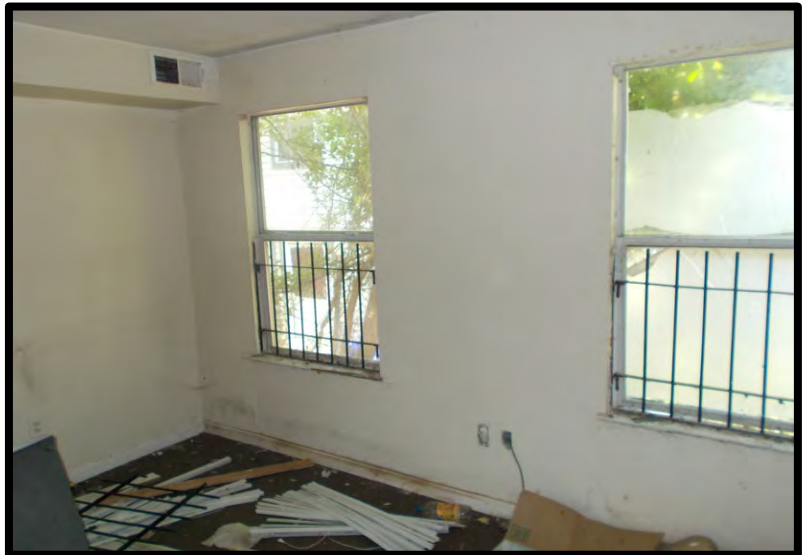
Photo No. 18

Additional view at rear wall of bedroom #2.

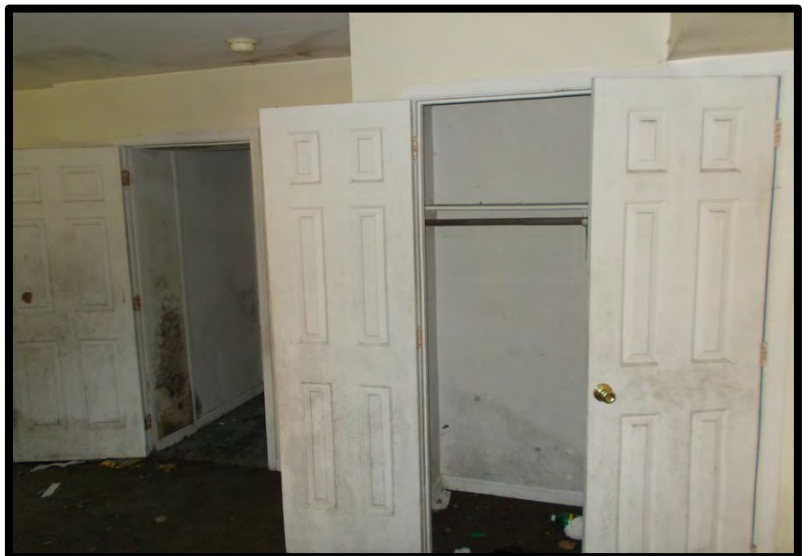
Photo No. 19

Panning 180 degrees from previous photo. View of
bedroom entry and bedroom closet.

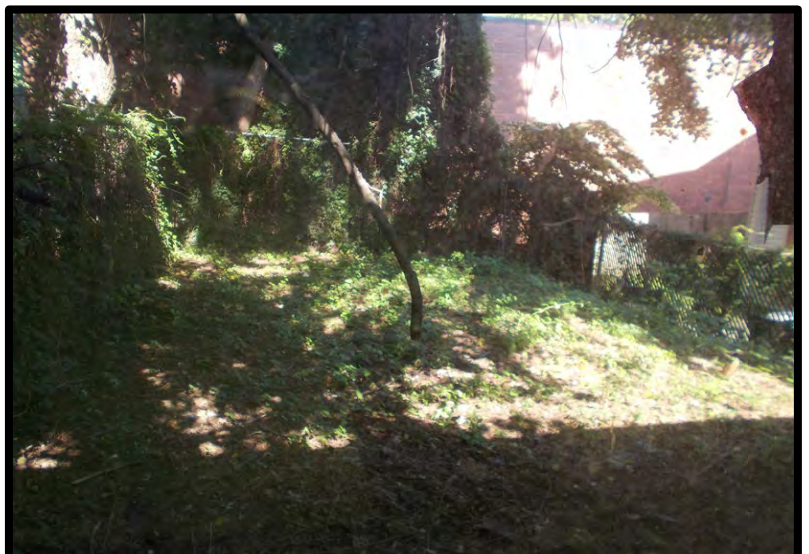
Photo No. 20

View of rear yard as seen from Unit A.

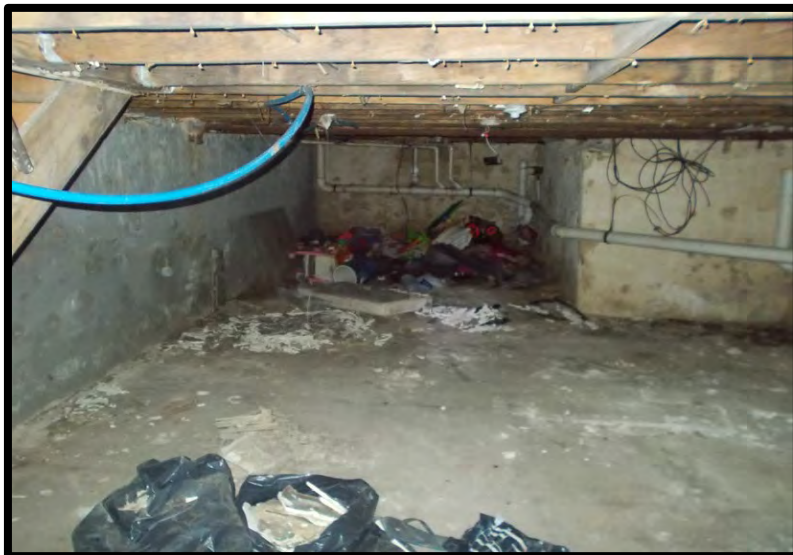
Photo No. 21

View of basement looking towards rear of building.

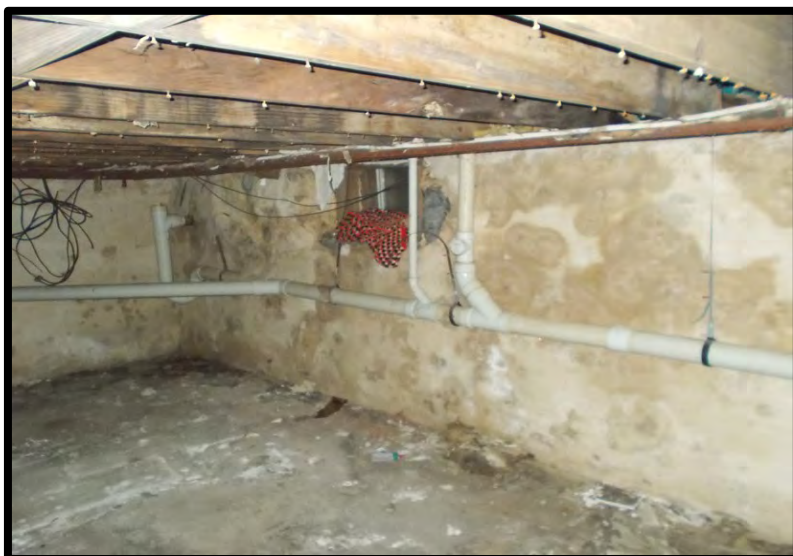
Photo No. 22

Panning right from previous photo.

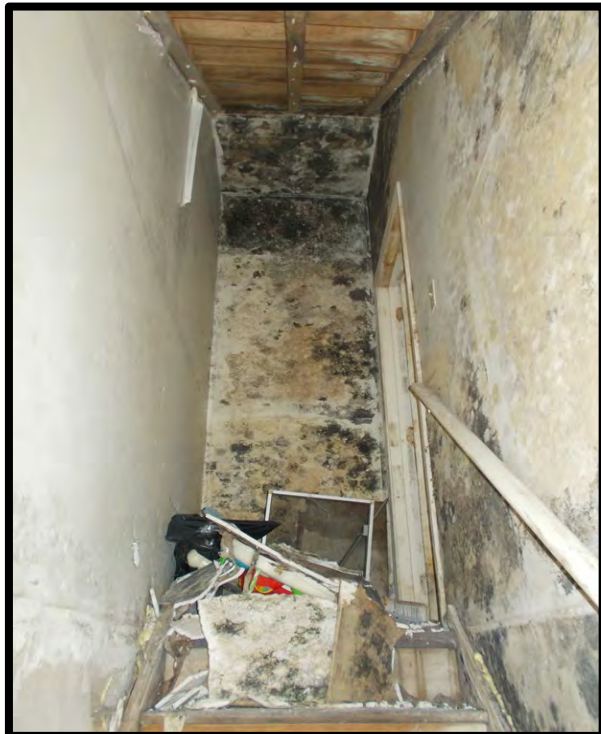
Photo No. 25

View at top of basement stairs looking towards first
floor from basement.

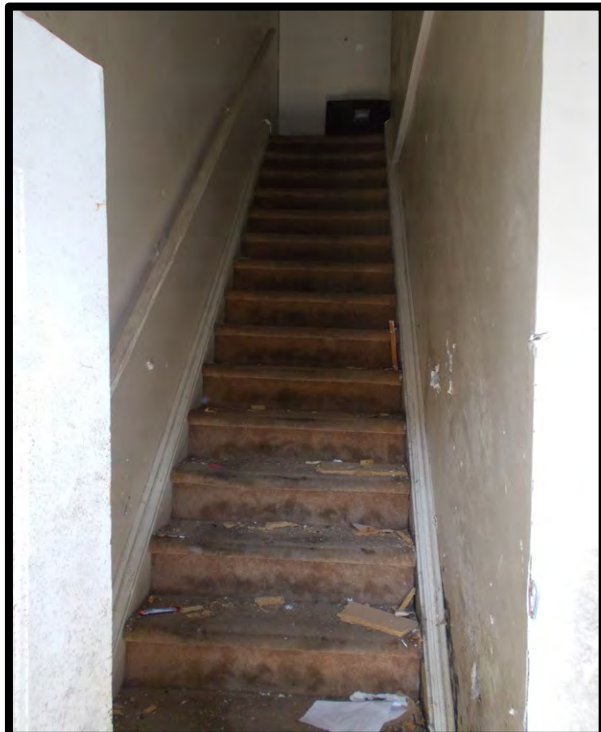
Photo No. 27

Interior view of stairs leading to second floor.

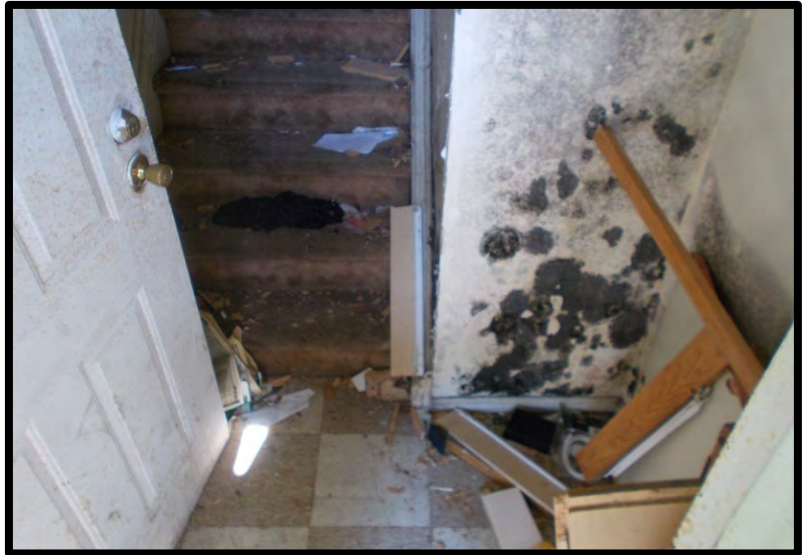
Photo No. 28

Panning down from previous photo. View of floor and walls at Unit B entry.

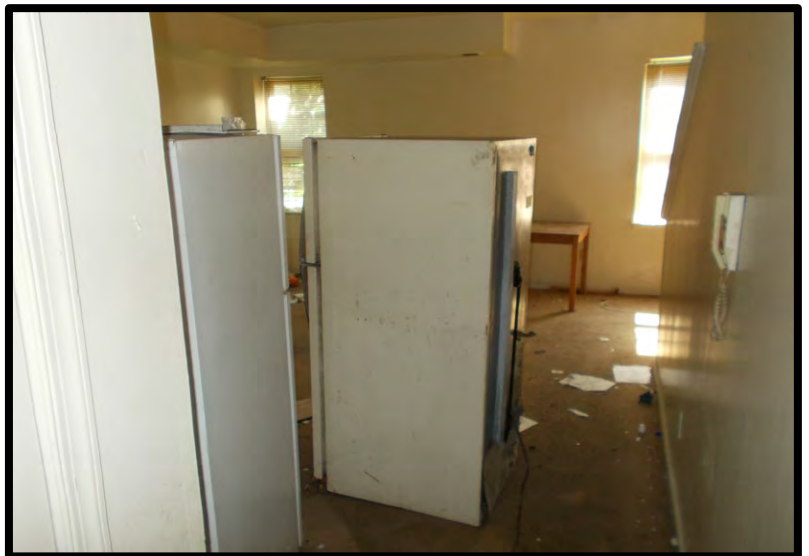
Photo No. 29

Looking towards front of building at second floor.
View of living room.

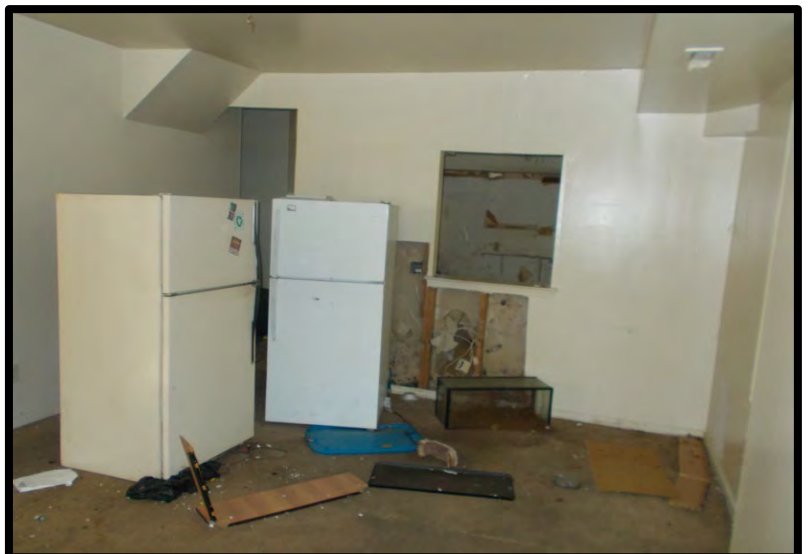
Photo No. 30

Overall view of living room looking towards kitchen
and apartment entry on the left.

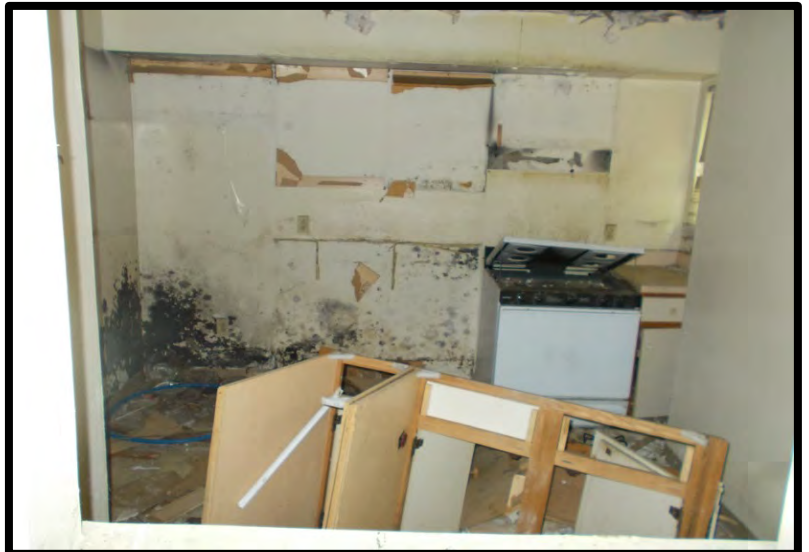
Photo No. 32

Overall view looking into kitchen from living room.

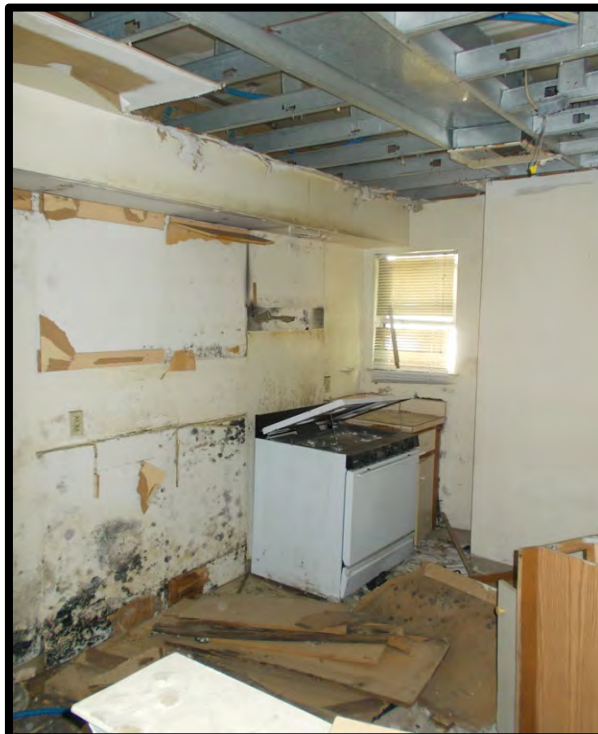
Photo No. 34

Additional view of kitchen as seen from hallway.

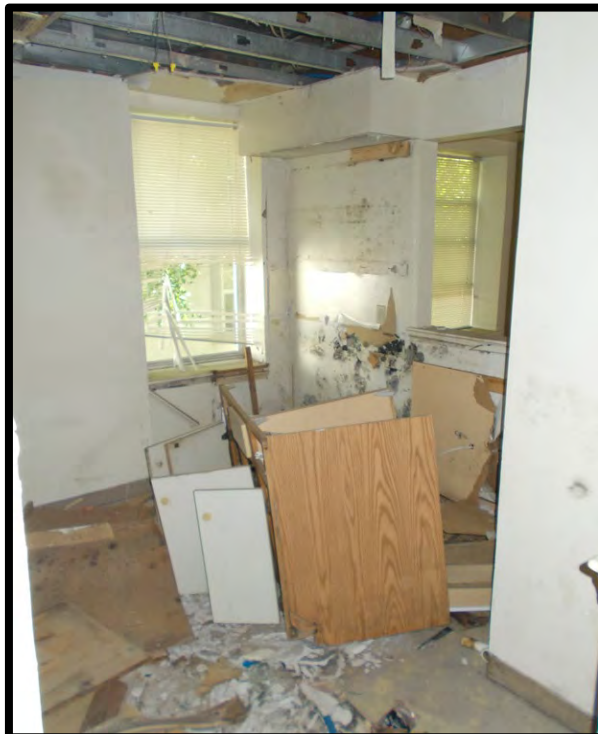
Photo No. 36

Additional view of kitchen demising wall with living room.

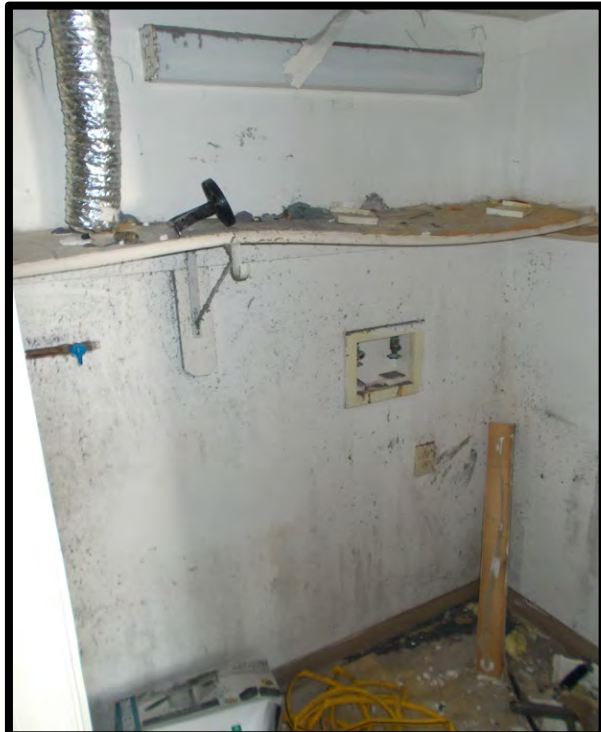
Photo No. 38

View of washer/dryer closet located at second floor.

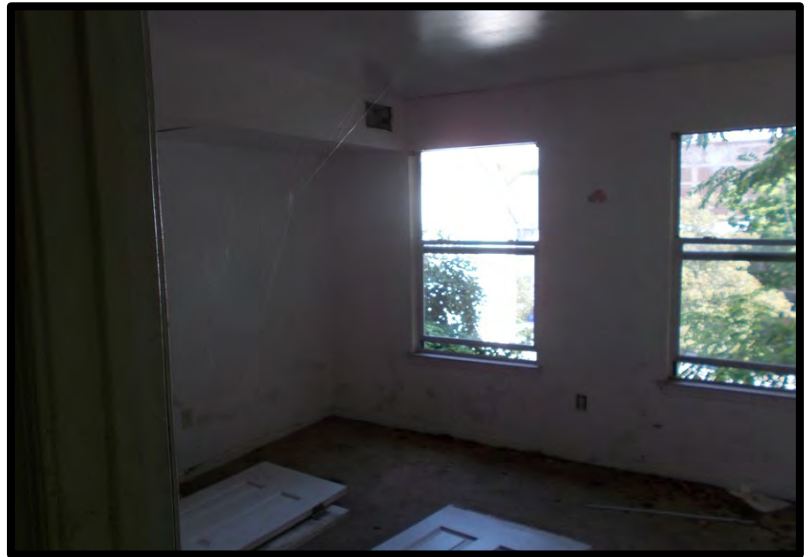
Photo No. 39

View of second floor bedroom #1 located at the rear
of the building

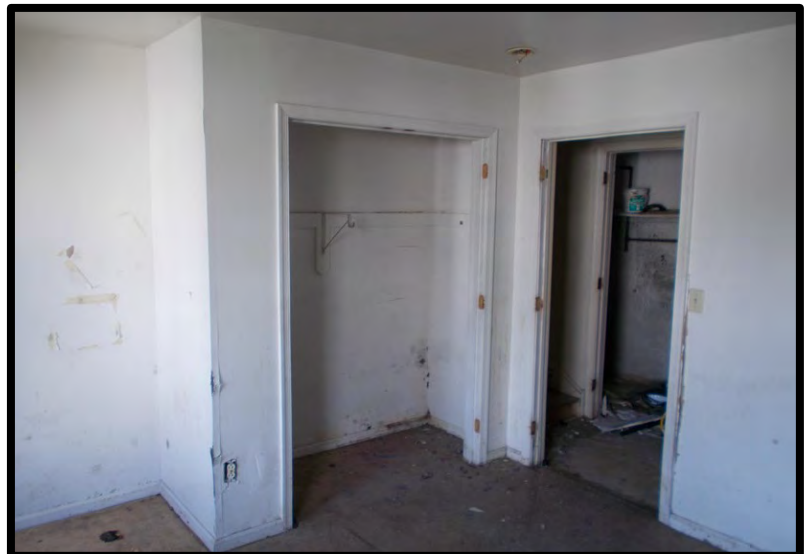
Photo No. 40

View of second floor bedroom #1 closet and entry.

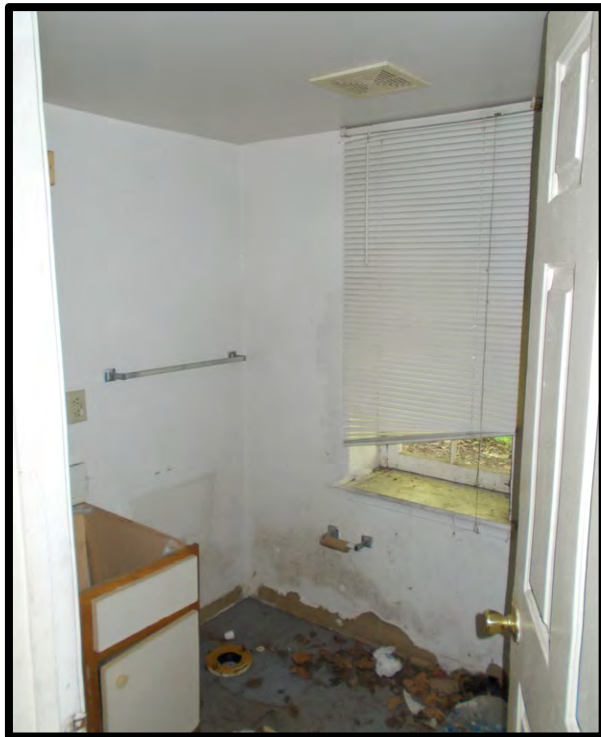
Photo No. 41

View of half bath located at the back of the second floor.

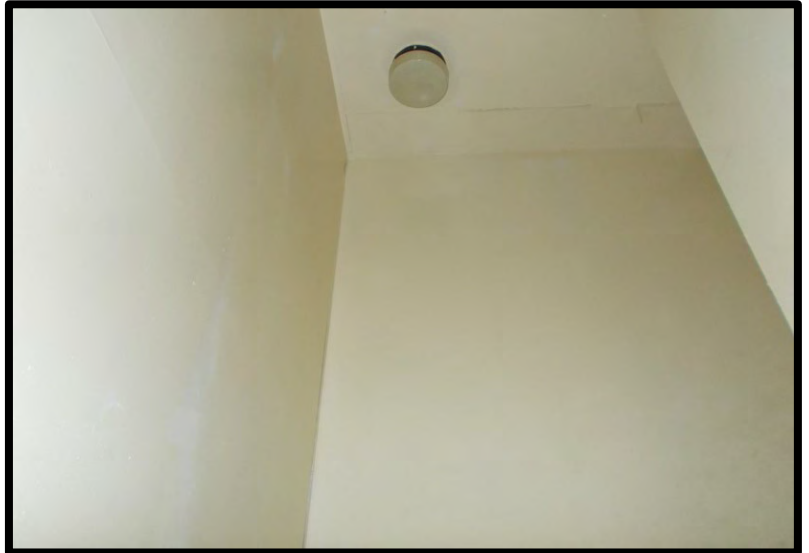
Photo No. 43

View of ceiling above landing leading to third floor.

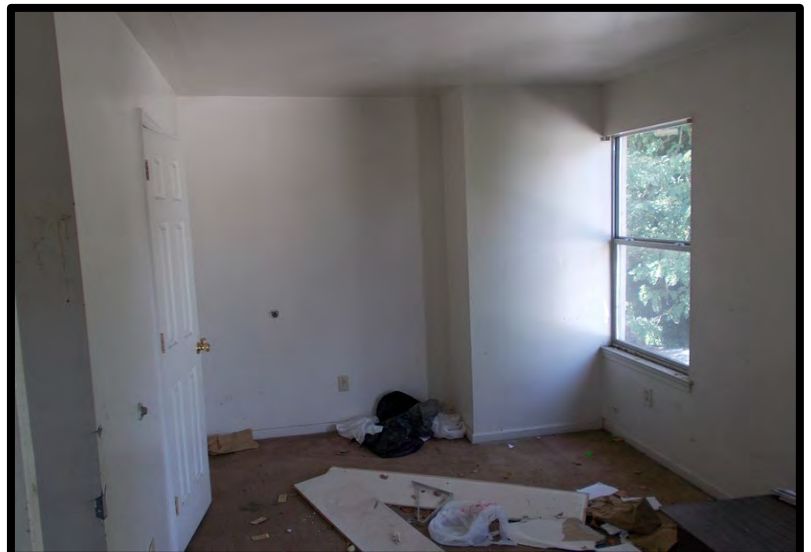
Photo No. 46

Panning left from bedroom entry.

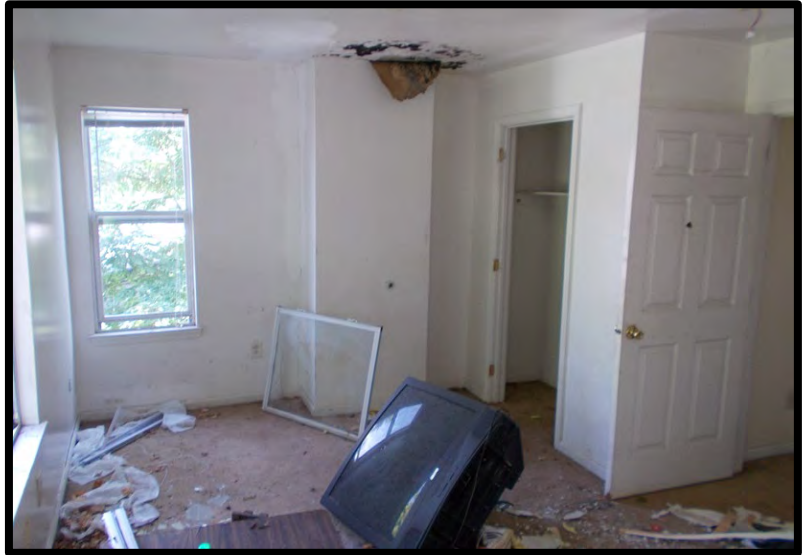
Photo No. 47

Panning 180 degrees and 90 degrees from previous photos also looking at bedroom at the rear of the building opposite stair at third floor.

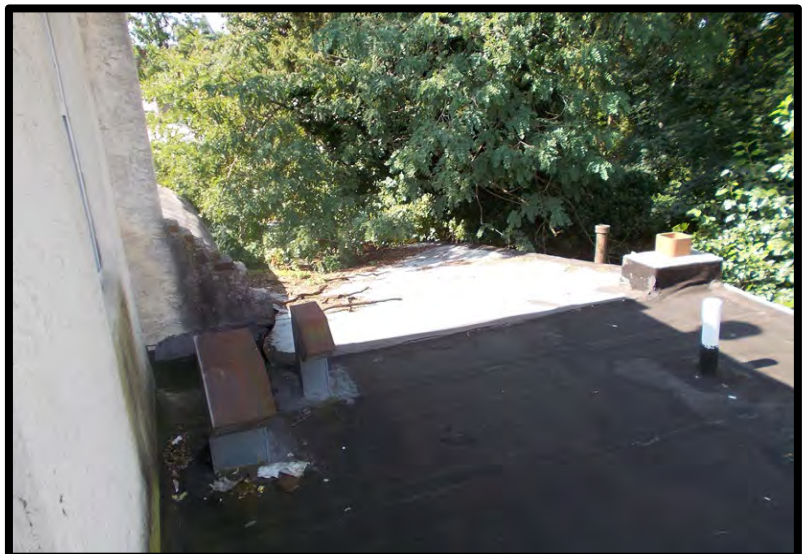
Photo No. 49

Panning left from previous photo. Note the silver sloped portion is adjacent building and not part of this property.

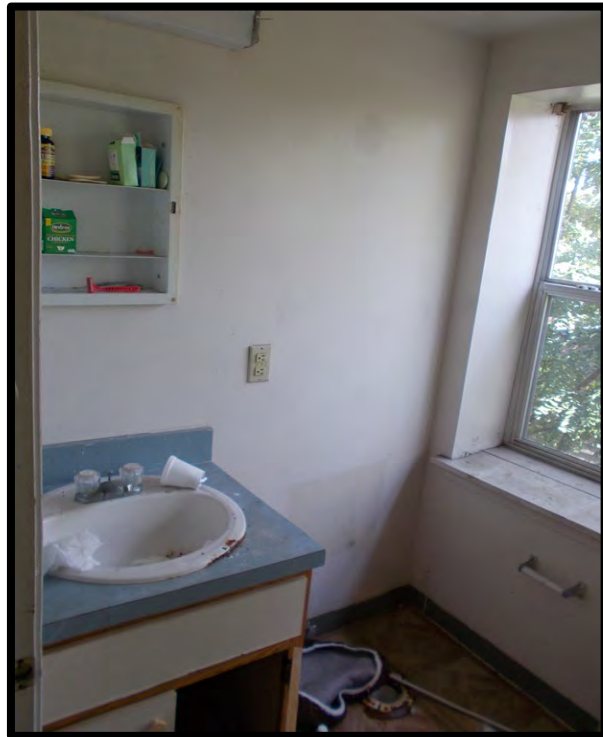
Photo No. 50

View of third floor bathroom as seen from hallway.

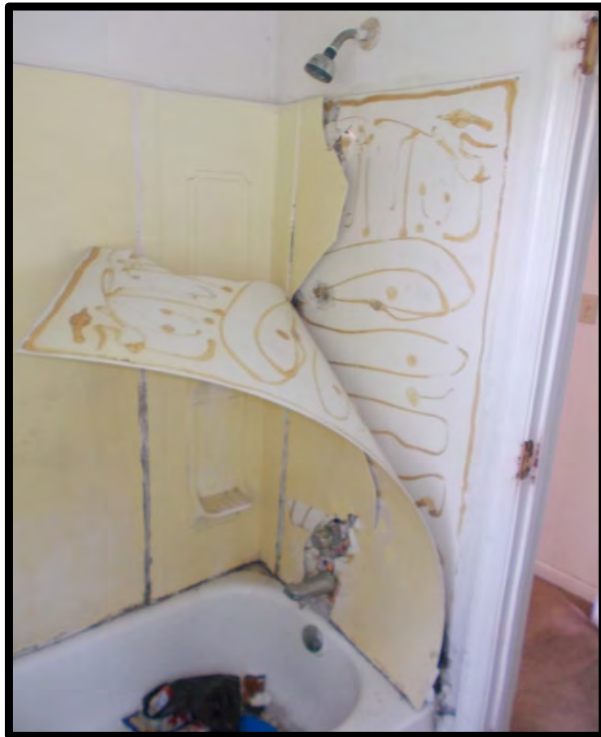
Photo No. 52

View of bathtub at third floor bathroom.

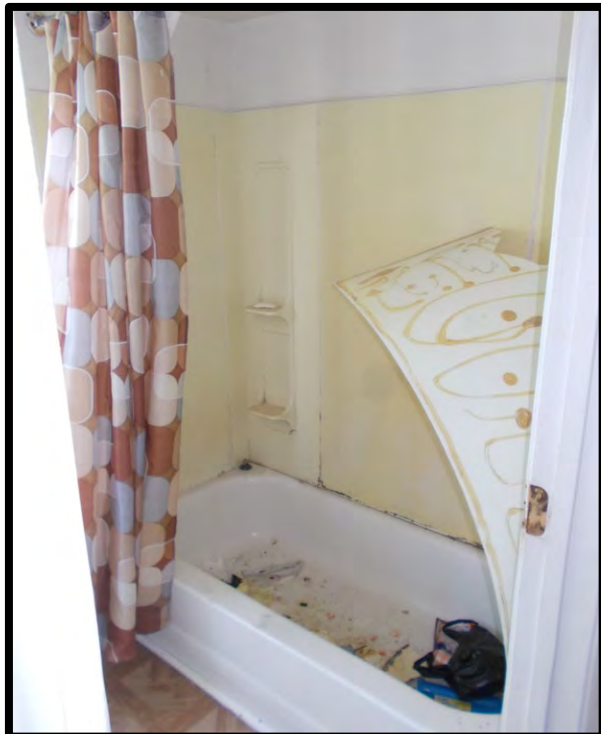
Photo No. 53

Overall view of bathtub within third floor bathroom.

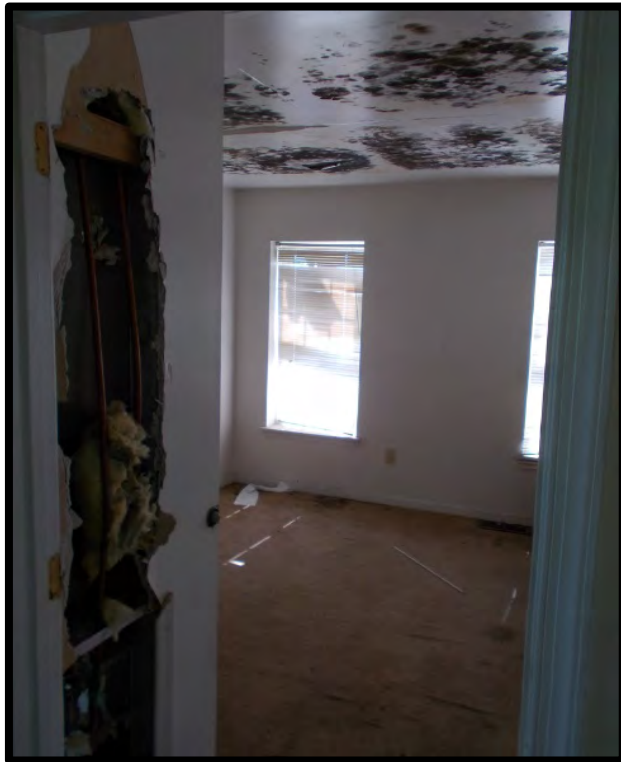
Photo No. 54

Depicts view looking into front bedroom from hallway.

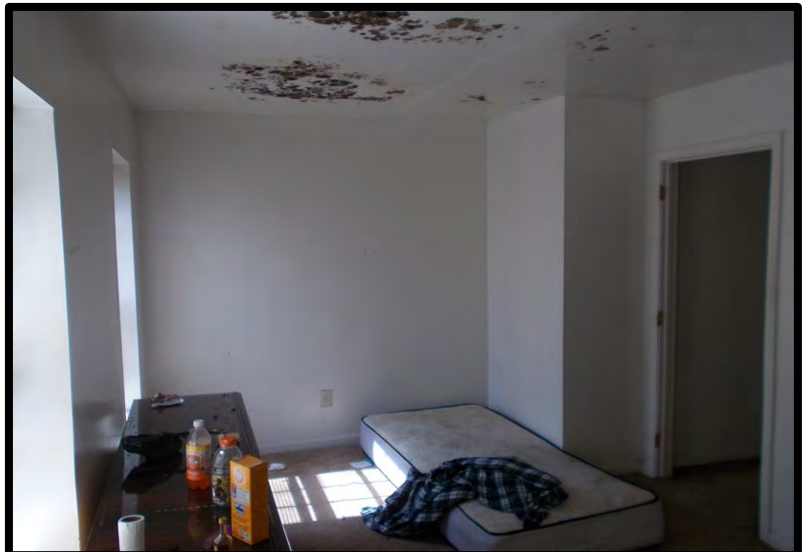
Photo No. 55

View looking at bedroom entry for front bedroom third floor.

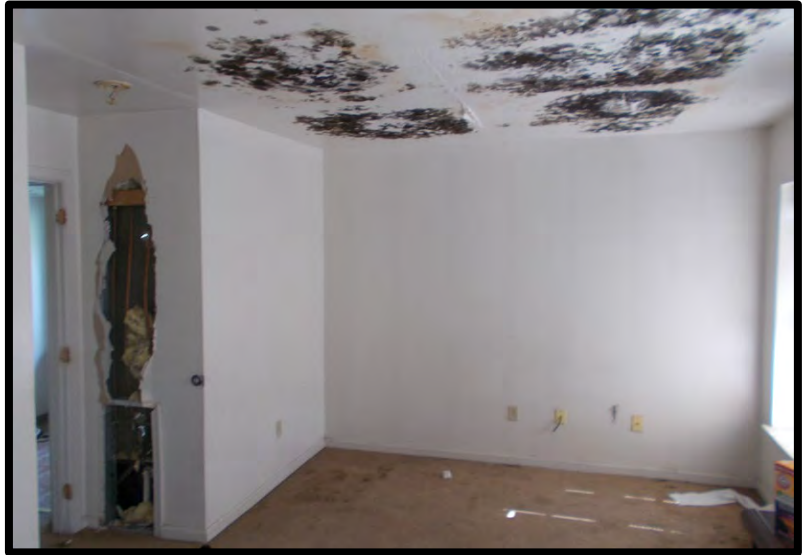
Photo No. 56

Panning 180 degrees from previous photo, additional view of front bedroom.

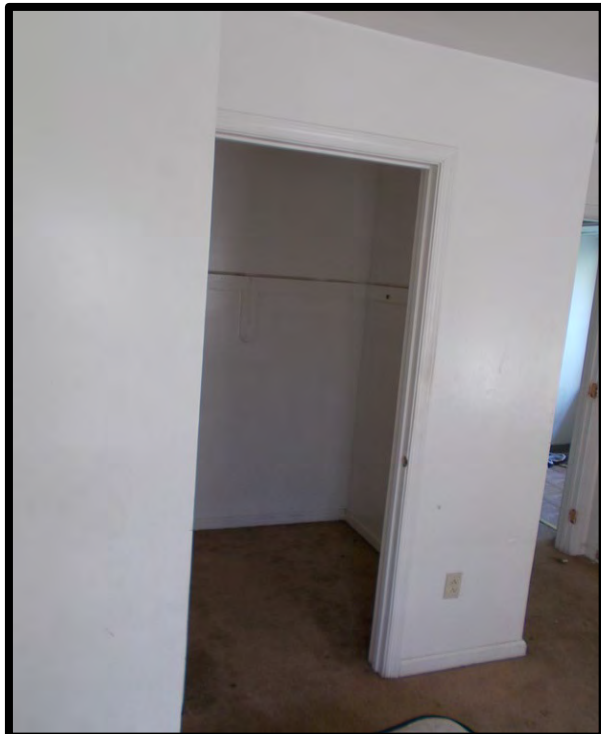
Photo No. 57

Depicts view of front bedroom closet.

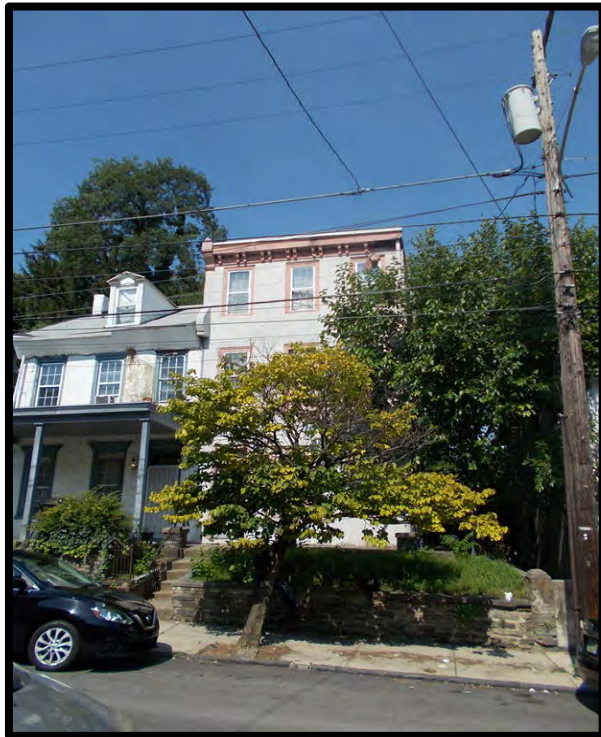
Photo No. 58

Overall view of building as seen from East Church Lane.

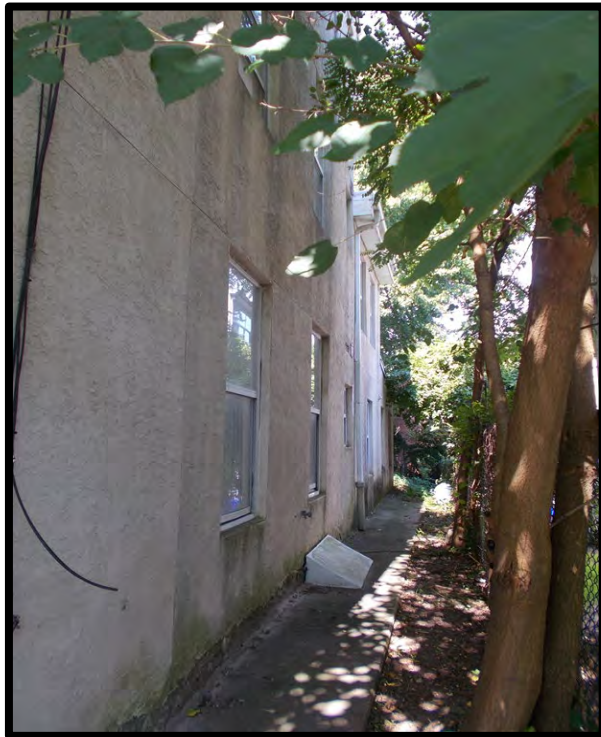
Photo No. 60

Looking along north side of property and exterior wall.

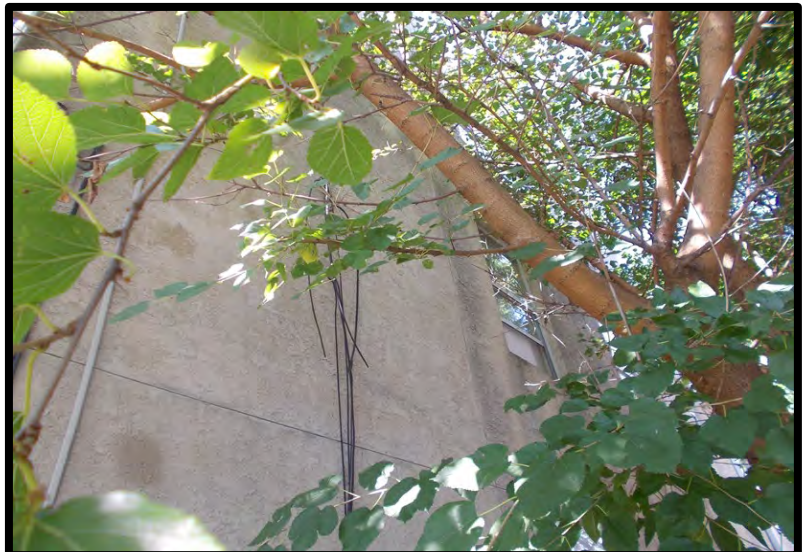
Photo No. 61

Panning up from previous photo.

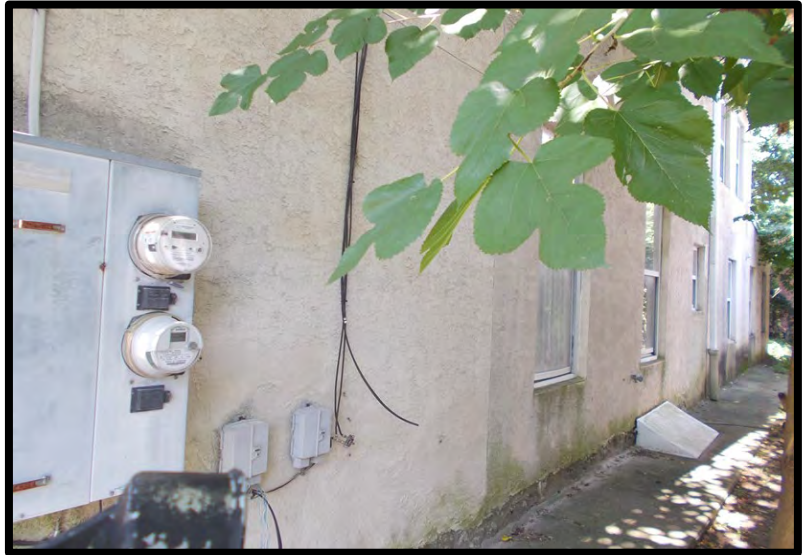
Photo No. 62

Additional view of electric meters located on the north
side of the property.
