Germantown/Mount Airy Properties

Physical Conditions and Needs Assessment

Premises S

117 W. Manheim St

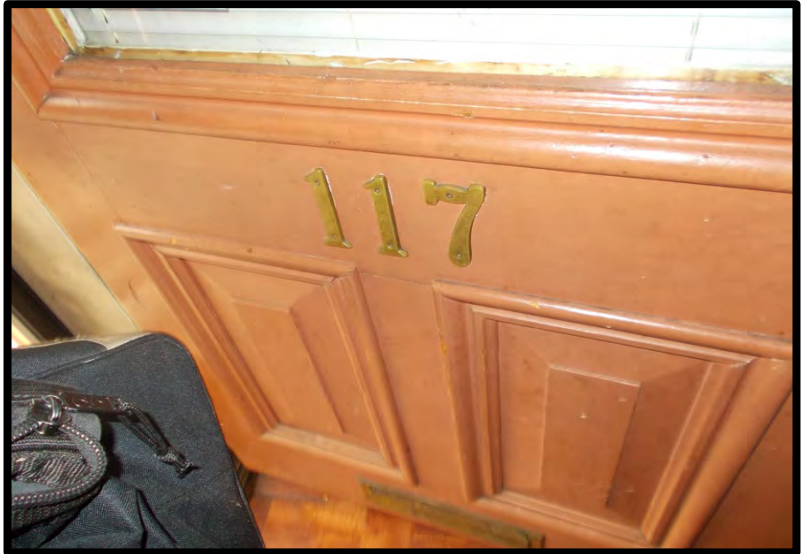
Photo No. 1

View of entry to 117 West Manheim Street.

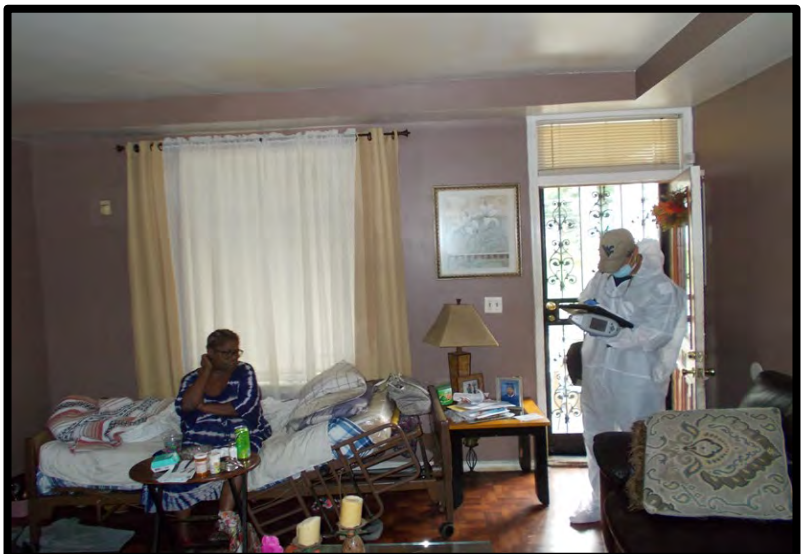
Photo No. 3

Panning 180 degrees from previous photo. Depicts
additional view of living room and dwelling entry.

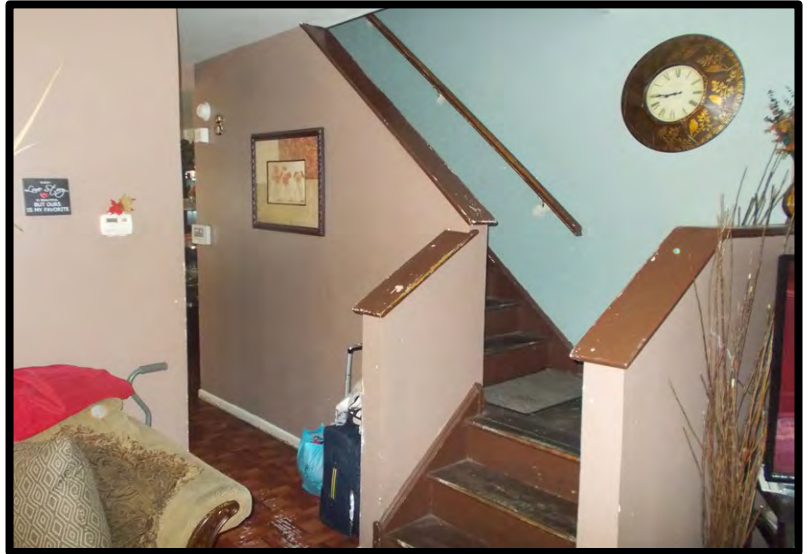
Photo No. 4

View of stairs leading to second floor.

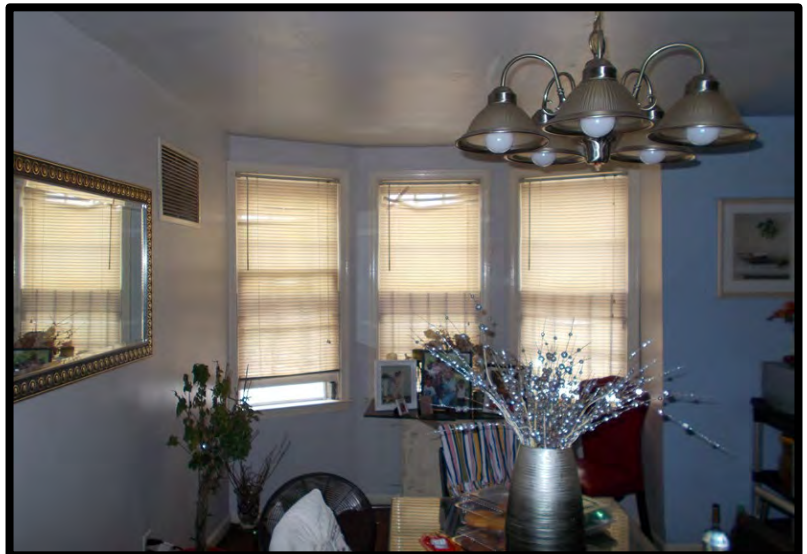
Photo No. 9

Panning left from previous photo. Additional view of exterior wall at dining area.

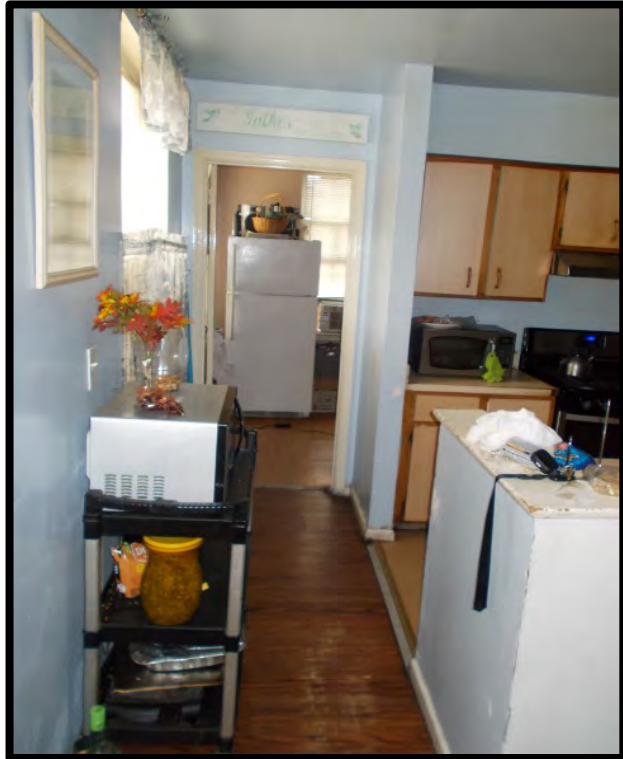
Photo No. 10

View looking at rear room beyond kitchen first floor.

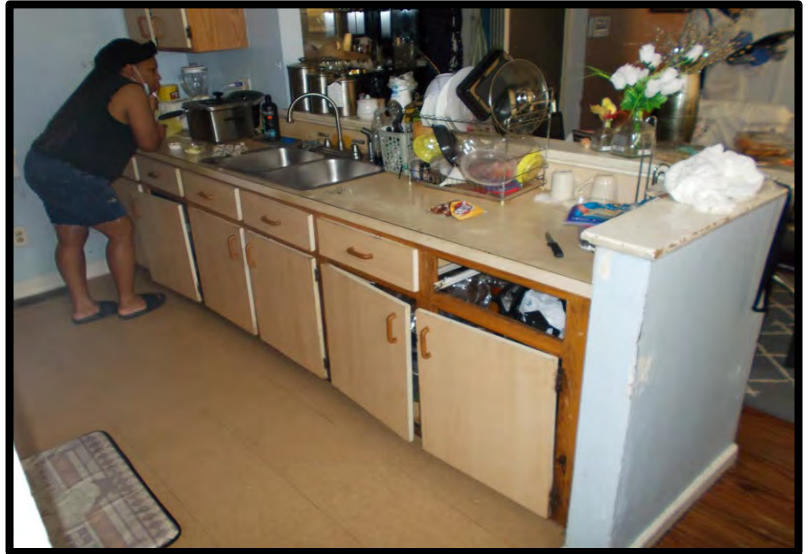
Photo No. 12

Panning 90 degrees from previous photo. Additional view of kitchen cabinets and countertop.

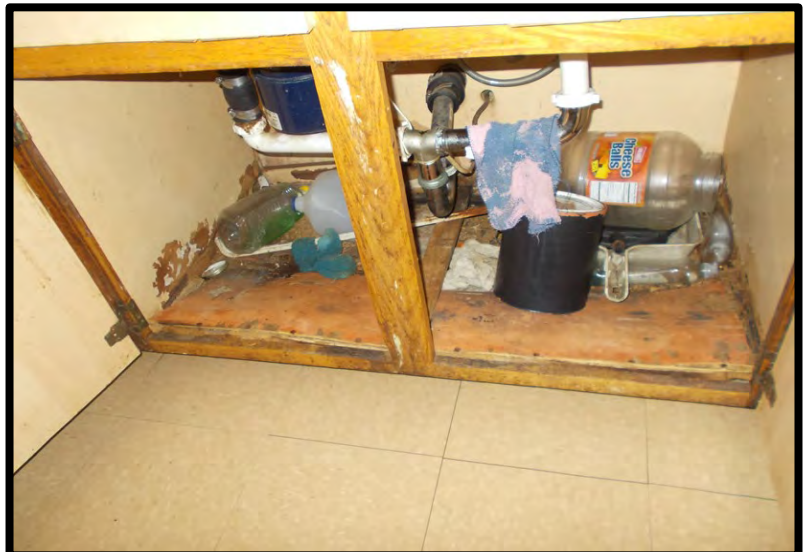
Photo No. 15

View of sink base cabinet. Noticeable issues with drainage.

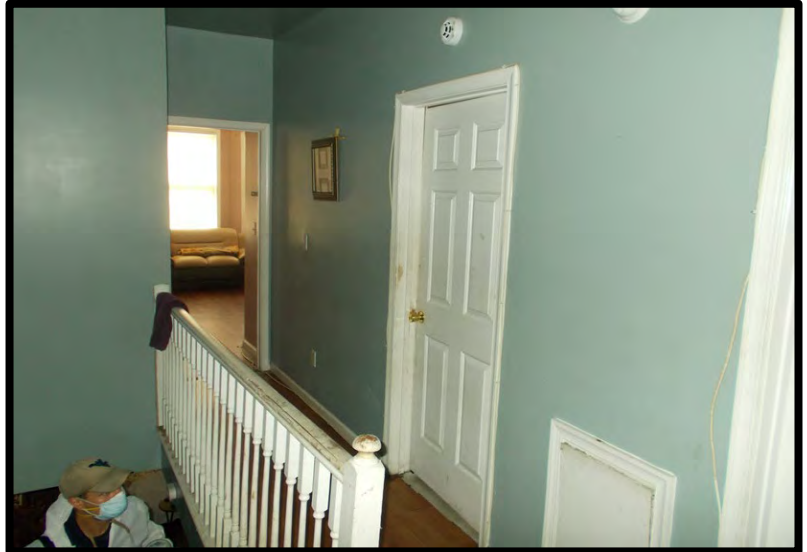
Photo No. 21

Panning 180 degrees from previous photo. View of hallway facing front of dwelling second floor.

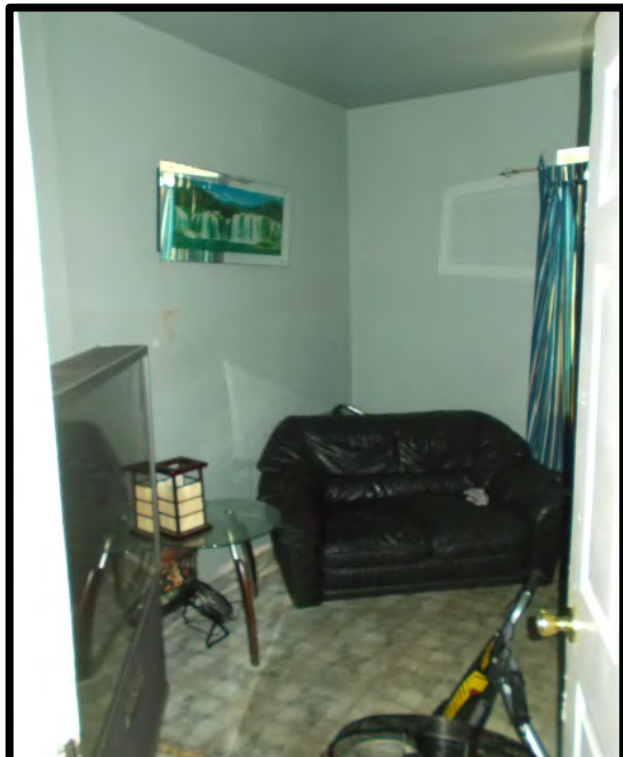
Photo No. 26

View of bedroom #2 second floor.

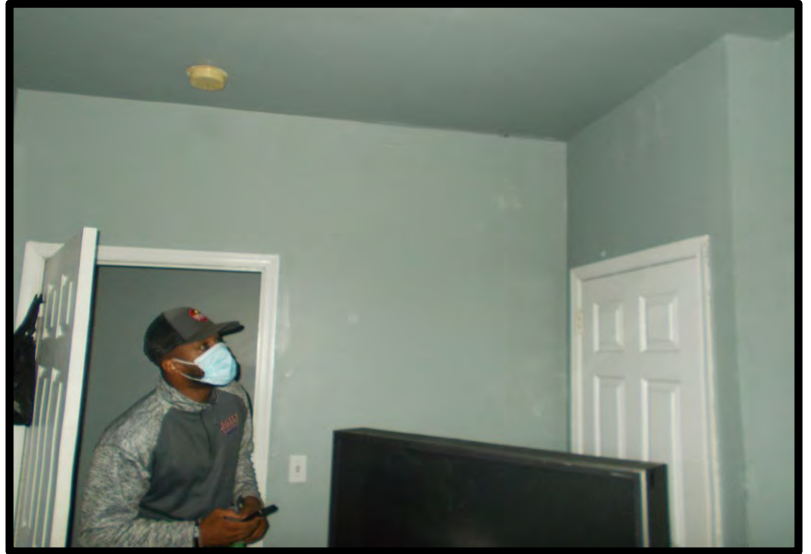
Photo No. 27

Panning 180 degrees from previous photo. View of
bedroom entry and closet.

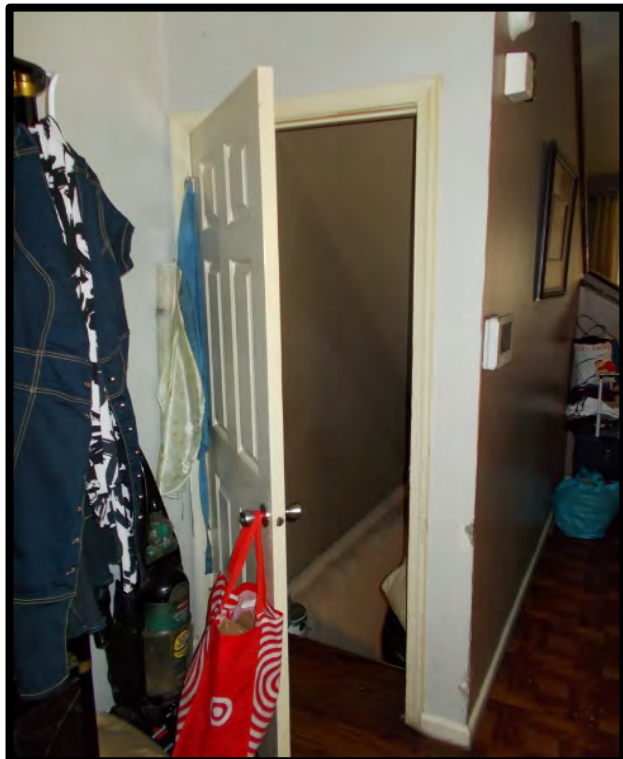
Photo No. 38

View of basement stairs from dining room.

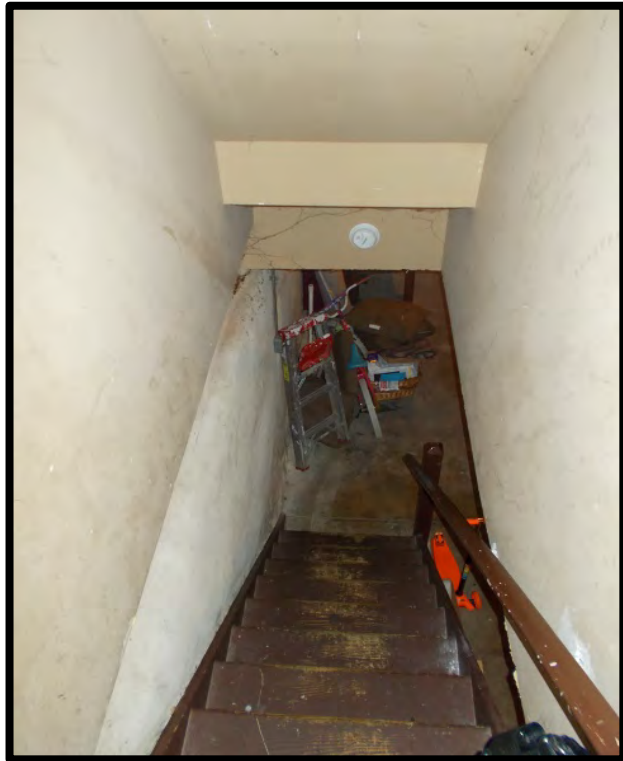
Photo No. 39

View looking down basement stairs.

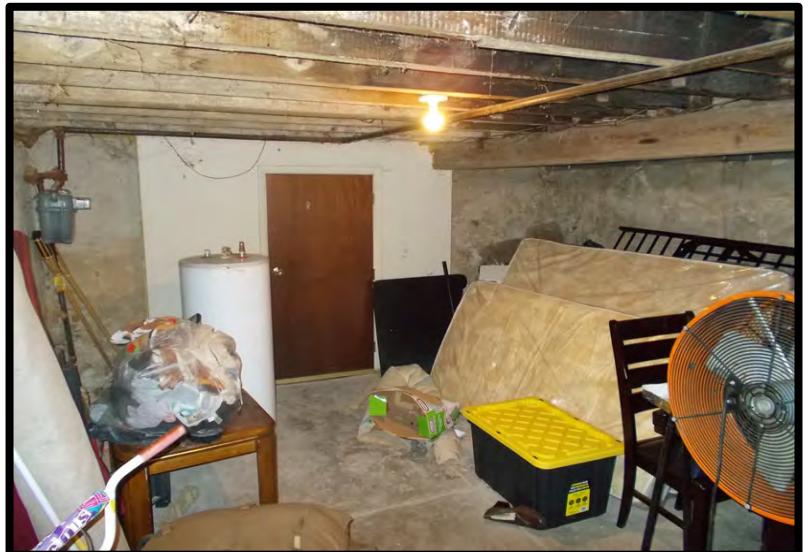
Photo No. 40

View looking towards front of dwelling. Door leads to space below front entry porch.

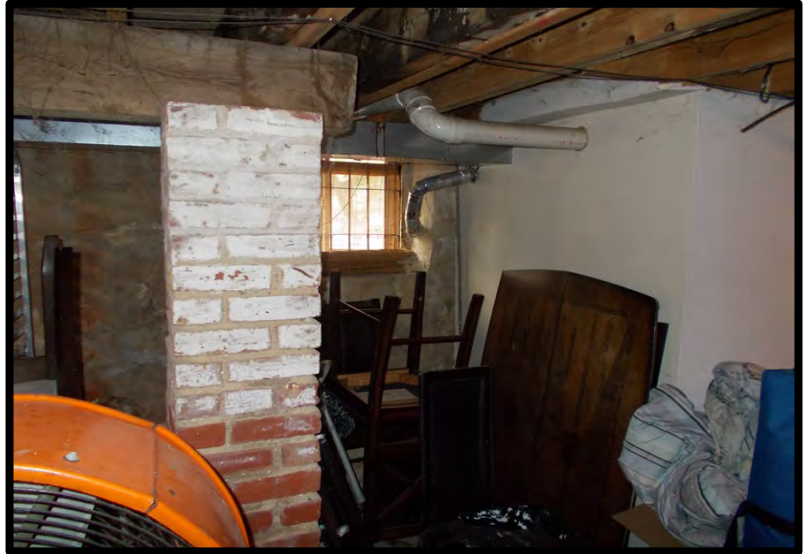
Photo No. 41

View within basement at exterior wall. Room on the right is a mechanical room.

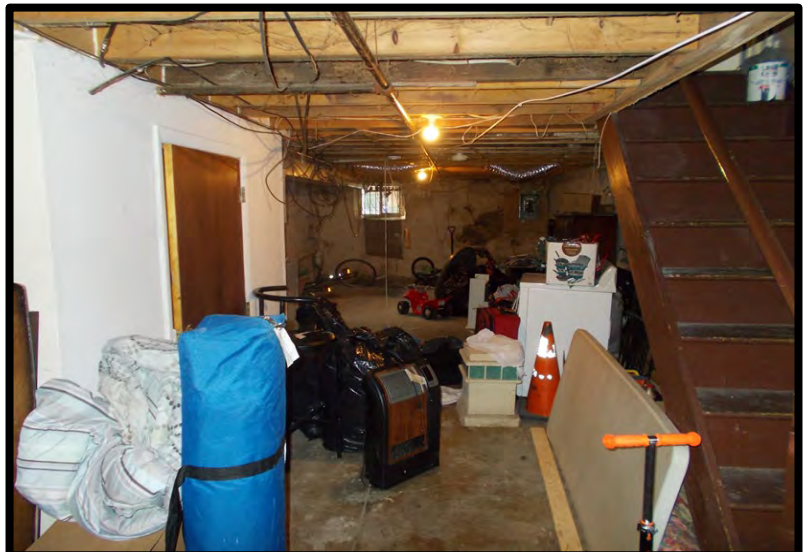
Photo No. 42

Panning right from previous photo. View looking at rear of dwelling within basement.

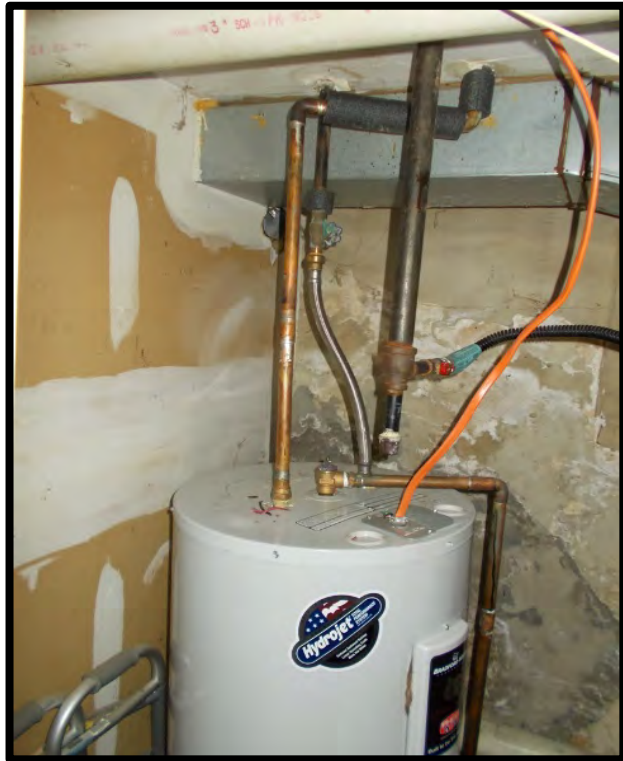
Photo No. 43

View of electric hot water heater in basement.

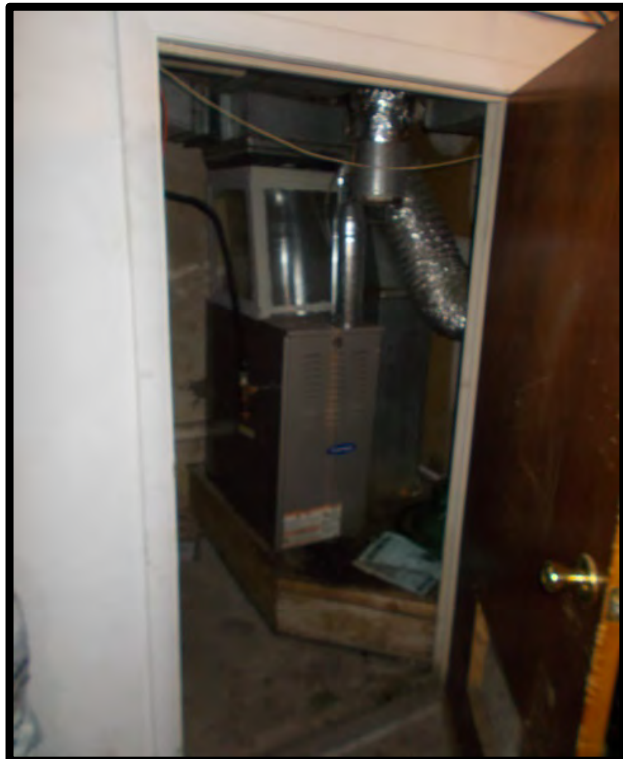
Photo No. 44

View of mechanical equipment in basement.

3.4.2	Heating	√			Replacement of the furnace, filter and thermostat is recommended as they are antiquated.
3.4.3	Air Conditioning and Ventilation		√		Replace bathroom and kitchen exhaust fans.

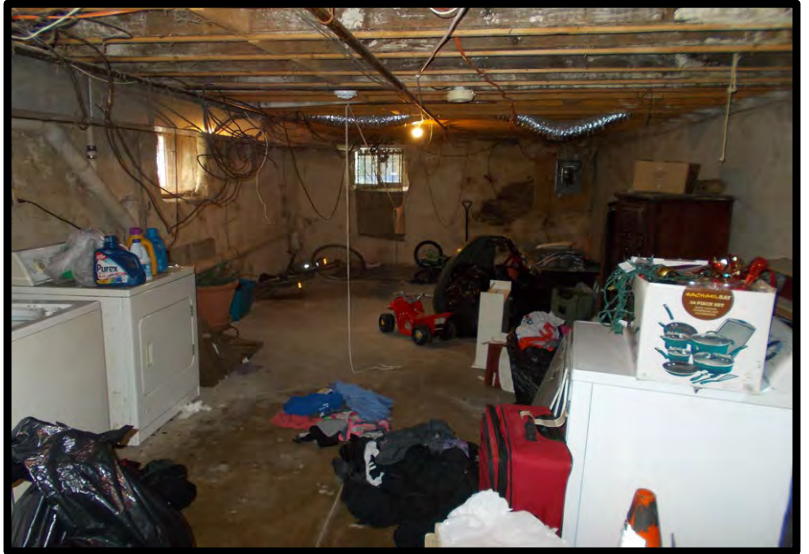
Photo No. 45

Additional view at rear of basement. Note
washer/dryer hook up is located on the left of photo.

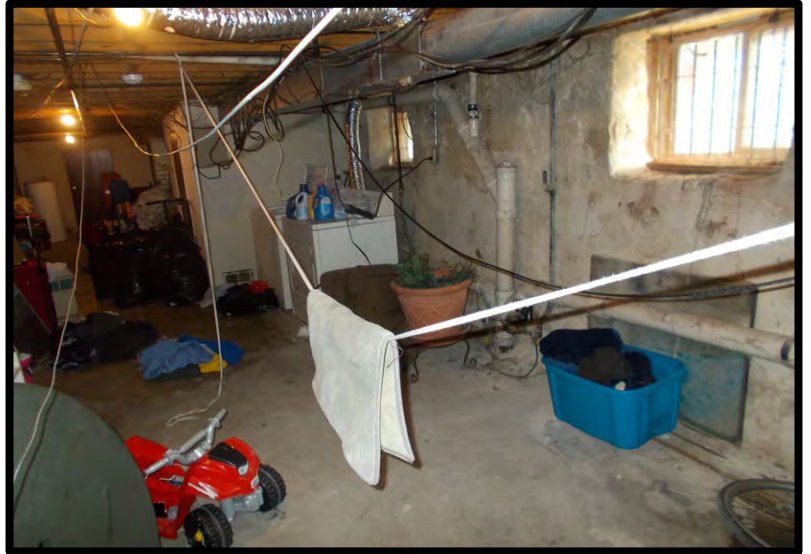
Photo No. 47

Sanitary piping is in good condition and working efficiently.

Additional view of basement as seen from rear of dwelling. Also visible in the photo is the sanitary discharge line.

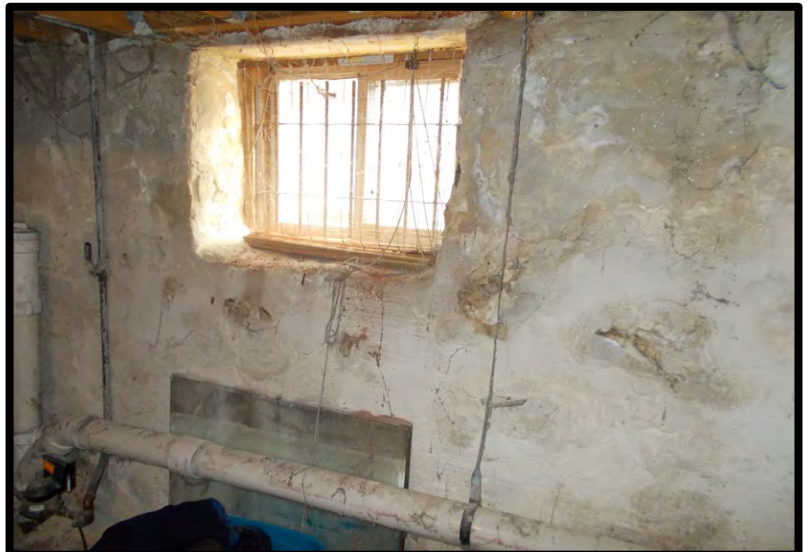
Photo No. 48

View of basement window located adjacent to sanitary discharge line.

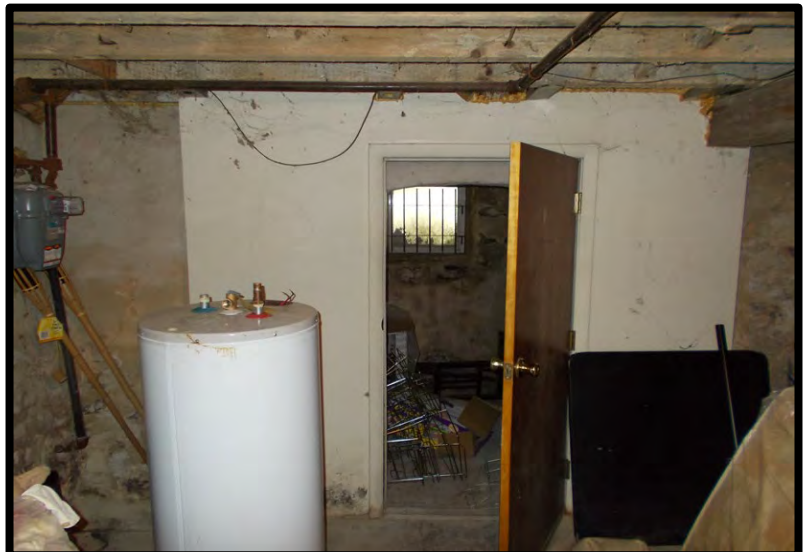
Photo No. 50

View of basement space below porch entry.

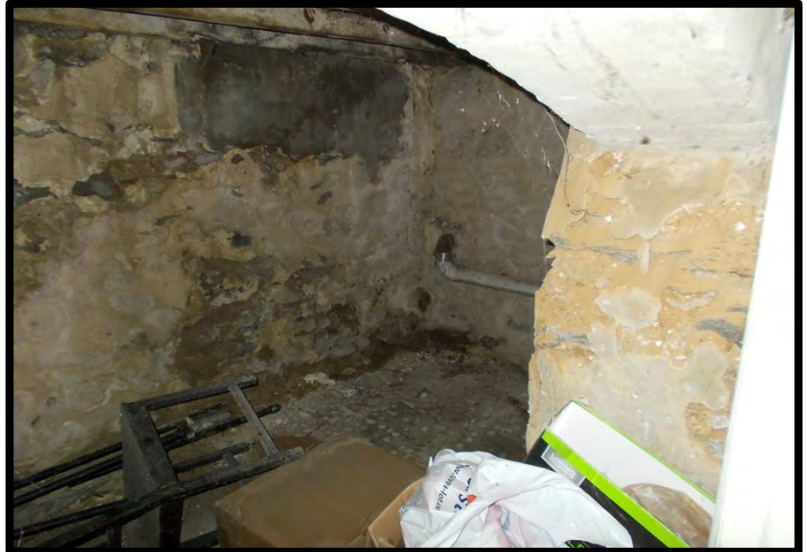
Photo No. 51

Additional view of space below porch entry.

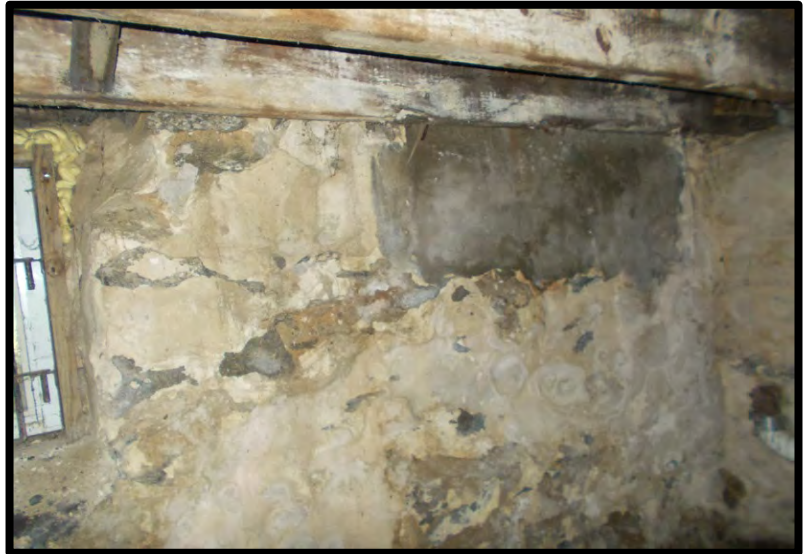
Photo No. 54

Panning left from Photo No. 52.

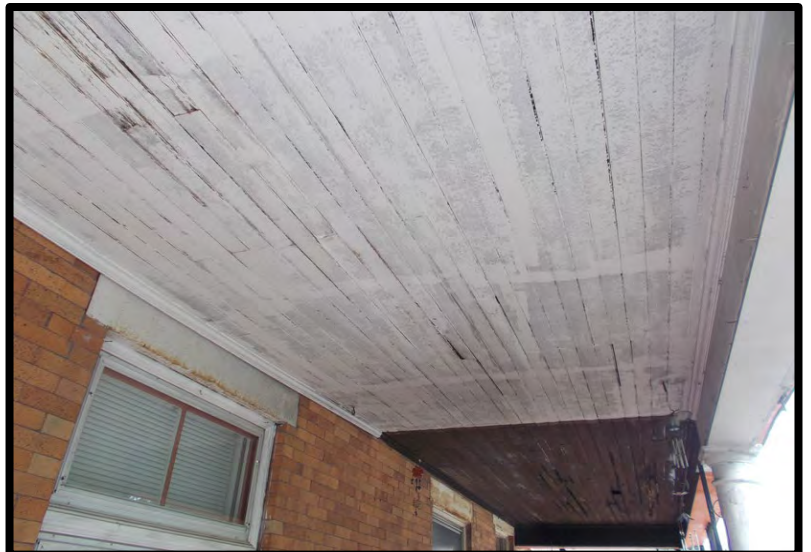
Photo No. 55

View of underside of porch ceiling entry.

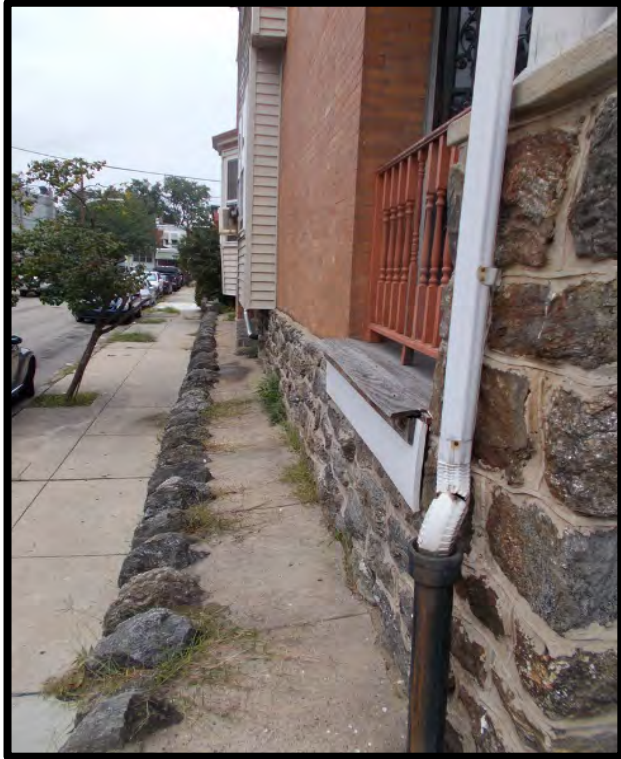
Photo No. 56

View looking along Marion Street.

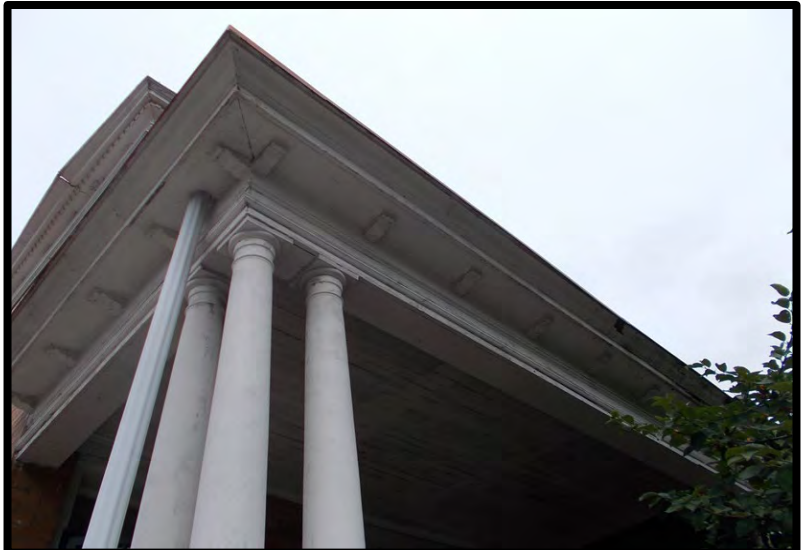
Photo No. 57

Detailed view of wood detail and support for porch entry.

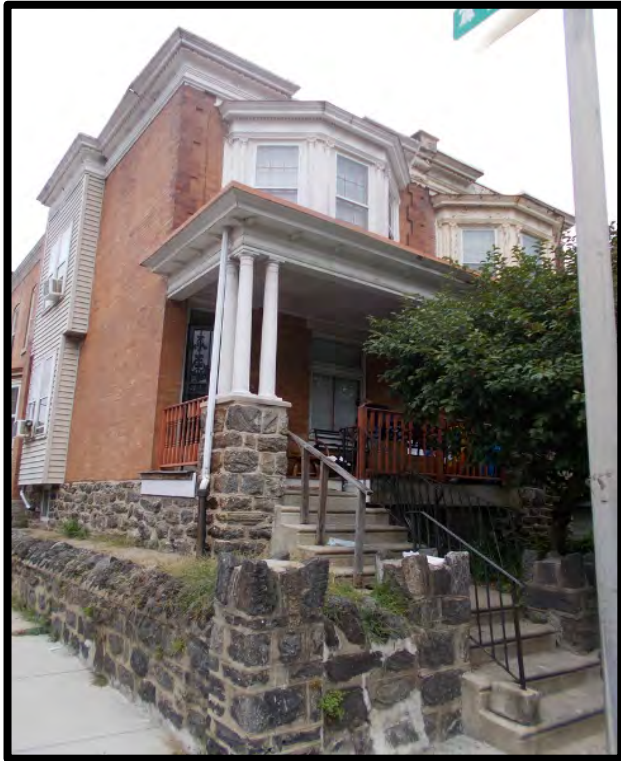
Photo No. 60

Overall view of front of dwelling.

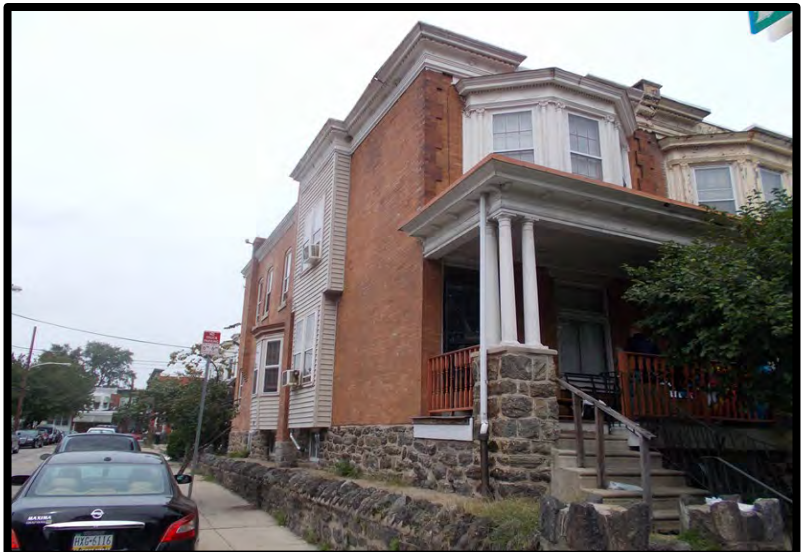
Photo No. 61

Overall view of front of dwelling.

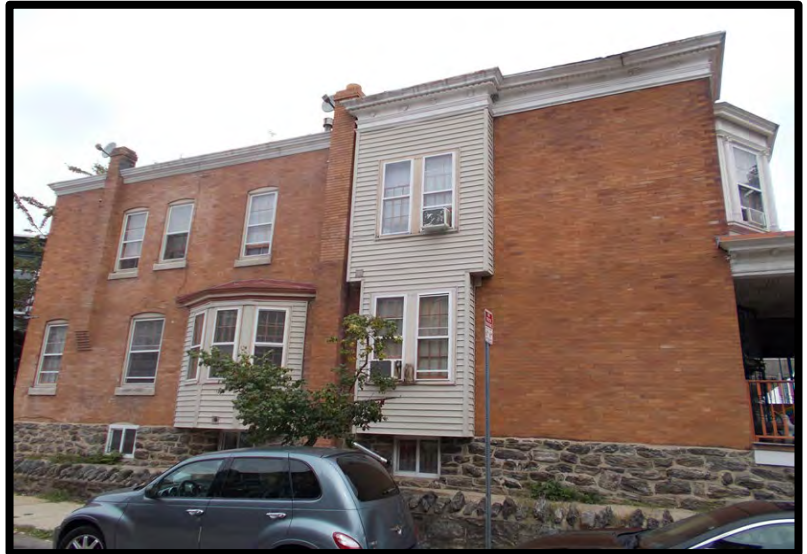
Photo No. 62

Overall view of side of dwelling.

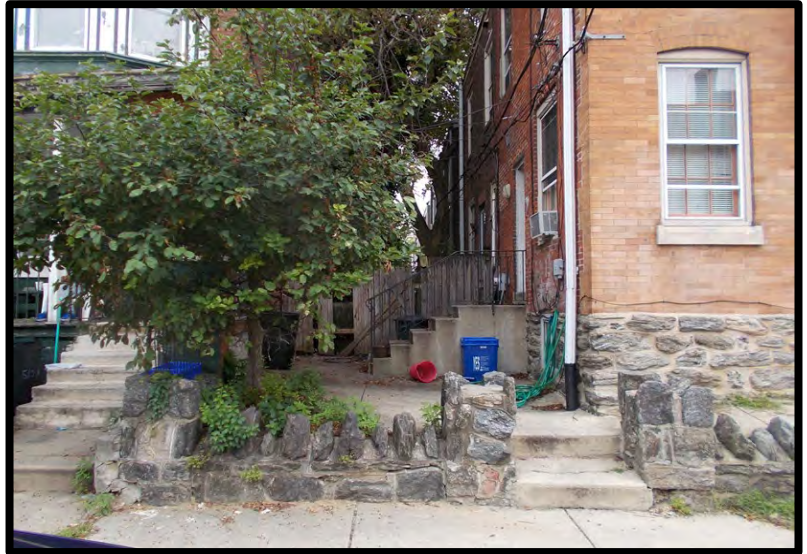
Photo No. 67

Depicts rear yard as seen from Marion Street.

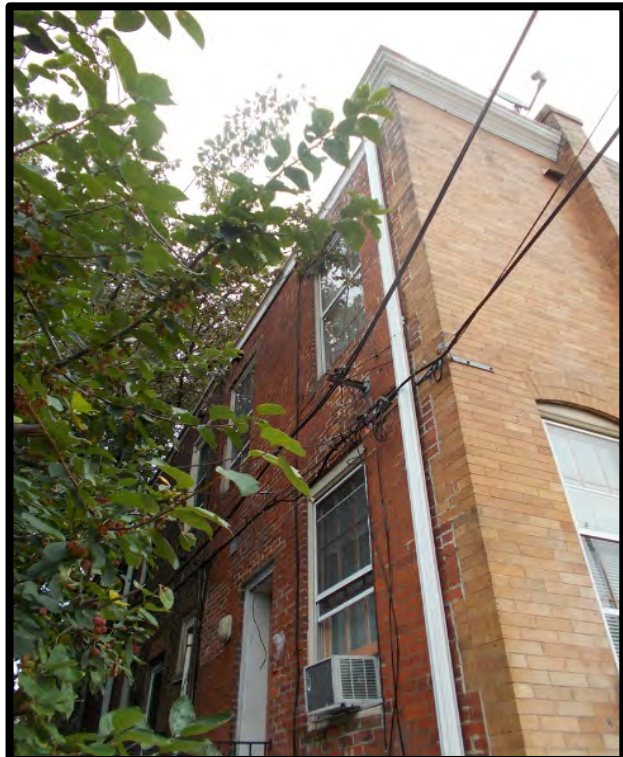
Photo No. 68

Depicts first and second floors of the rear of the structure.

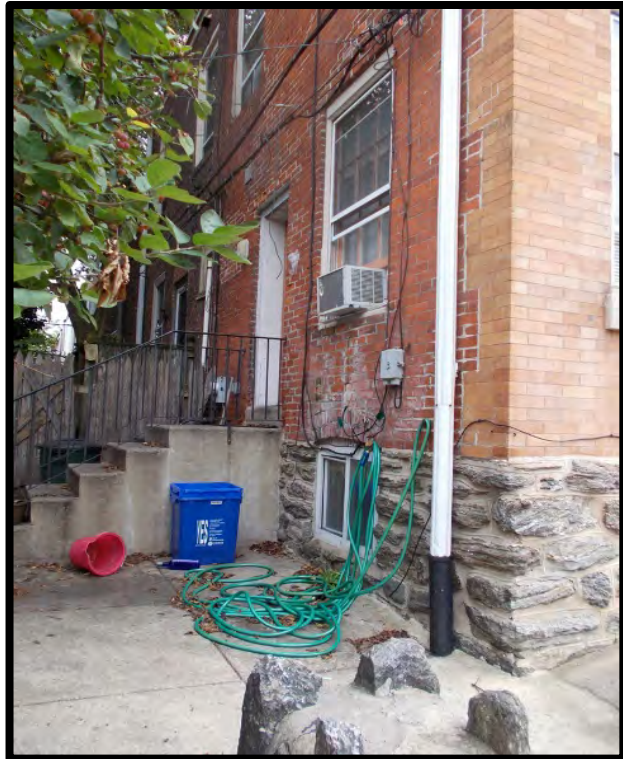
Photo No. 69

Panning down from previous photo. Depicts view of first floor and basement at rear of building.

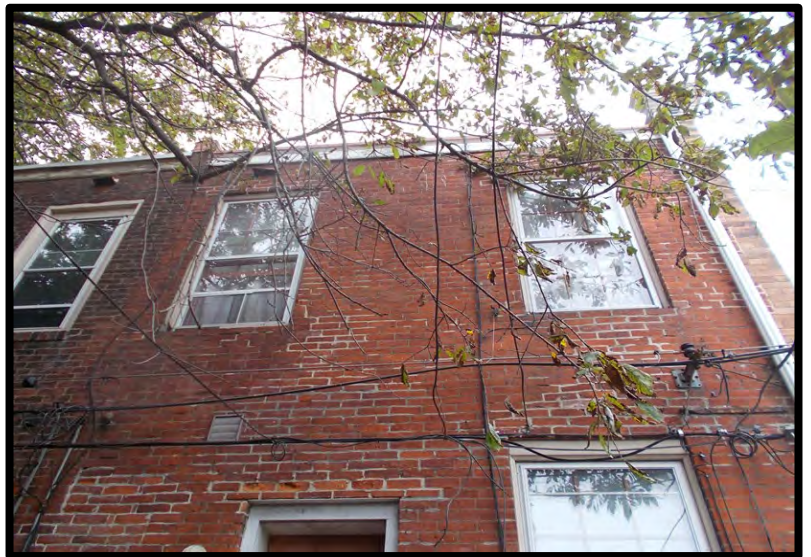
Photo No. 72

Panning up from previous photo.
