Germantown/Mount Airy Properties

Physical Conditions and Needs Assessment

Premises T

4949 Germantown Avenue

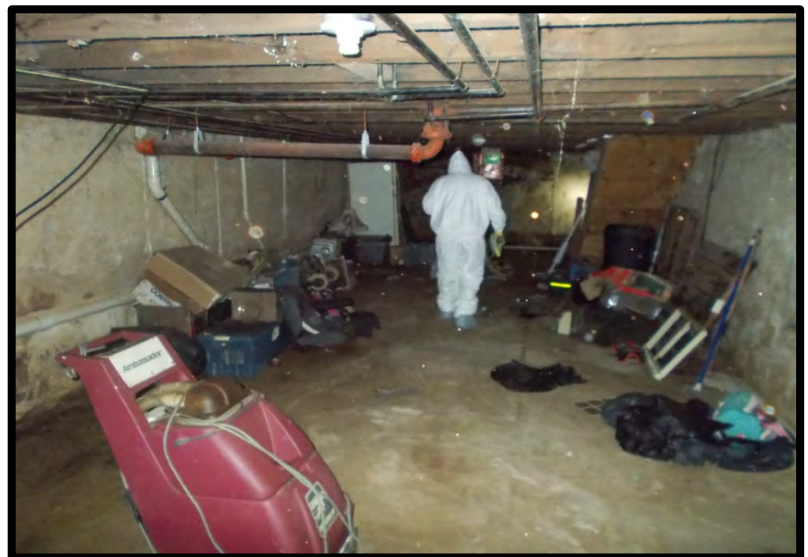
Photo No. 19

Additional view of basement with cast iron waste piping.

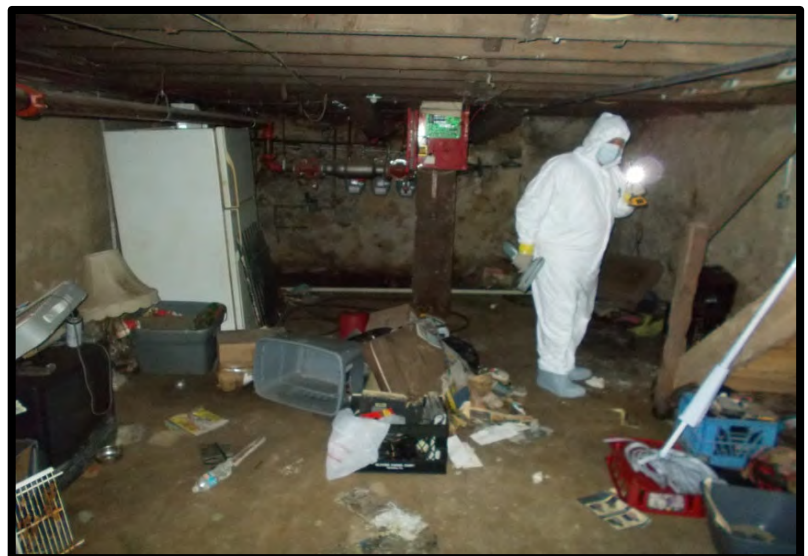
Photo No. 20

View of Fire Alarm Control Panel located in front area of basement.

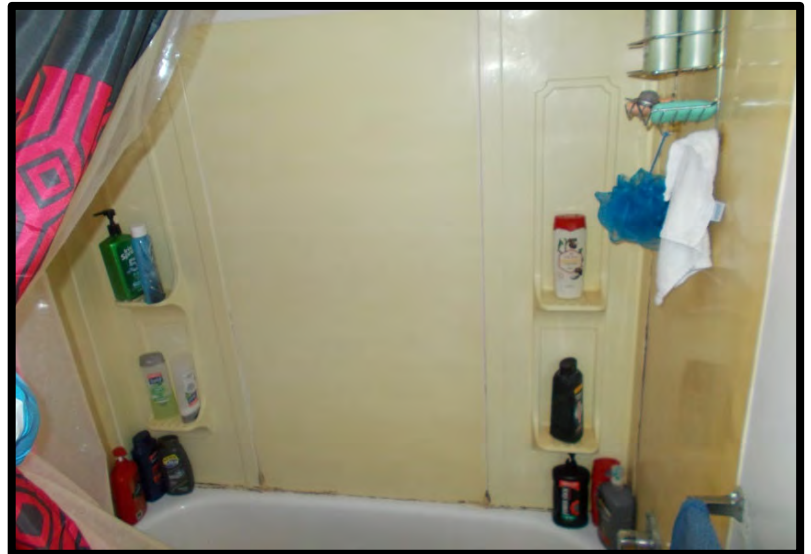
Photo No. 31

View of bathtub surround within the 3rd Fl bathroom.

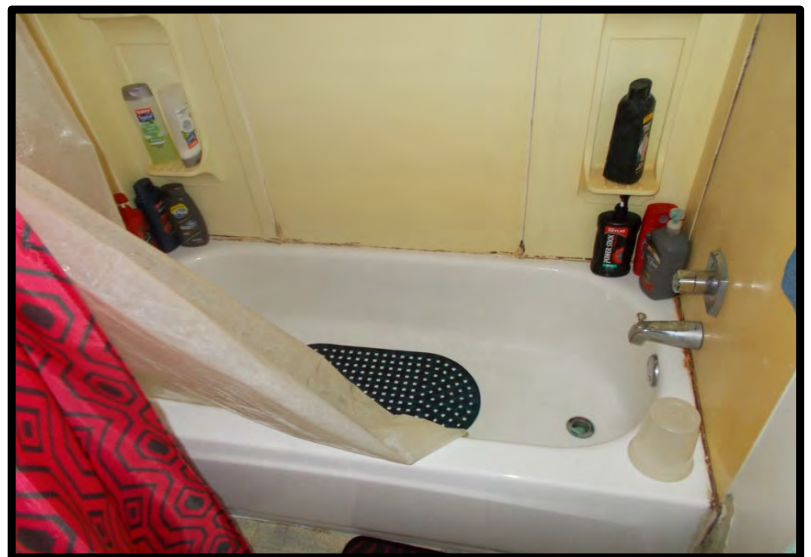
Photo No. 32

Panning down from previous photo. Detail view of bathtub.

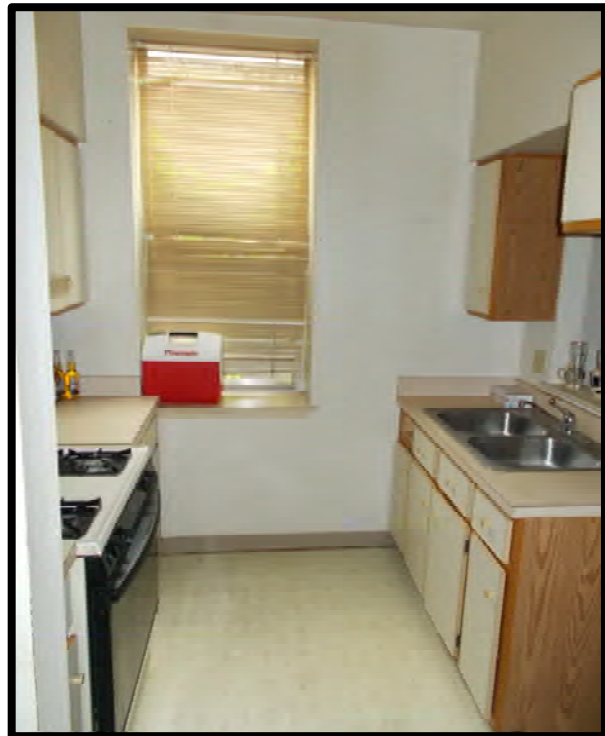
Photo No. 45

Additional view of kitchen in Unit B.

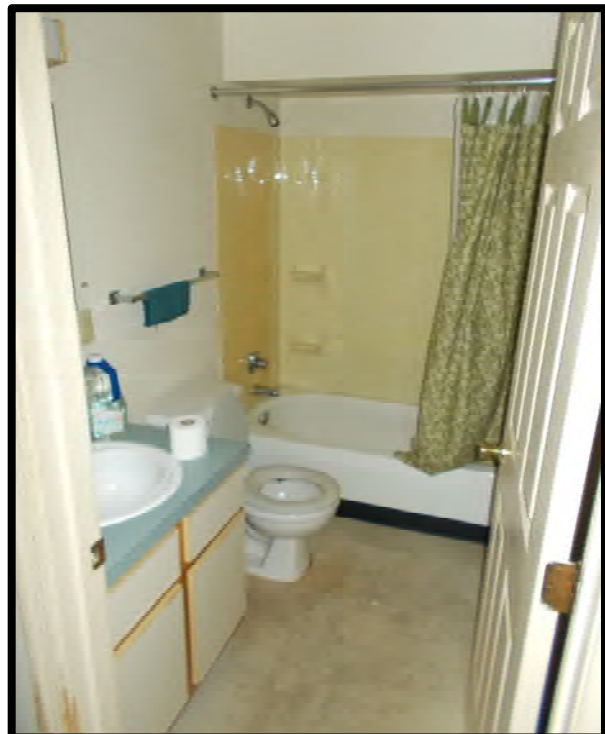
Photo No. 46

View of bathroom in unit B.

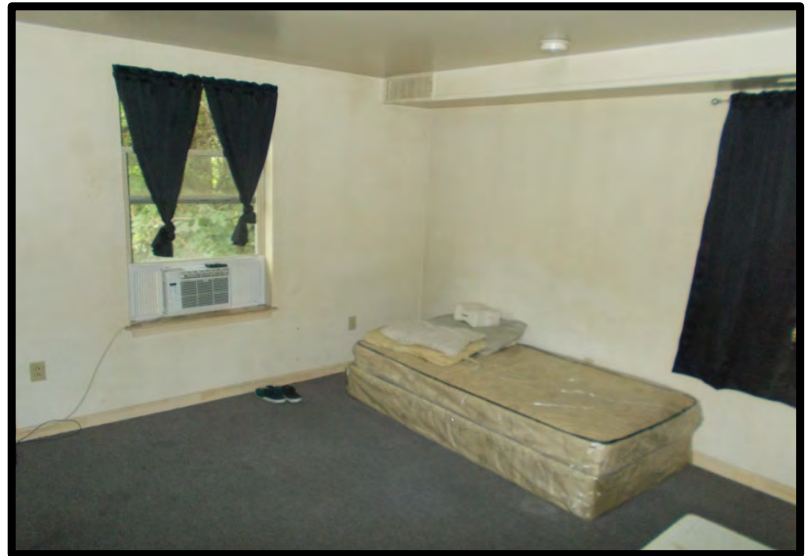
Photo No. 47

View of bedroom interior within Unit B.

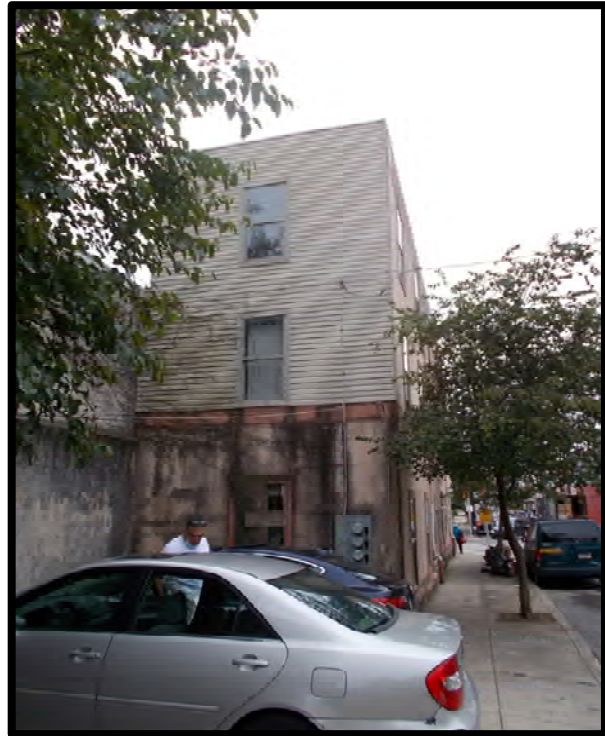
Photo No. 49

View of north elevation of 4951 Germantown Ave.

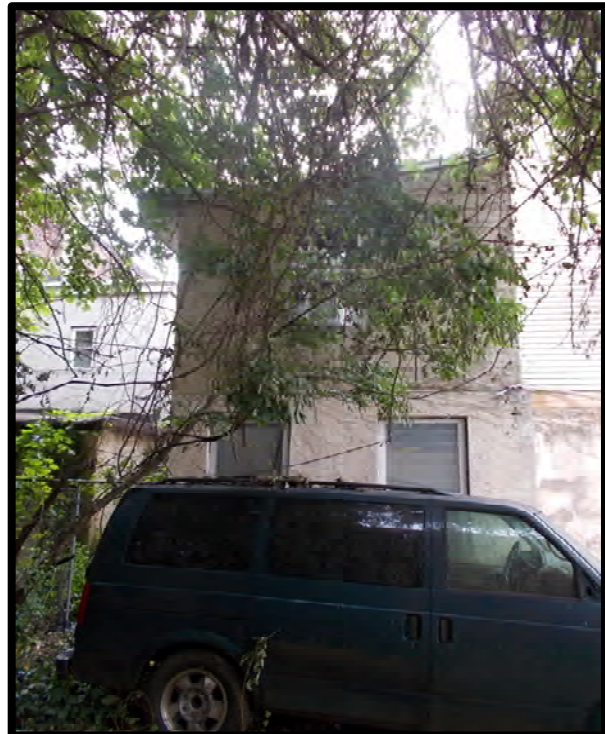
Photo No. 50

View of north elevation of 4949 Germantown Ave.

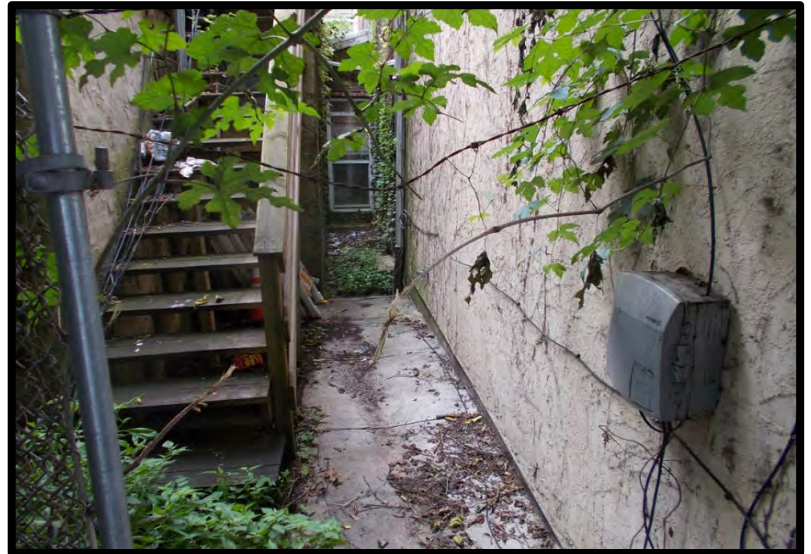
Photo No. 53

Additional view of east elevation of 4949 Germantown Ave.

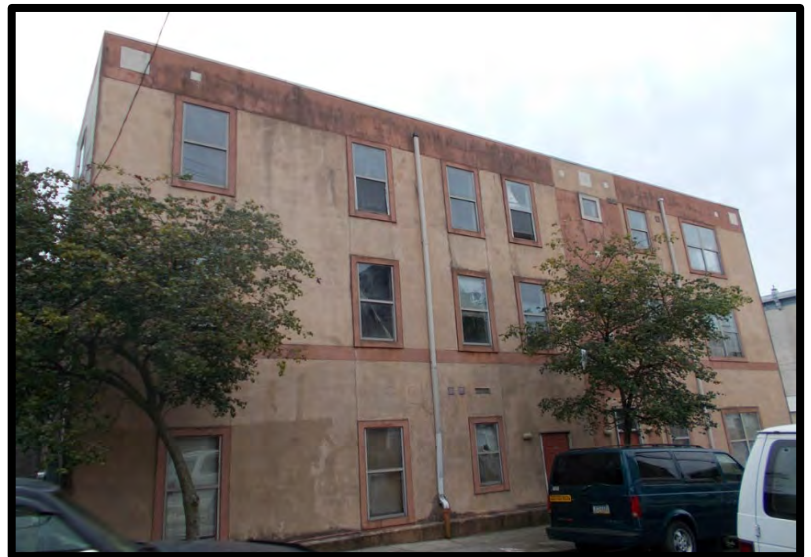
Photo No. 54

View of west elevation of 4951 Germantown Ave. (E. Seymour St.)

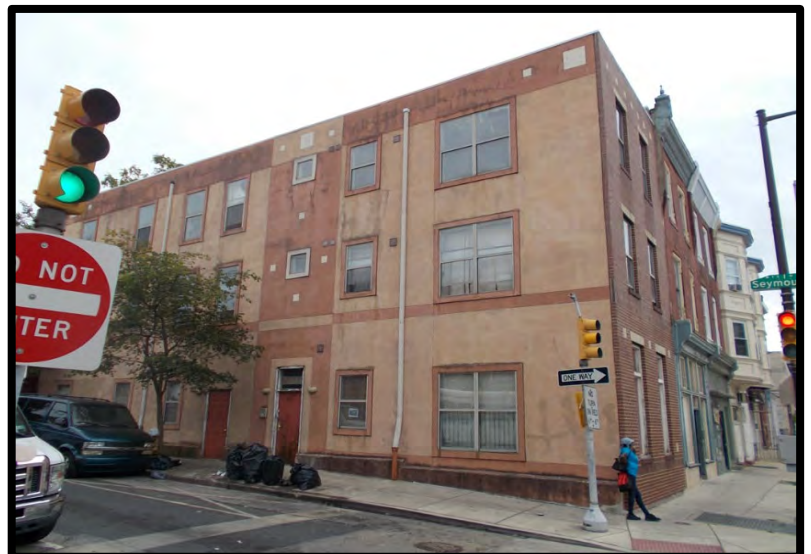
Photo No. 55

View of southwest corner of 4951 Germantown Ave.

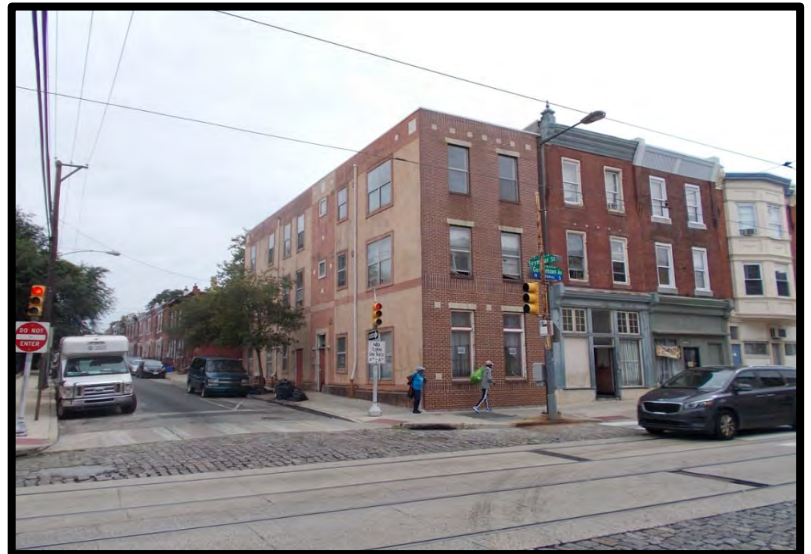
Photo No. 56

View of south elevations of 4951 and 4949
Germantown Ave.

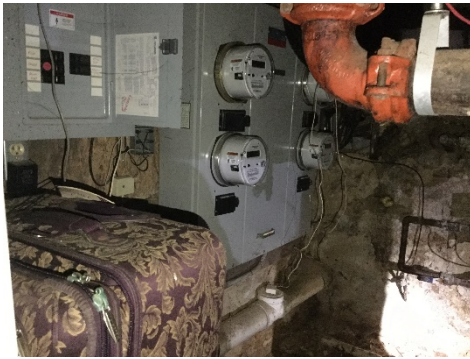
Electric meters & panel.

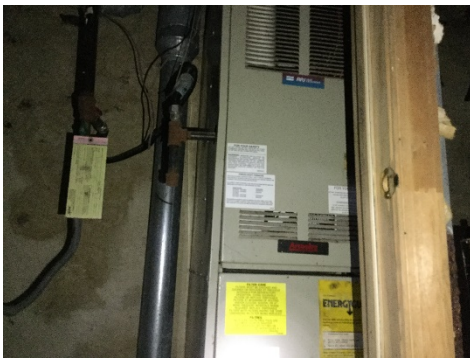
Gas Fired Furnace.

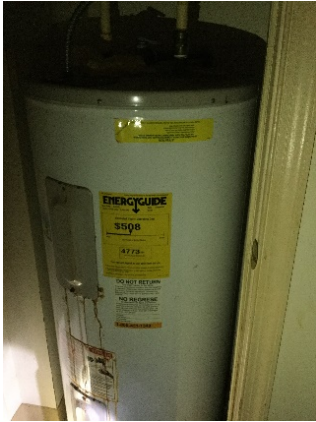
Connected hot water heater.

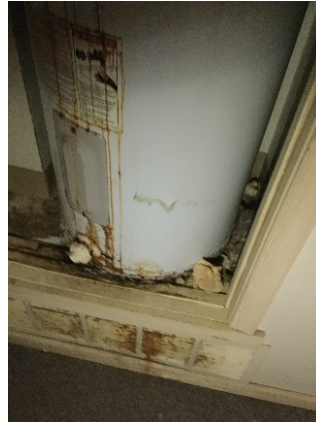
Hot water heater damaged.

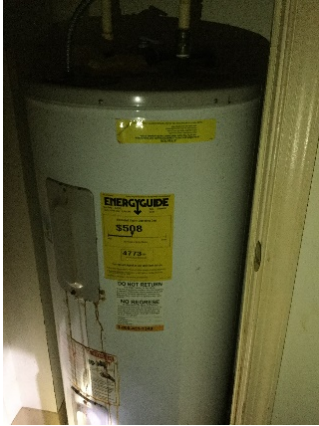
Connected hot water heater.

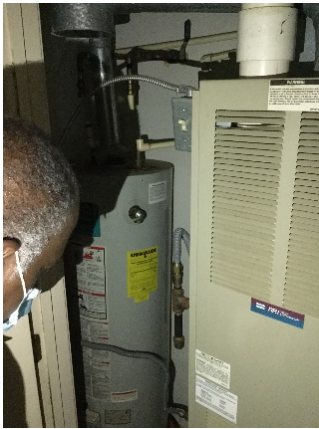
Furnace and 2nd hot water heater.
