# Germantown/Mount Airy Properties

## Physical Conditions and Needs Assessment

### Premises U

**4951 Germantown Ave**

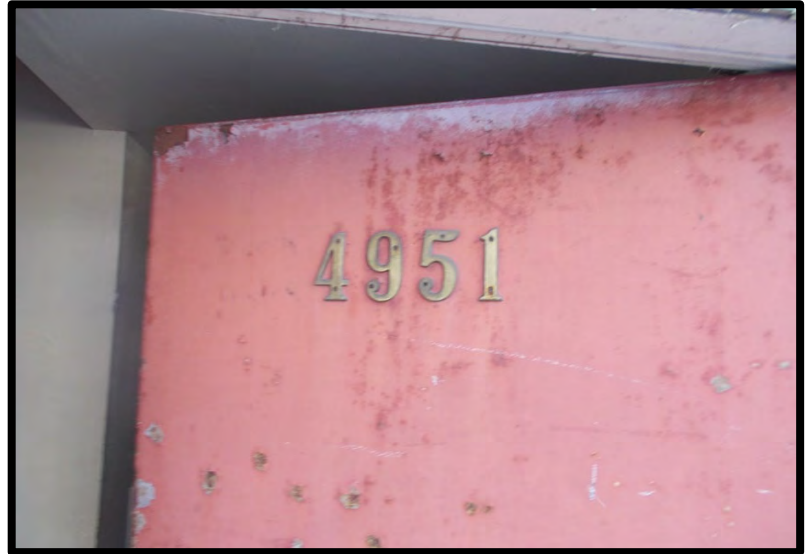
**Photo No. 1**

Exterior entry to 4951 Germantown Avenue.

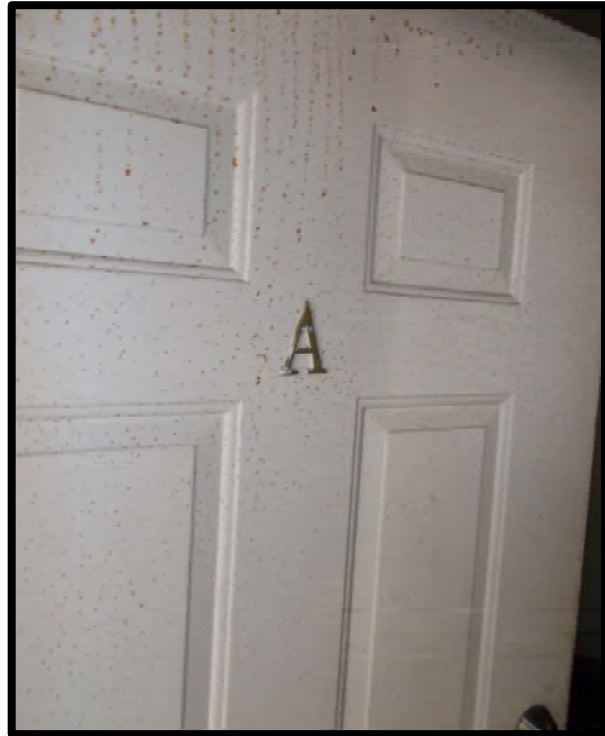
**Photo No. 3**

Apt. A entrance visible beyond.

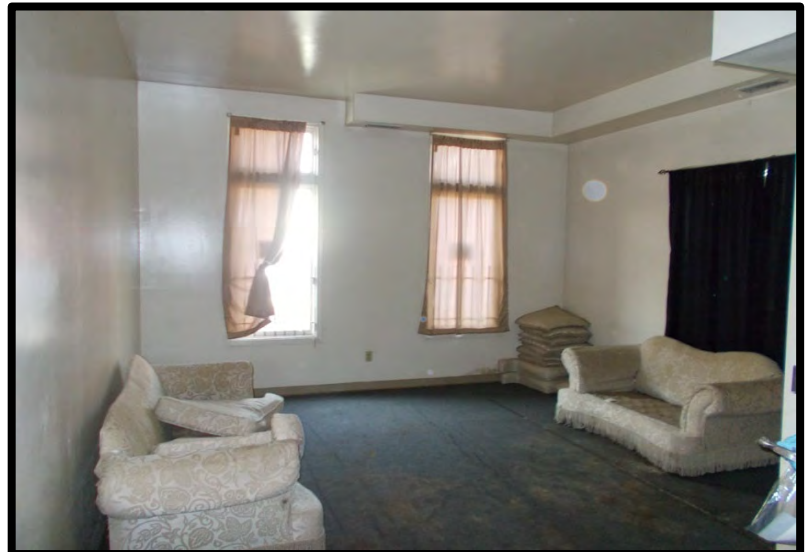
**Photo No. 4**

Depicts view of living room.

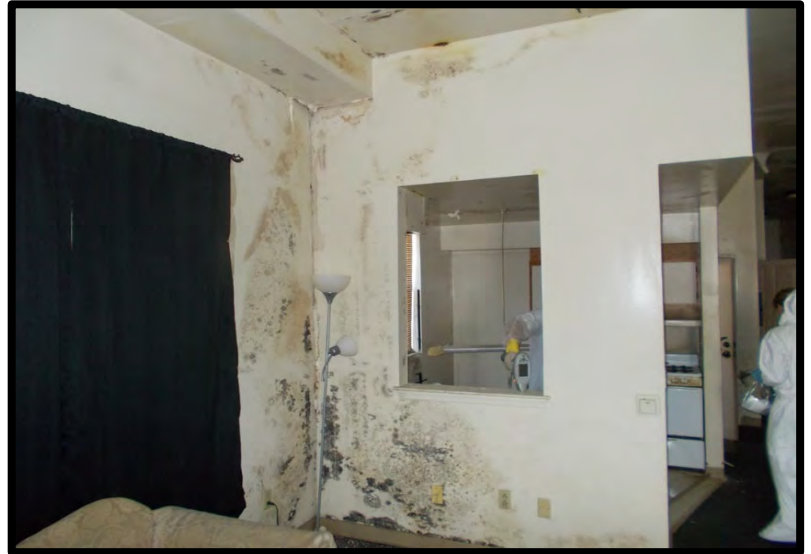
**Photo No. 5**

View of kitchen and living room corner at exterior wall.

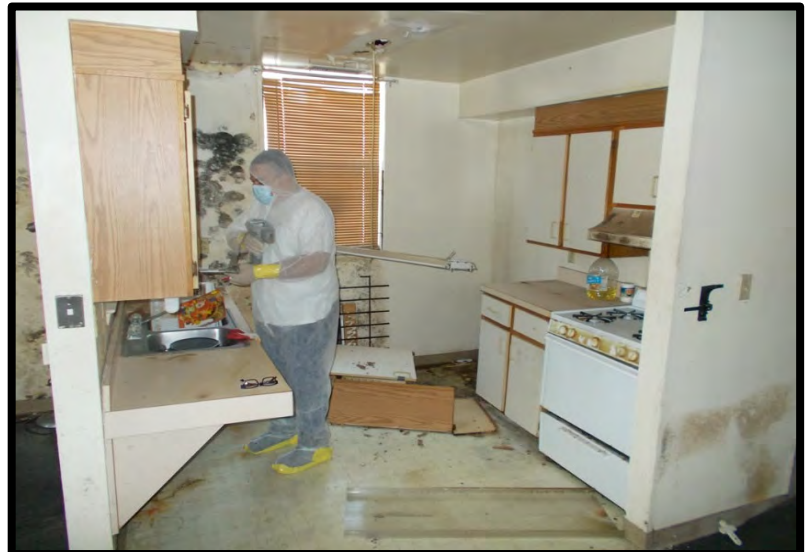
**Photo No. 6**

View of kitchen.

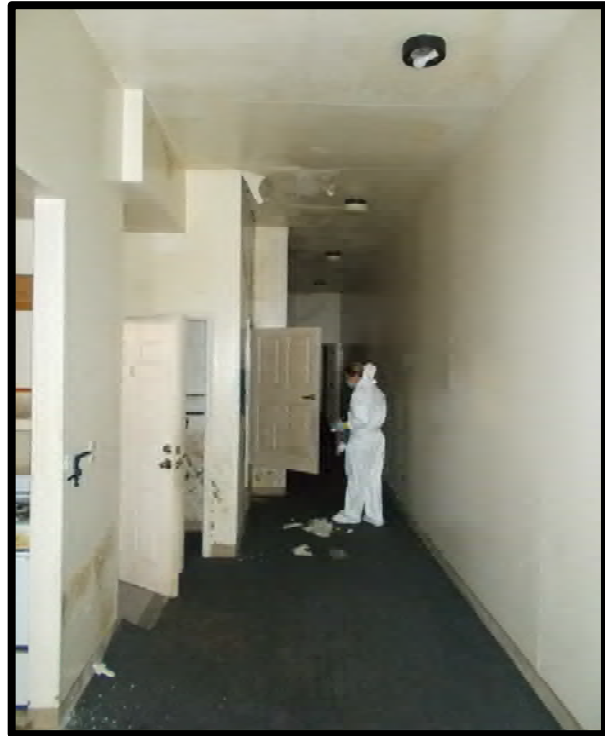
**Photo No. 7**

View looking down hallway from living room to bedrooms.

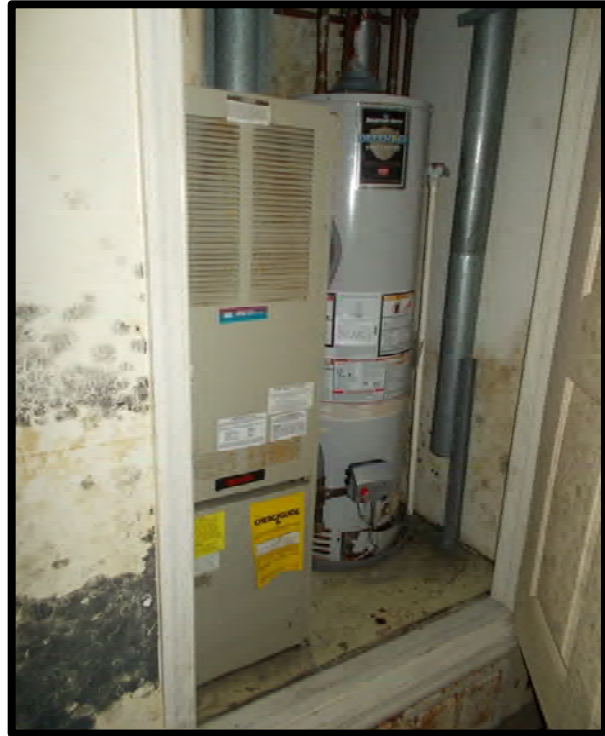
**Photo No. 9**

Depicts view of installed hot air furnace and hot water heater.

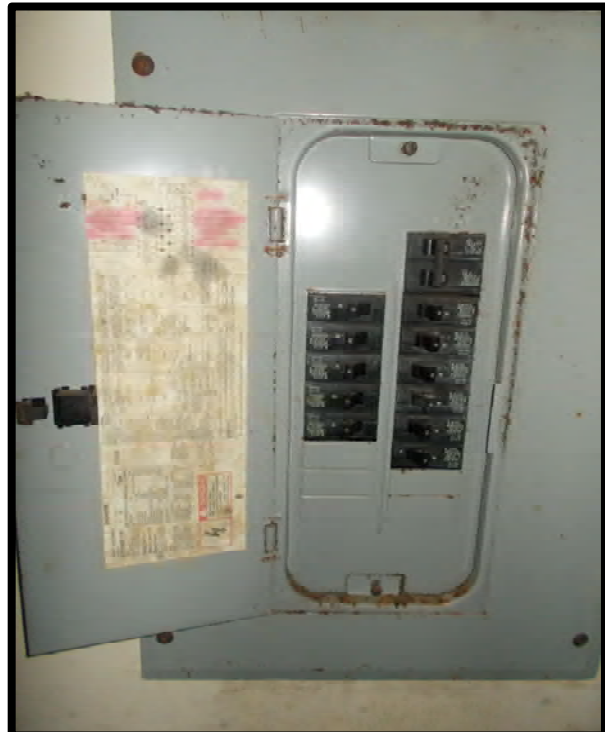
**Photo No. 10**

Depicts close up view of apartment electrical panel.

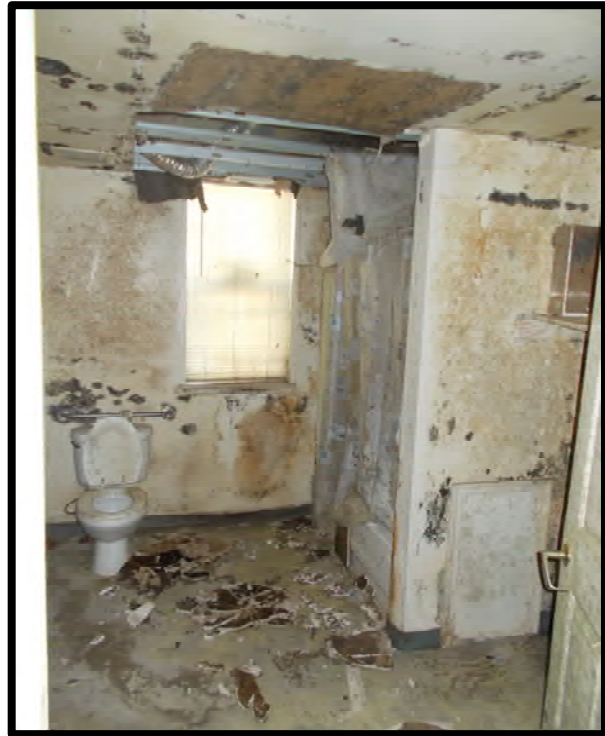
**Photo No. 11**

Depicts view of bathroom. It appears that this unit was made to be handicap accessible.

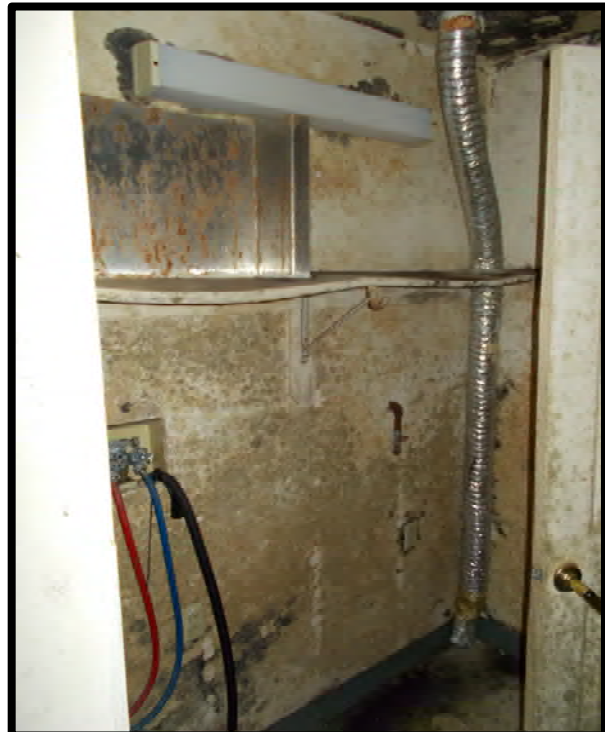
**Photo No. 12**

Depicts view of washer/dryer closet.

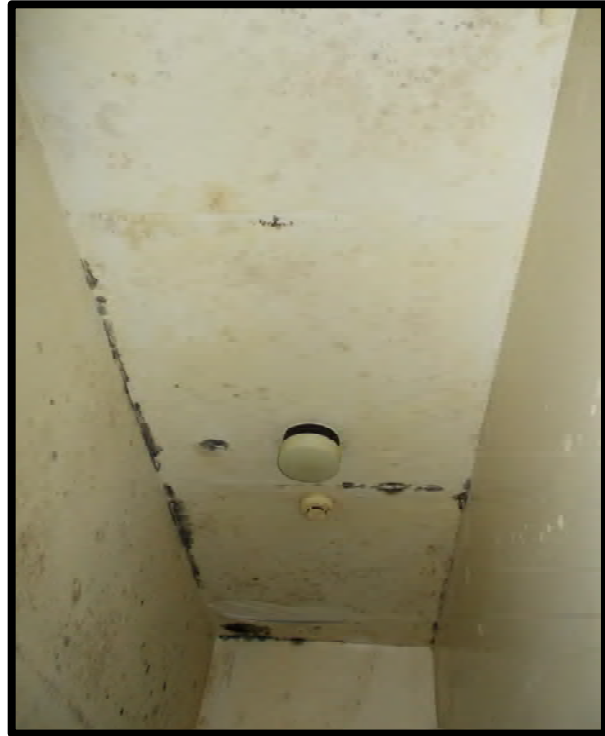
**Photo No. 13**

View of ceiling at hallway.

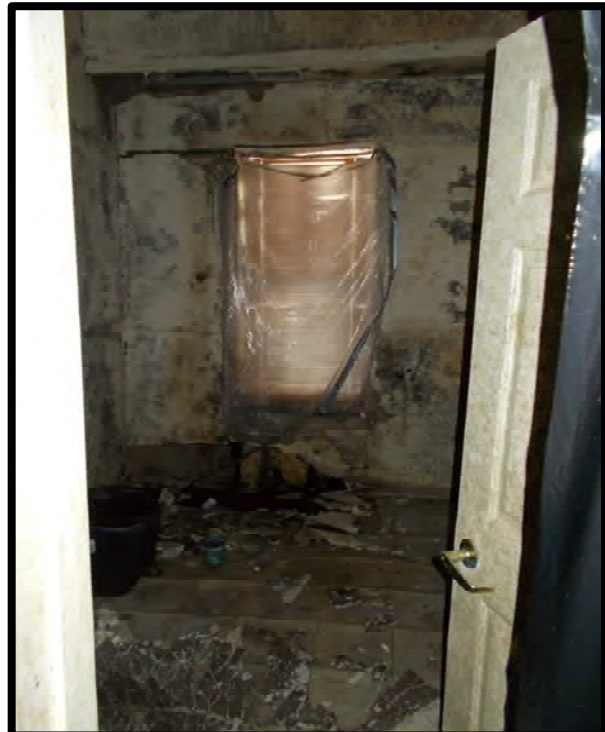
**Photo No. 14**

View of bedroom #1.

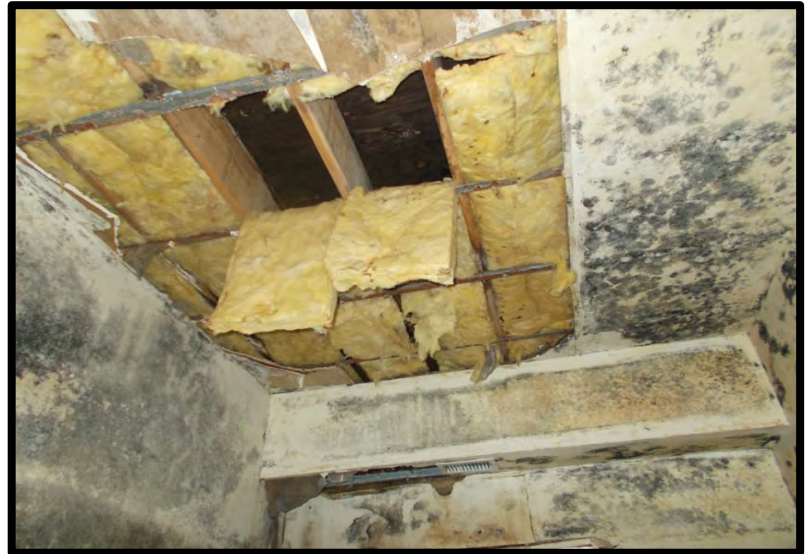
**Photo No. 15**

View of ceiling within bedroom #1.

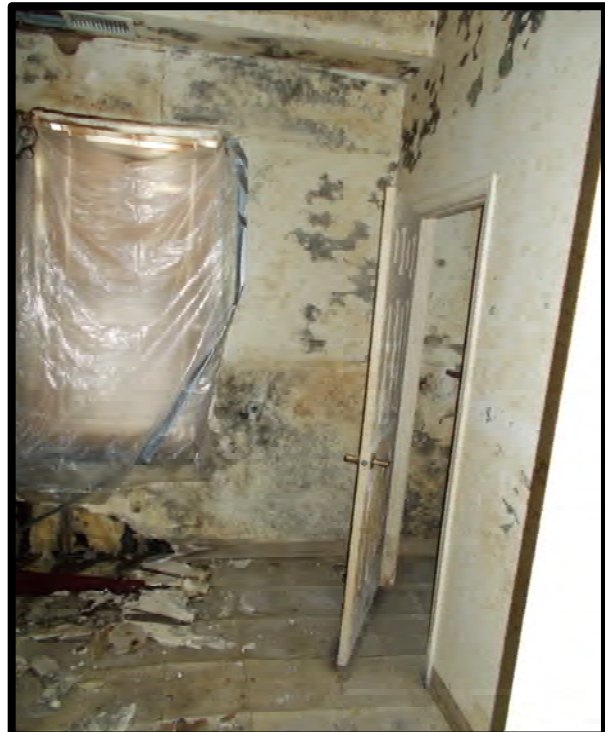
**Photo No. 16**

Panning right from Photo No. 14. View of bedroom closet.

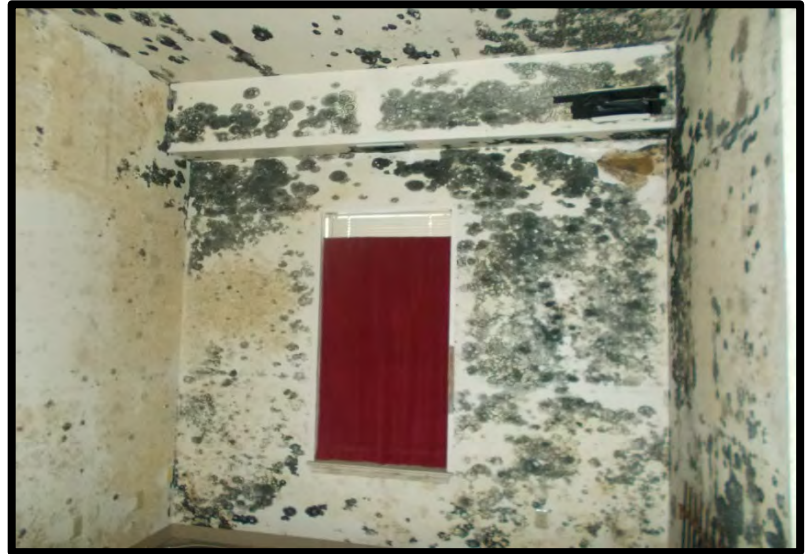
**Photo No. 17**

View of bedroom #2.

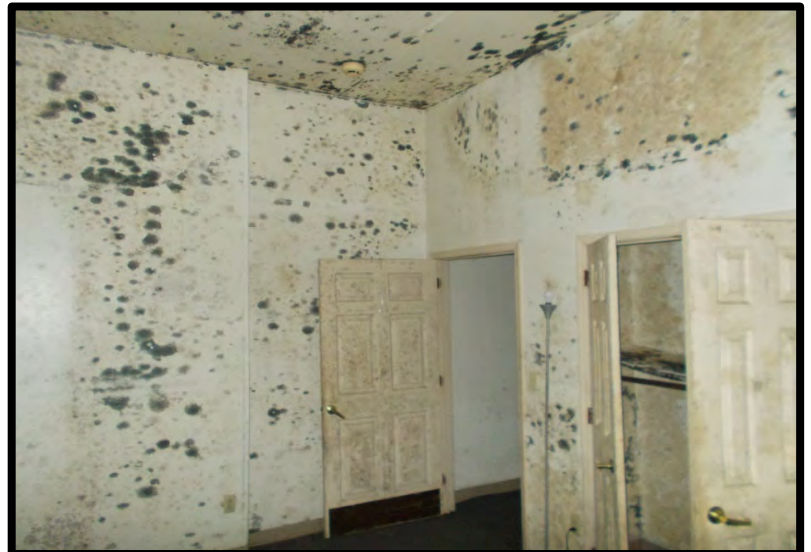
**Photo No. 18**

View looking towards bedroom #2 entry and bedroom closets.

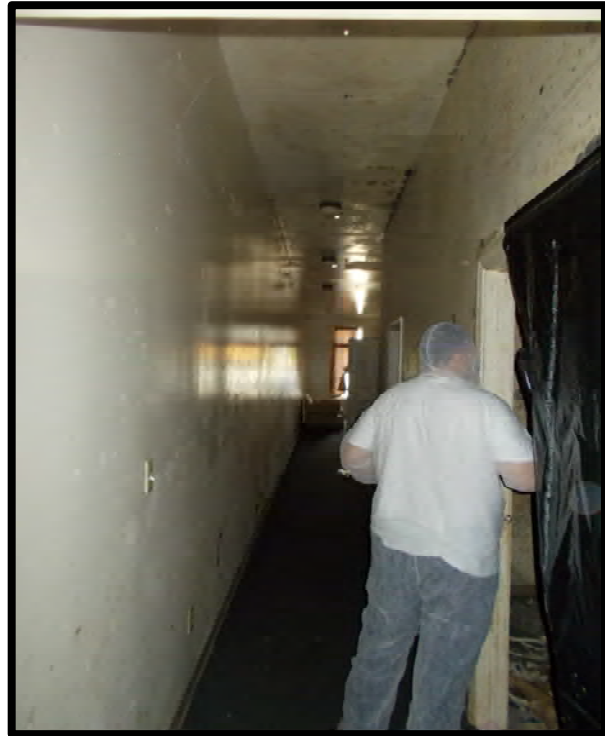
**Photo No. 19**

View looking down hallway from bedrooms back  
towards living room.

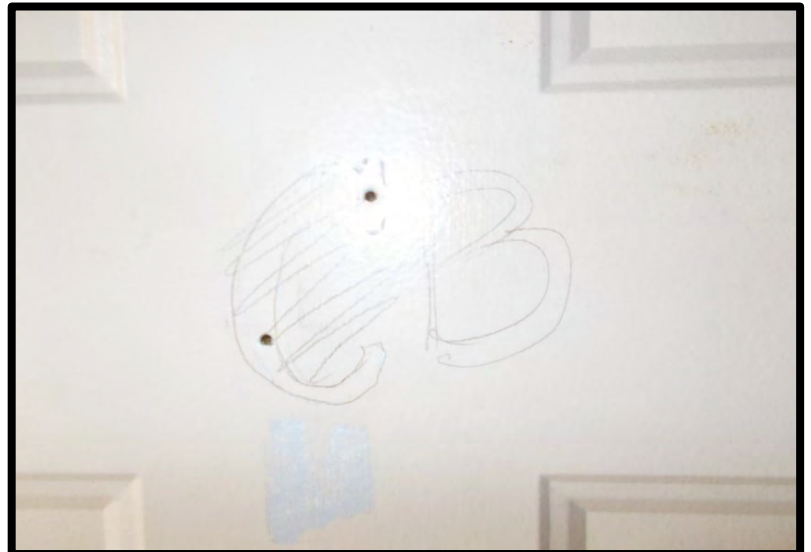
**Photo No. 20**

Unit B.

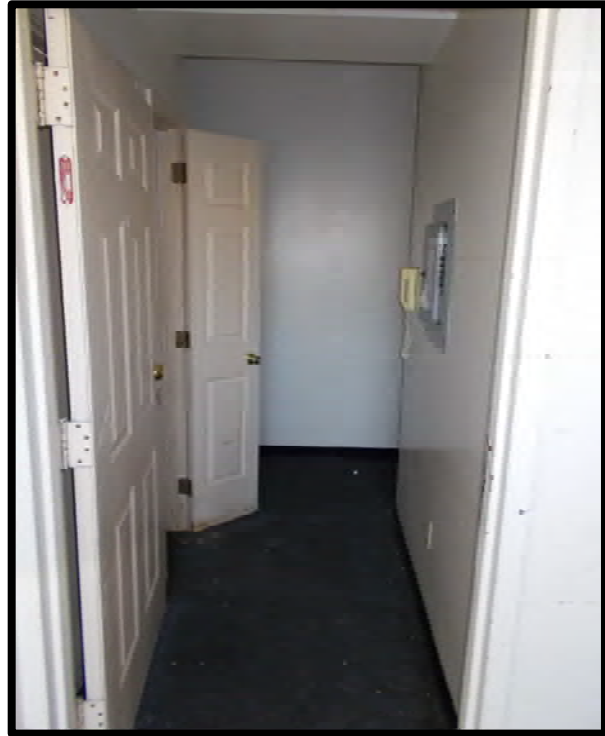
**Photo No. 21**

View looking in apartment.

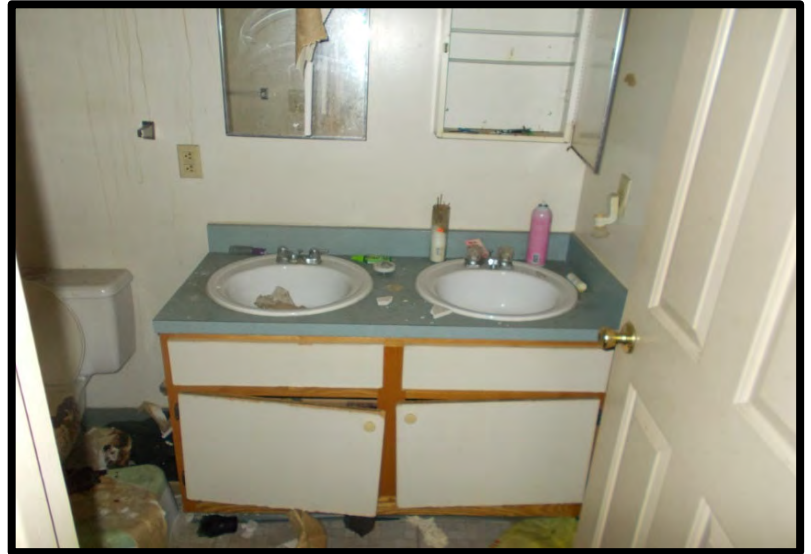
**Photo No. 25**

Additional view of double lavatory vanity.

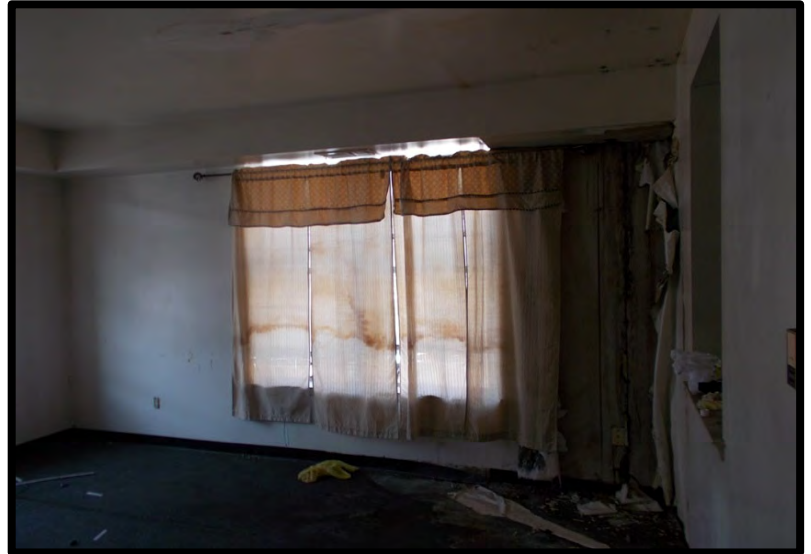
**Photo No. 29**

Panning right from previous photo. Additional view of living room and opening to kitchen at right.

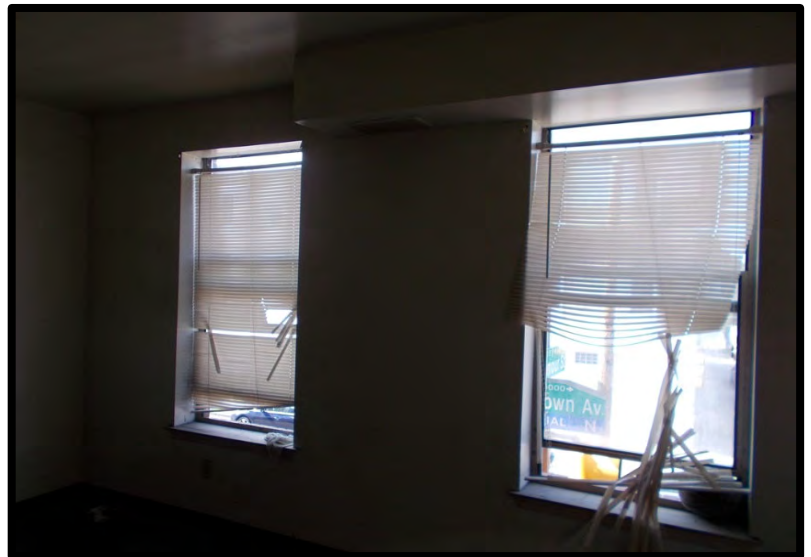
**Photo No. 30**

Additional view of living room windows facing Germantown Avenue.

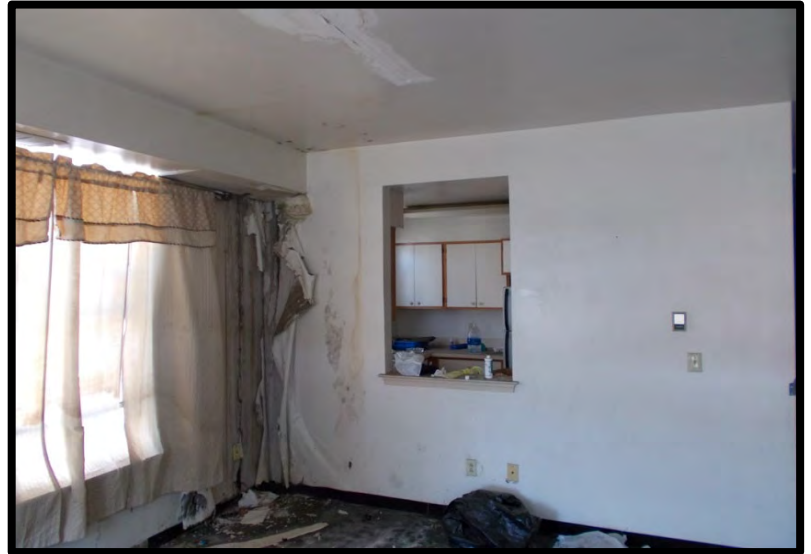
**Photo No. 32**

Panning left from previous photo. View of kitchen  
opening and demising wall.

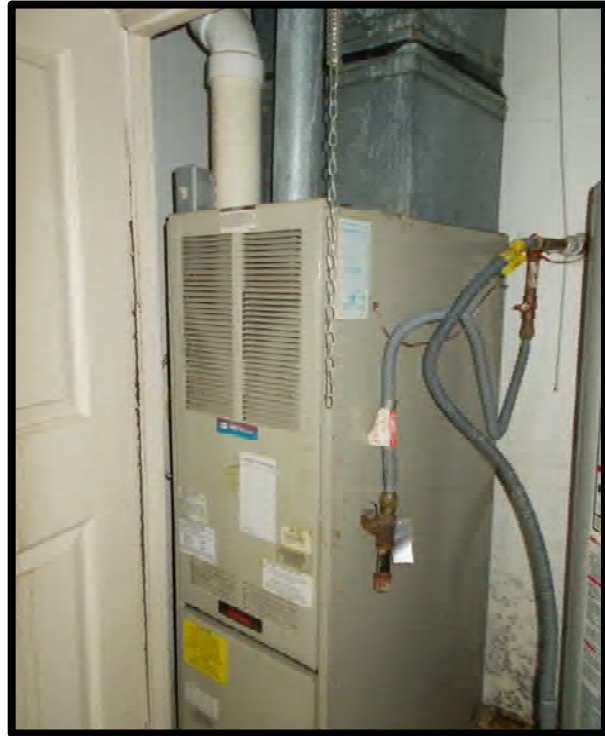
**Photo No. 34**

View of installed hot air furnace.

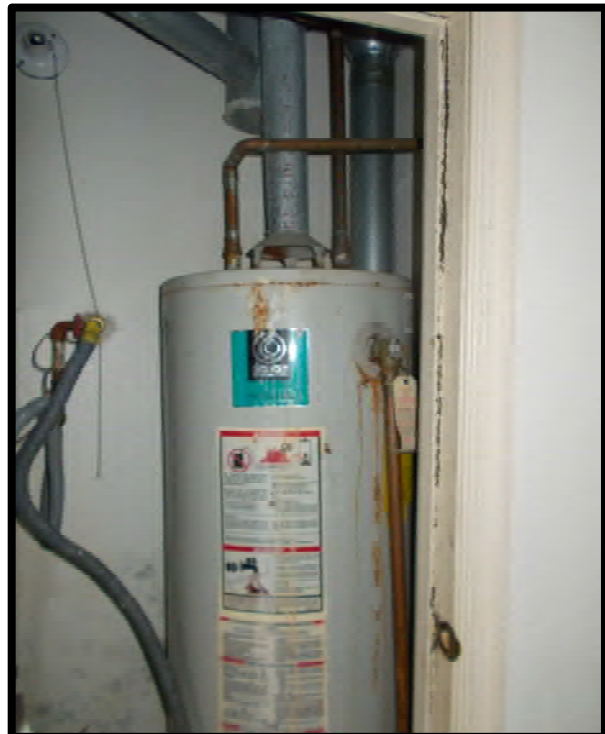
**Photo No. 35**

Panning right from previous photo. View of gas-fired hot water heater.

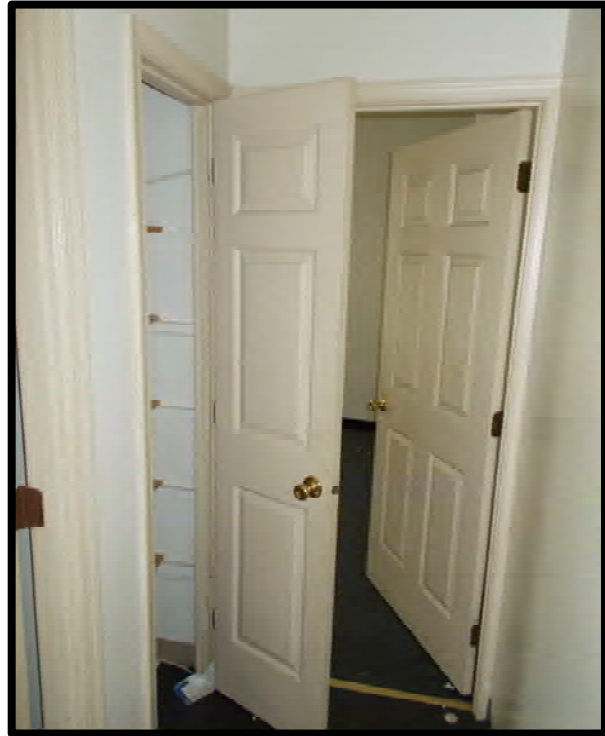
**Photo No. 38**

View of hallway closet and entry to rear master bedroom.

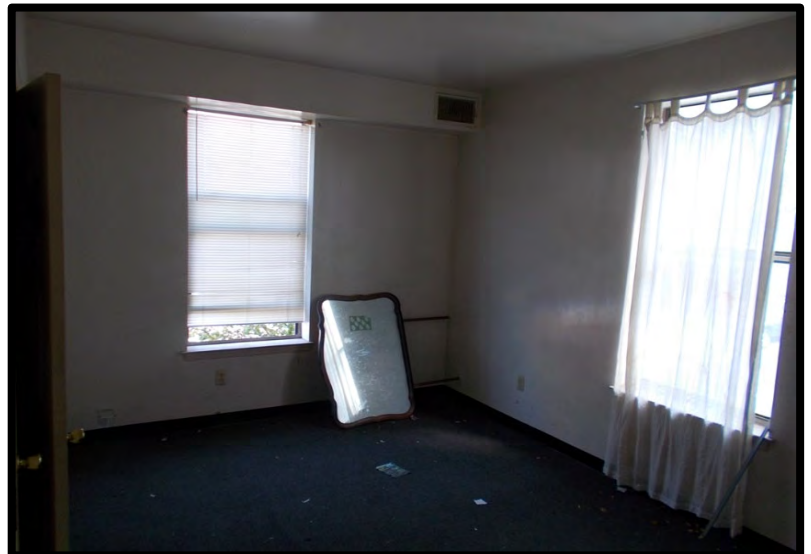
**Photo No. 39**

View inside bedroom #3 which is at the rear of the building.

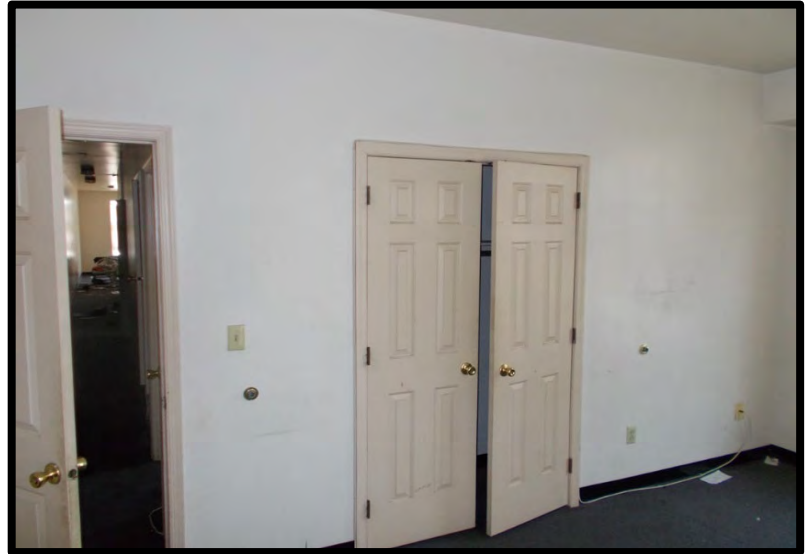
**Photo No. 40**

Panning 180 degrees from previous photo. View of bedroom entry and closet.

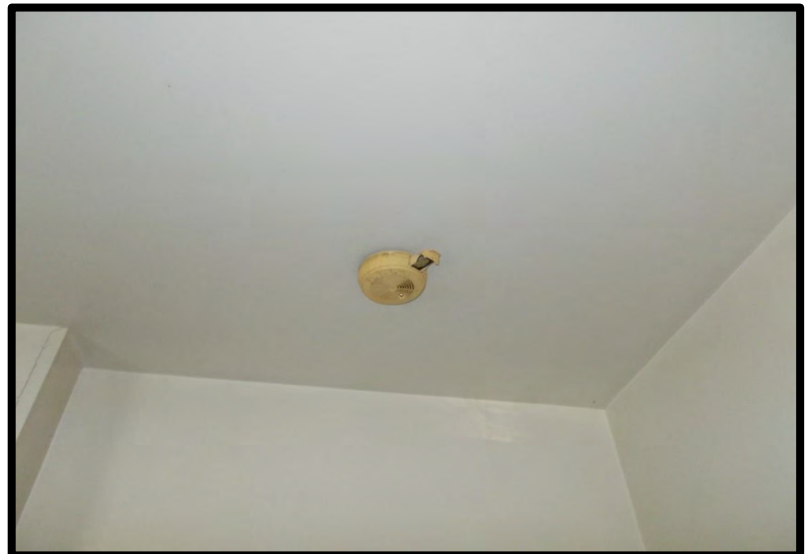
**Photo No. 41**

Depicts smoke detector installed on ceiling outside bedrooms.

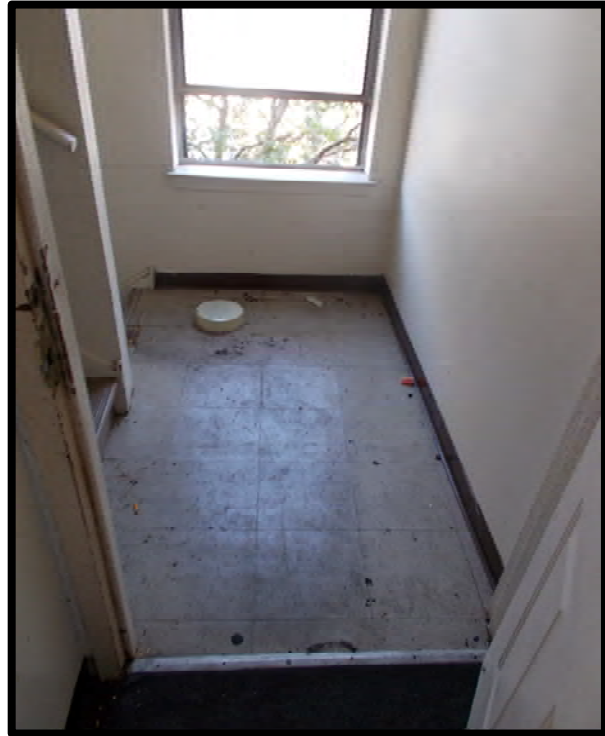
**Photo No. 42**

Depicts second floor landing at stairs.

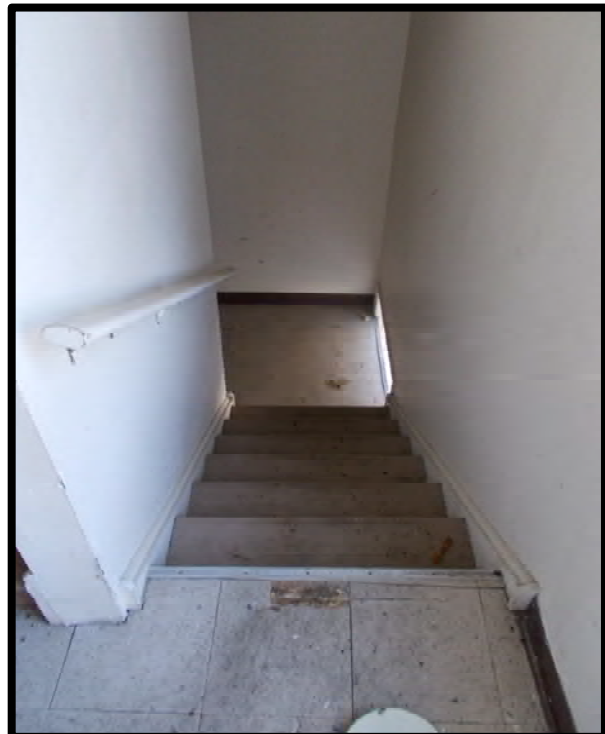
**Photo No. 43**

View looking down towards first floor from second floor landing.

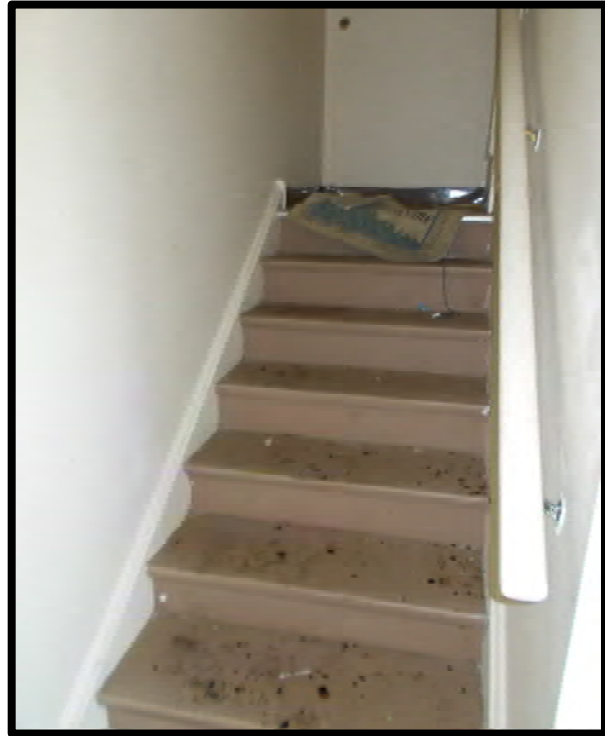
**Photo No. 44**

View of stairs leading up to the 3rd floor.

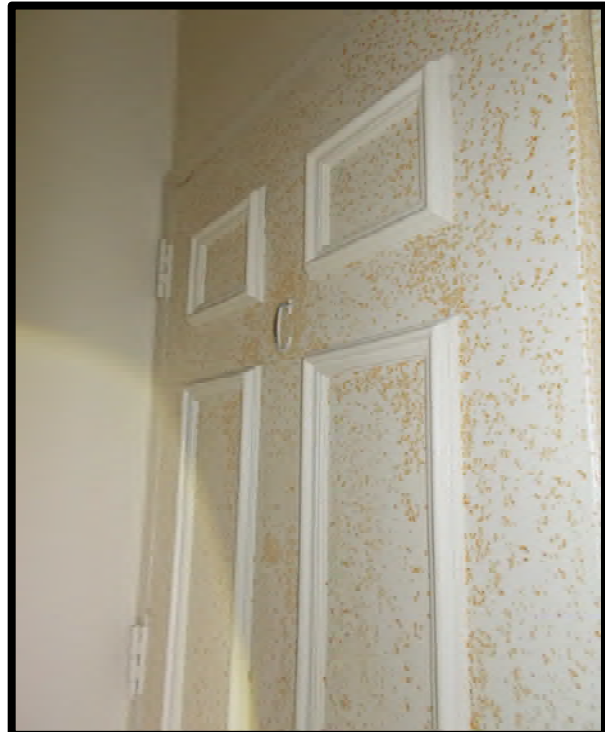
**Photo No. 45**

Entry door to Apt. C. Door is located midway up between second and third floors.

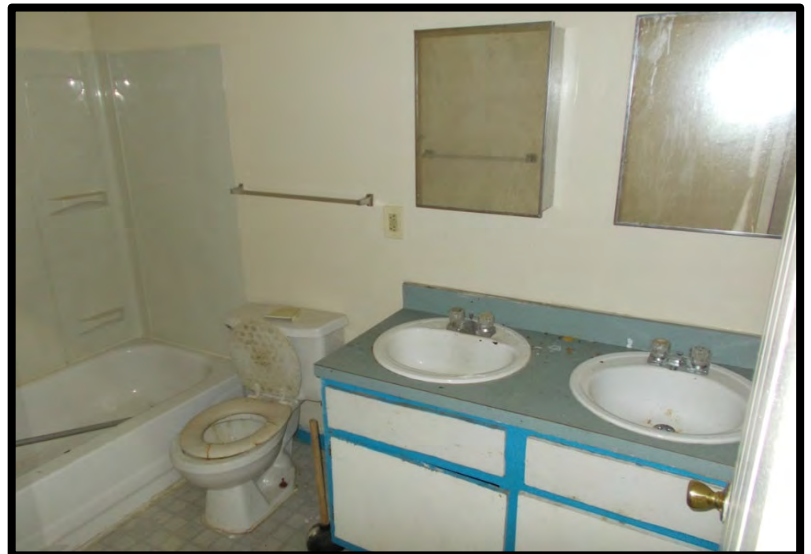
**Photo No. 51**

View of interior of bathroom.

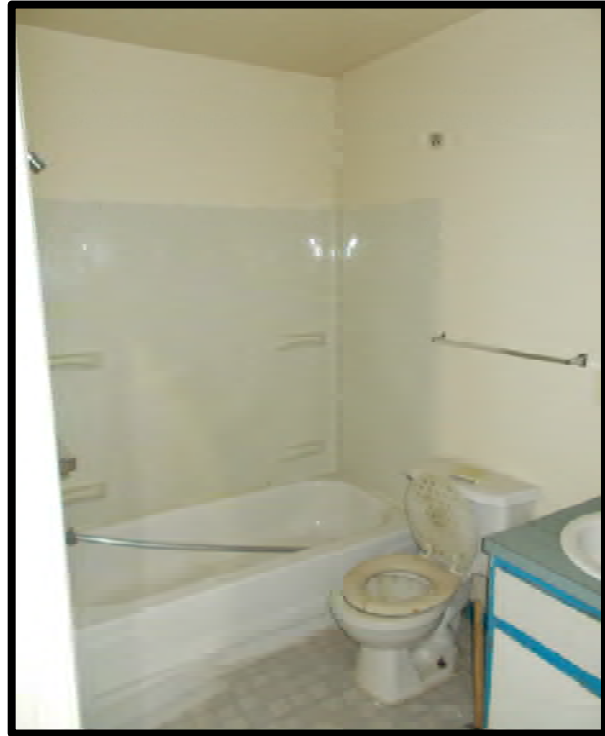
**Photo No. 52**

Panning left from previous photo. View of water closet and bathtub.

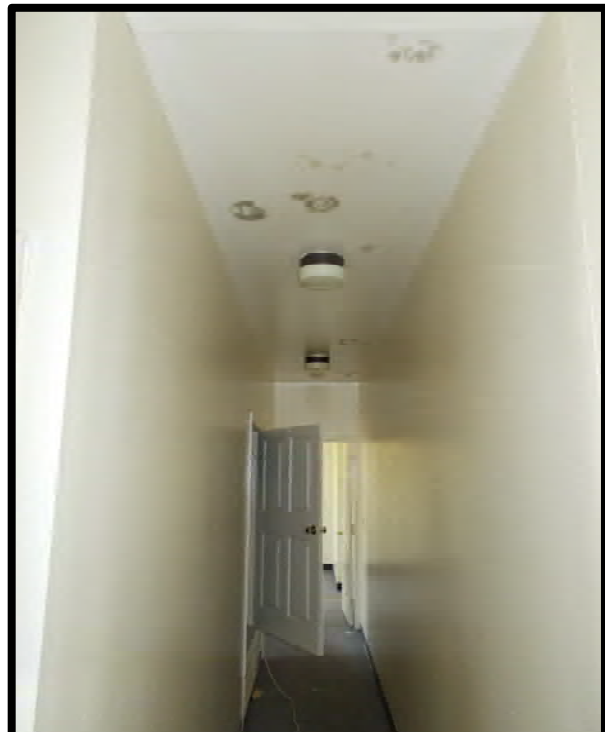
**Photo No. 58**

View looking down hallway from living room.

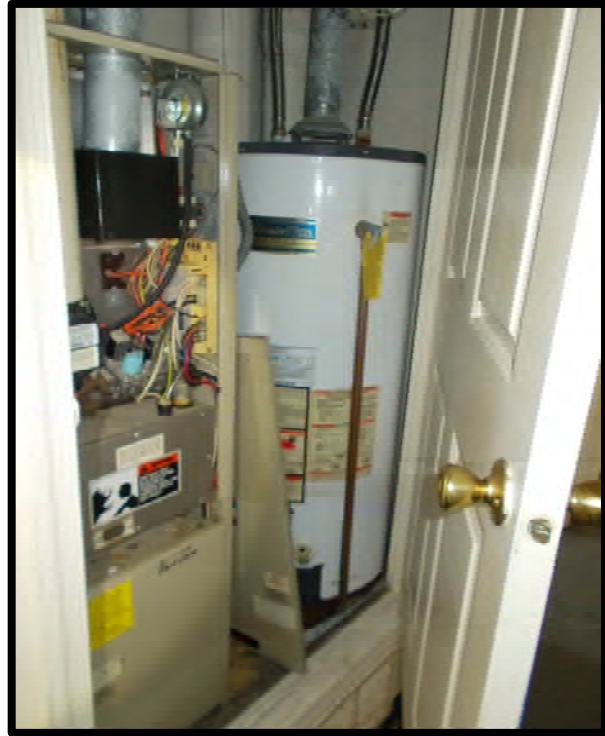
**Photo No. 59**

Depicts installed hot air furnace and hot water heater.

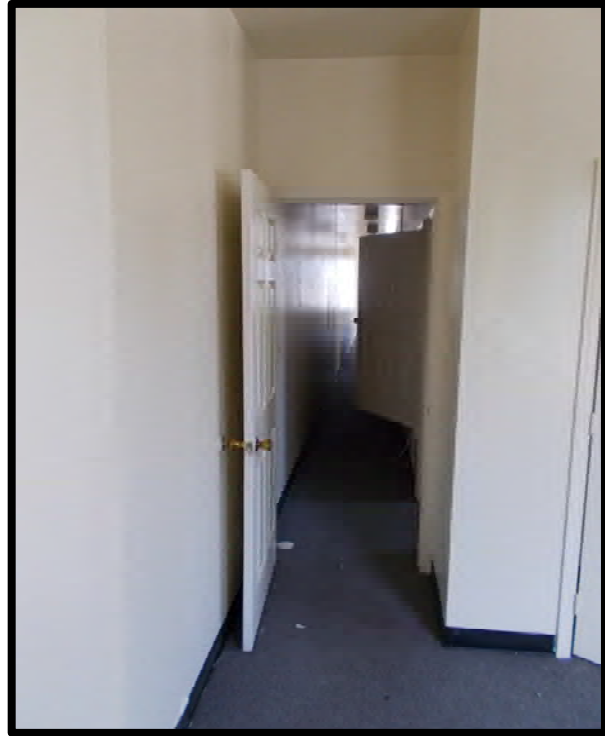
**Photo No. 63**

View of master bedroom #3 entry from hallway.

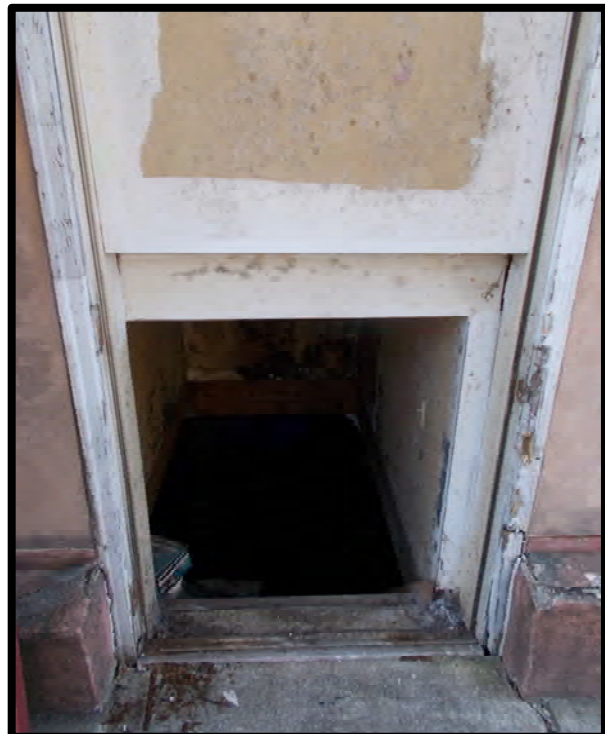
**Photo No. 66**

View of stairs leading to basement from exterior grade.

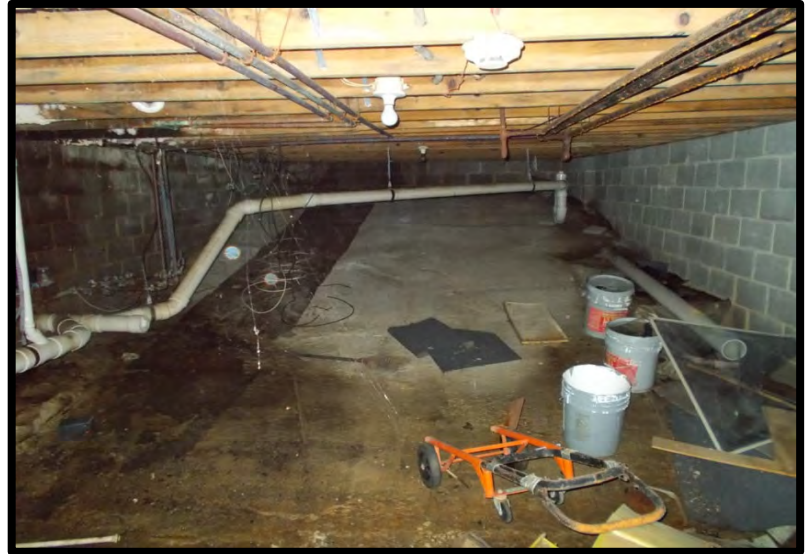
**Photo No. 67**

View within basement looking at rear of building.

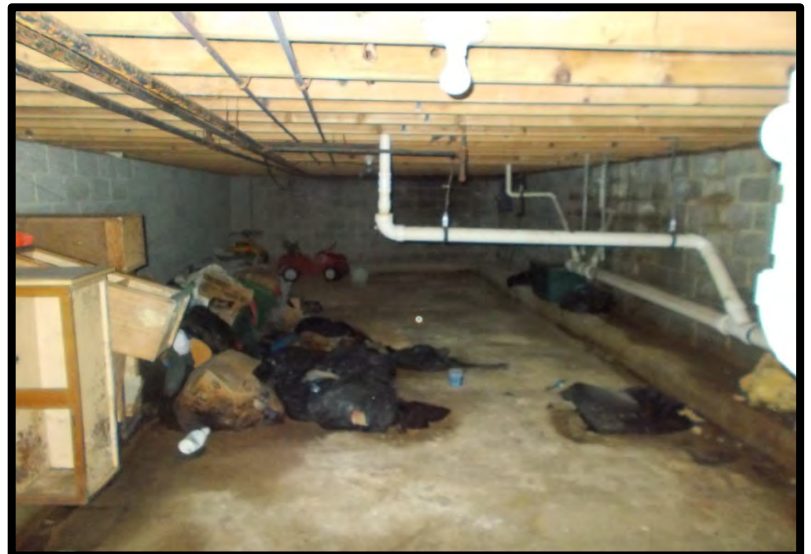
**Photo No. 69**

Panning left from previous photo. View looking towards Germantown Avenue along basement.

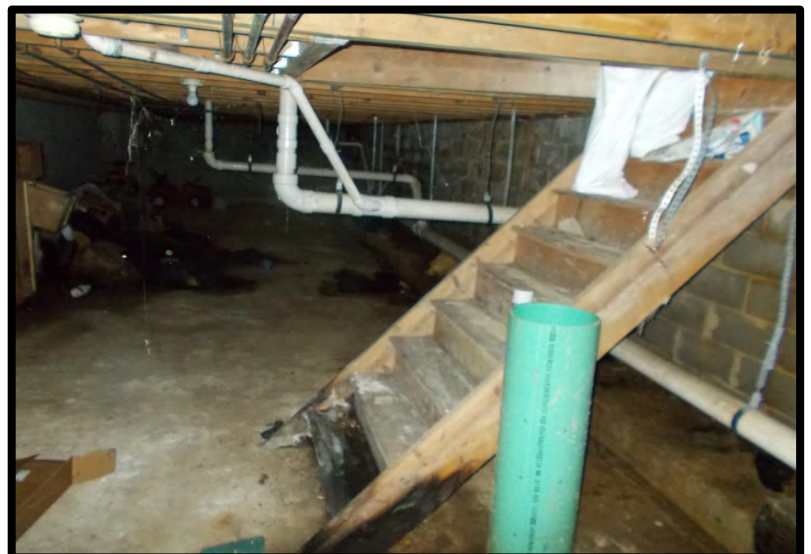
**Photo No. 72**

View of wooden stairs leading to exterior grade.

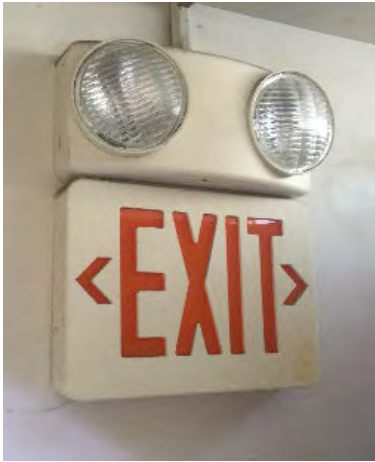
Emergency exit sign and light in hallway.

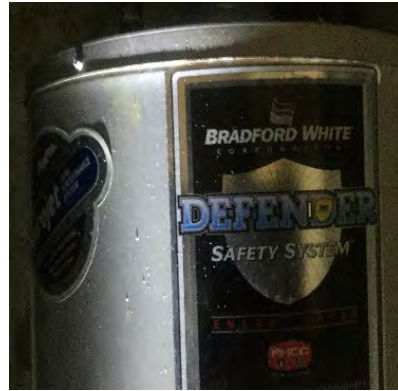
Hot water heater.

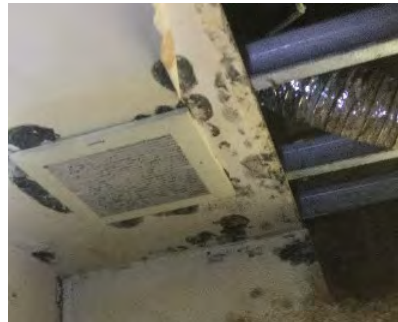
Exhaust vent and water damage to ceiling.
