# Germantown/Mount Airy Properties

## Physical Conditions and Needs Assessment

### Premises V

**5417 Lena St**

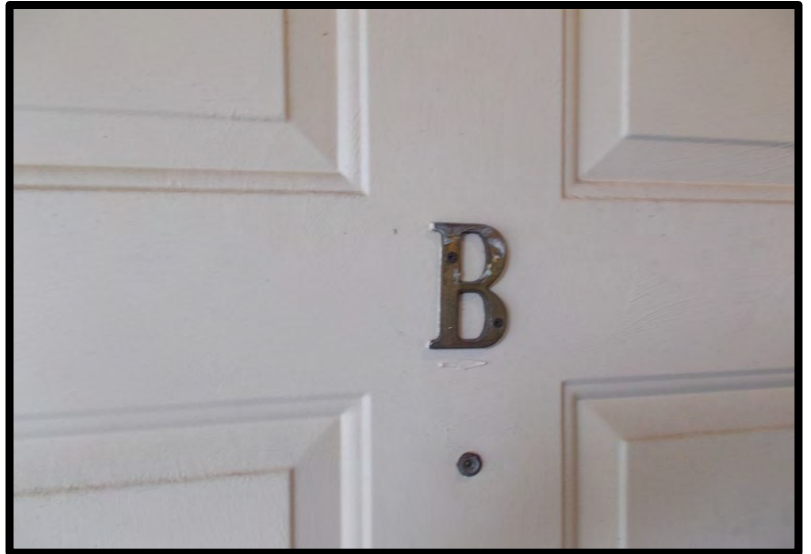
**Photo No. 3**

Depicts apartment entry to Unit B.

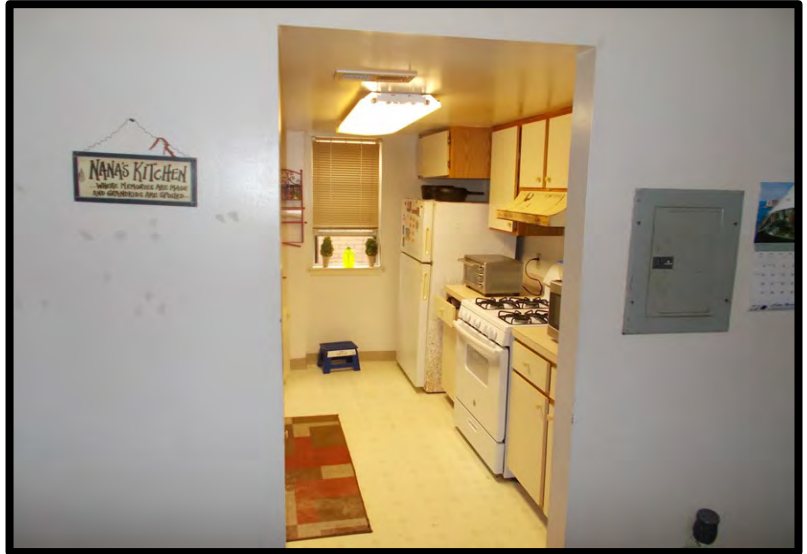
**Photo No. 5**

Depicts overall view of kitchen second floor Unit B.

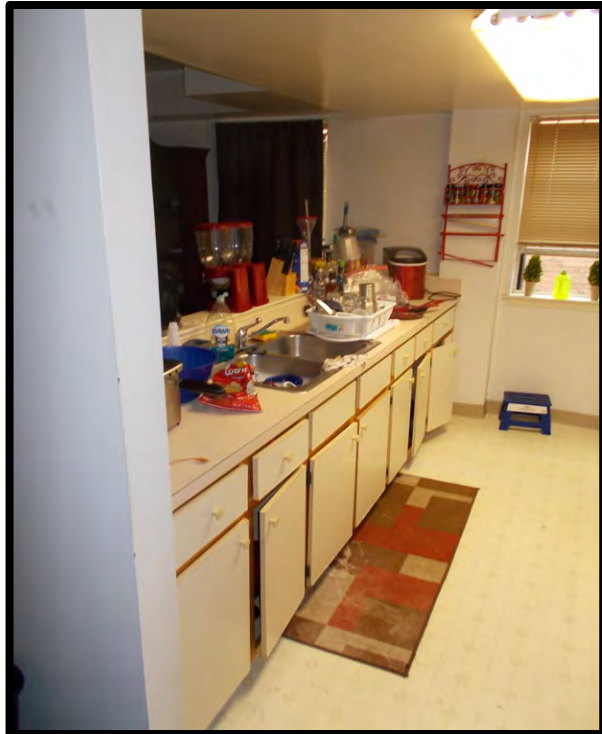
**Photo No. 7**

Panning from Photo #5. Depicts additional view of kitchen cabinets and pass-through to living room.

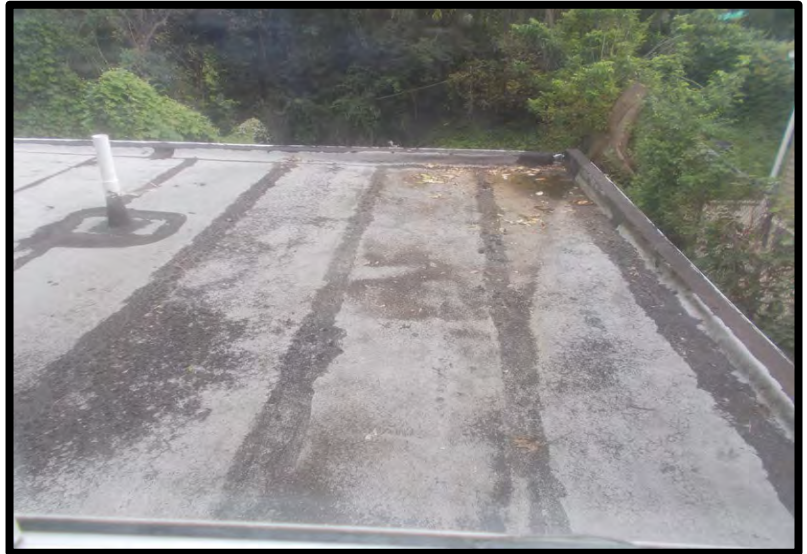
**Photo No. 38**

The roof over the first floor appears to be a granulated sheet. It appears to be in fair to poor condition. The third-floor roof is a 3-tab asphalt shingle, "A" shaped roof in fair to poor condition. Some curling of the shingle was noted. There was evidence of missing trim along the rake. It was observed that the third floor roof had been damaged due to natural hazards. There is damage to existing gutters.

Depicts view of first floor roof as seen through window on third floor.

*Replacement of first floor roof is highly recommended.  
Third floor roof has exhibited signs of water infiltration and replacement with new architectural shingles is required.  
Replacement/Repair of the trim is required.  
Replacement of damaged gutters in their entirety should be considered.*

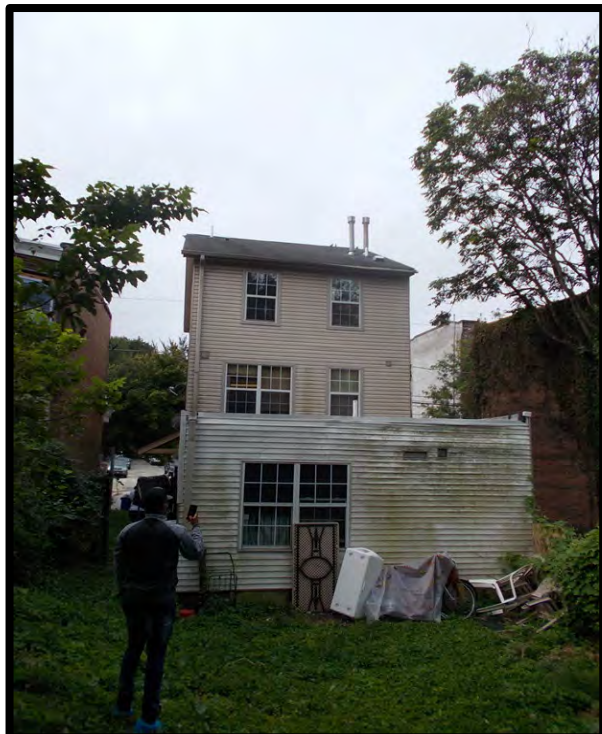
**Photo No. 48**

View of rear of structure. It is possible to see where the tree landed across the rear portion of the structure.

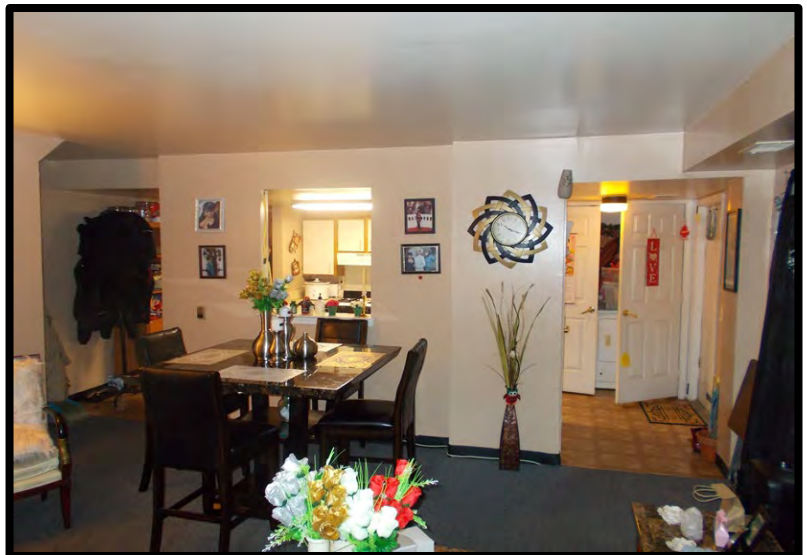
**Photo No. 55**

Overall view of apartment entry, kitchen and washer/dryer closet beyond. Left side of photo is hallway to rear bedrooms.

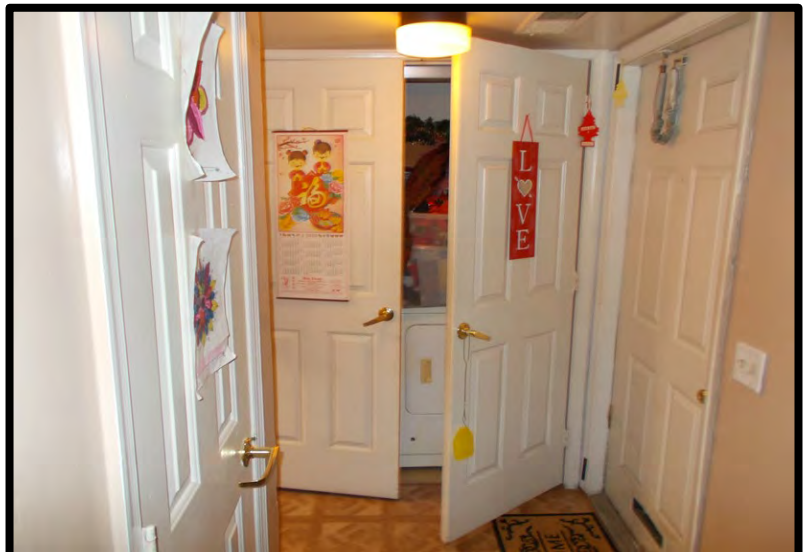
**Photo No. 56**

Close up view of washer/dryer closet at apartment entry.

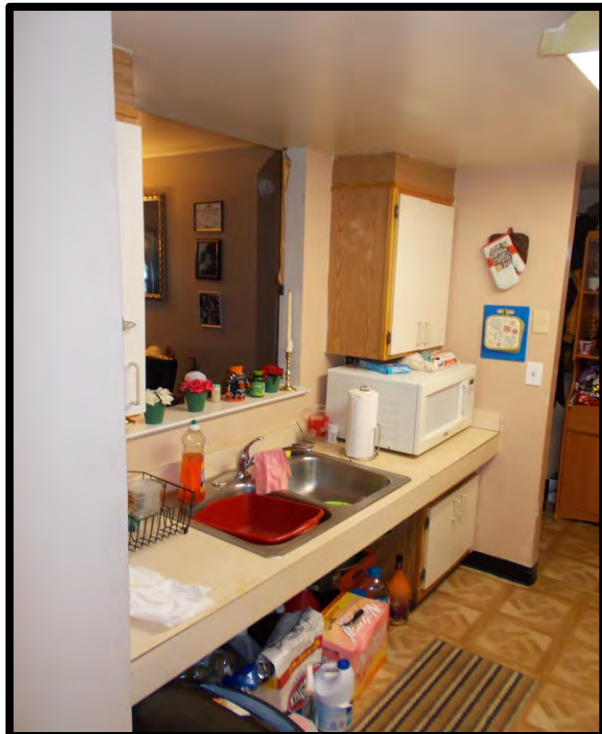
**Photo No. 58**

Panning left from previous photo. Additional view of kitchen. Note this unit appears to be handicap accessible.

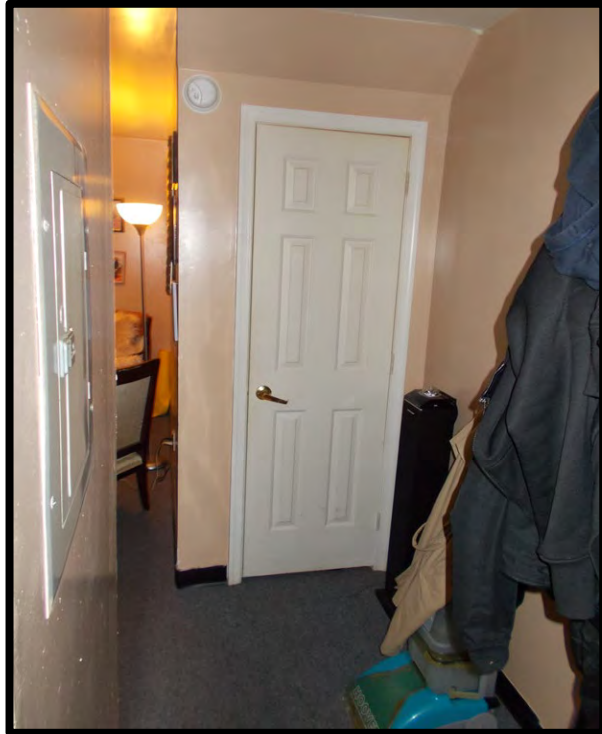
**Photo No. 59**

View of closet below stairs leading to second floor.

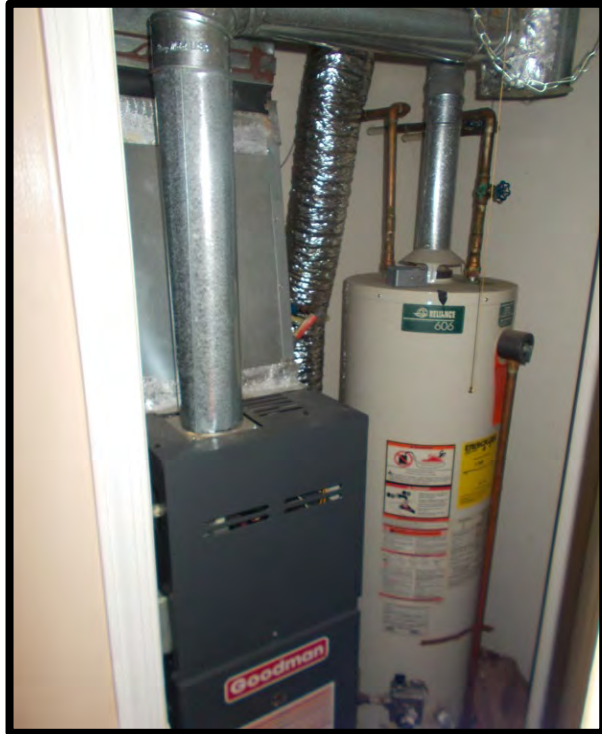
**Photo No. 61**

View of gas-fired hot water heater and furnace.

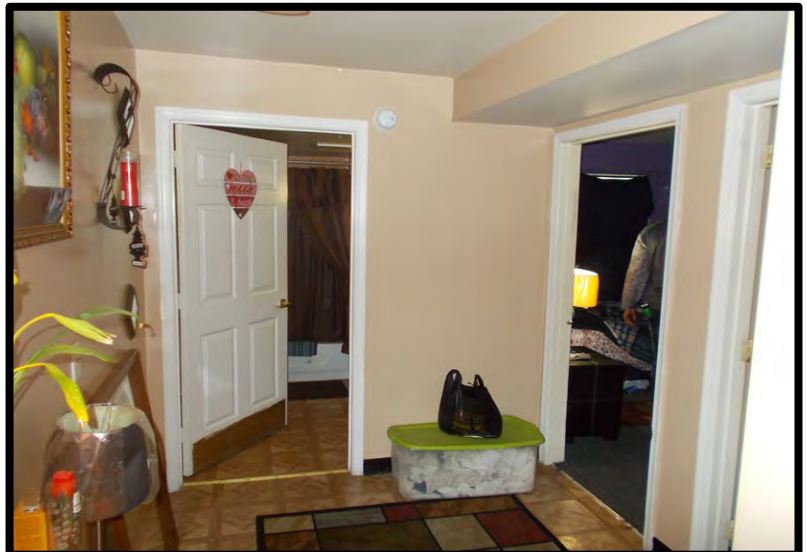
**Photo No. 62**

View of first floor bathroom straight ahead with bedrooms on the right.

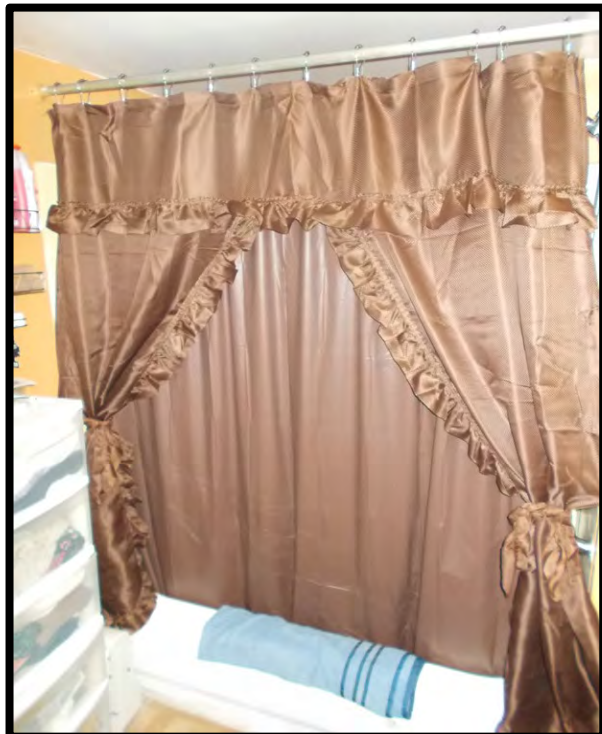
**Photo No. 64**

View of bathtub within first floor bathroom.

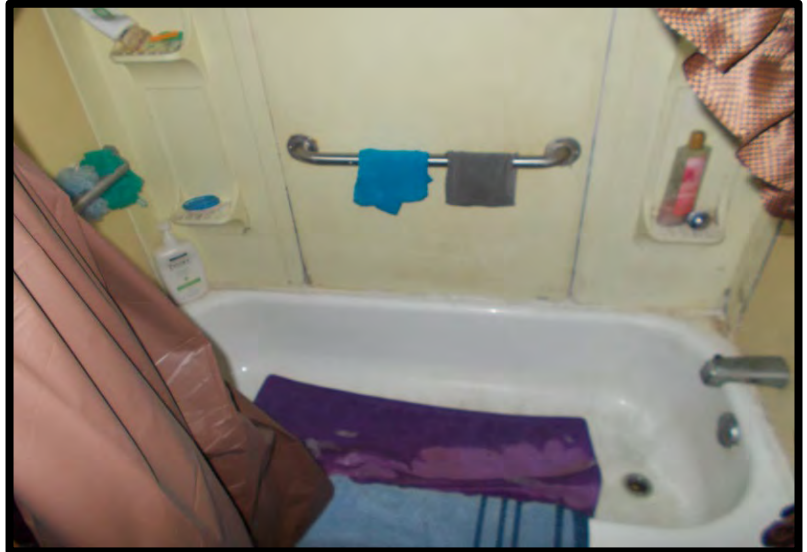
**Photo No. 65**

Overall view of bathtub and fiberglass surround as well as installed handicap grab bars.

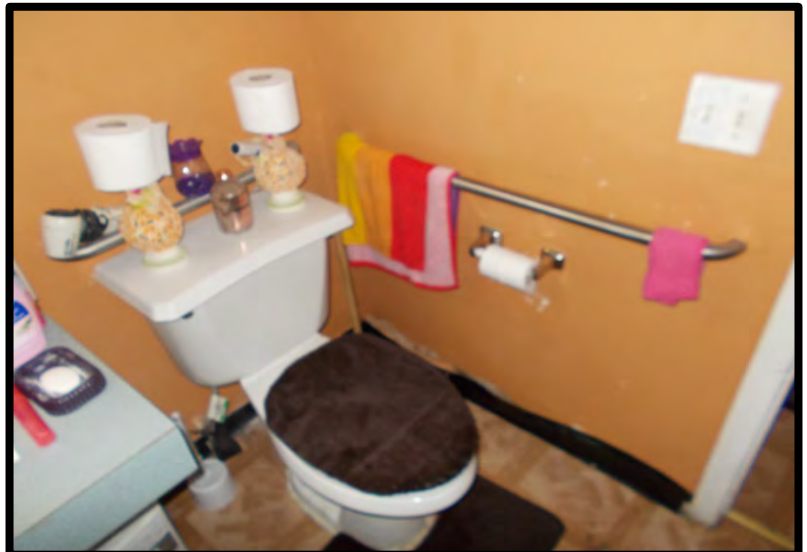
**Photo No. 66**

View of grab bars installed at water closet.

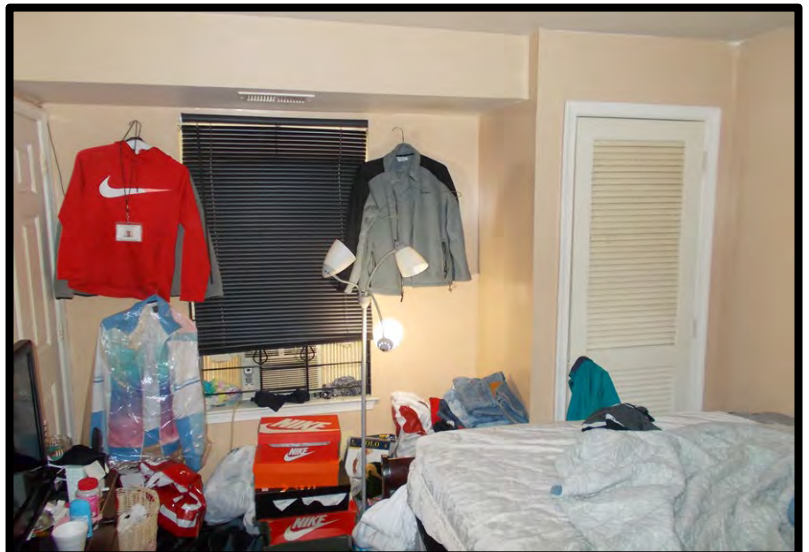
**Photo No. 72**

View of closet and exterior wall of bedroom #2.

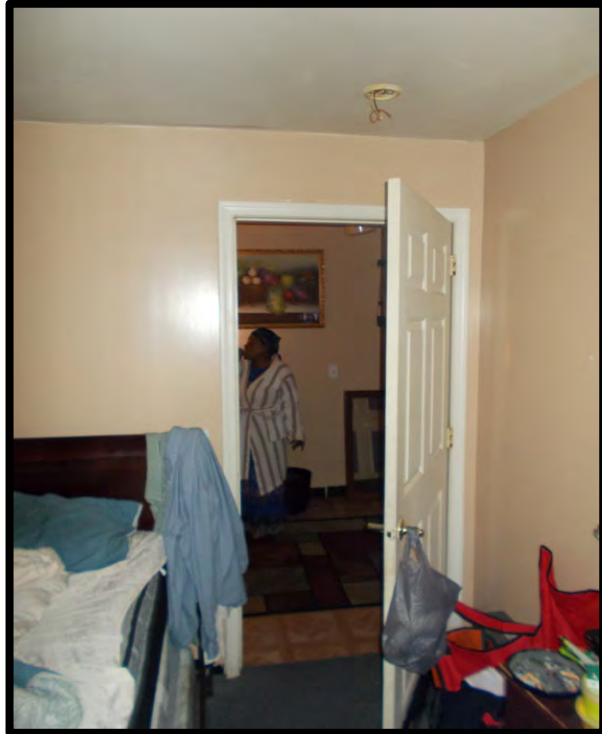
**Photo No. 73**

Panning 180 degrees from previous photo. View of bedroom entry.

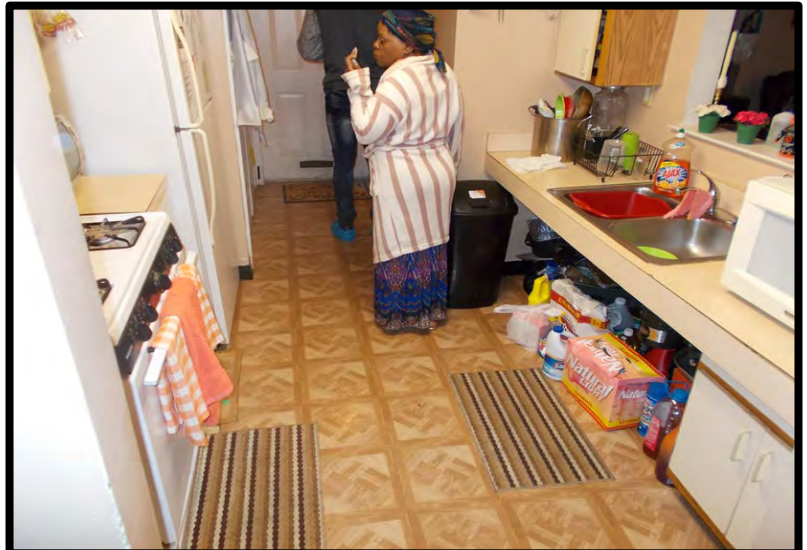
**Photo No. 76**

Overall view of kitchen flooring.

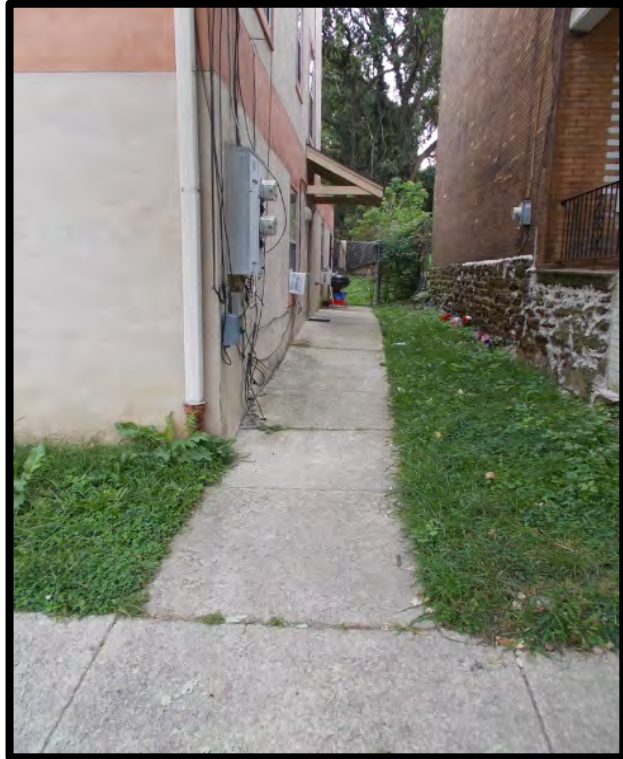
**Photo No. 77**

View of sloped sidewalk leading to apartment A.

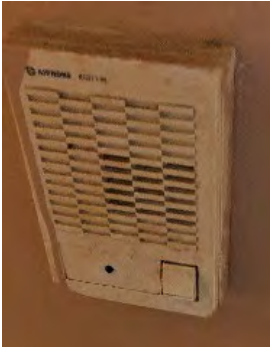
Intercom; works well.

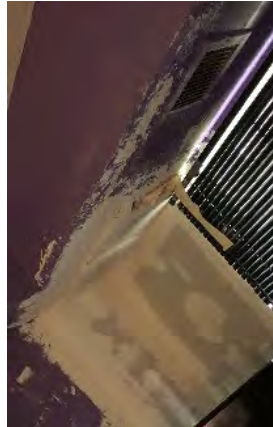
Master bedroom drywall after massive leaks.

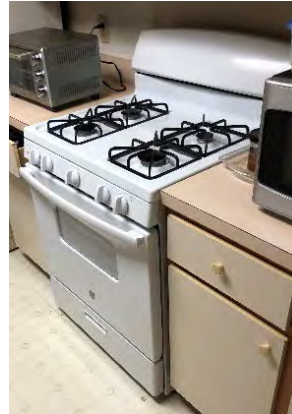
Gas stove.
