# Germantown/Mount Airy Properties

## Physical Conditions and Needs Assessment

### Premises Y

**5423-27 Lena Street**

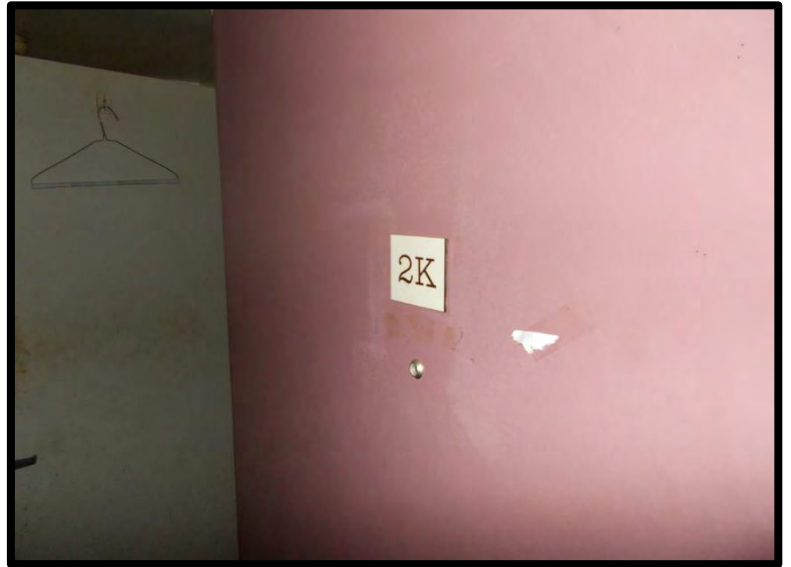
**Photo No. 1**

Unit 2K.

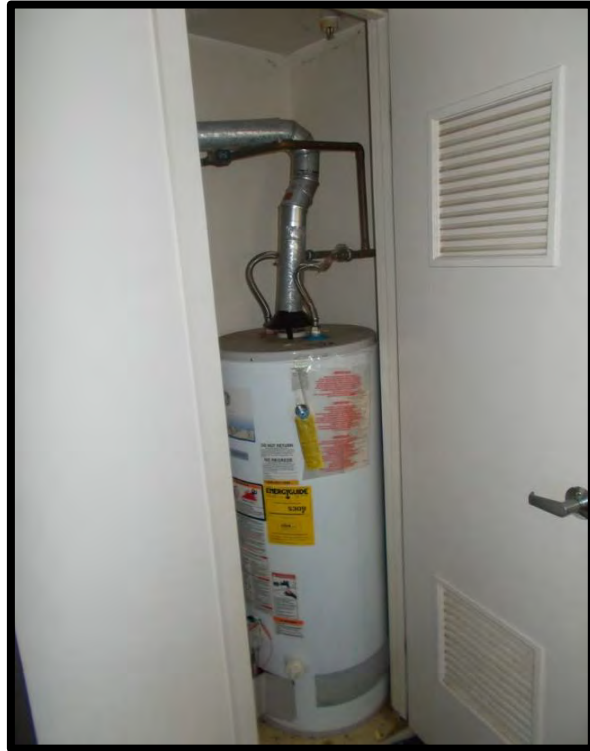
**Photo No. 5**

View of installed hot water heater.

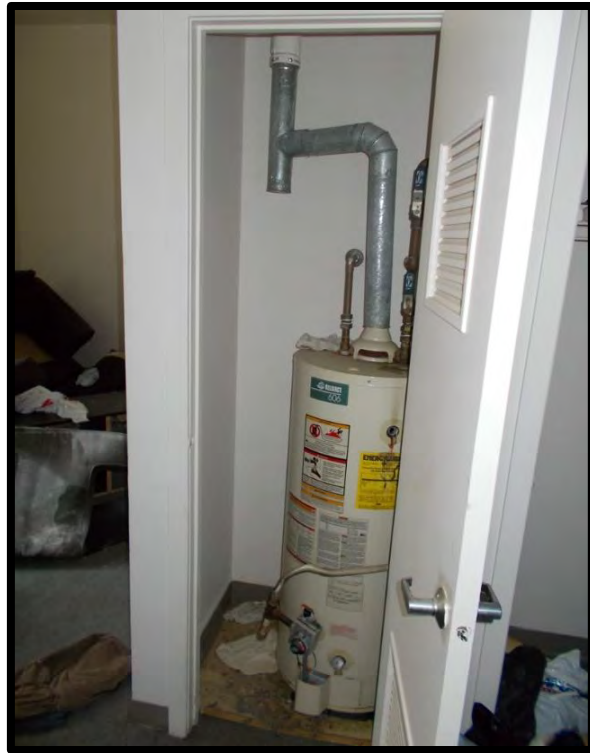
**Photo No. 13**

View of installed gas fired hot water heater.

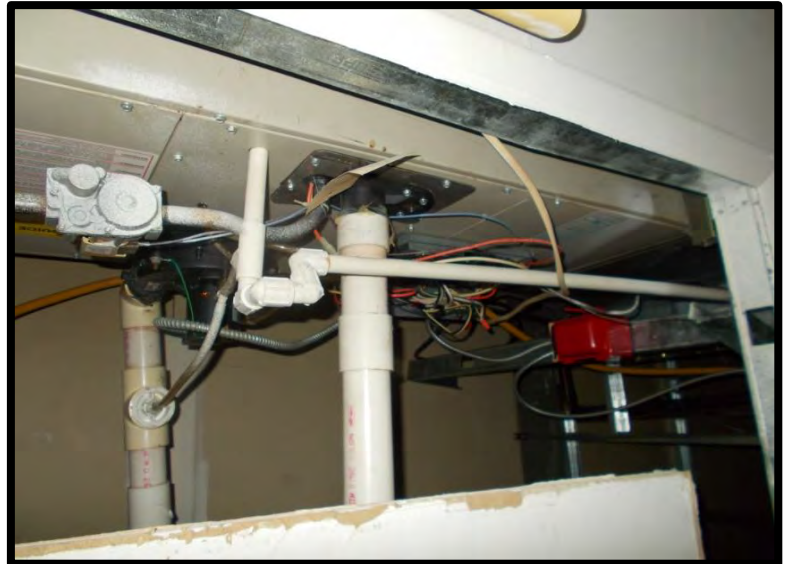
**Photo No. 18**

View of above ceiling air handling unit in the kitchen.

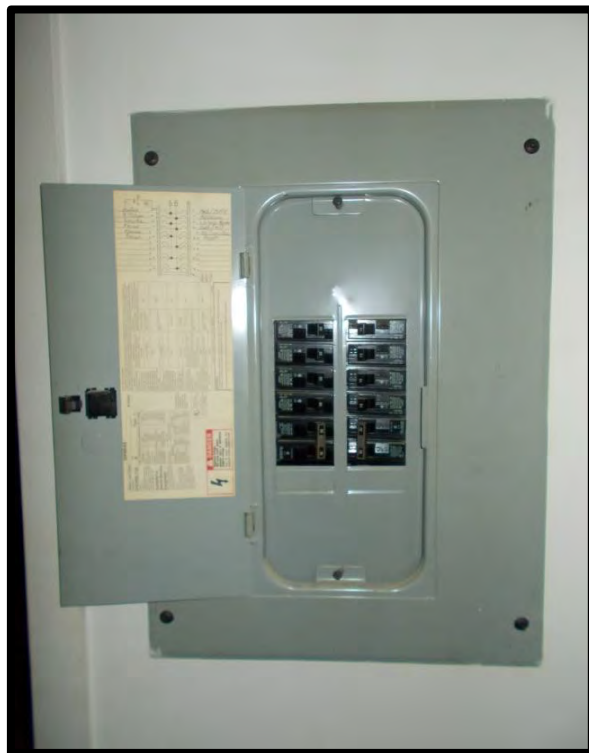
**Photo No. 26**

View of typical apartment electrical panel.

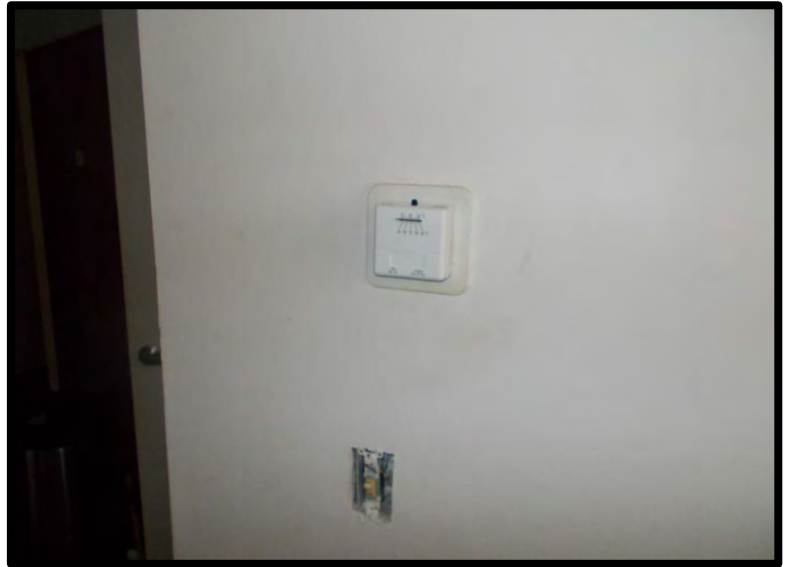
**Photo No. 29**

View of typical thermostat.

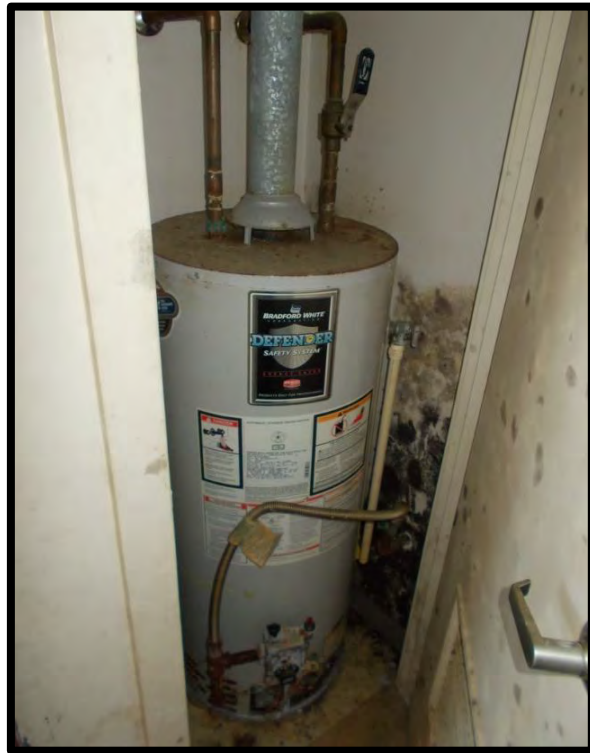
**Photo No. 42**

View of installed hot water heater.

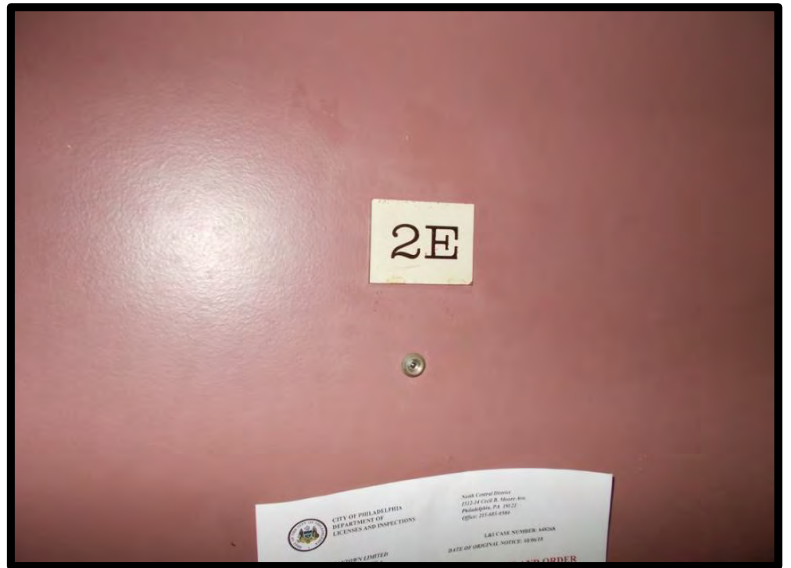
**Photo No. 44**

Unit 2E.

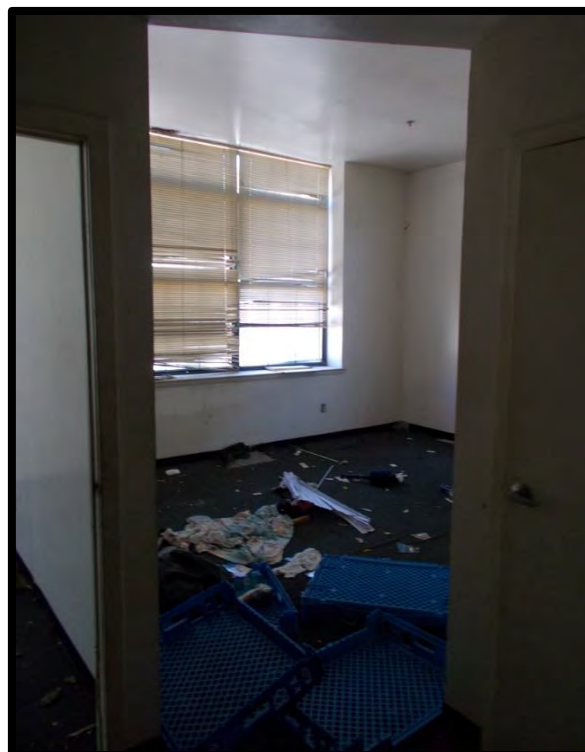
**Photo No. 46**

View looking into living room from entry.

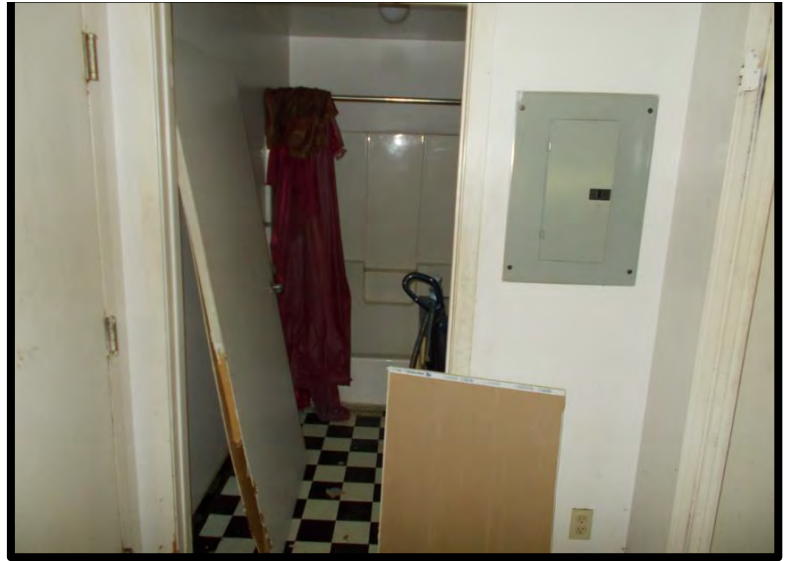
**Photo No. 47**

View looking at bathroom and apartment electrical panel from entry.

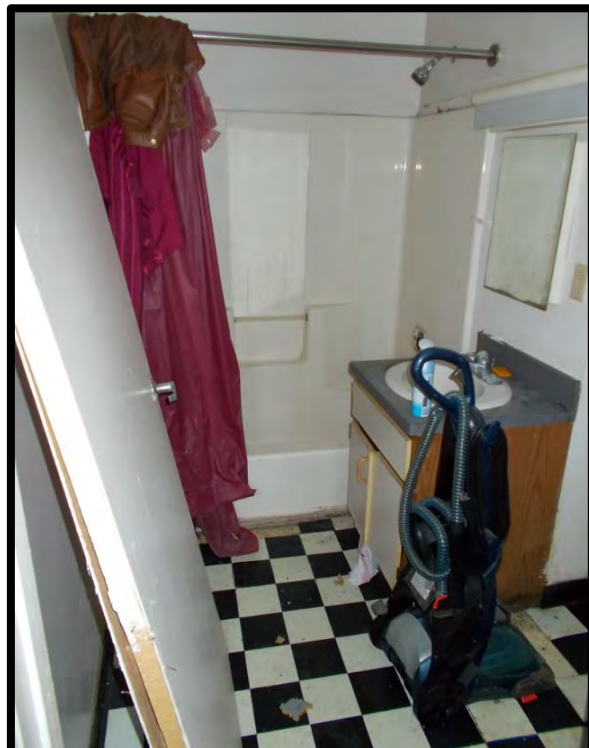
**Photo No. 48**

Additional view looking into bathroom.

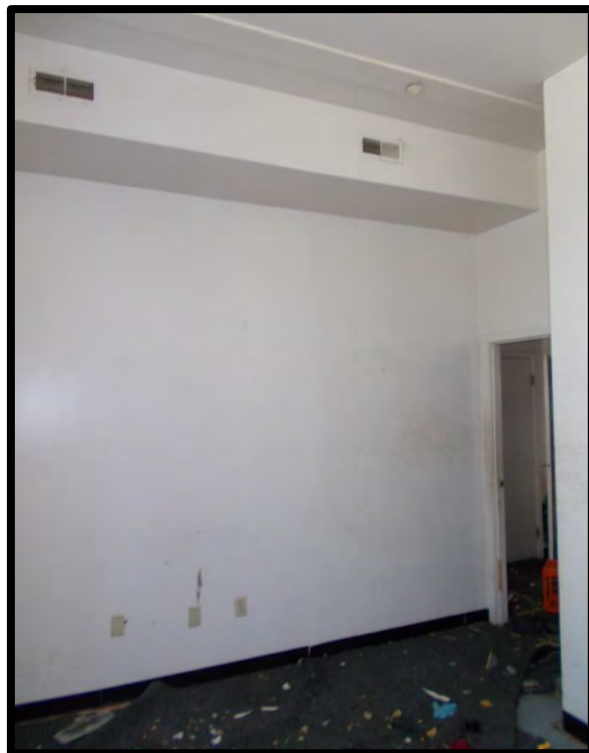
**Photo No. 52**

Panning left from previous photo. View of ducted forced air in bedroom.

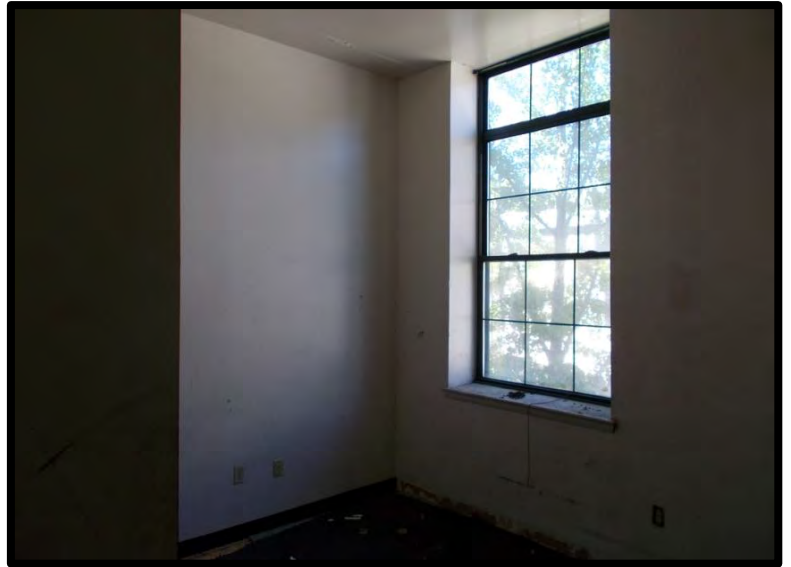
**Photo No. 53**

View of exterior wall in bedroom.

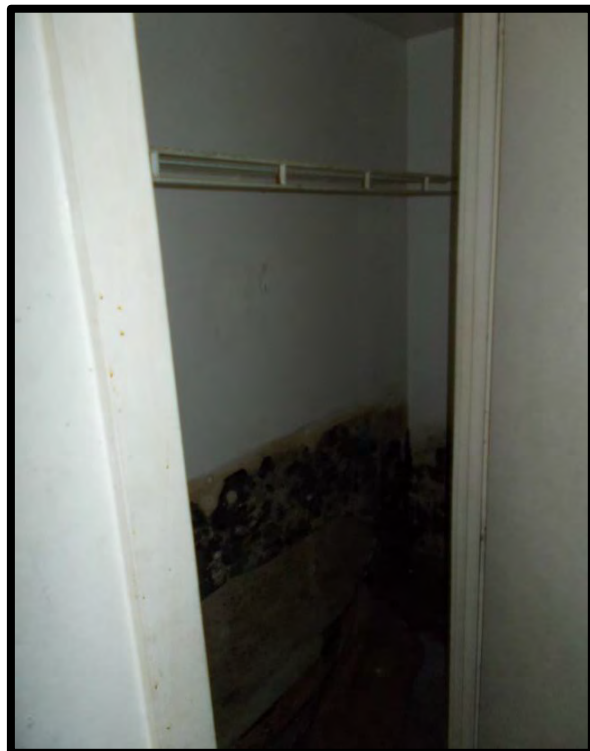
**Photo No. 54**

View of entry closet.

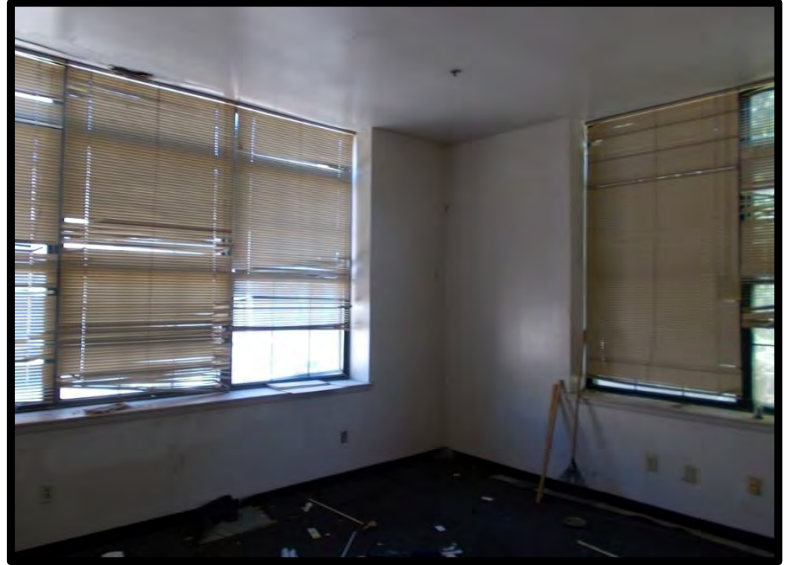
**Photo No. 55**

View of living room from entry.

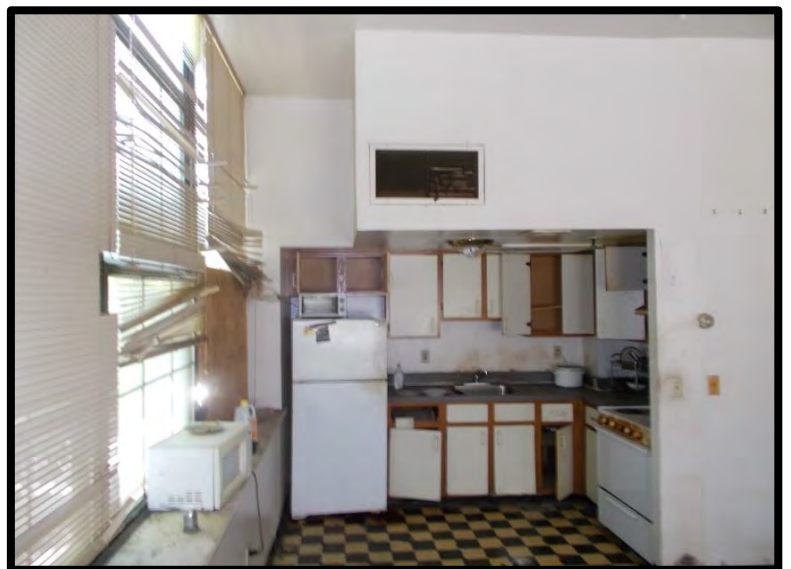
**Photo No. 56**

View of kitchen from living room.

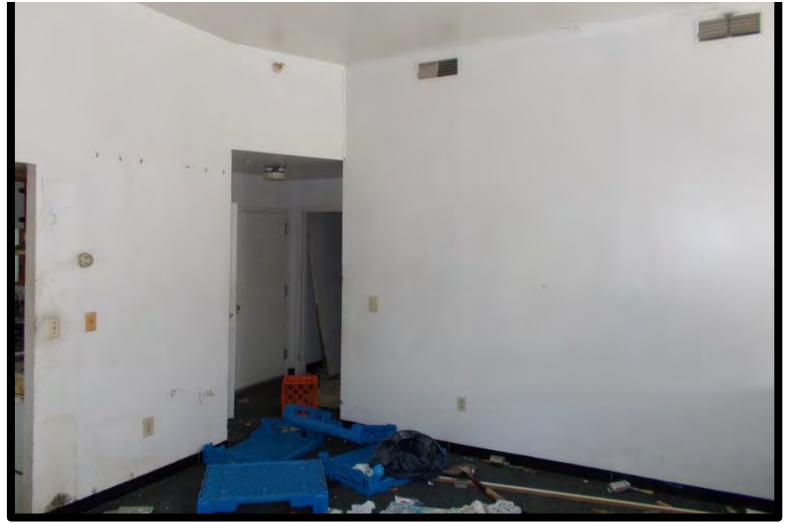
**Photo No. 57**

View looking towards entry from living room.

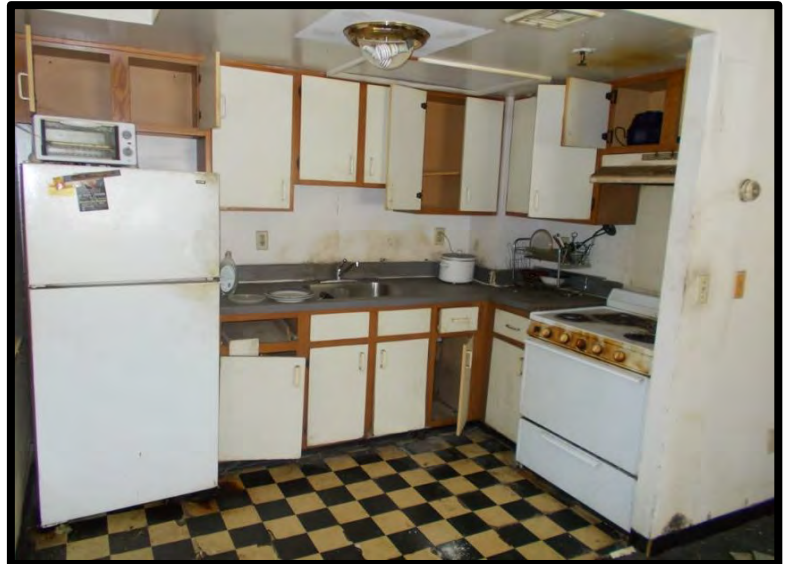
**Photo No. 58**

Additional view of kitchen.

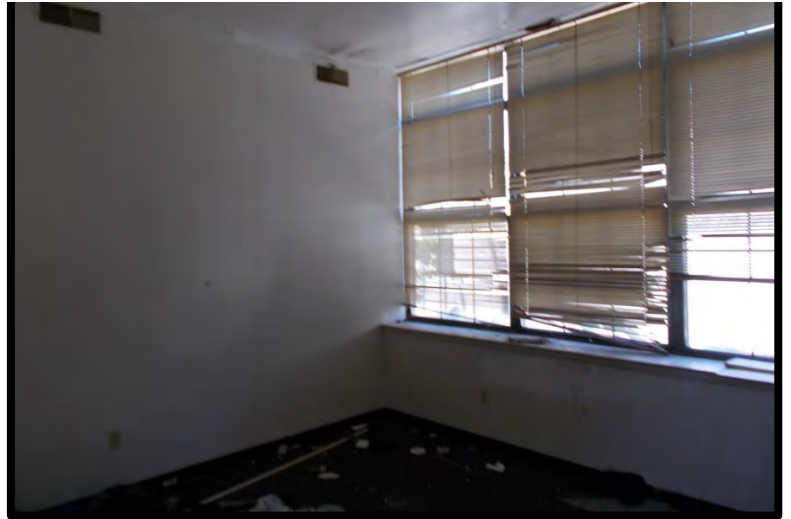
**Photo No. 59**

Looking towards shared wall between bedroom and living room.

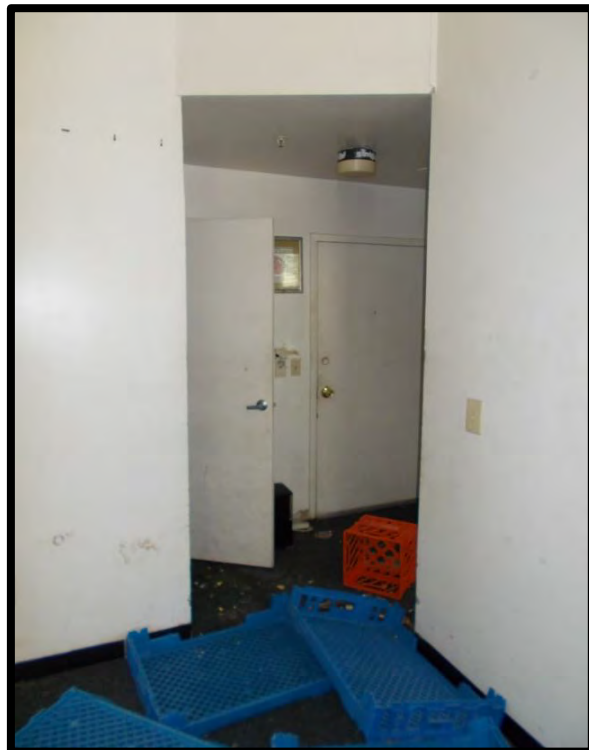
**Photo No. 60**

View of entry.

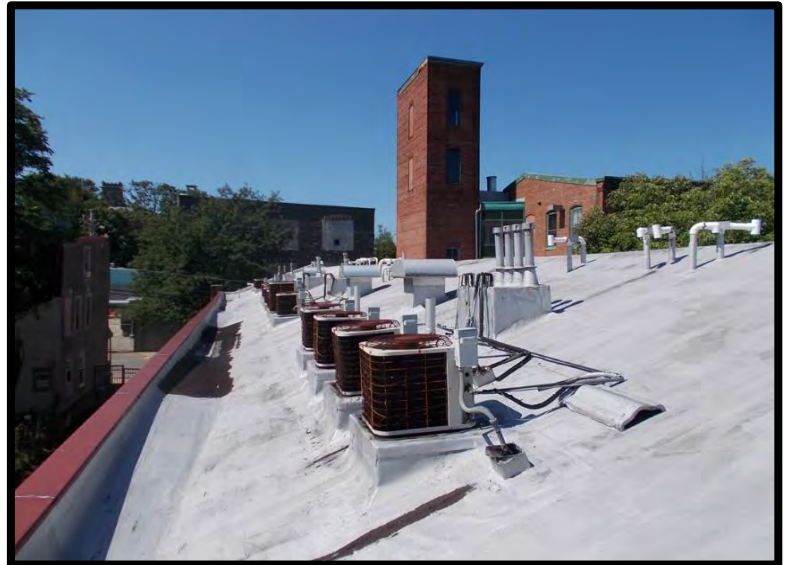
**Photo No. 63**

View looking west along rooftop. Depicted in photo are the condensing units for all apartments.

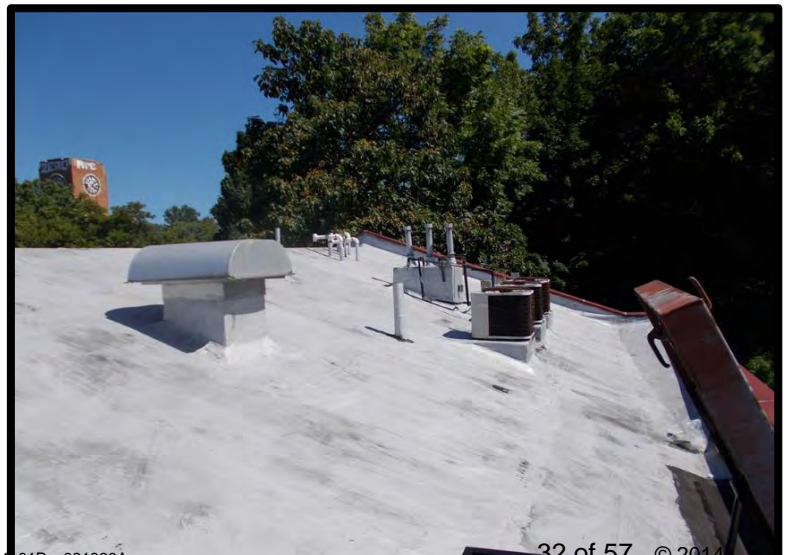
**Photo No. 65**

Panning right from previous photo.

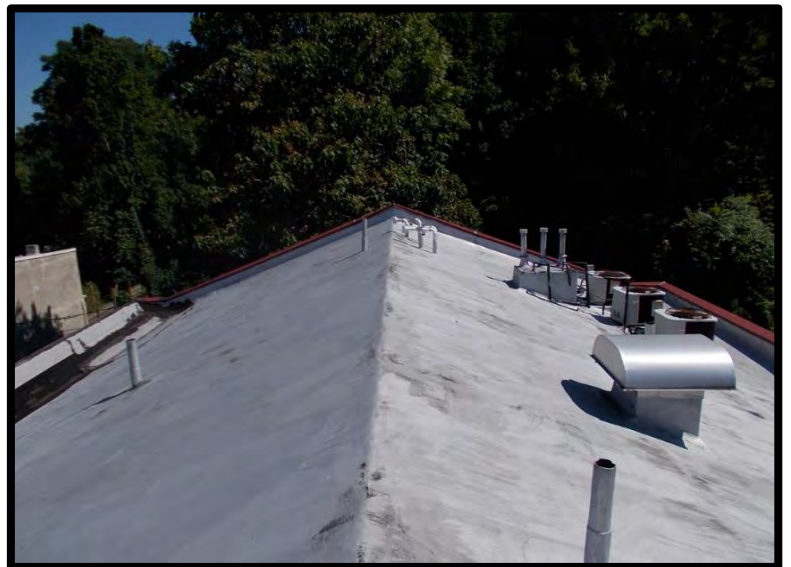
**Photo No. 67**

View looking east across rooftop.

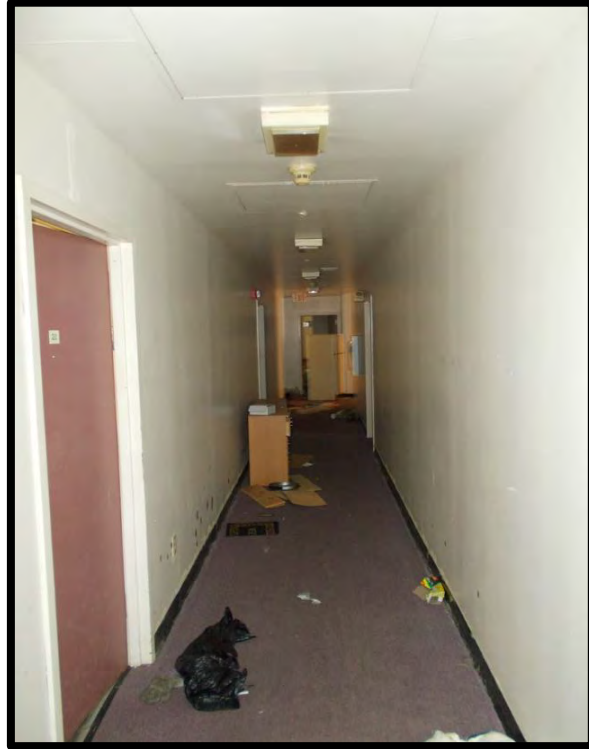
**Photo No. 70**

Ditto previous photo.

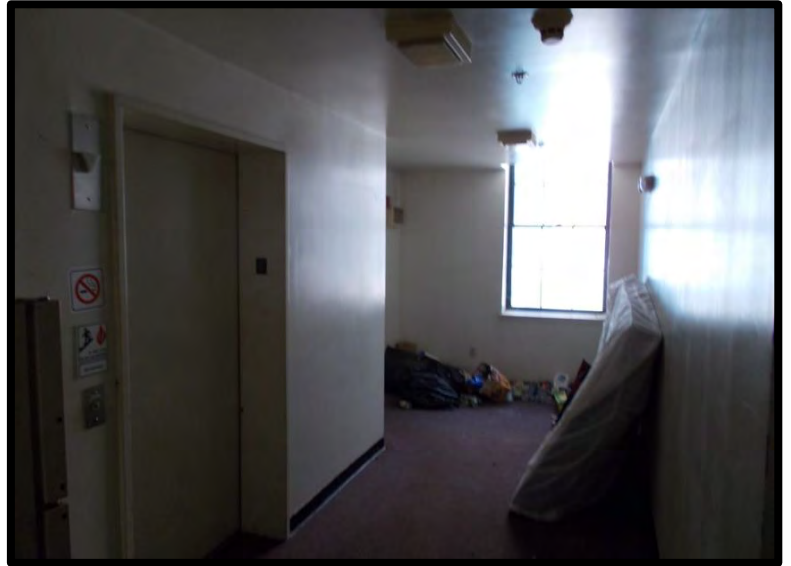
**Photo No. 72**

View of west exit stair entrance and elevator lobby.

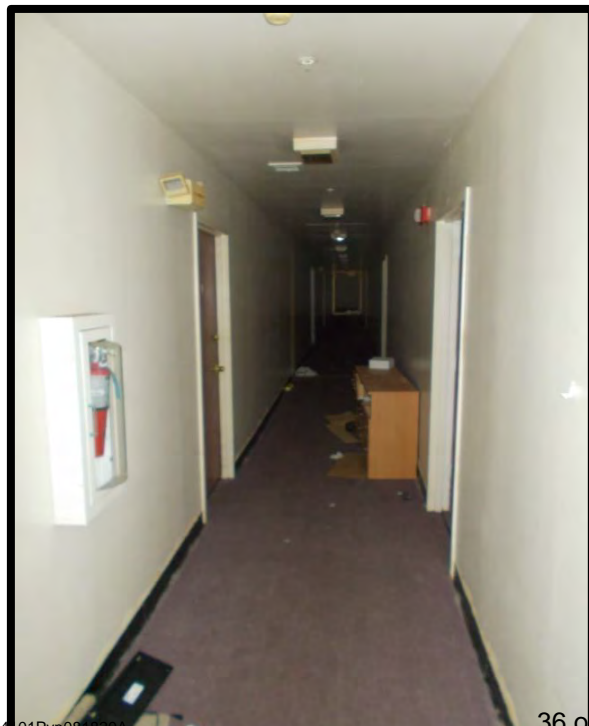
**Photo No. 73**

View looking east along second floor corridor.

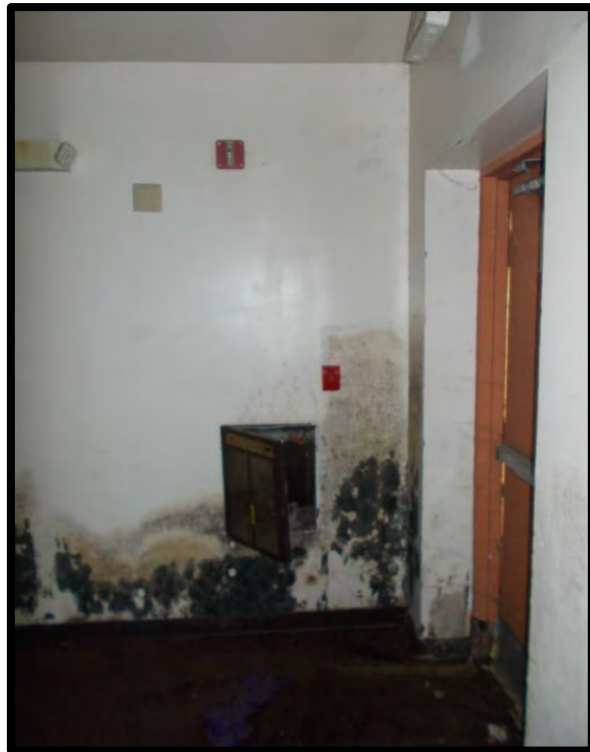
**Photo No. 78**

View of first floor landing. Door at right leads to exterior. South parking area.

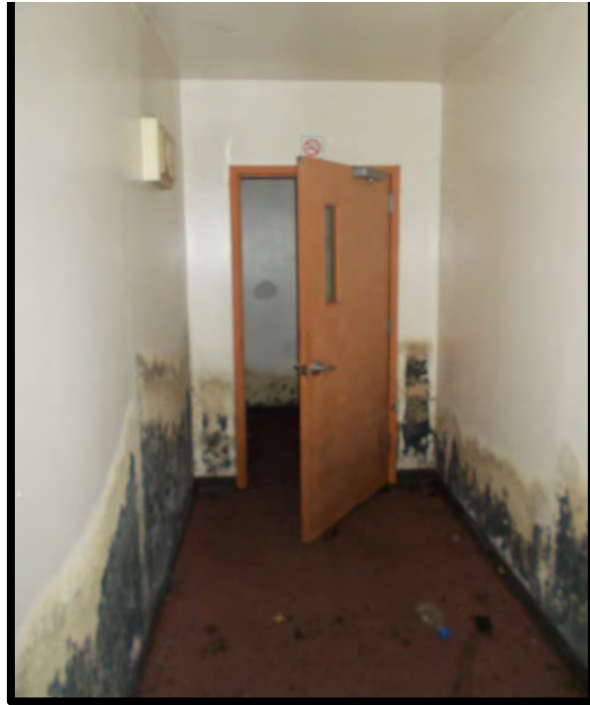
**Photo No. 79**

View looking towards exit door from first floor corridor.

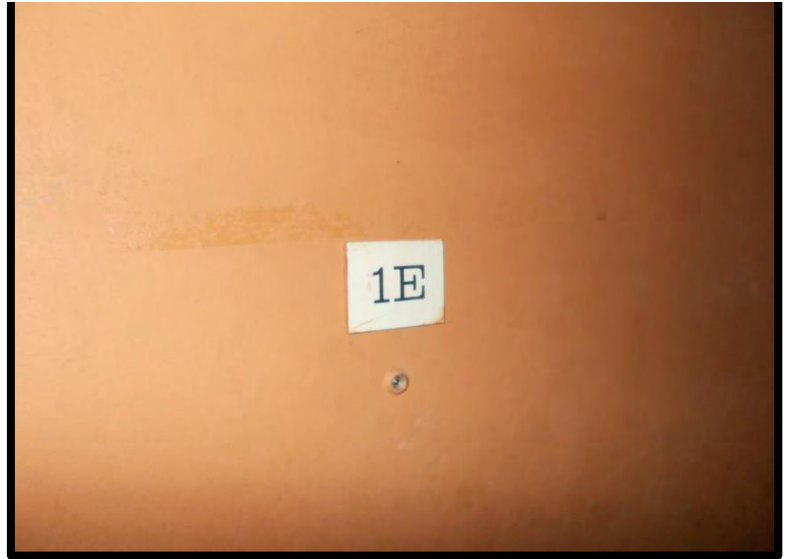
Photo No. 81

Unit 1E.

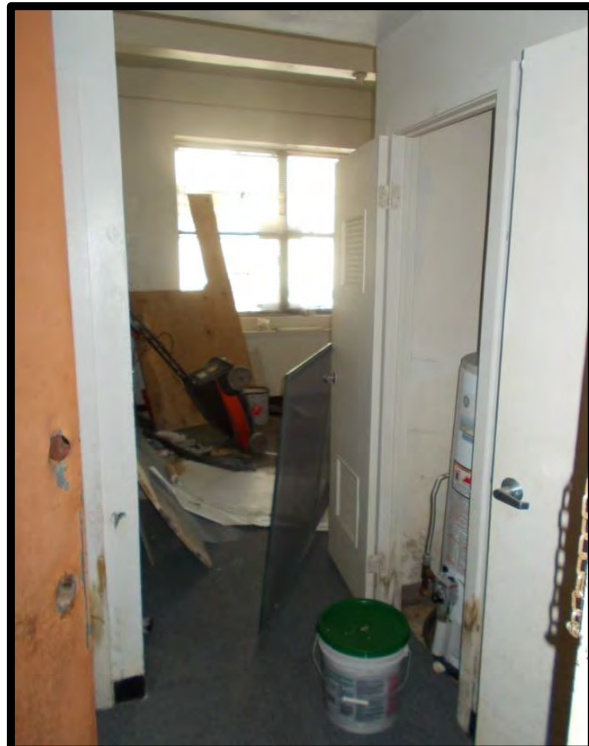
Photo No. 82

View looking towards living room. Hot water heater located at right of photo.

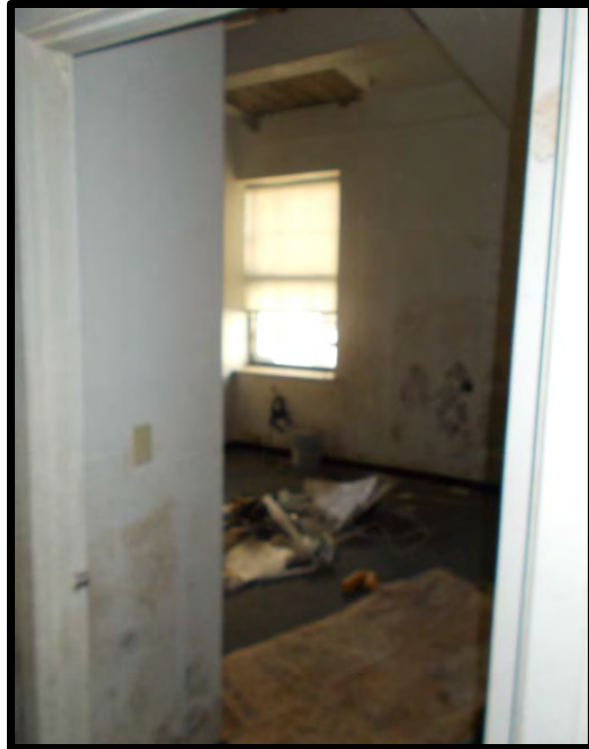
**Photo No. 83**

View into bedroom.

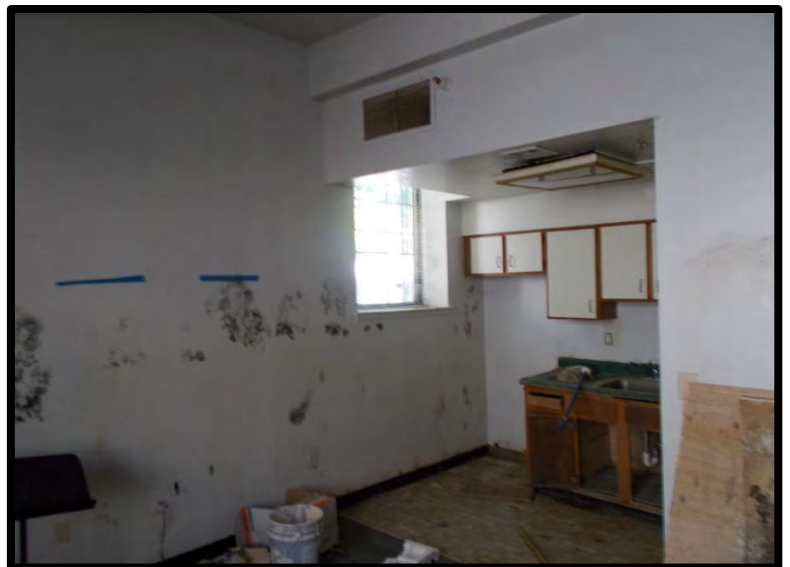
**Photo No. 86**

View of kitchen from living room.

*Cabinets and countertops are in poor condition and should be replaced.*

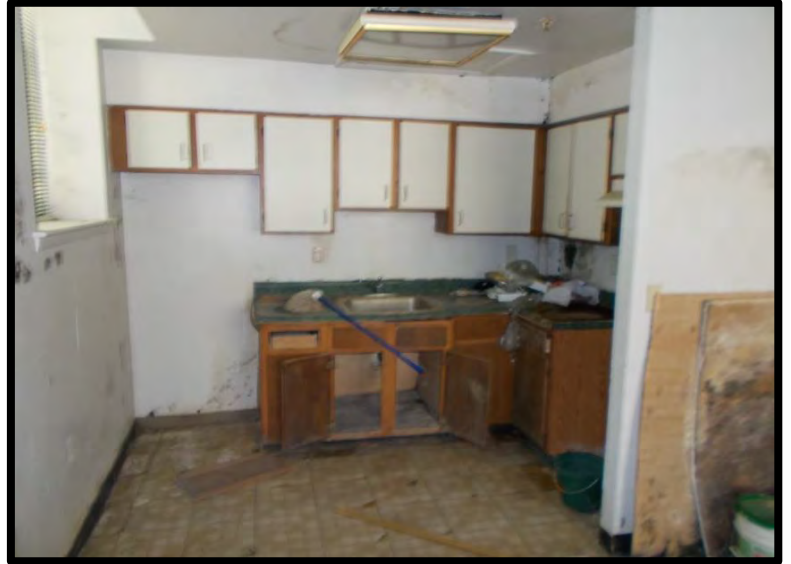
**Photo No. 87**

Additional view of kitchen.

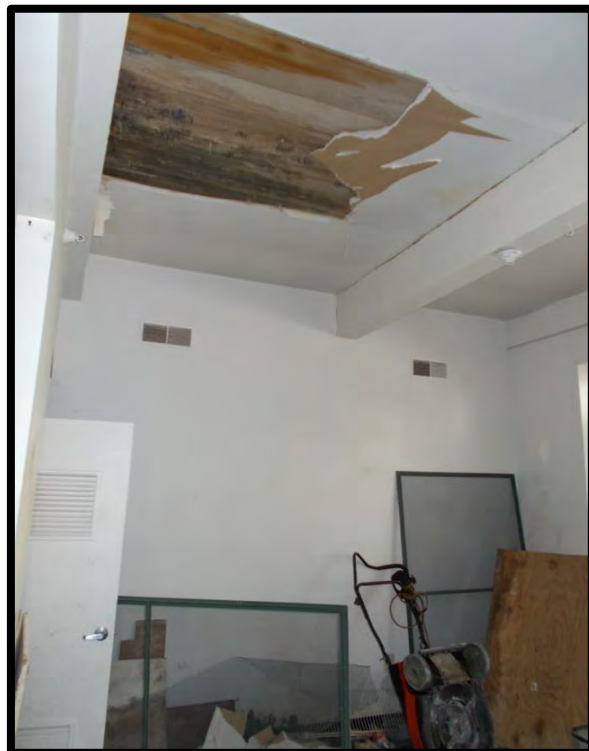
**Photo No. 88**

View of ceiling above living room entry.

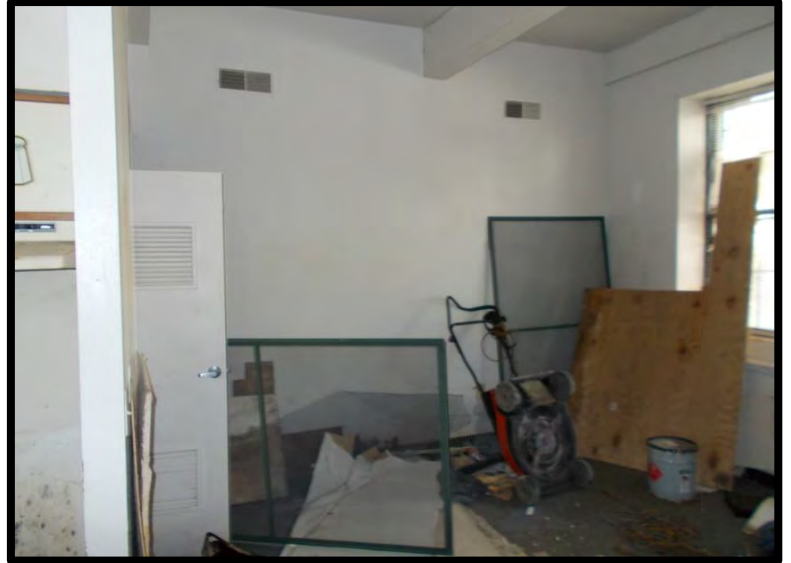
**Photo No. 89**

Panning down from previous photo. View of living room (shared wall with bedroom).

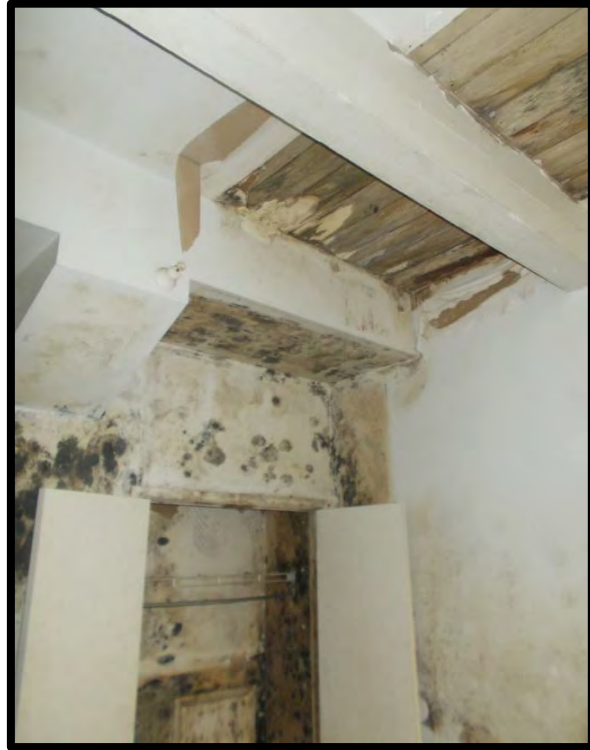
**Photo No. 91**

View of bedroom closet and ceiling above.

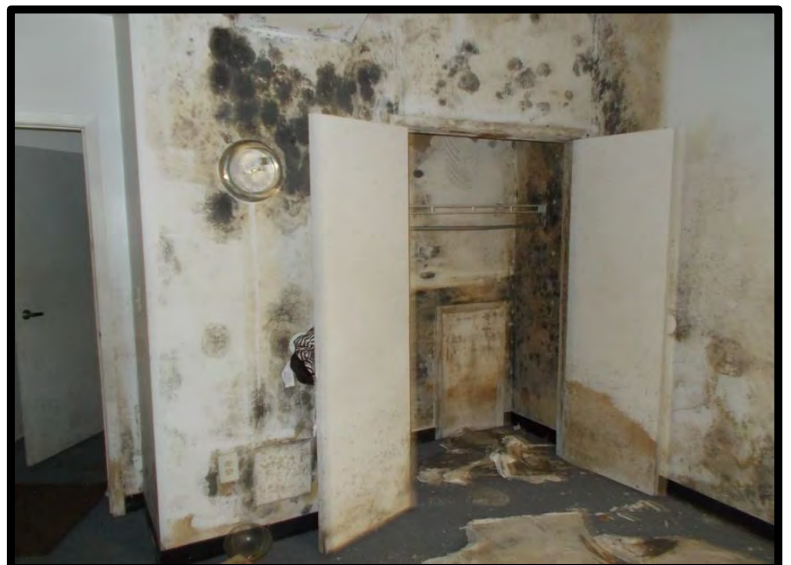
**Photo No. 92**

View of bedroom closet.

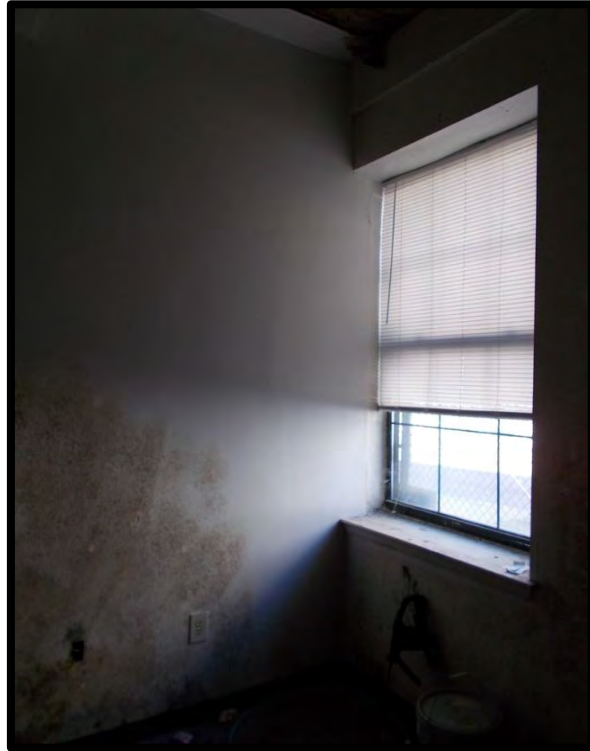
**Photo No. 93**

View of window located within bedroom.

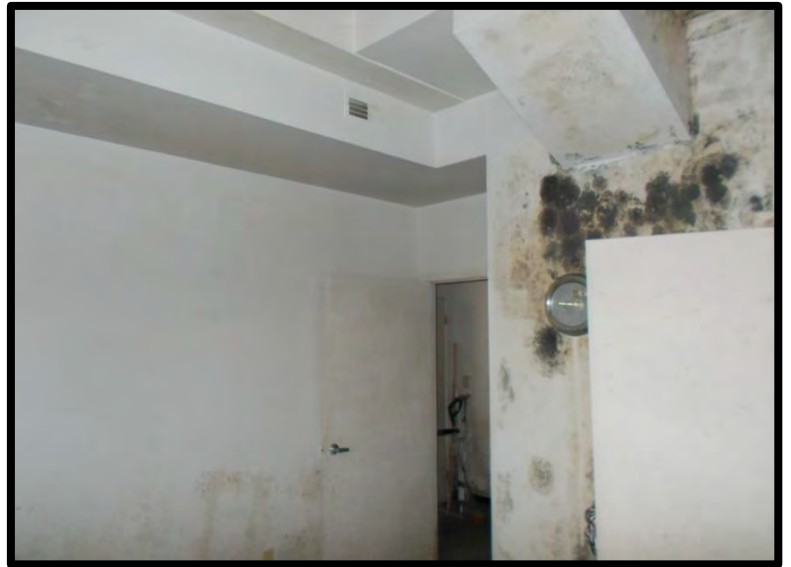
**Photo No. 95**

View of bedroom entry and ceiling.

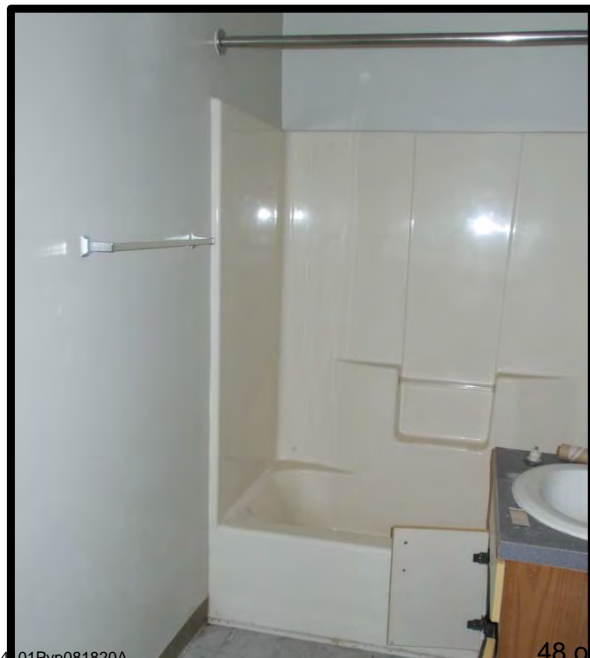
**Photo No. 96**

View of bathtub surround.

*Bathroom fixtures are in fair to poor condition and should be replaced.*

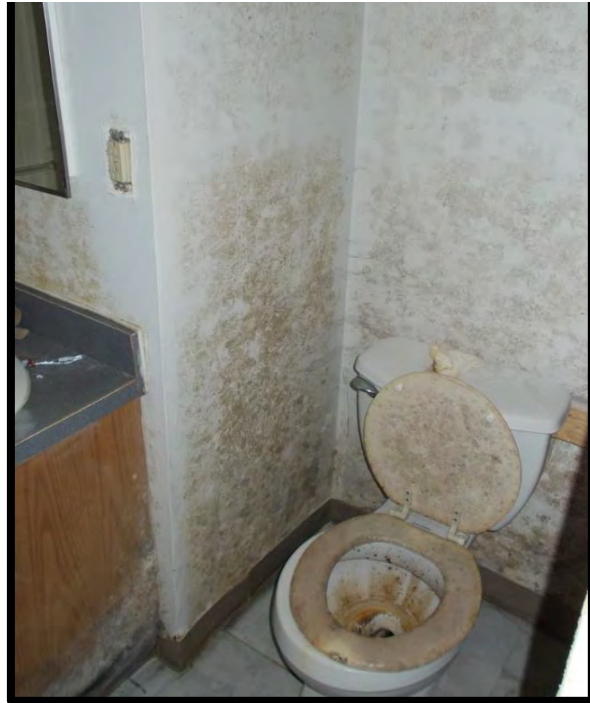
**Photo No. 98**

View of water closet.

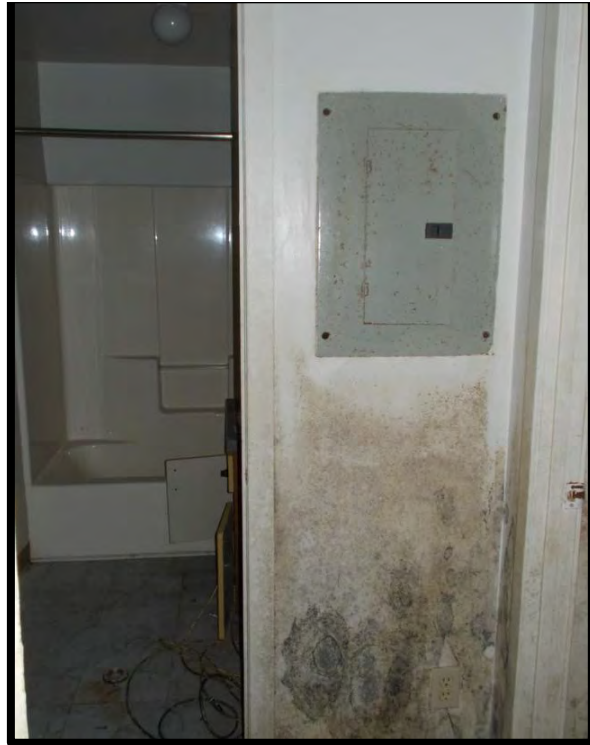
**Photo No. 100**

View looking into bathroom and apartment electrical panel at right.

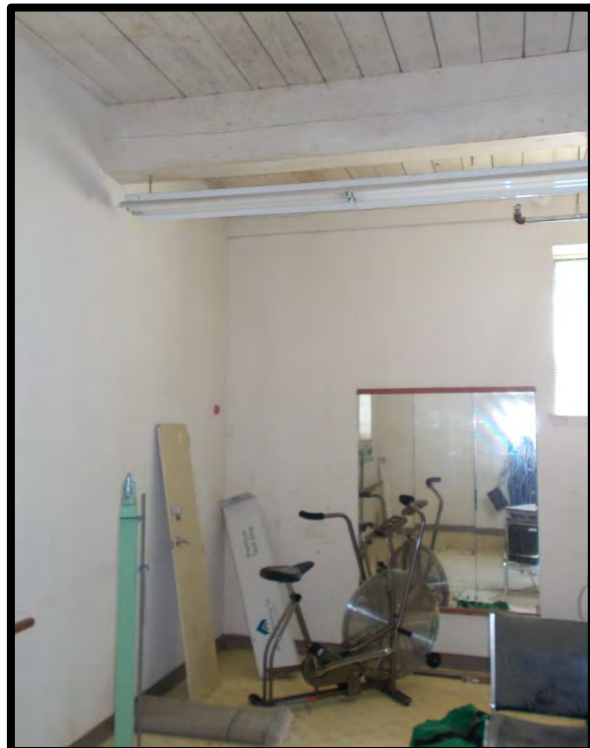
**Photo No. 101**

View inside what might be an exercise or craft room on the first floor.

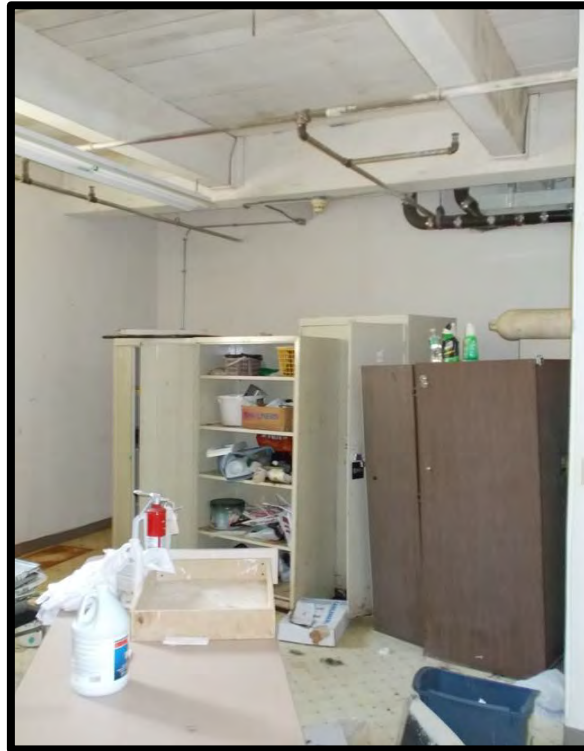
**Photo No. 102**

Additional view of exercise/craft room.

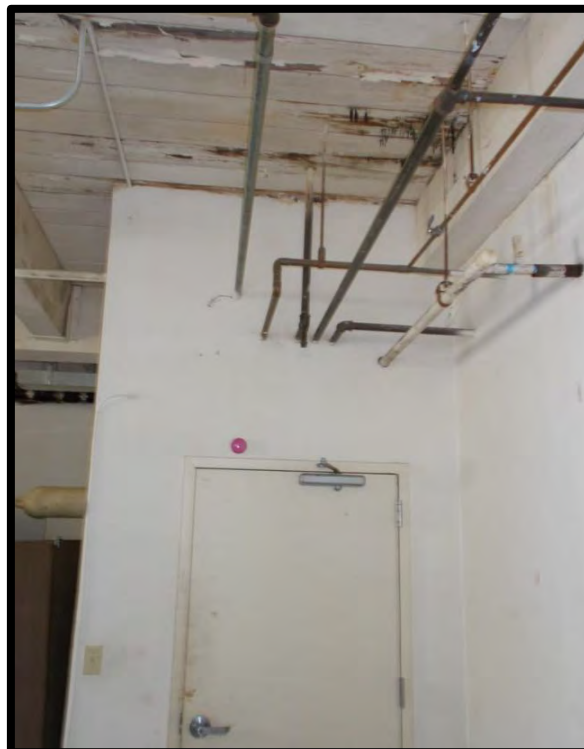
**Photo No. 103**

View at piping above entry to exercise/craft room.

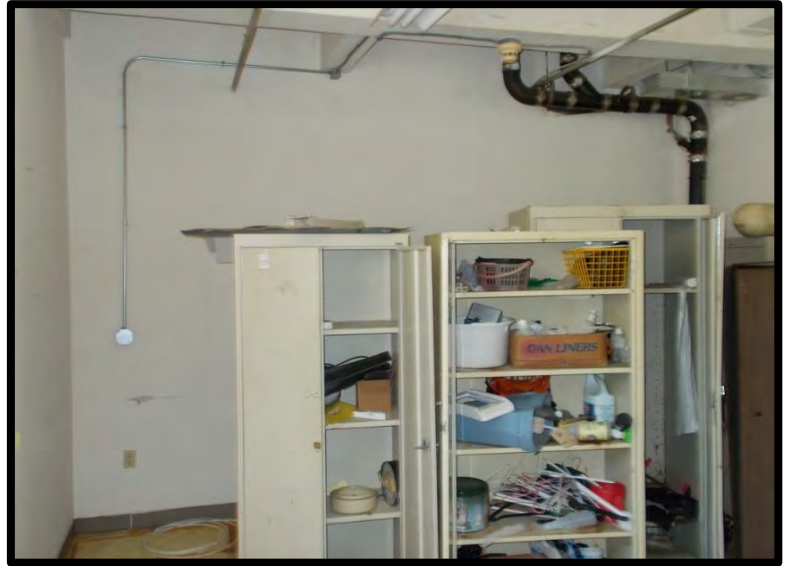
**Photo No. 104**

Ditto photo #102.

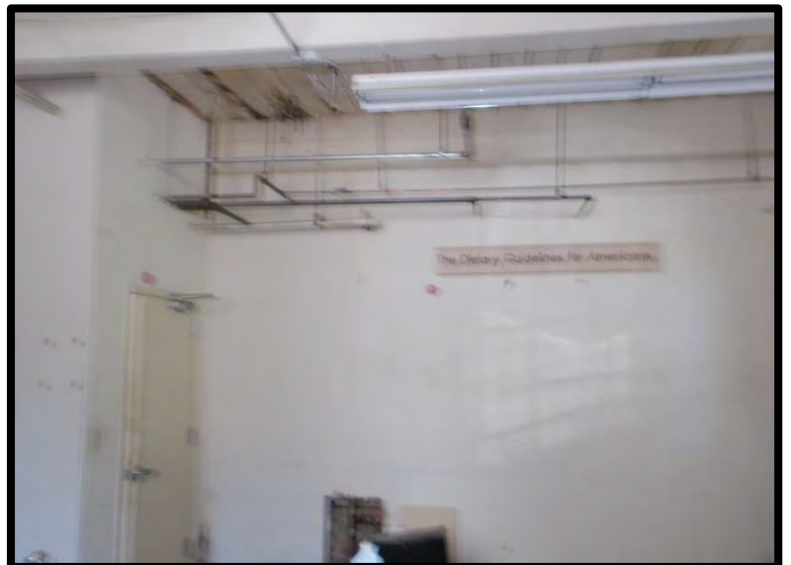
**Photo No. 105**

Ditto photo #103.

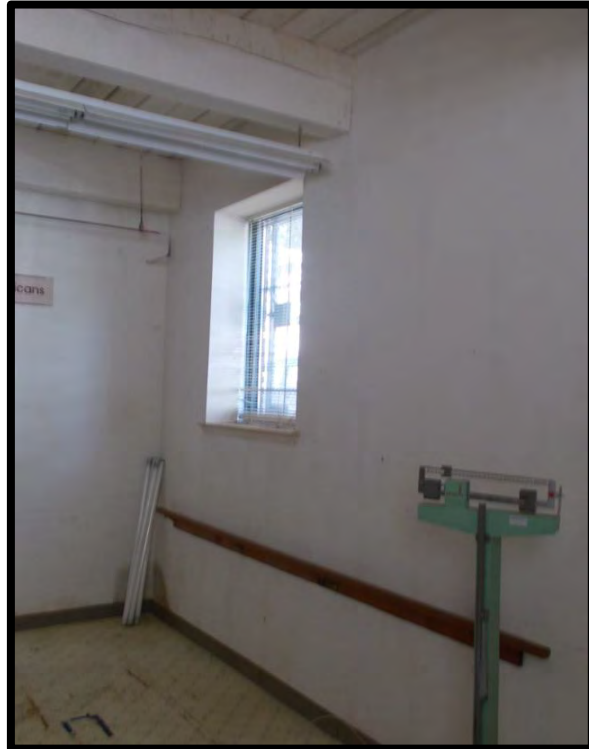
**Photo No. 106**

View of exterior wall at exercise/craft room.

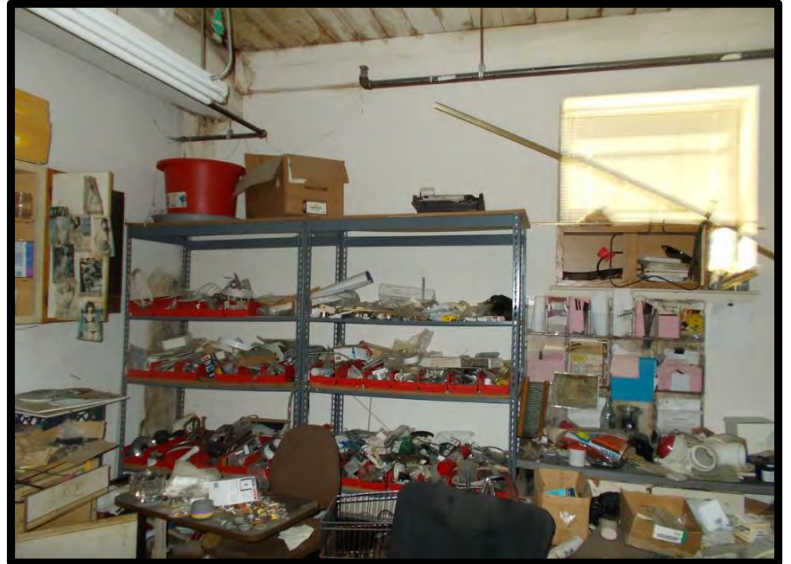
**Photo No. 110**

Panning left from previous photo.

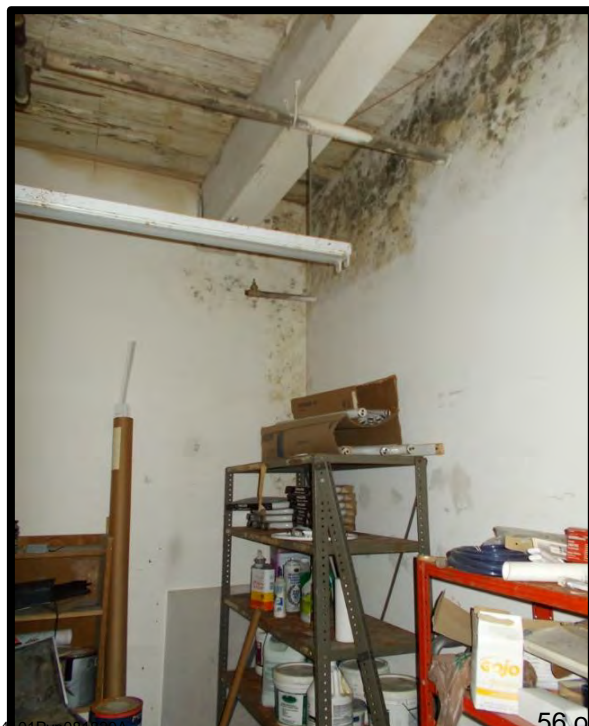
**Photo No. 111**

Panning right from photo #109.

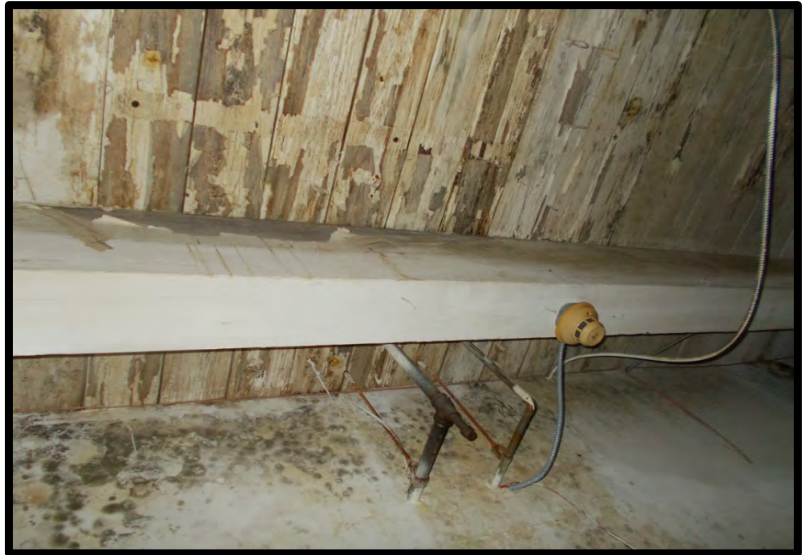
**Photo No. 115**

Depicts view of workshop ceiling.
