# Germantown/Mount Airy Properties

## Physical Conditions and Needs Assessment

### Premises Y

**5423-27 Lena Street**

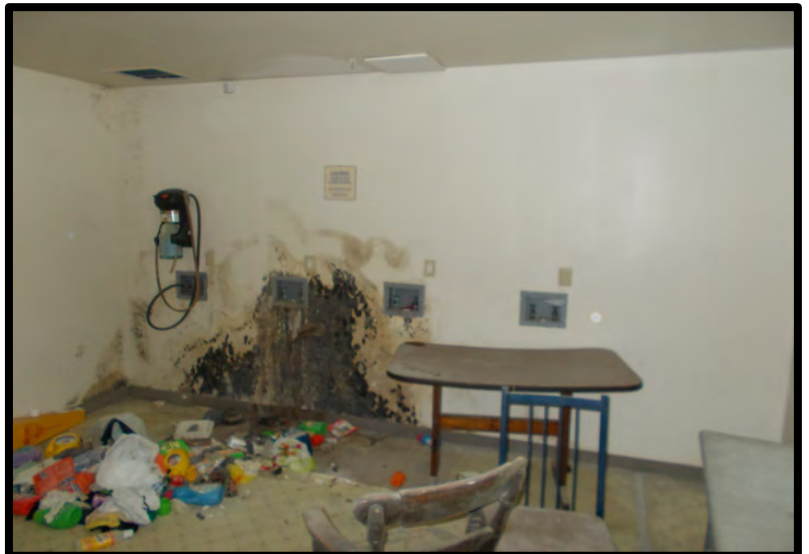
**Photo No. 116**

Depicts view of laundry area and washer hookups.

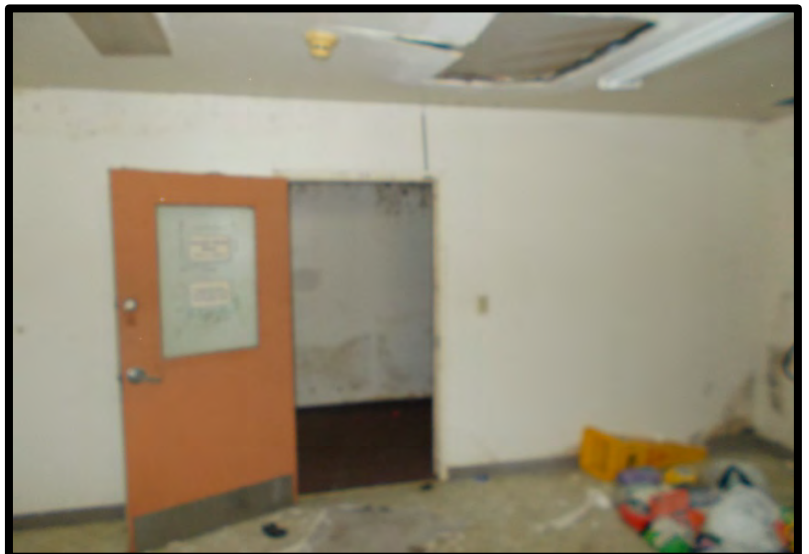
**Photo No. 117**

View of laundry room entry from corridor.

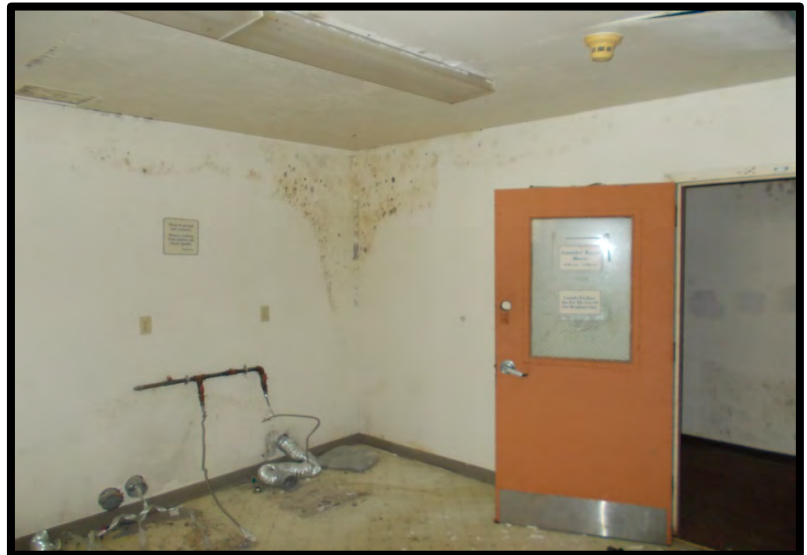
**Photo No. 118**

Panning left from previous photo. Pictured are the gas connections for dryers as well as the exhaust ductwork.

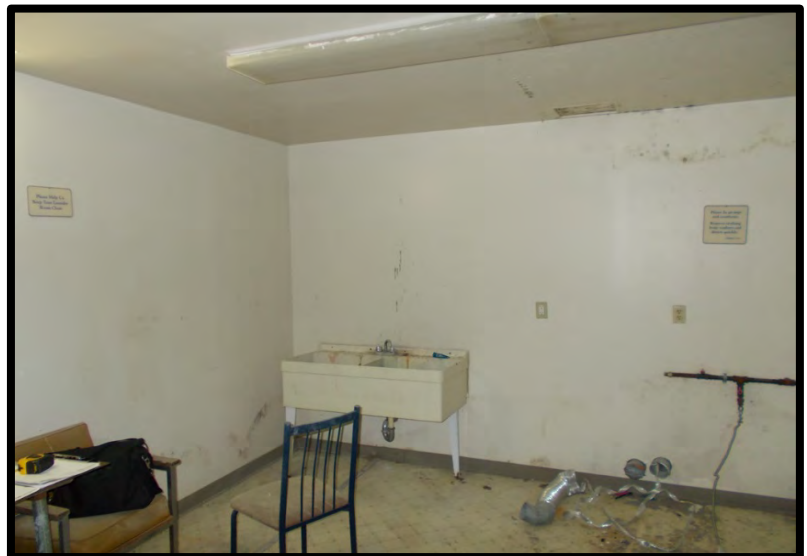
**Photo No. 119**

Panning left from previous photo. Gas hookup on right and double basin utility sink on left.

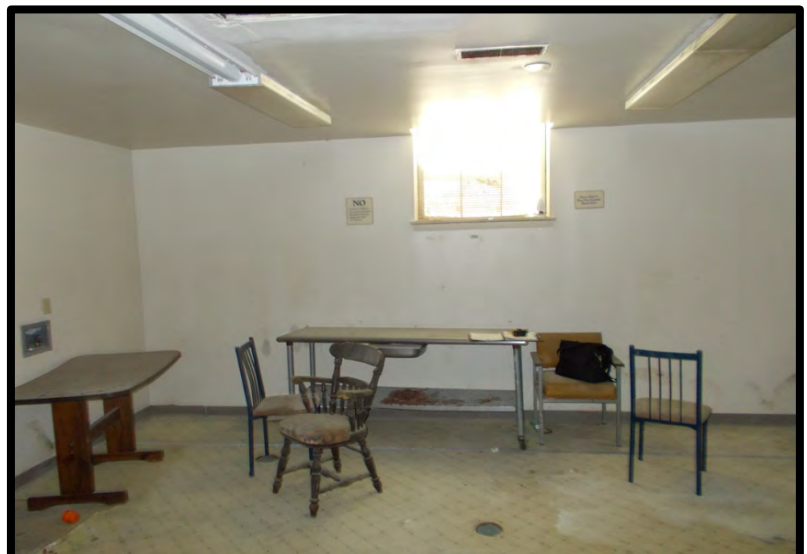
**Photo No. 120**

View of exterior wall at laundry room.

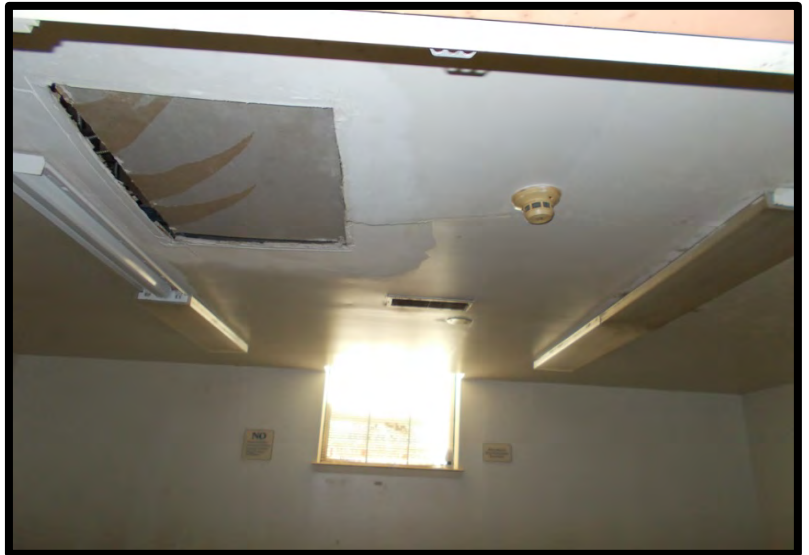
**Photo No. 121**

Panning up from previous photo. View of laundry room ceiling.

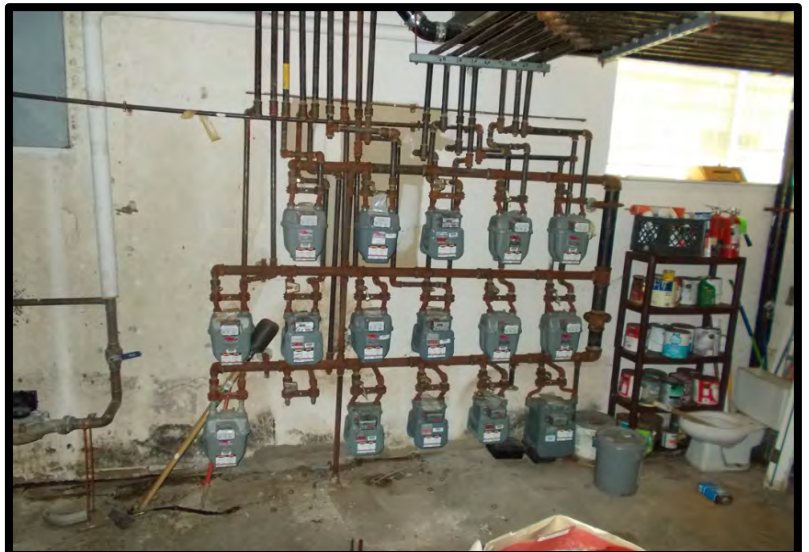
**Photo No. 122**

Depicts view of gas meters.

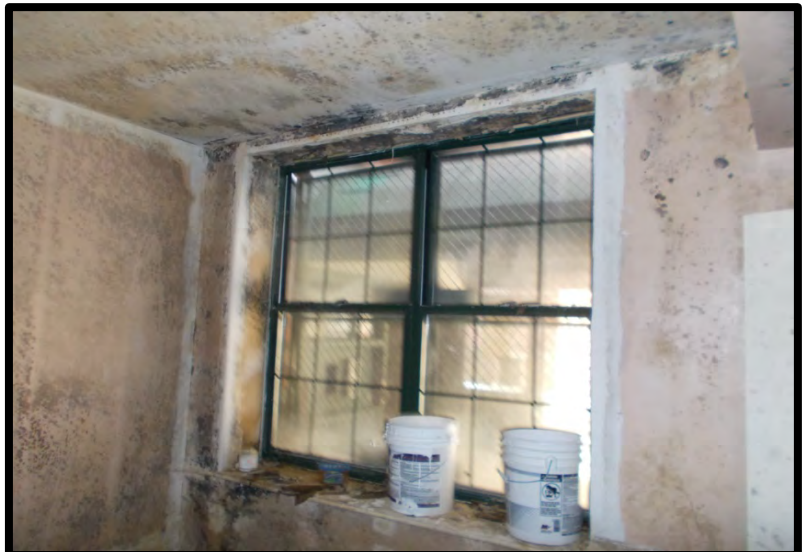
**Photo No. 159**

View of exterior wall in bedroom. Note, windows do not meet ADA compliance for reach.

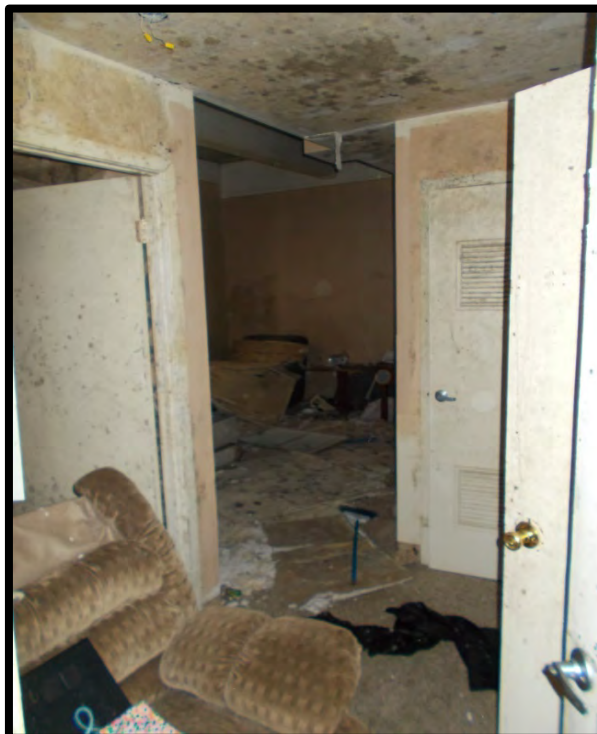
**Photo No. 164**

View at living room, bedroom and entry from bathroom. Note that not all door hardware is lever style in compliance with ADA requirements.

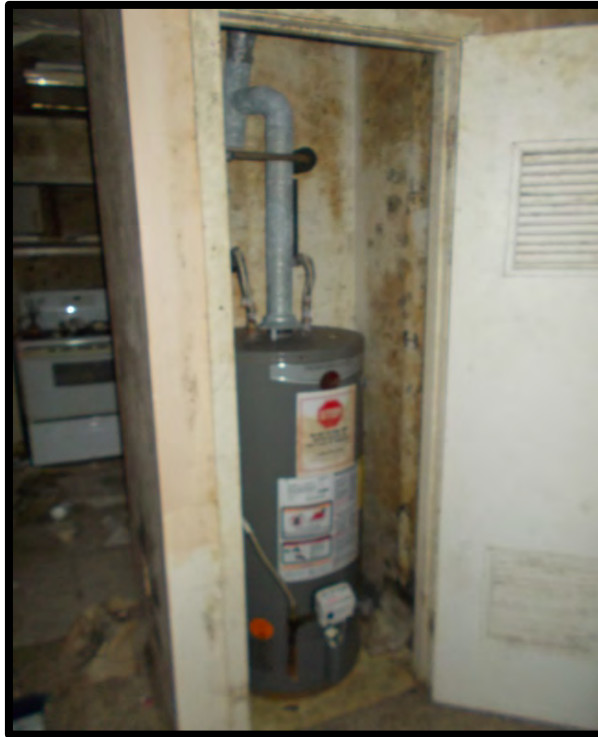
**Photo No. 165**

View of installed hot water heater.

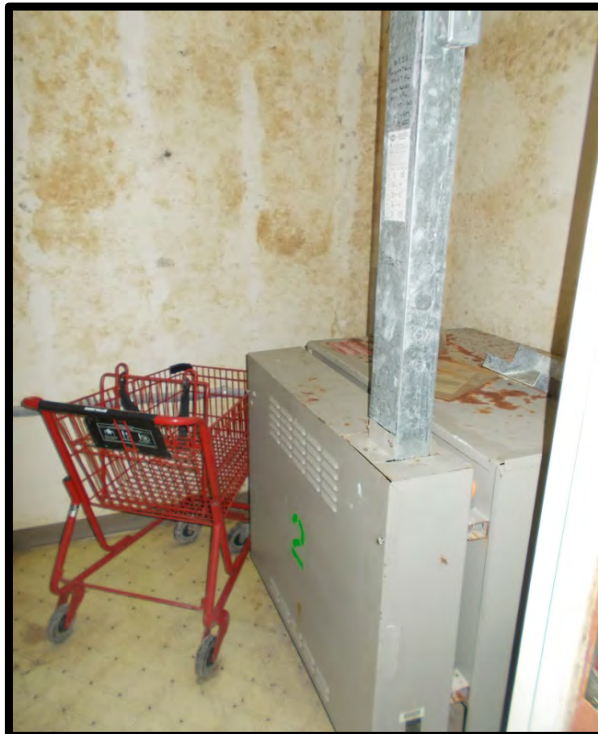
**Photo No. 168**

View of elevator machine equipment.

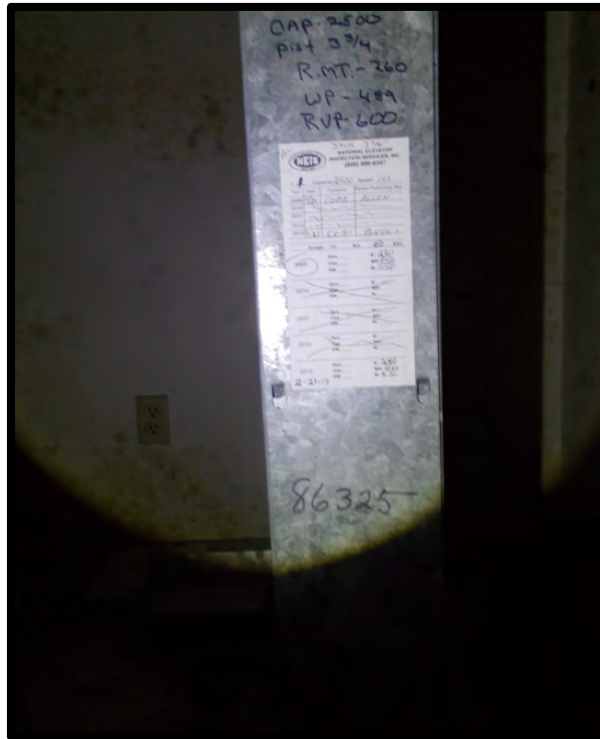
**Photo No. 171**

View of elevator inspection sticker.

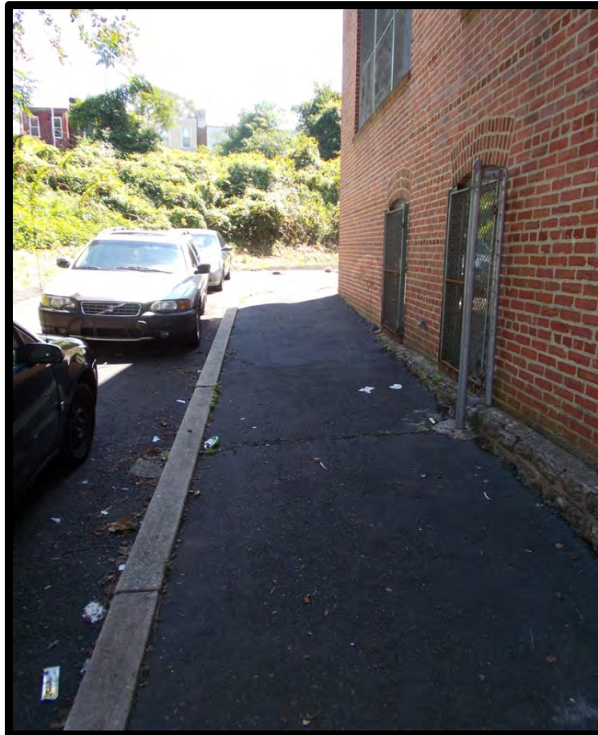
**Photo No. 201**

View of asphalt sidewalk along east side of building.

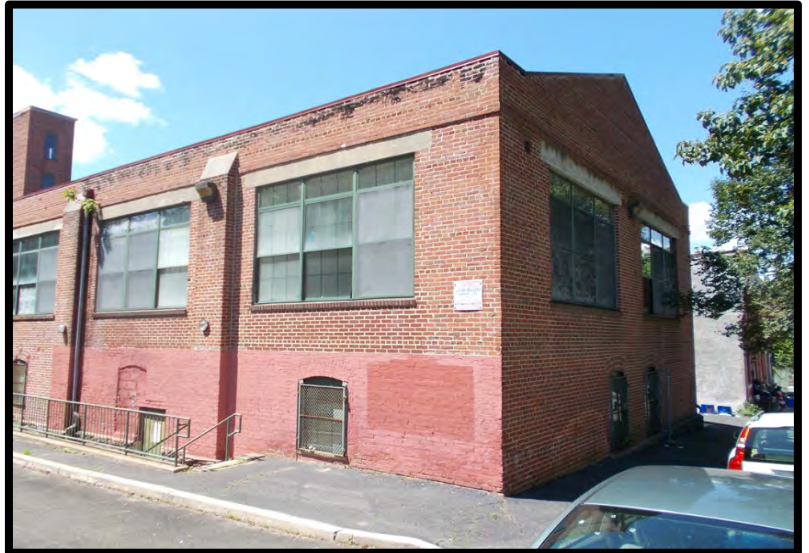
**Photo No. 203**

View of south façade, east side, showing discoloration at parapet and vegetative growth along second floor windows.

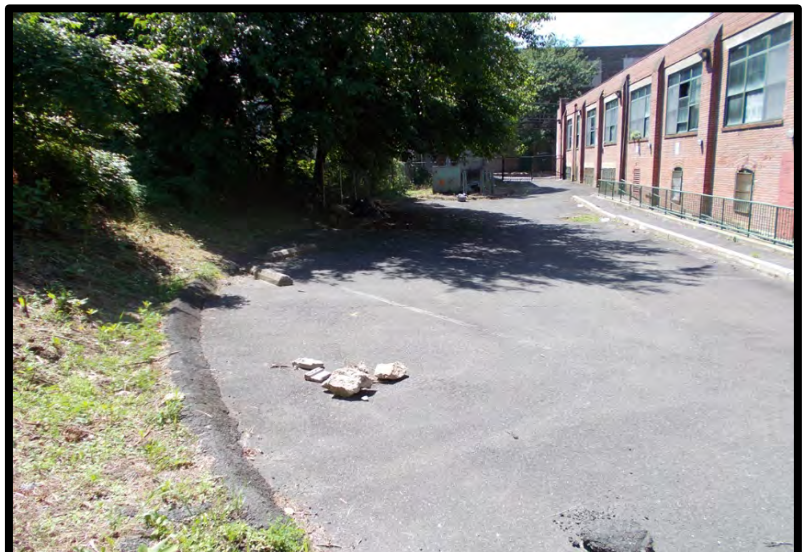
**Photo No. 205**

View of south parking area and asphalt curbing.

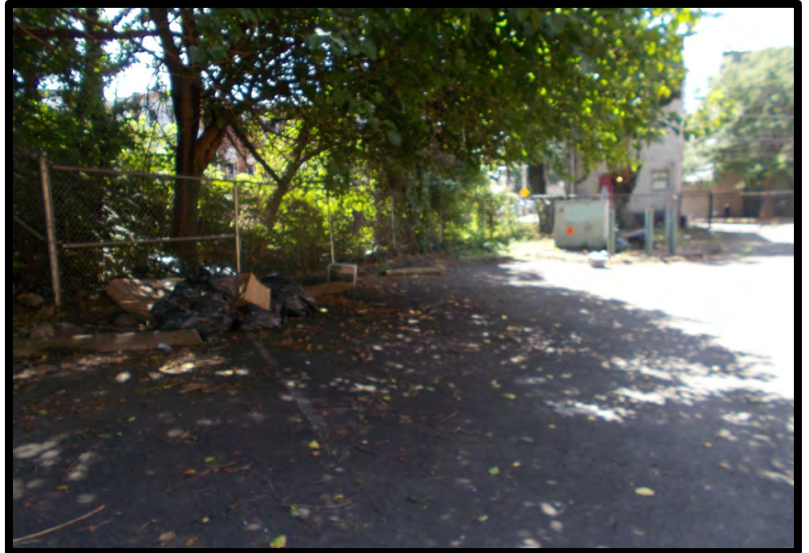
**Photo No. 209**

Panning left from previous photo.

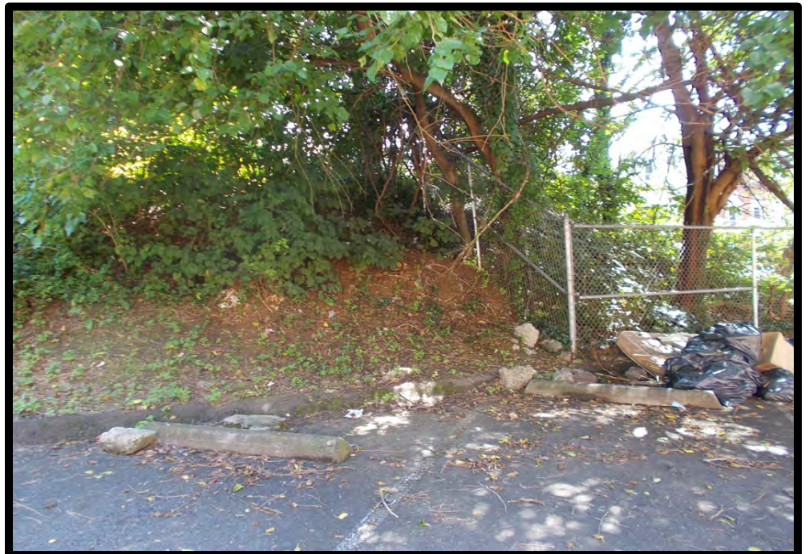
**Photo No. 210**

Panning left from previous photo.

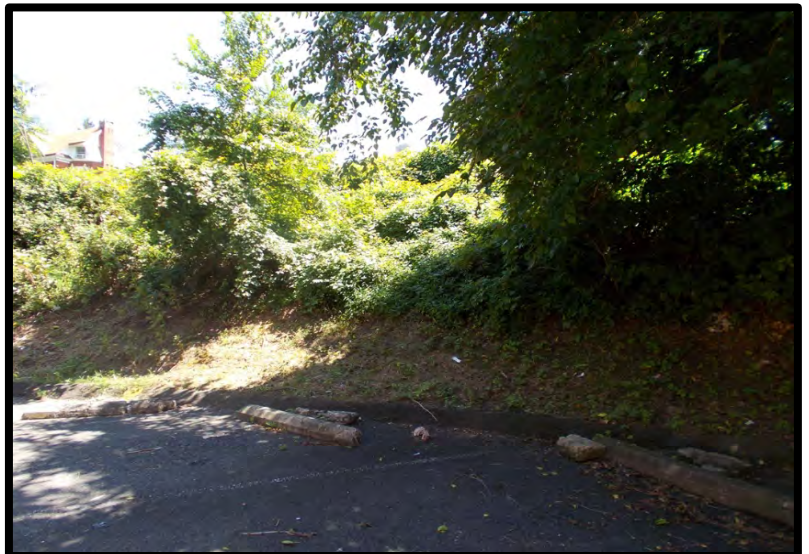
**Photo No. 211**

Panning left from previous photo.

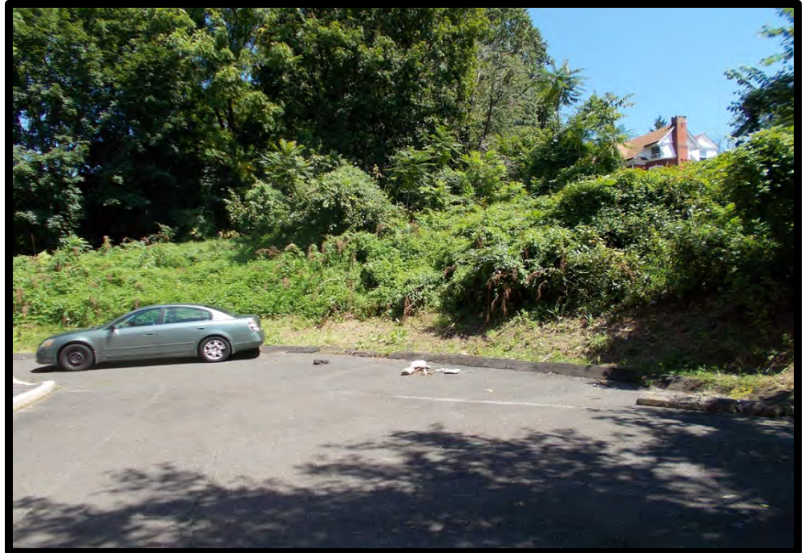
**Photo No. 212**

Panning left from previous photo.

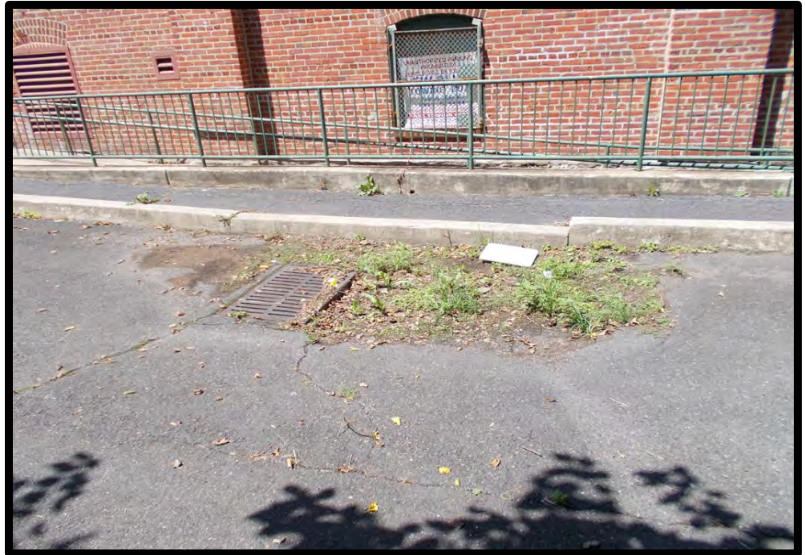
**Photo No. 215**

Additional view of south façade, west side.

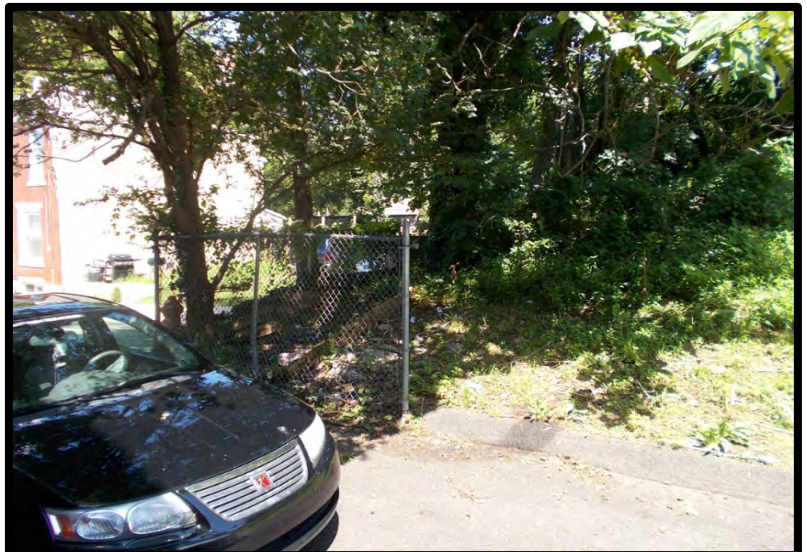
**Photo No. 221**

View looking west along north side of building. Concrete and asphalt sidewalk will require replacement.

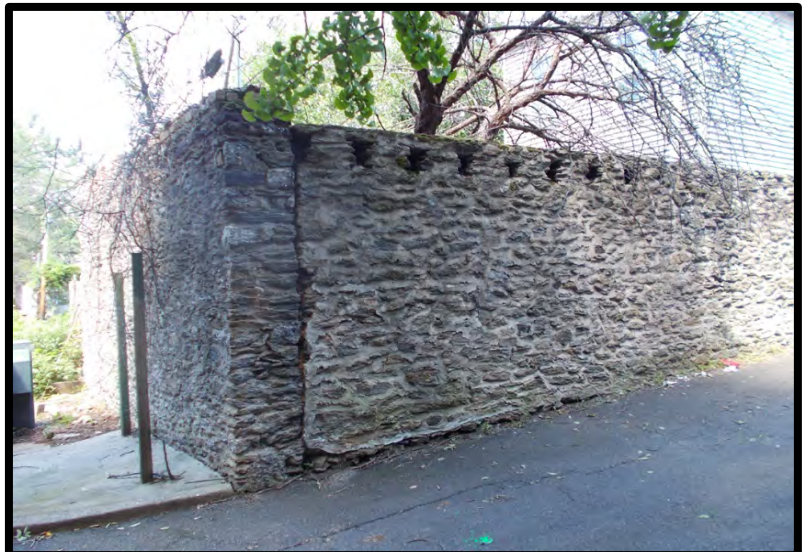
Additional view of stone retaining wall.

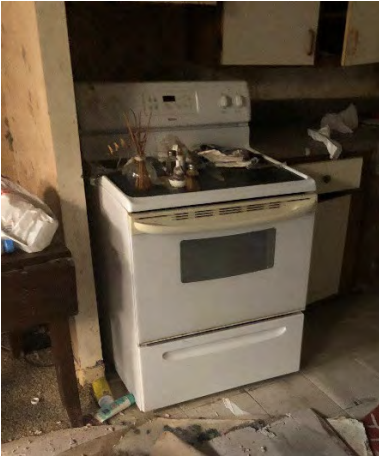
Unit 1a kitchen.

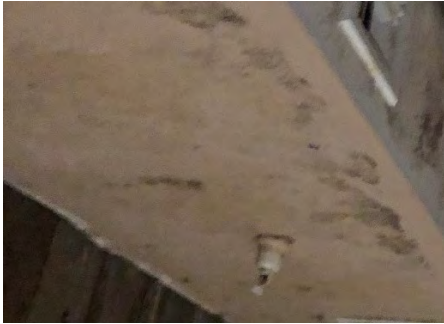
Sprinkler head in Unit A.
